# National Transportation Safety Board

CEN22LA141

## **MATERIALS LABORATORY**

Factual Report 23-012

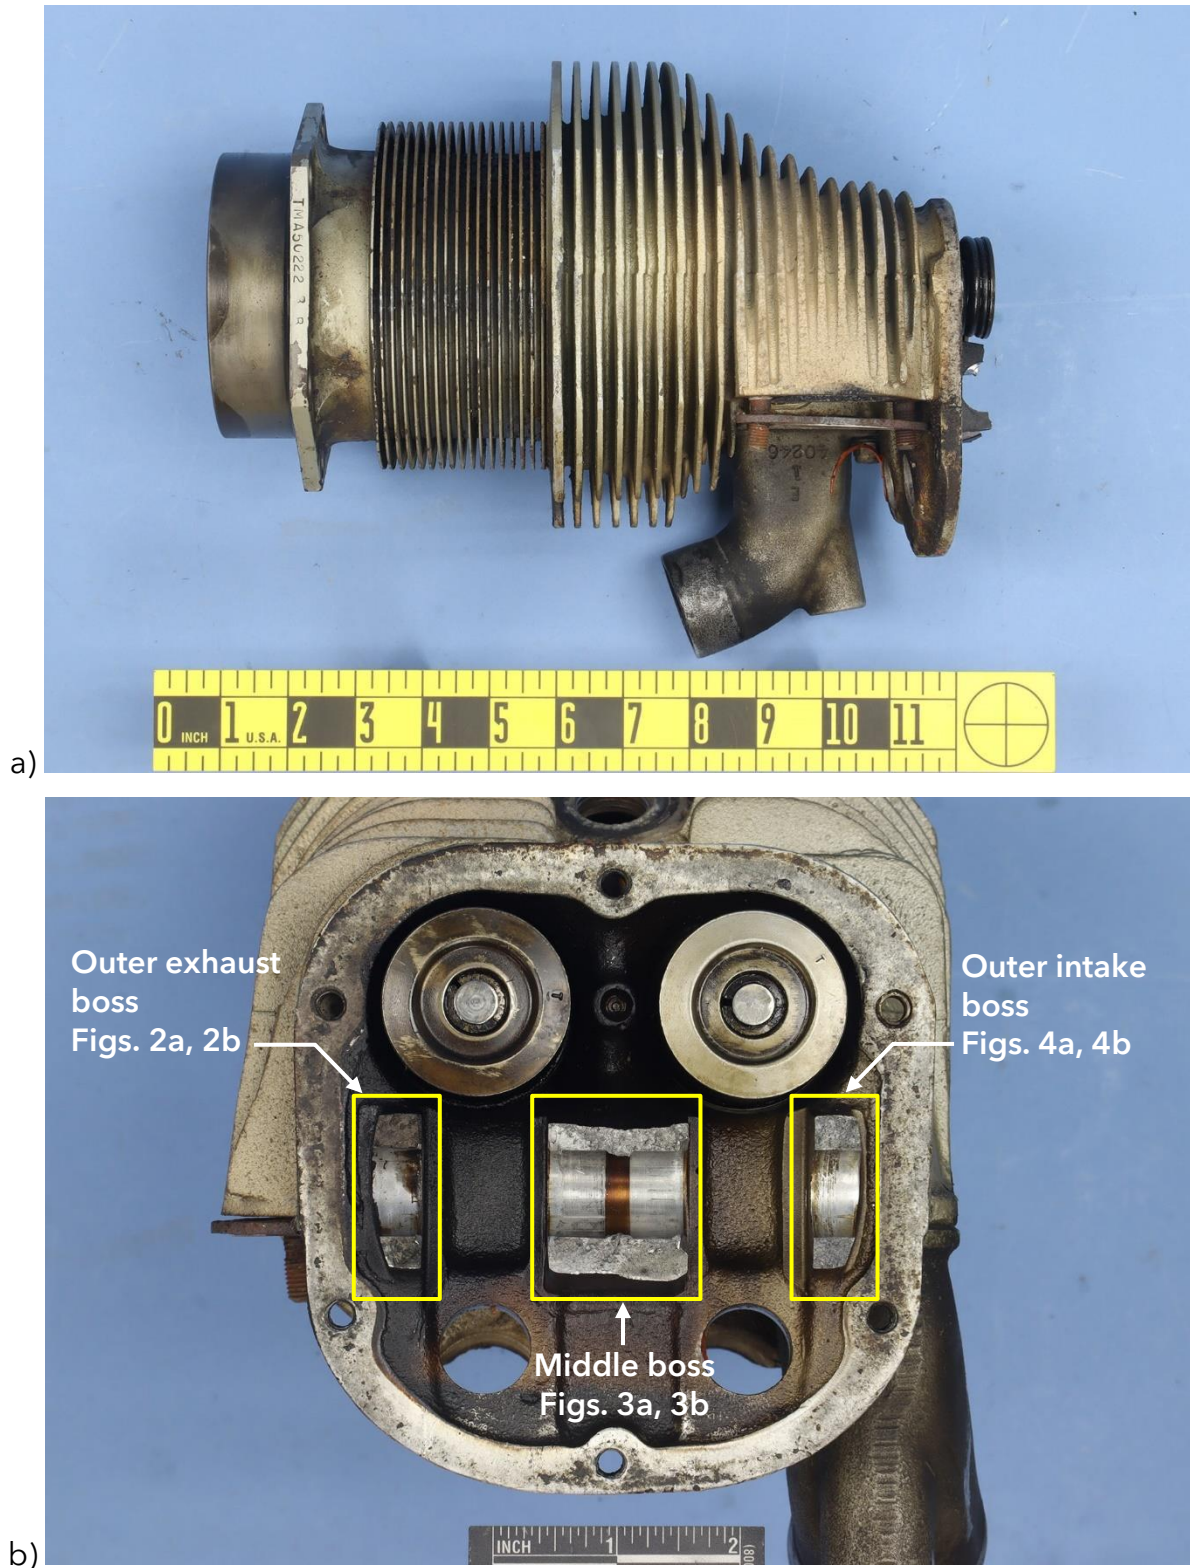
The number 1 cylinder assembly from a Continental Motors O-200-A was submitted to the NTSB Materials Laboratory for examination as shown in figures 1a and 1b. As indicated in figure 1b, the bosses supporting the exhaust and intake rocker shafts had fractured. The fracture surfaces were examined with the aid of a stereomicroscope and are shown in greater detail in figures 2 - 4.

**Figure 1.** Number 1 cylinder assembly as received: a) view of cylinder side and b) view of rocker box with fractured rocker shaft bosses, as indicated.

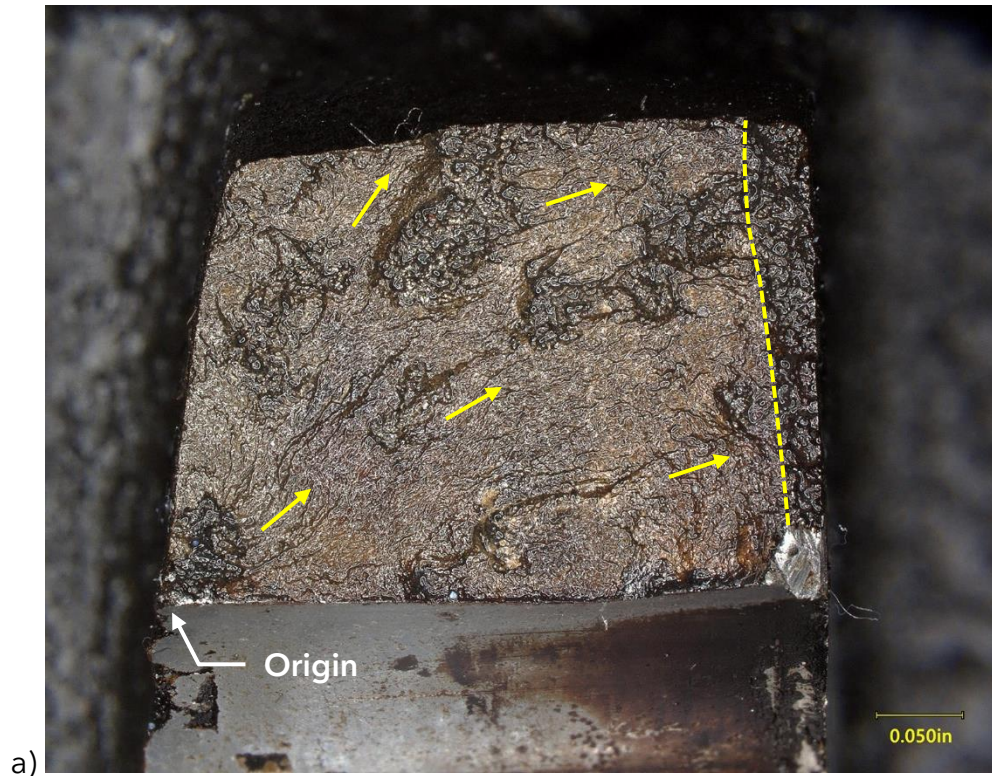
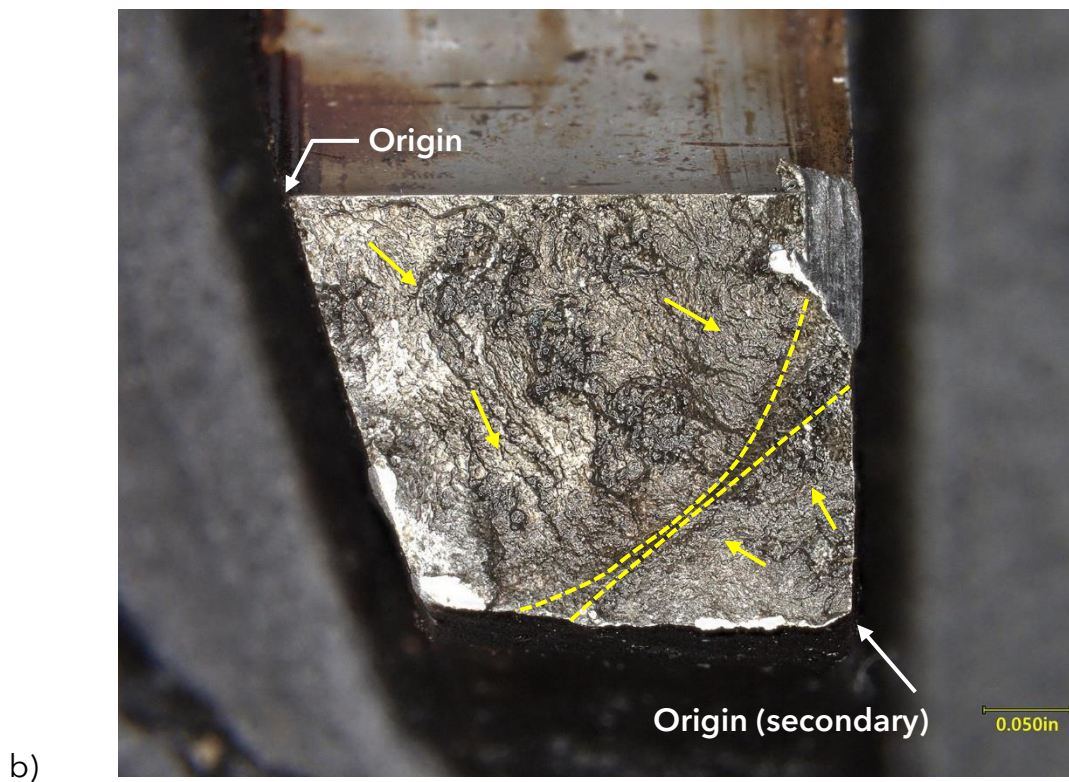
Features consistent with fatigue crack initiation and progression were observed on the bosses supporting the exhaust rocker shaft. The upper and lower fractures on the outer boss are shown in figures 2a and 2b, respectively. The fracture surfaces were tinted and had a flat feathery appearance across most of the fractures with radial lines progressing away from the outer edges of the rocker shaft bore hole. The origin areas did not exhibit any notable features. The features were consistent with fatigue crack initiation at and progression from the bore hole. On the lower fracture surface, a secondary fatigue crack was observed initiating at the lower inner corner of the boss, which progressed toward the primary crack, the two cracks meeting along a final overstress parting line. The percentage of fatigue crack progression on the upper and lower fractures, measured on calibrated digital images, was 93% and 94%, respectively.

**Figure 2.** Outer exhaust rocker shaft boss fractures: a) upper fracture and b) lower fracture. Yellow arrows indicate the local direction of crack propagation. The yellow dashed lines indicate approximate transition from fatigue to overstress.

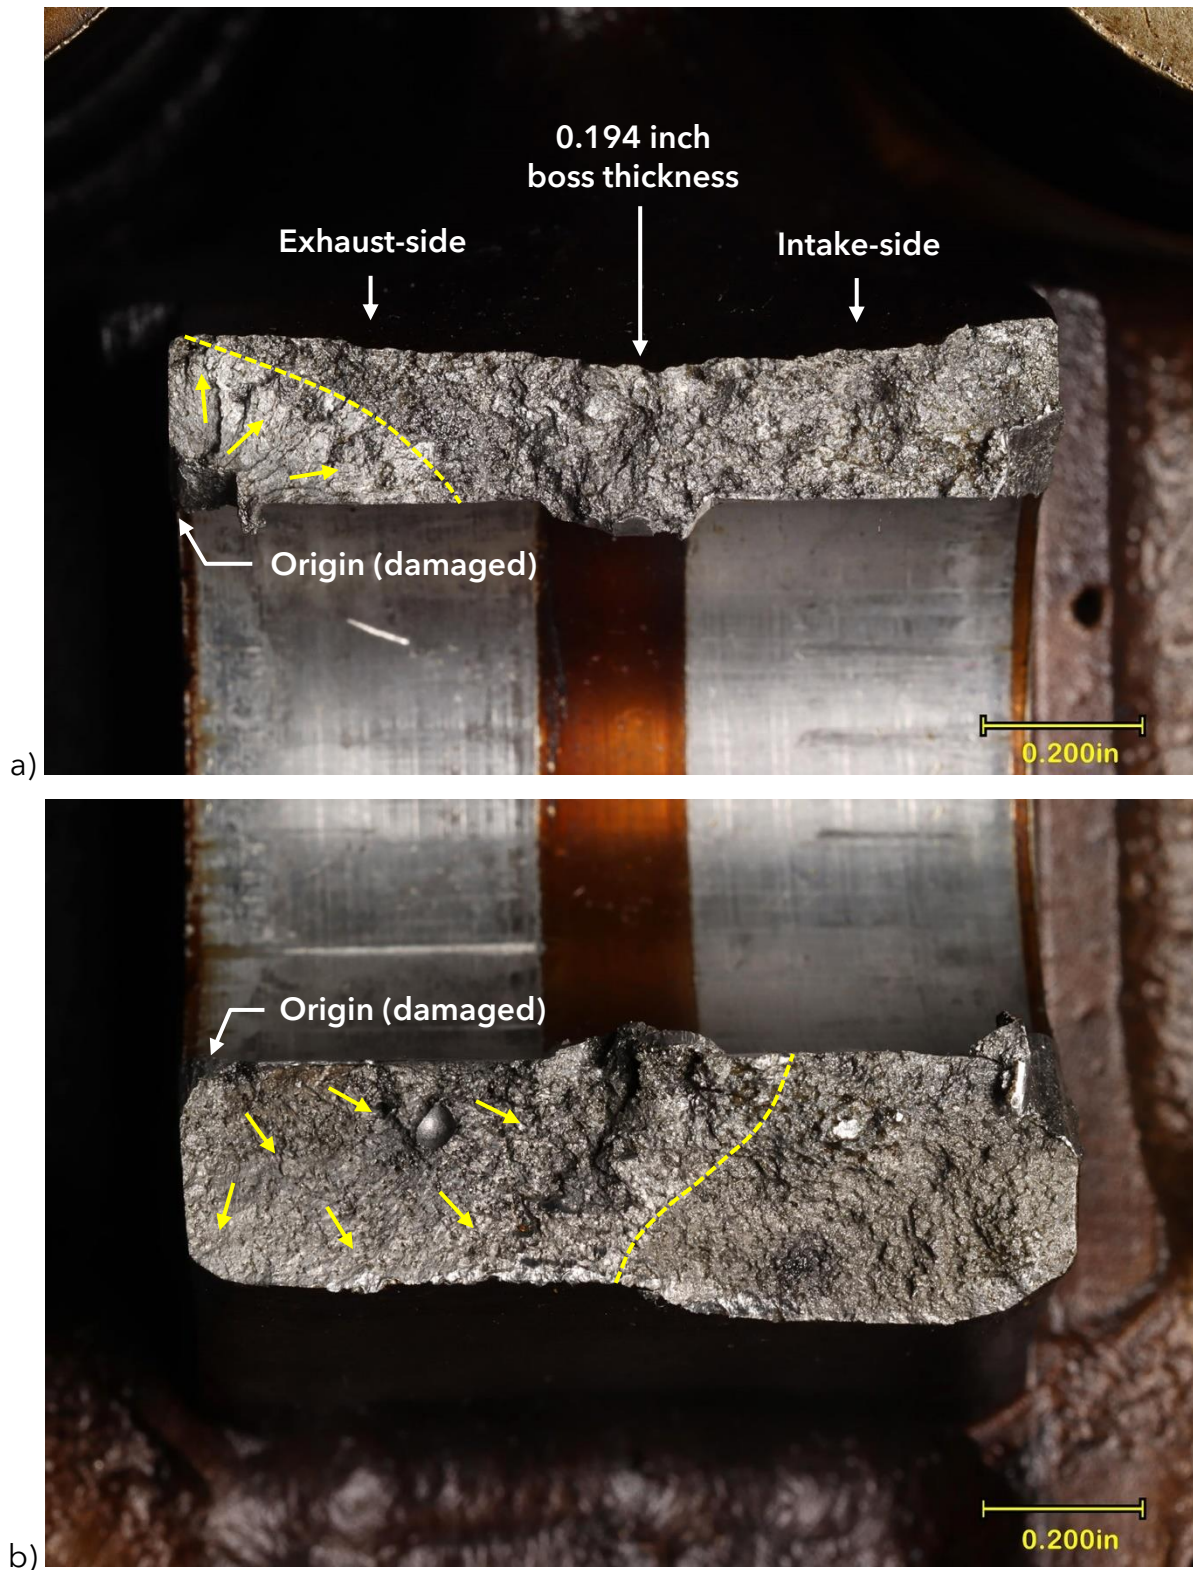
The middle boss supported both the exhaust and intake rocker shafts. The upper and lower fracture surfaces, shown in figures 3a and 3b, respectively, exhibited flat feathery features on the side supporting the exhaust rocker shaft with radial lines progressing away from the rocker shaft bore hole. The origin areas were damaged. The features were consistent with crack initiation at and progression away from the rocker shaft bore hole. The percentage of fatigue crack propagation on the upper

and lower fractures was 24% and 56%, respectively. The remainder of each fracture surface exhibited rough granular features, consistent with overstress.

**Figure 3.** Middle rocker shaft boss fractures: a) upper fracture and b) lower fracture. Yellow arrows indicate the local direction of crack propagation. The yellow dashed lines indicate approximate transition from fatigue to overstress.

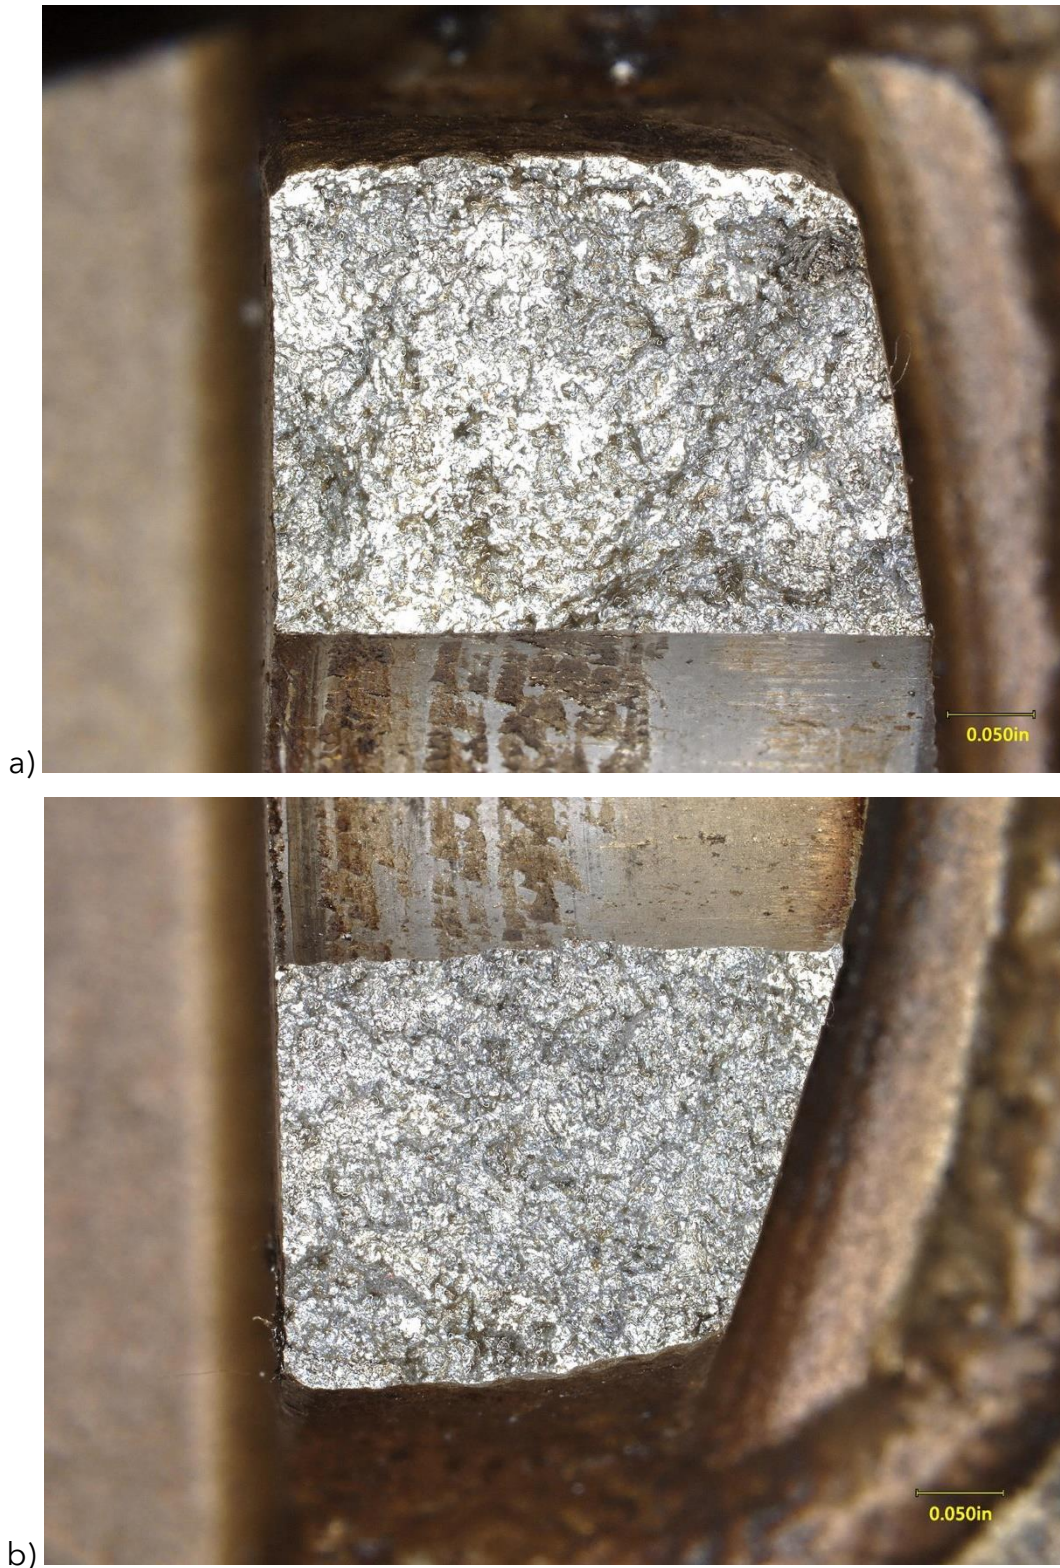
The fractures surfaces on the outer intake rocker shaft boss are shown in figures 4a and 4b. The upper and lower fractures exhibited rough granular features, consistent with overstress fractures.

**Figure 4.** Outer intake rocker shaft boss fractures: a) upper fracture and b) lower fracture. The fractures exhibited a rough granular appearance, consistent with overstress.
