## The National Transportation Safety Board

Office of Aviation Safety  
Central Region  
Memorandum for the Record  
Engine Examination Findings  
CEN22LA144  
Minot, North Dakota  
March 11, 2022

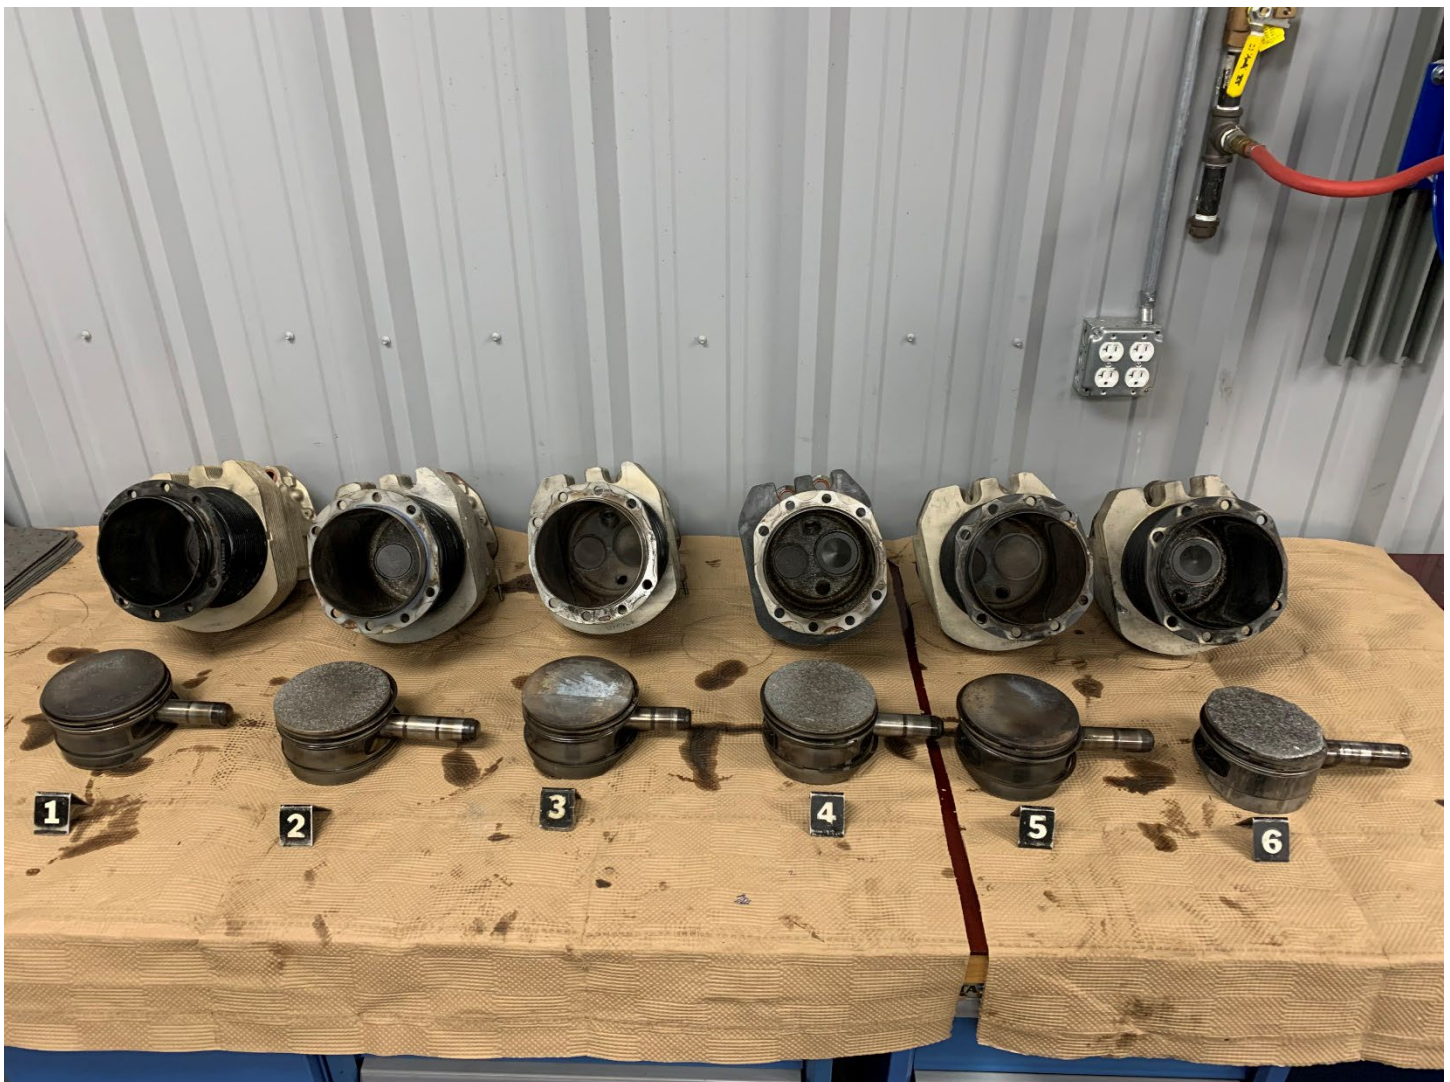
Photo 1 Piston Damage #1 through #6

A detailed examination of the engine was performed at Continental Motors, Mobile, Alabama, under the supervision of the NTSB. According to maintenance records, the most recent oil change was completed @1086.7 hours; entry dated February 14, 2022. The engine was removed from the shipping container and placed on a disassembly stand. The magneto to engine timing was checked as received. Continental specification is 22° BTC the timing was found to be right magneto 23° left magneto 22°. It was noted some of the cylinder barrel paint was discolored from overheating. The breakaway torque was measured as the cylinders were removed and no anomalies were found. When the cylinders were removed it was noted that all six piston heads had indications of detonation or preignition. The number six piston was damaged the most and portions were melted away. The damage to the pistons appeared to have happened over an unspecified/unknown time.

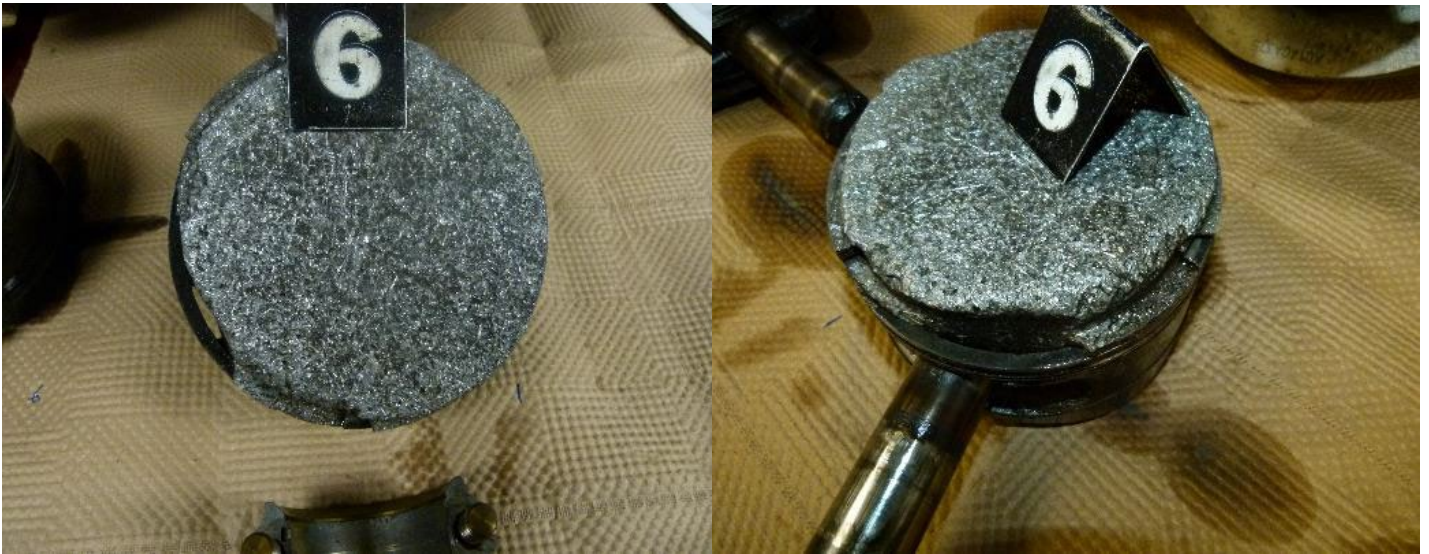
Photo 2 Closeup Views of #6 Piston Damage

The crankshaft and main bearings exhibited a slight amount of lubrication distress. The extent of damage found at the number six piston was consistent with the lubrication distress found in the engine.

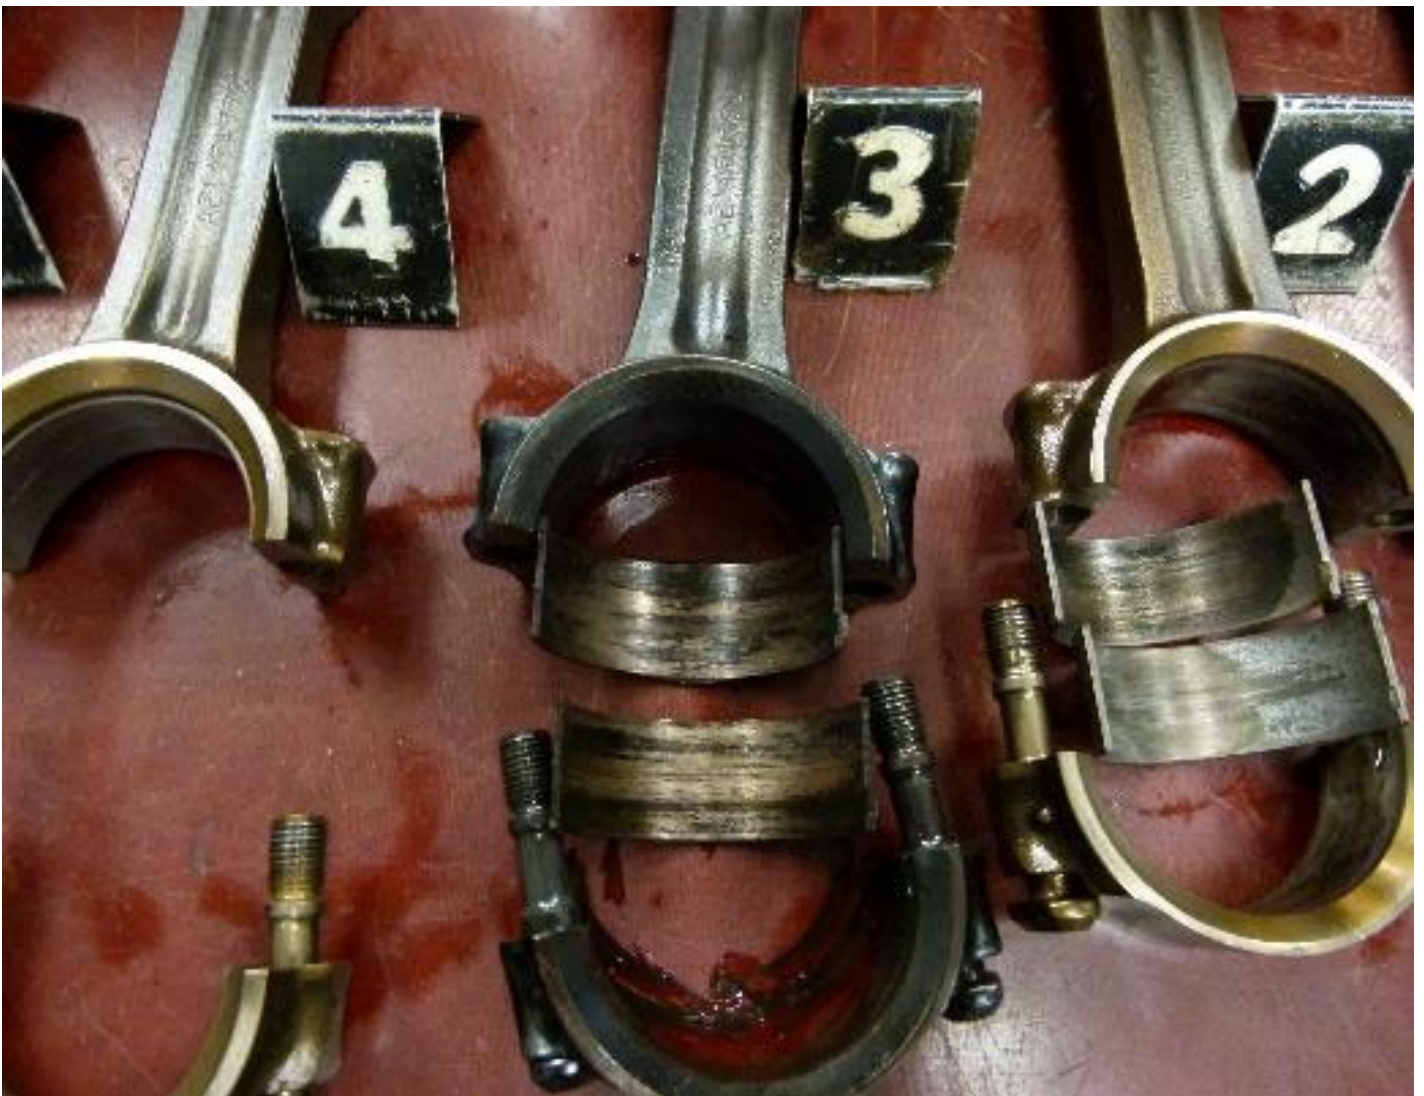
Photo 3 Closeup View of #3 Connecting Rod & Bearing Showing Thermal Distress

The connecting rod bearings were inspected and exhibited varying degrees of heat damage consistent with lubrication distress. The number three connecting rod & bearing showed the most heat damage.

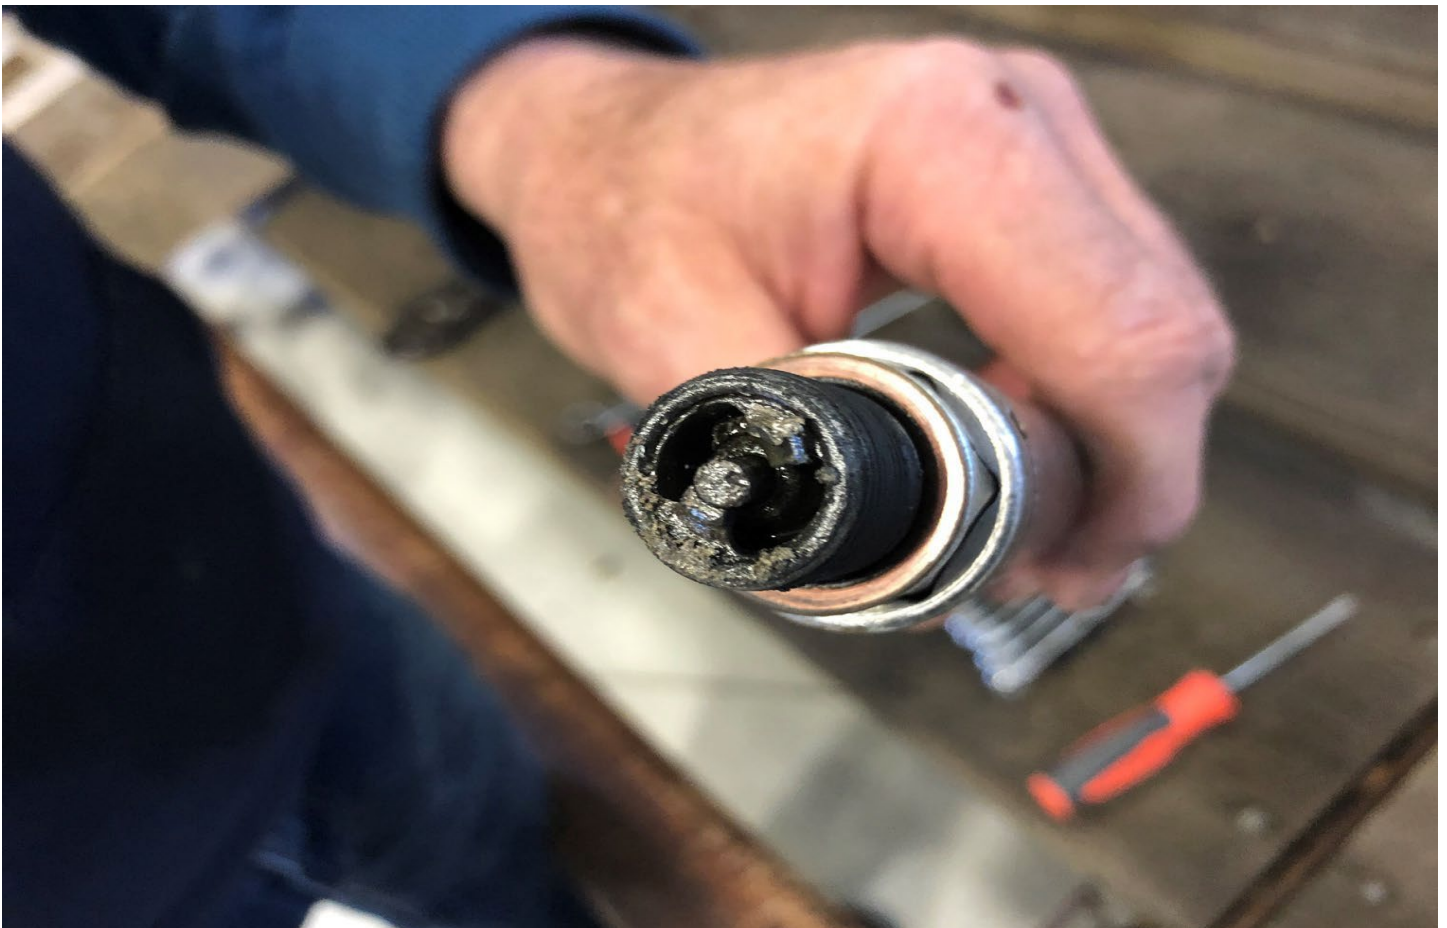
Photo 4 #2 Top Spark Plug (Courtesy of FAA)

Cylinder #6, #4, and #2 top & bottom spark plugs had severe impact damage and the electrodes showed severe impact damage. #1, #2, and #5 spark plugs were not observed. Each spark plug electrode appeared to be "hammered" closed. The porcelain portion of the spark plugs showed impact damage. The wear patterns of the spark plugs could not be determined due to the impact damage.

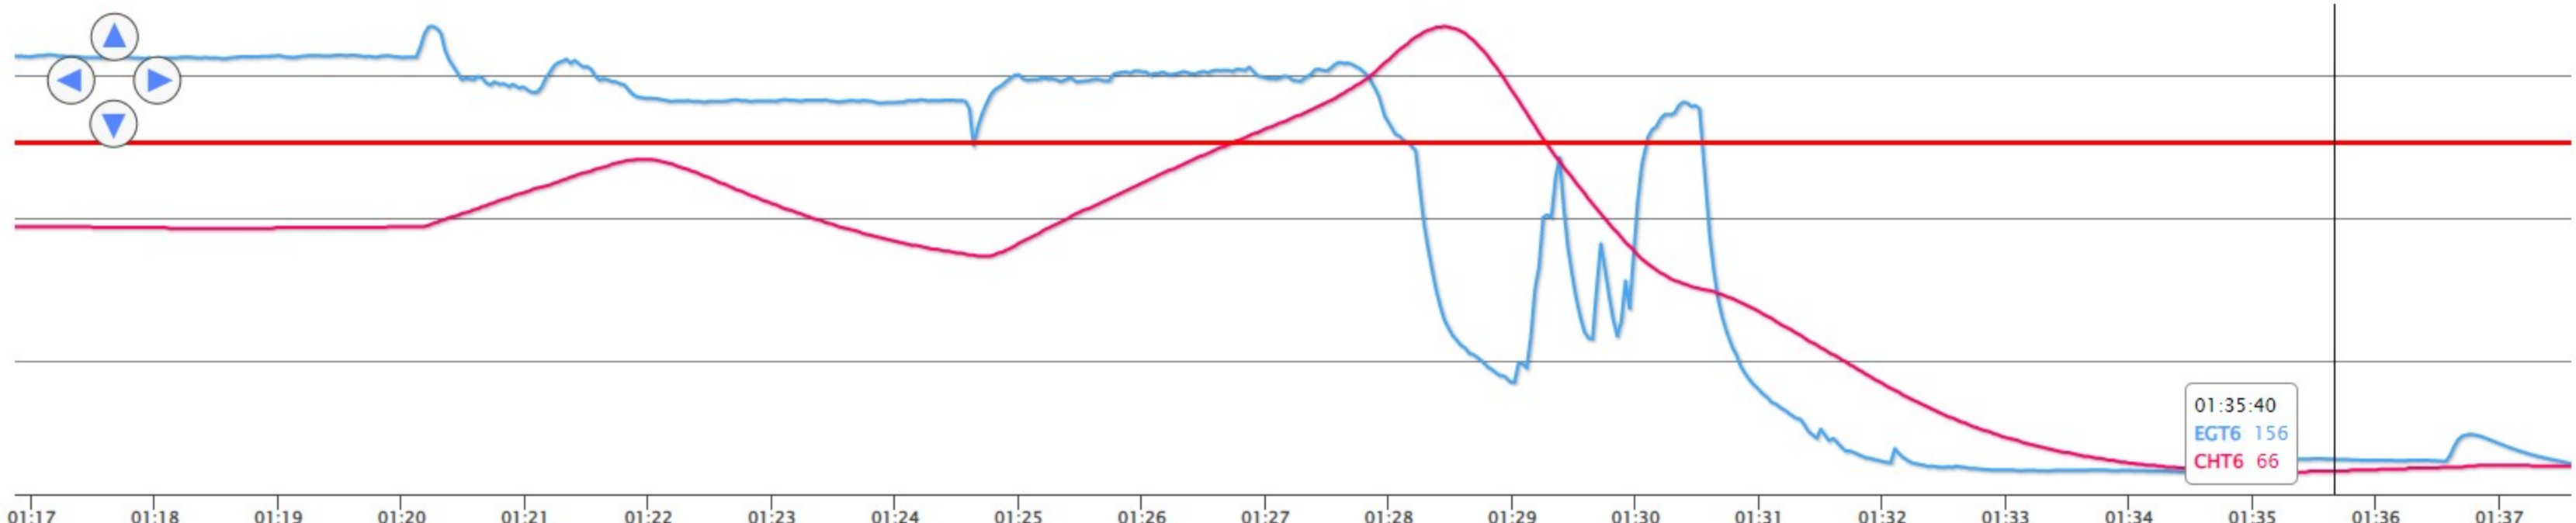
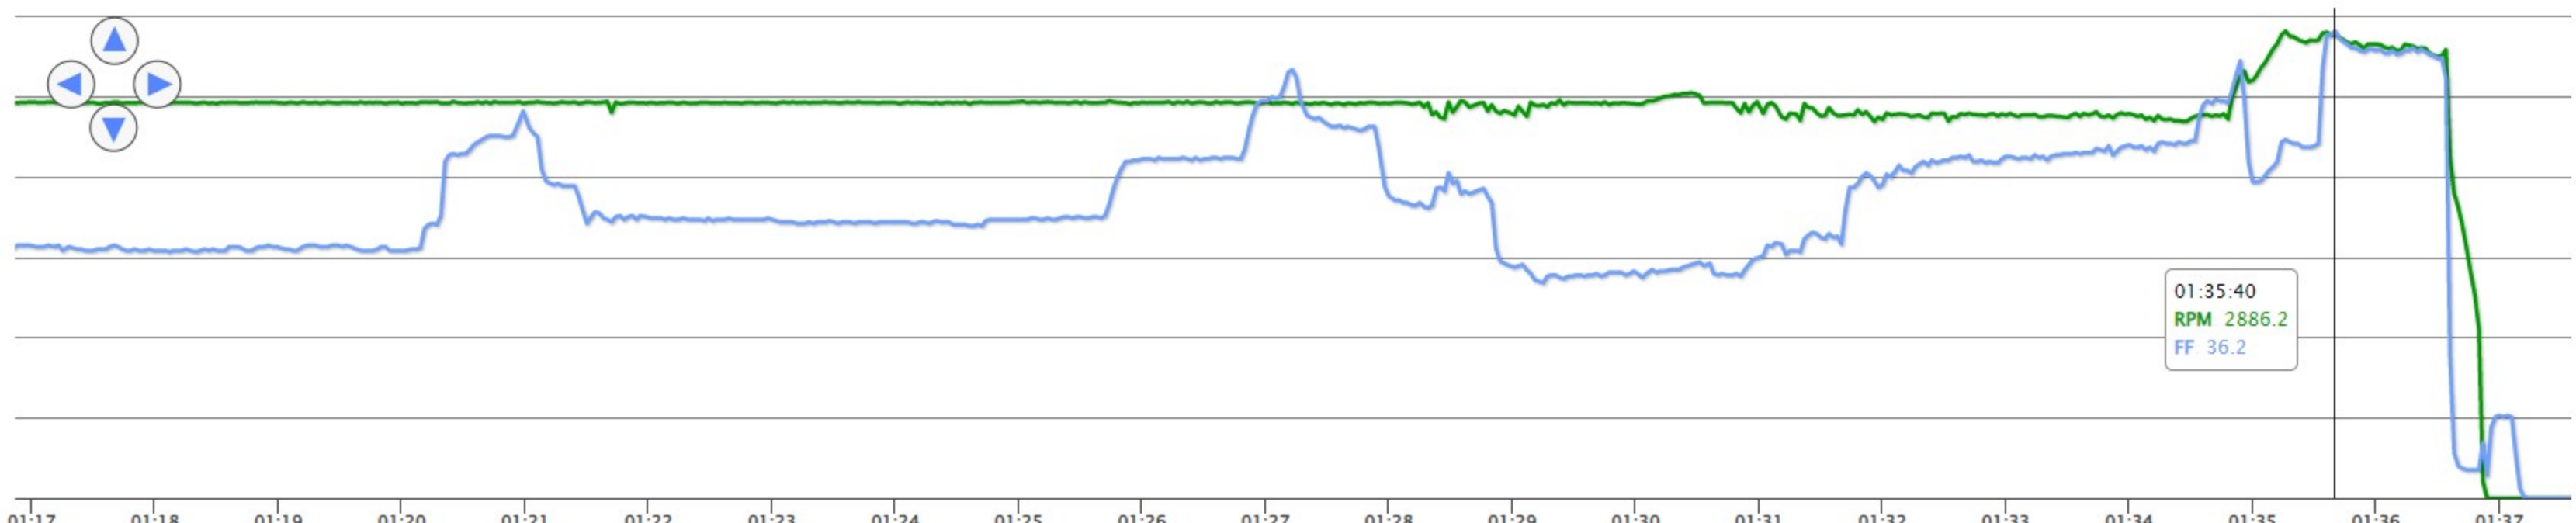
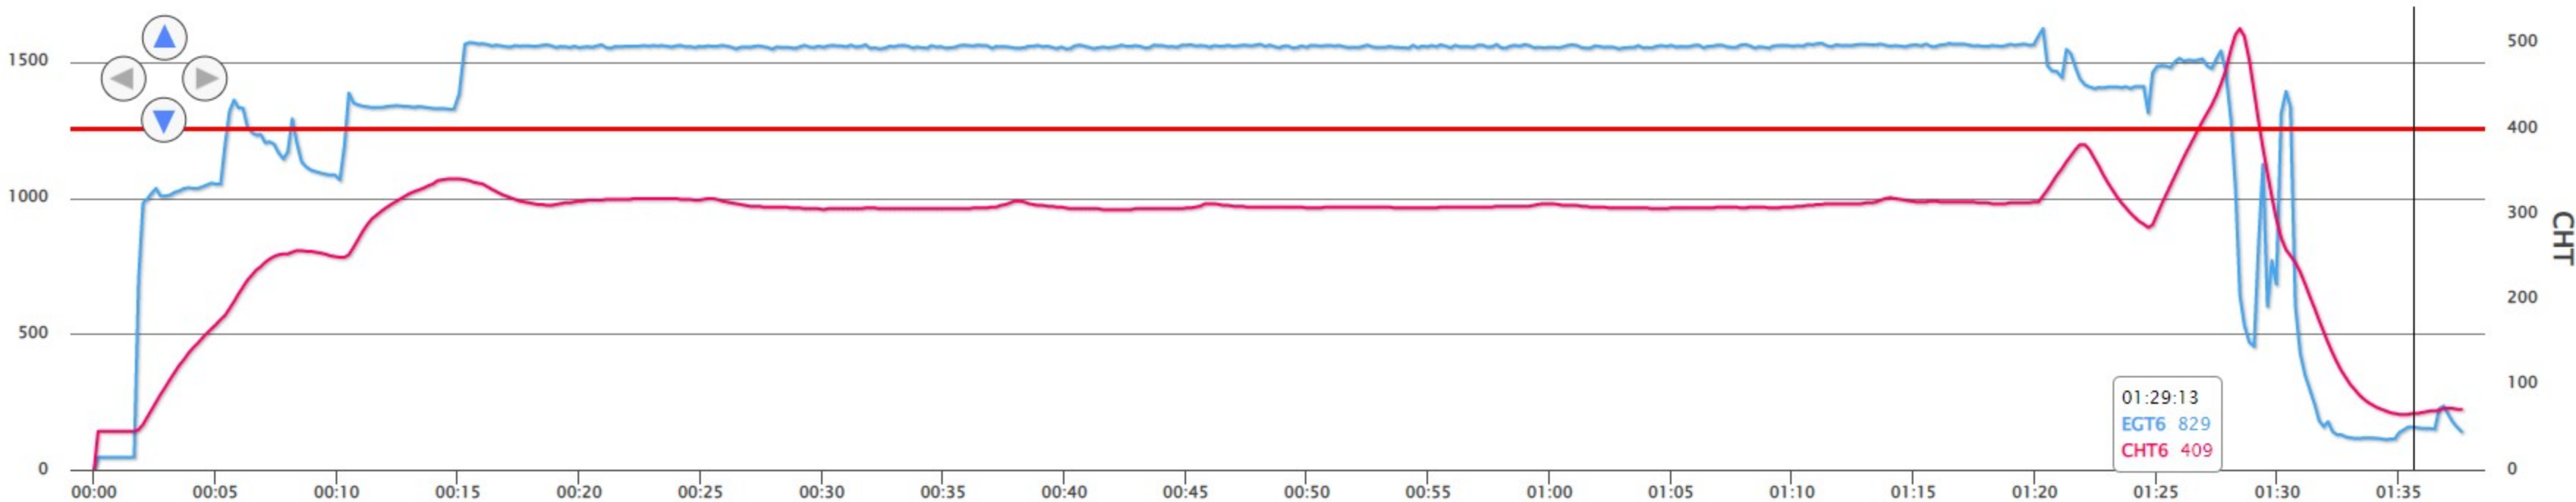
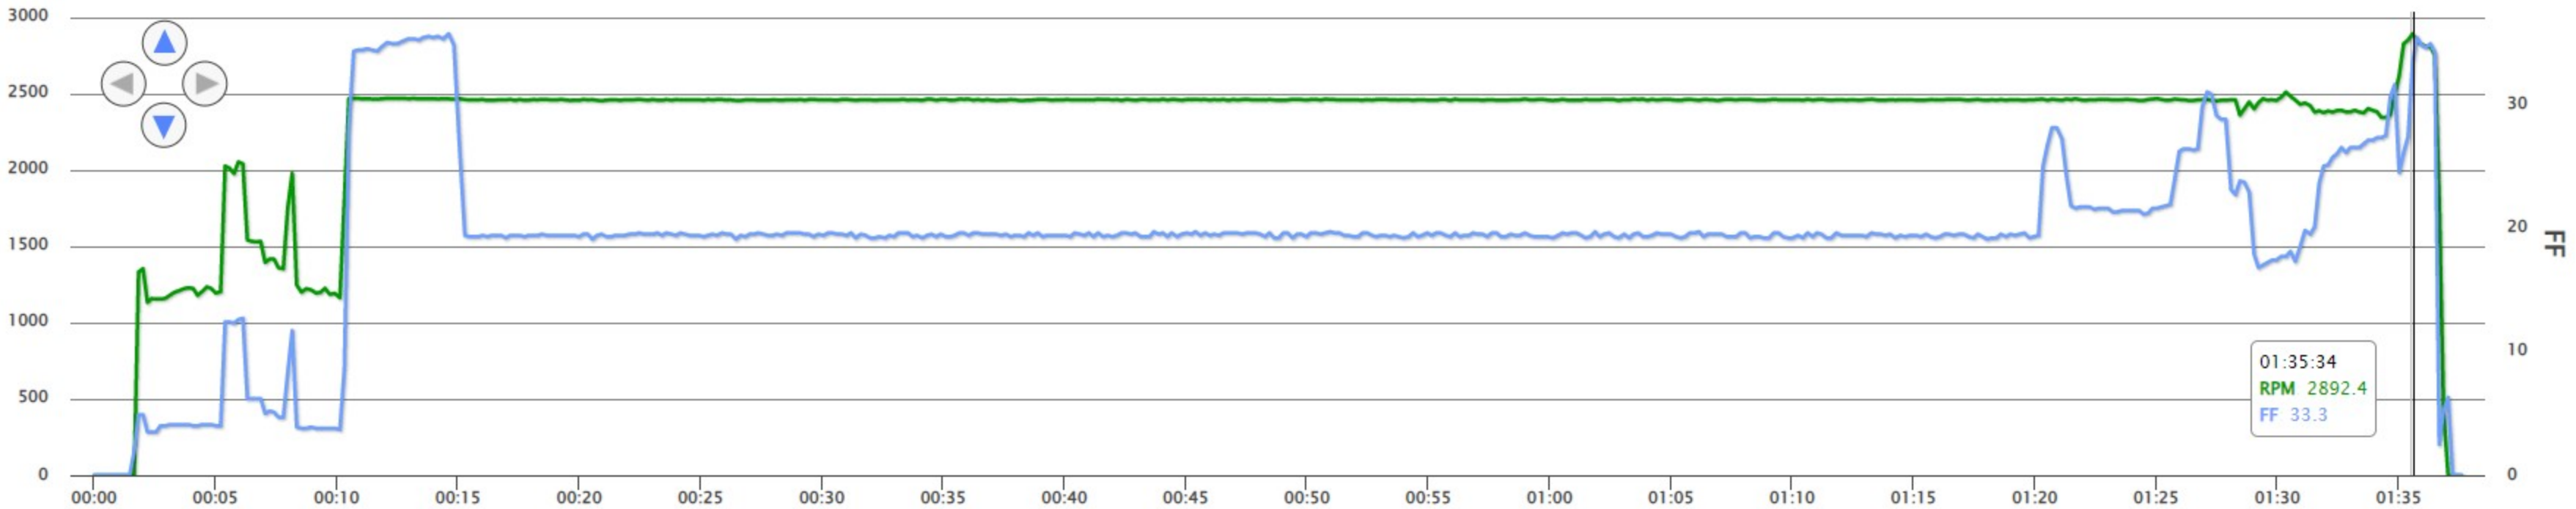
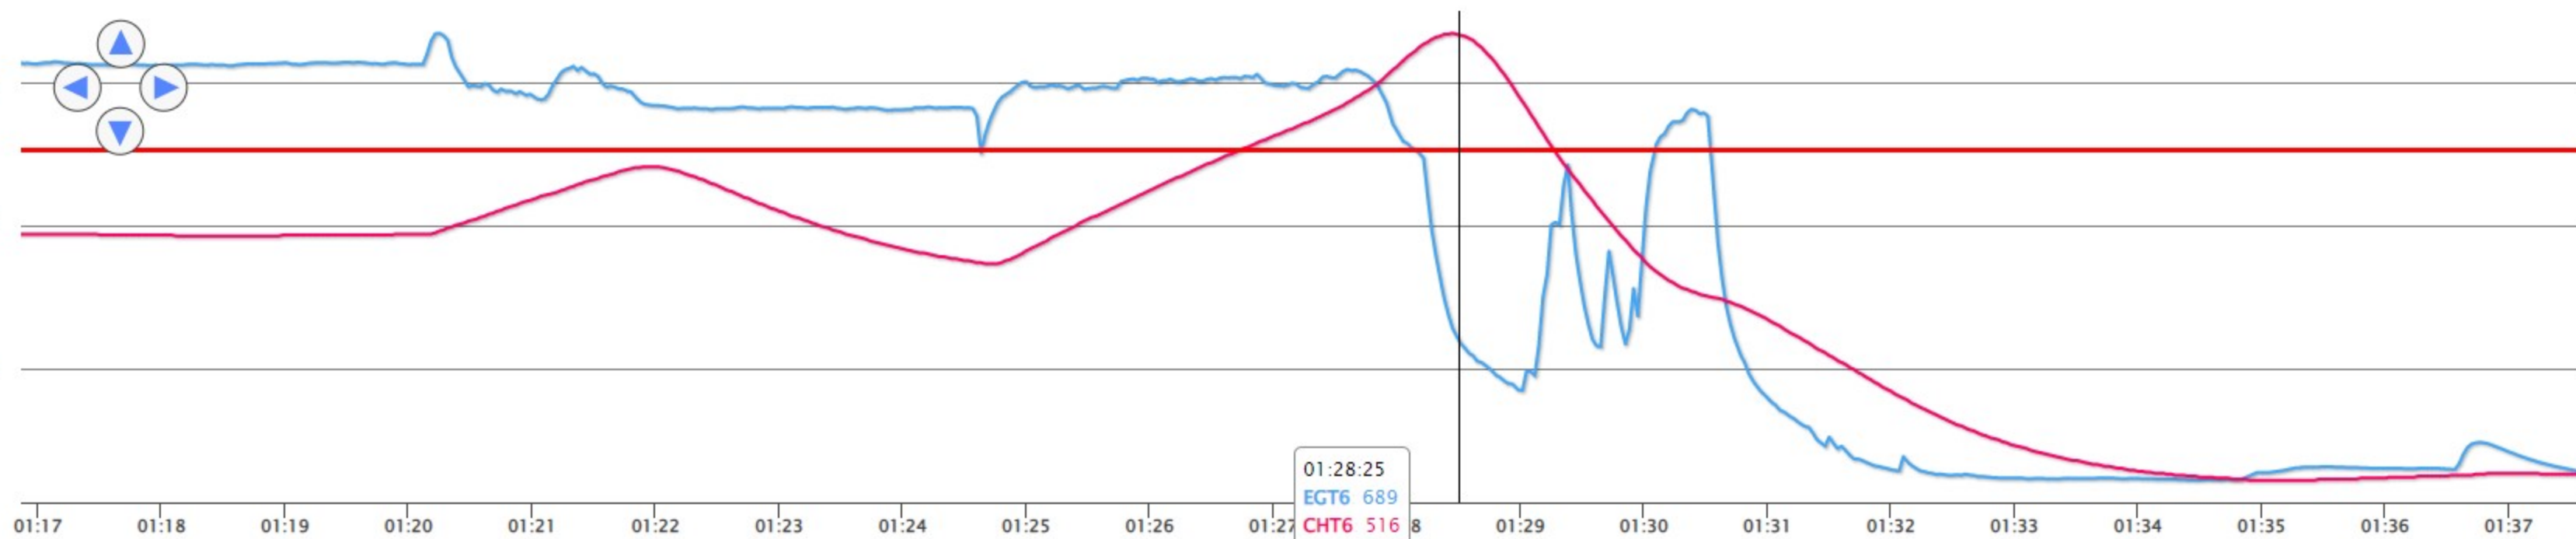
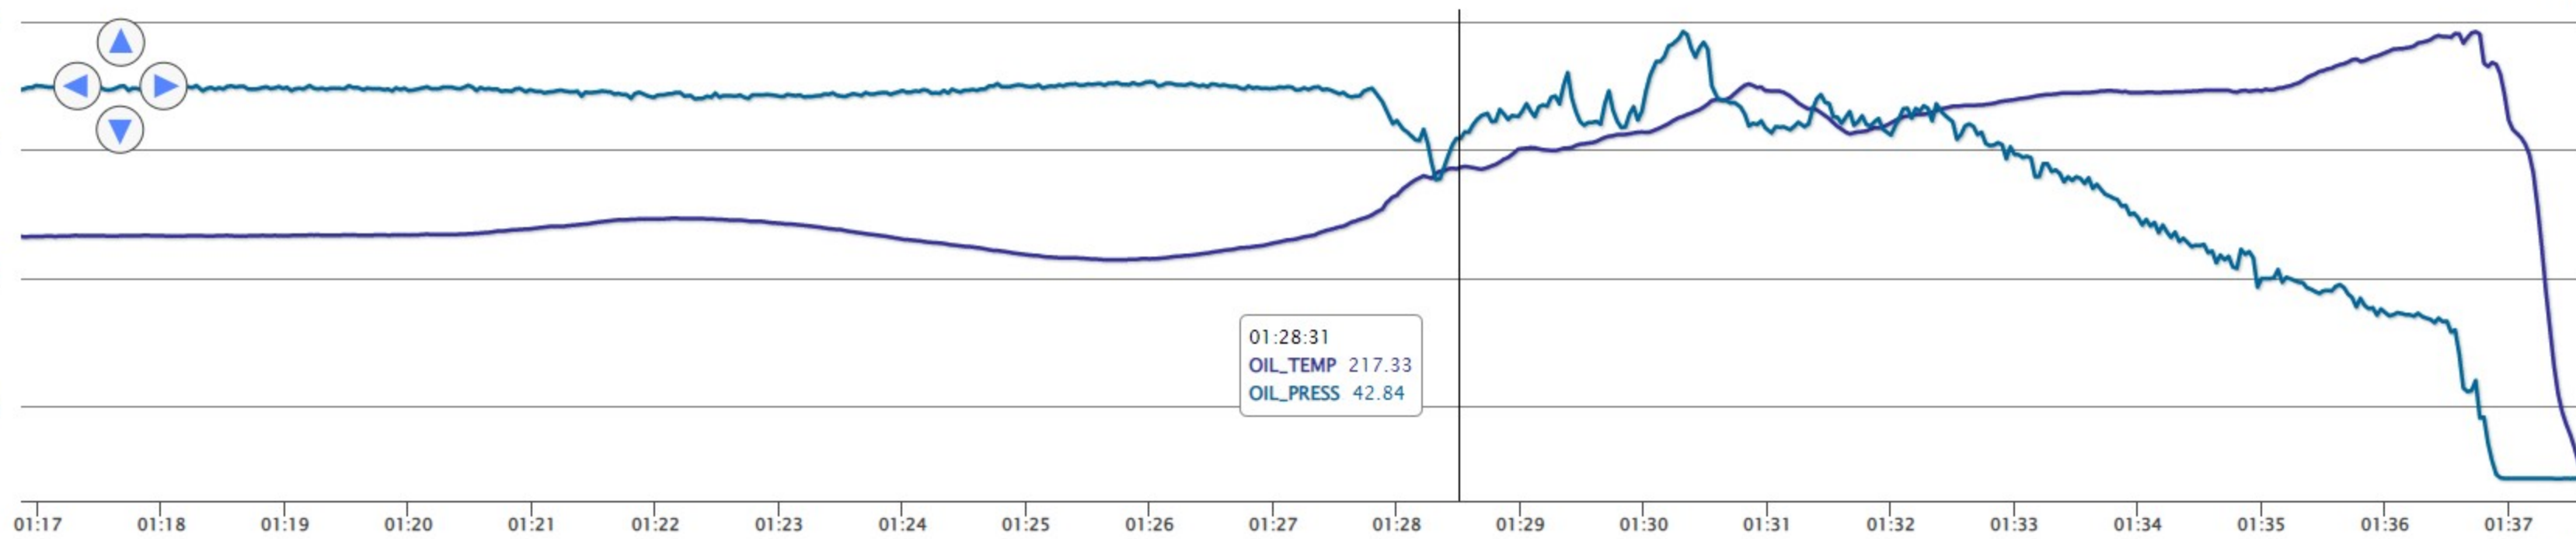
Downloaded engine monitoring data showed that cylinder #6 failed in flight. The data also shows cylinder's #2 & #4 failing shortly after, resulting power to be reduced drastically. The data plots are attached to this memorandum.
