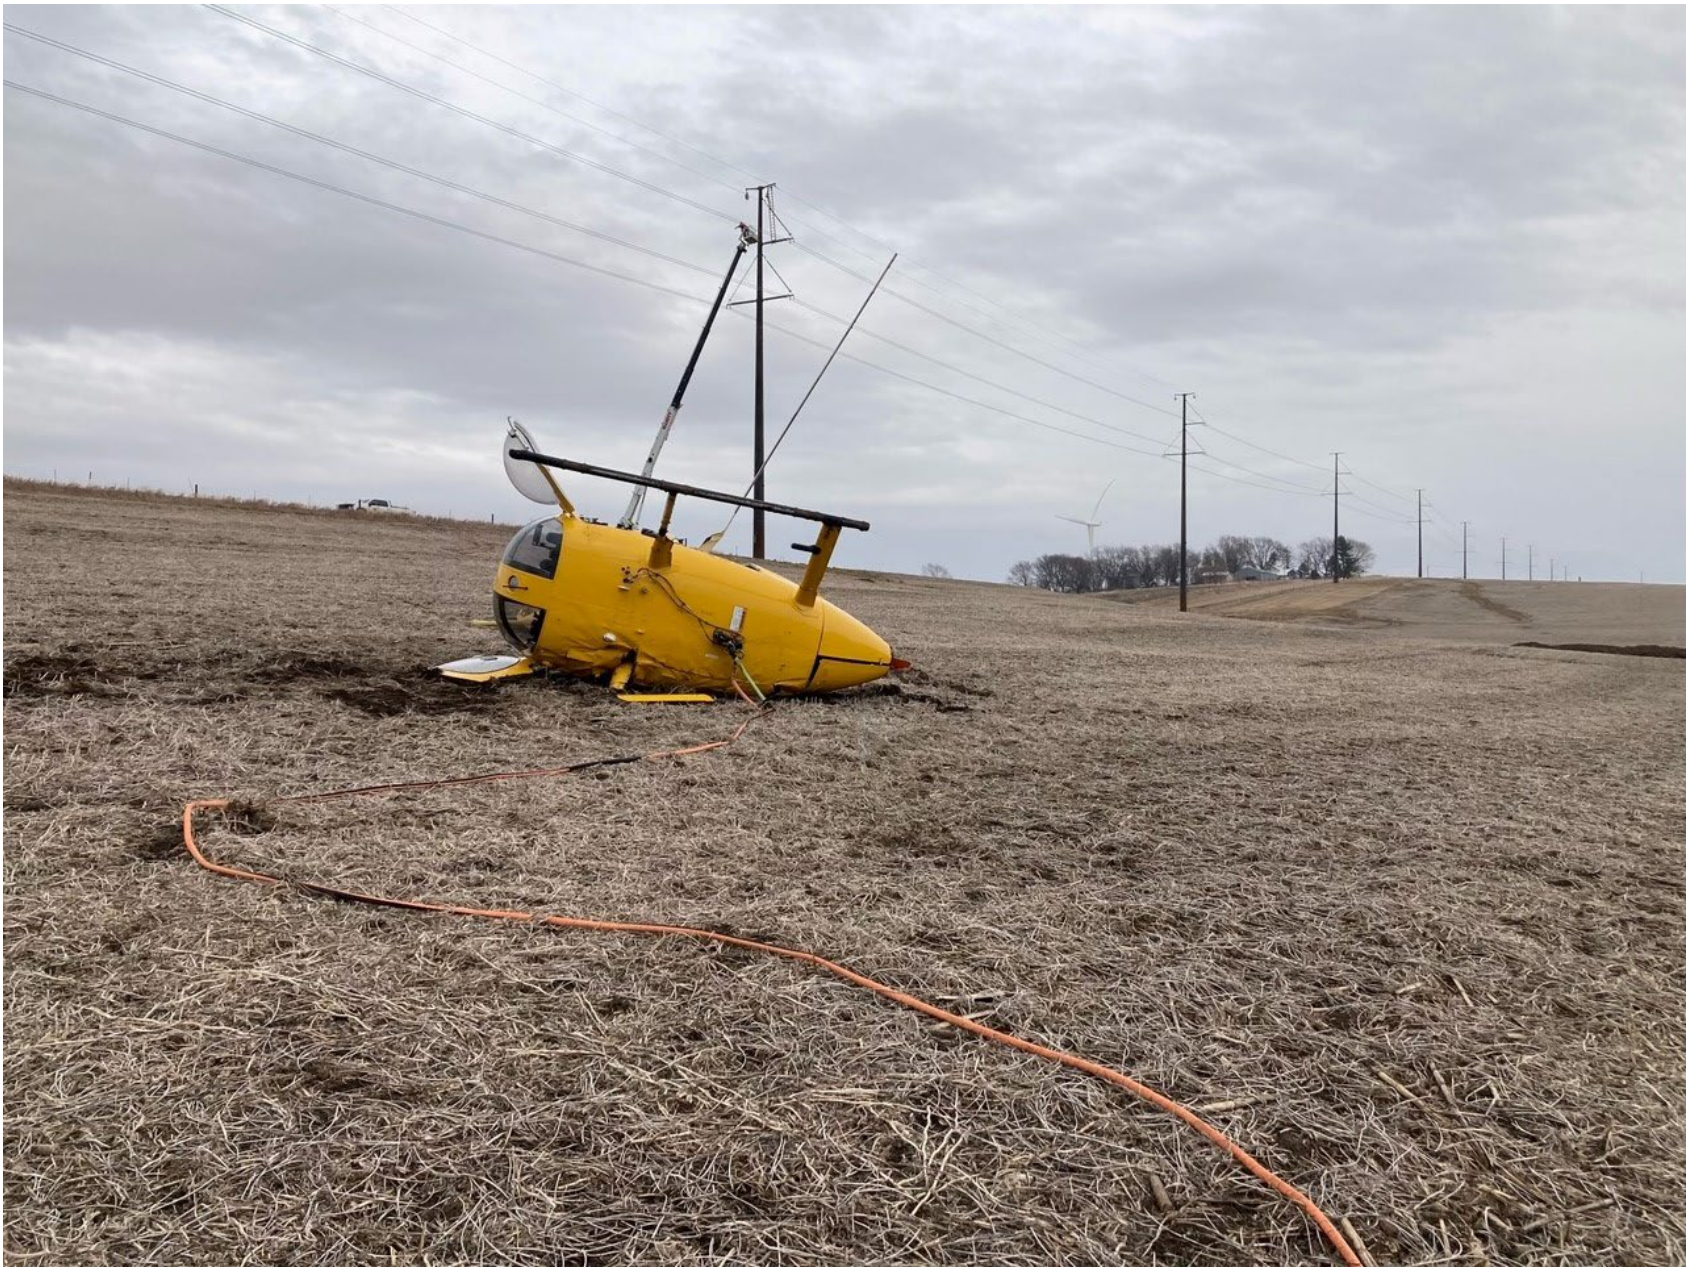
**Photo 1 – View of the underside of the helicopter at the accident site (courtesy of Winco Powerline Services).**

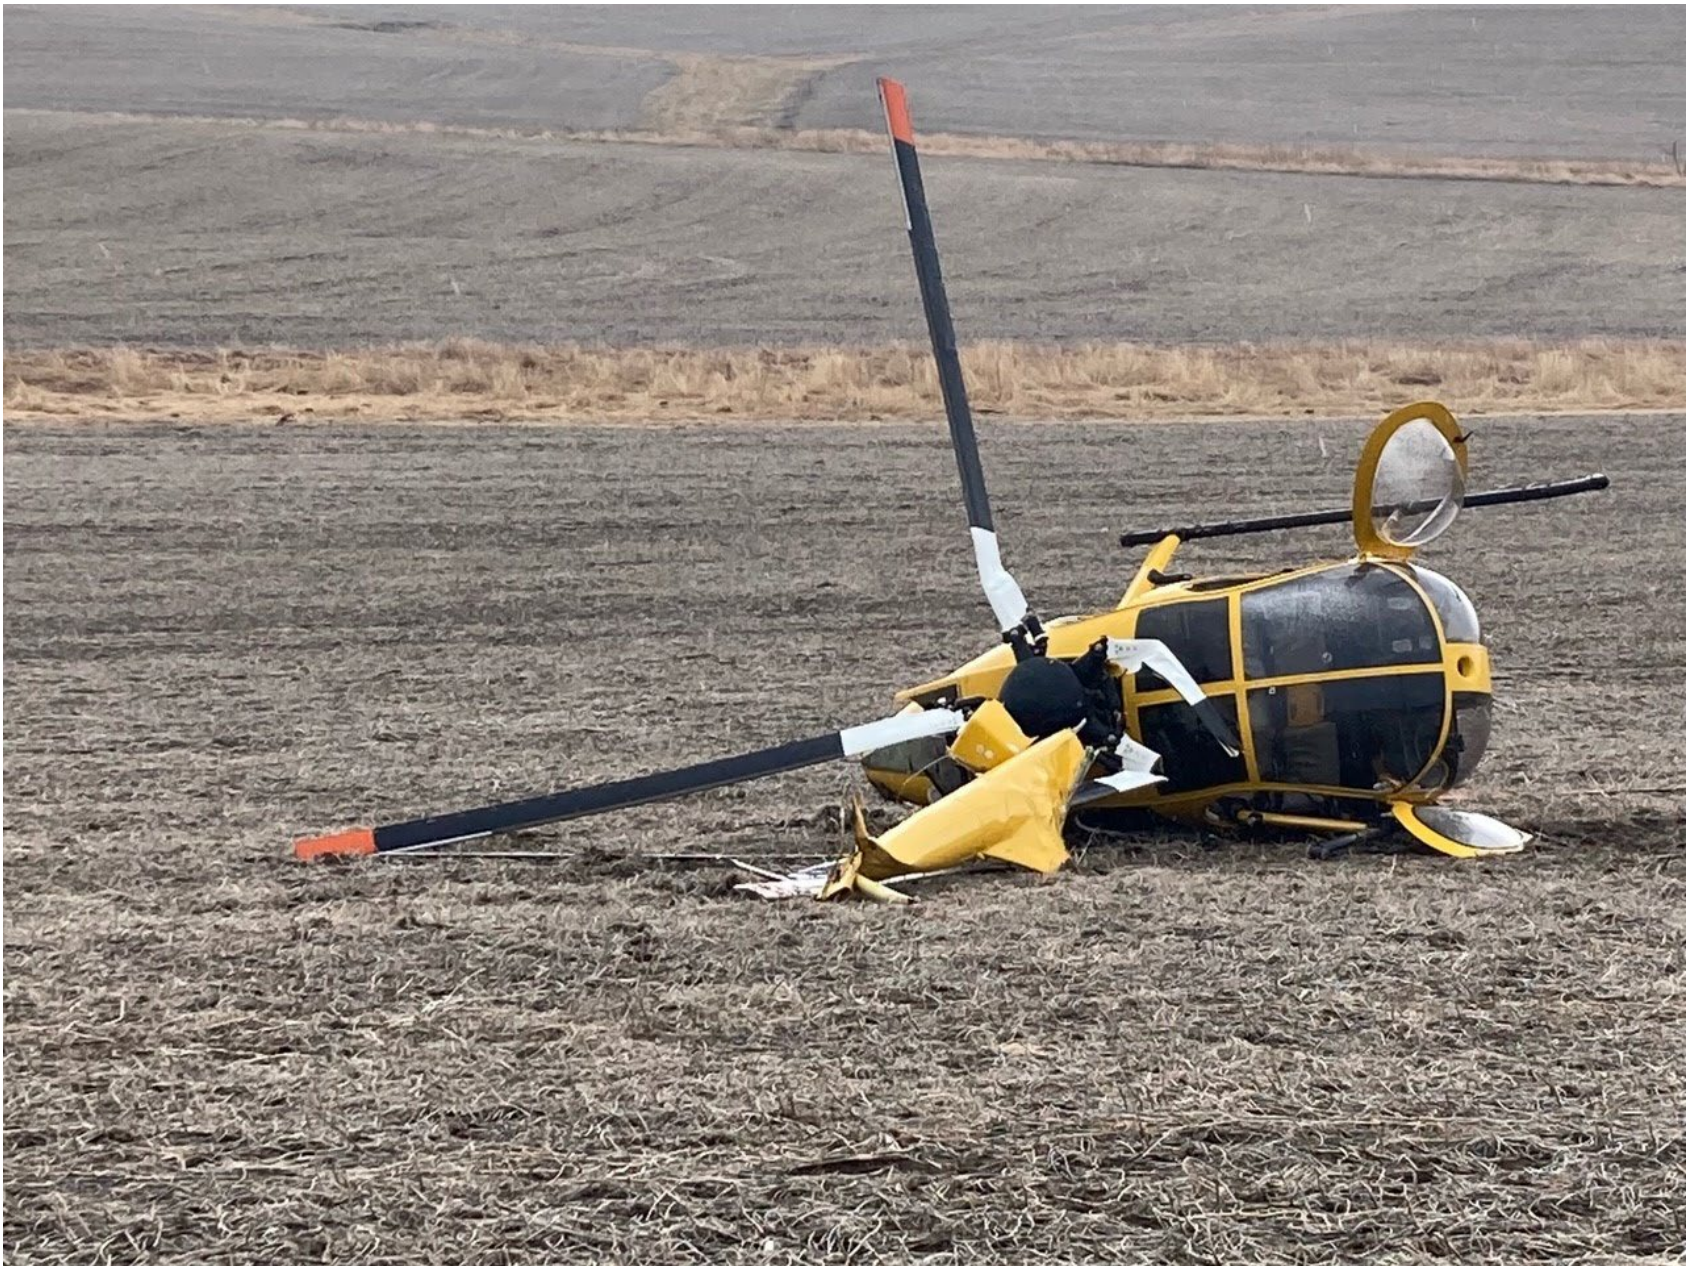
**Photo 2 – View of the top side of the helicopter at the accident site (courtesy of Winco Powerline Services).**

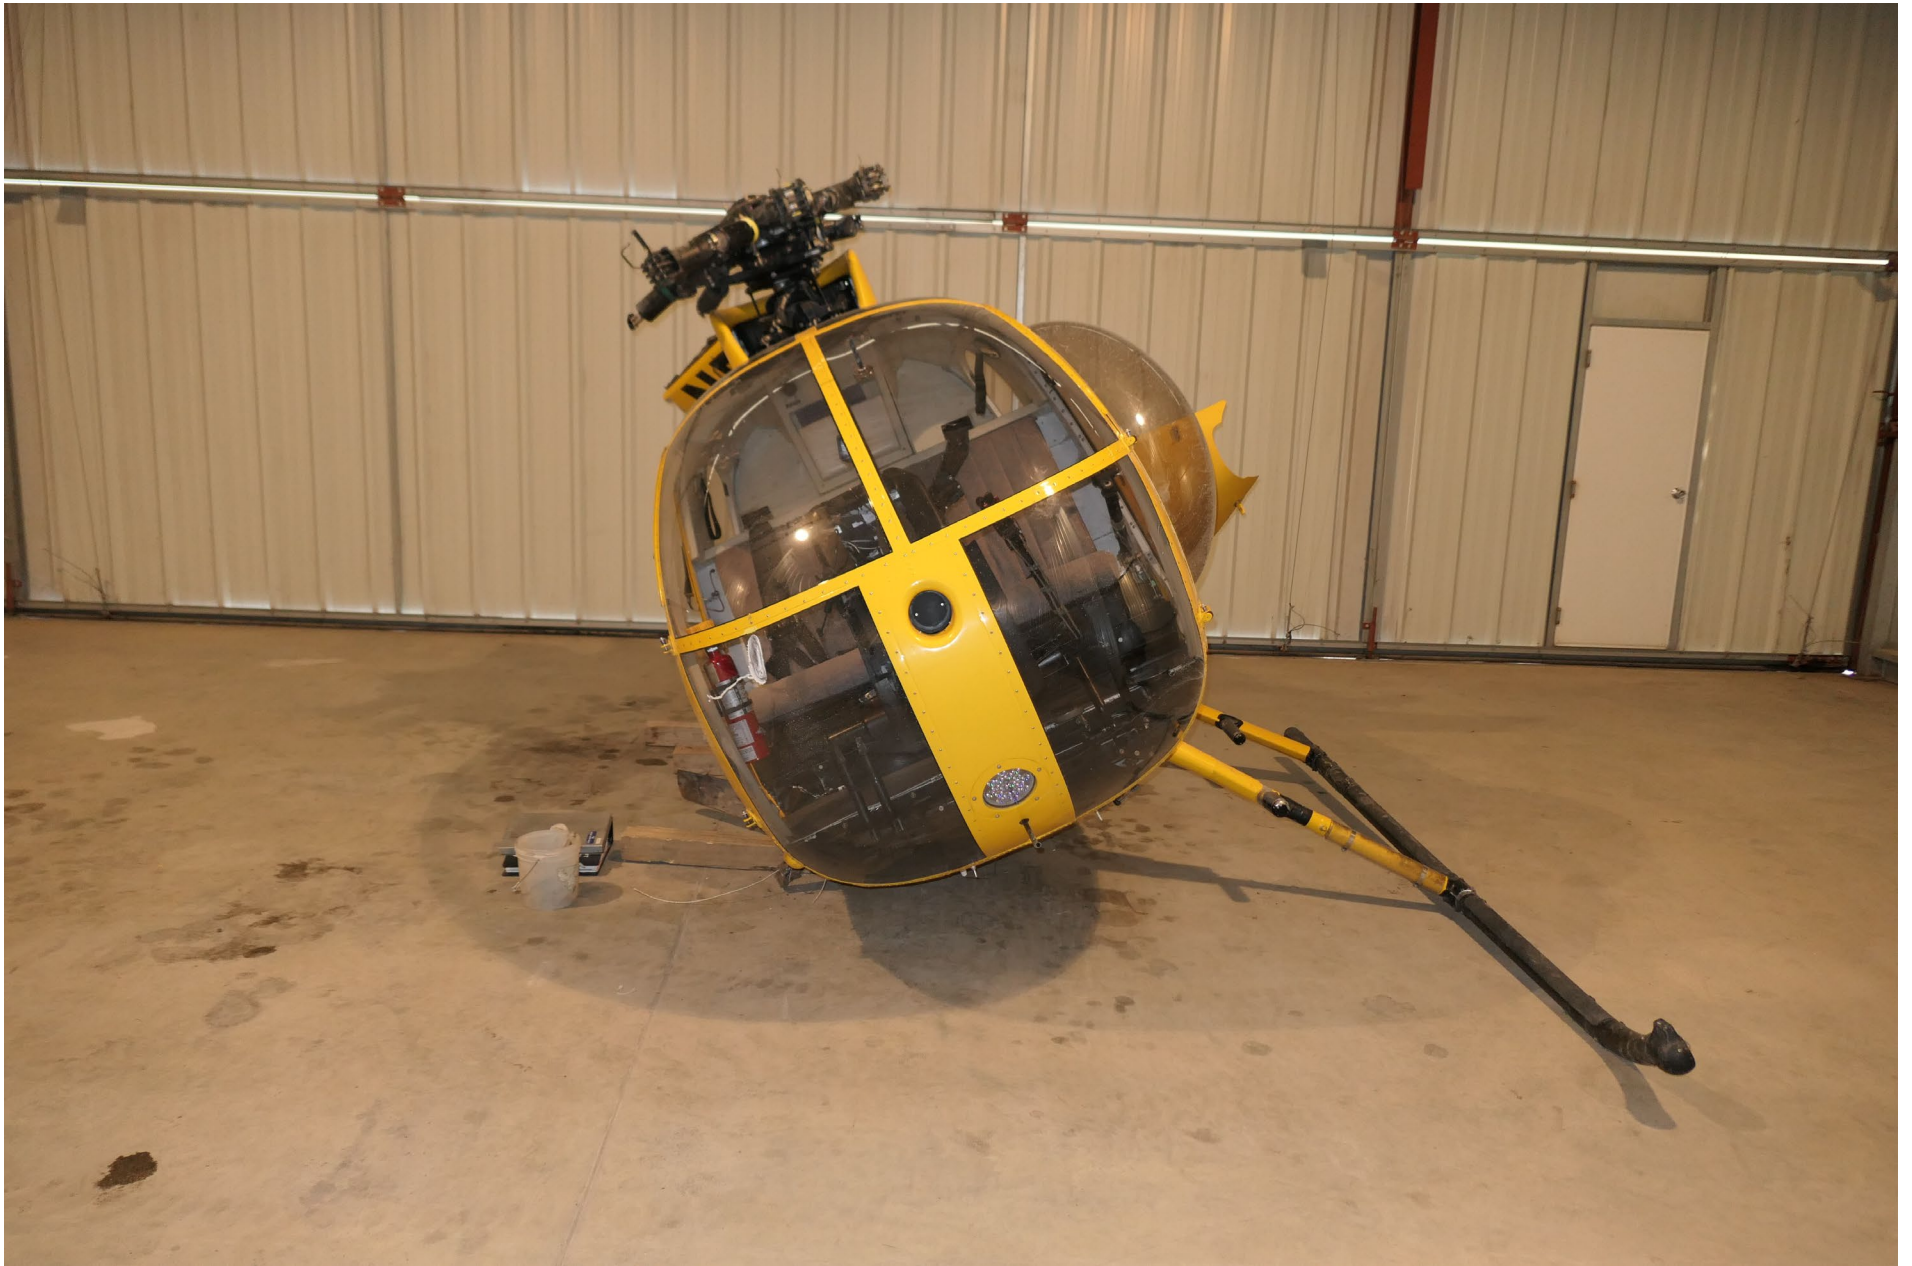
**Photo 3 – View of the front of the fuselage after it was recovered from the accident site (courtesy of MD Helicopters).**

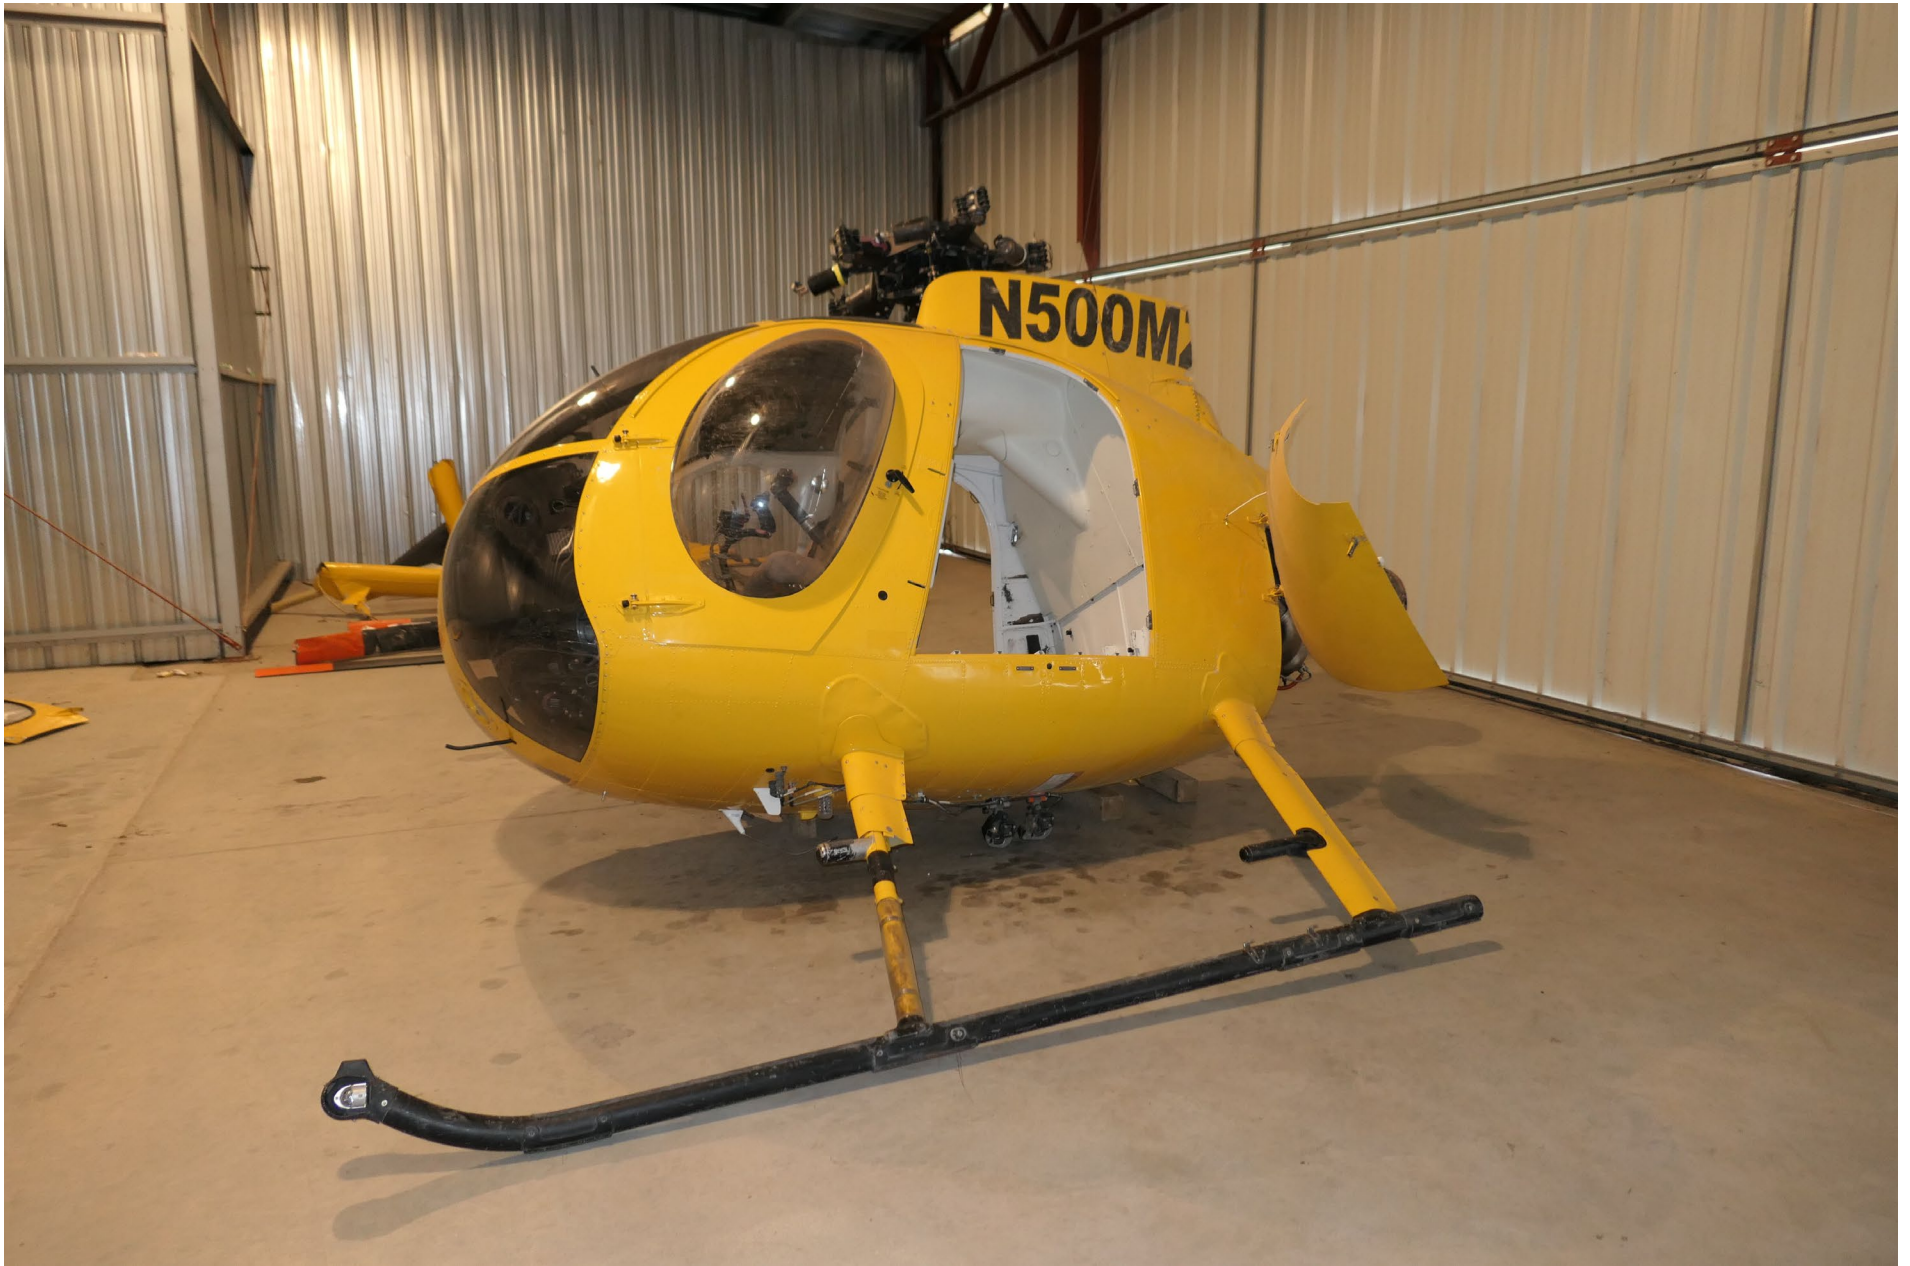
**Photo 4 – View of the left side of the fuselage after it was recovered from the accident site (courtesy of MD Helicopters).**

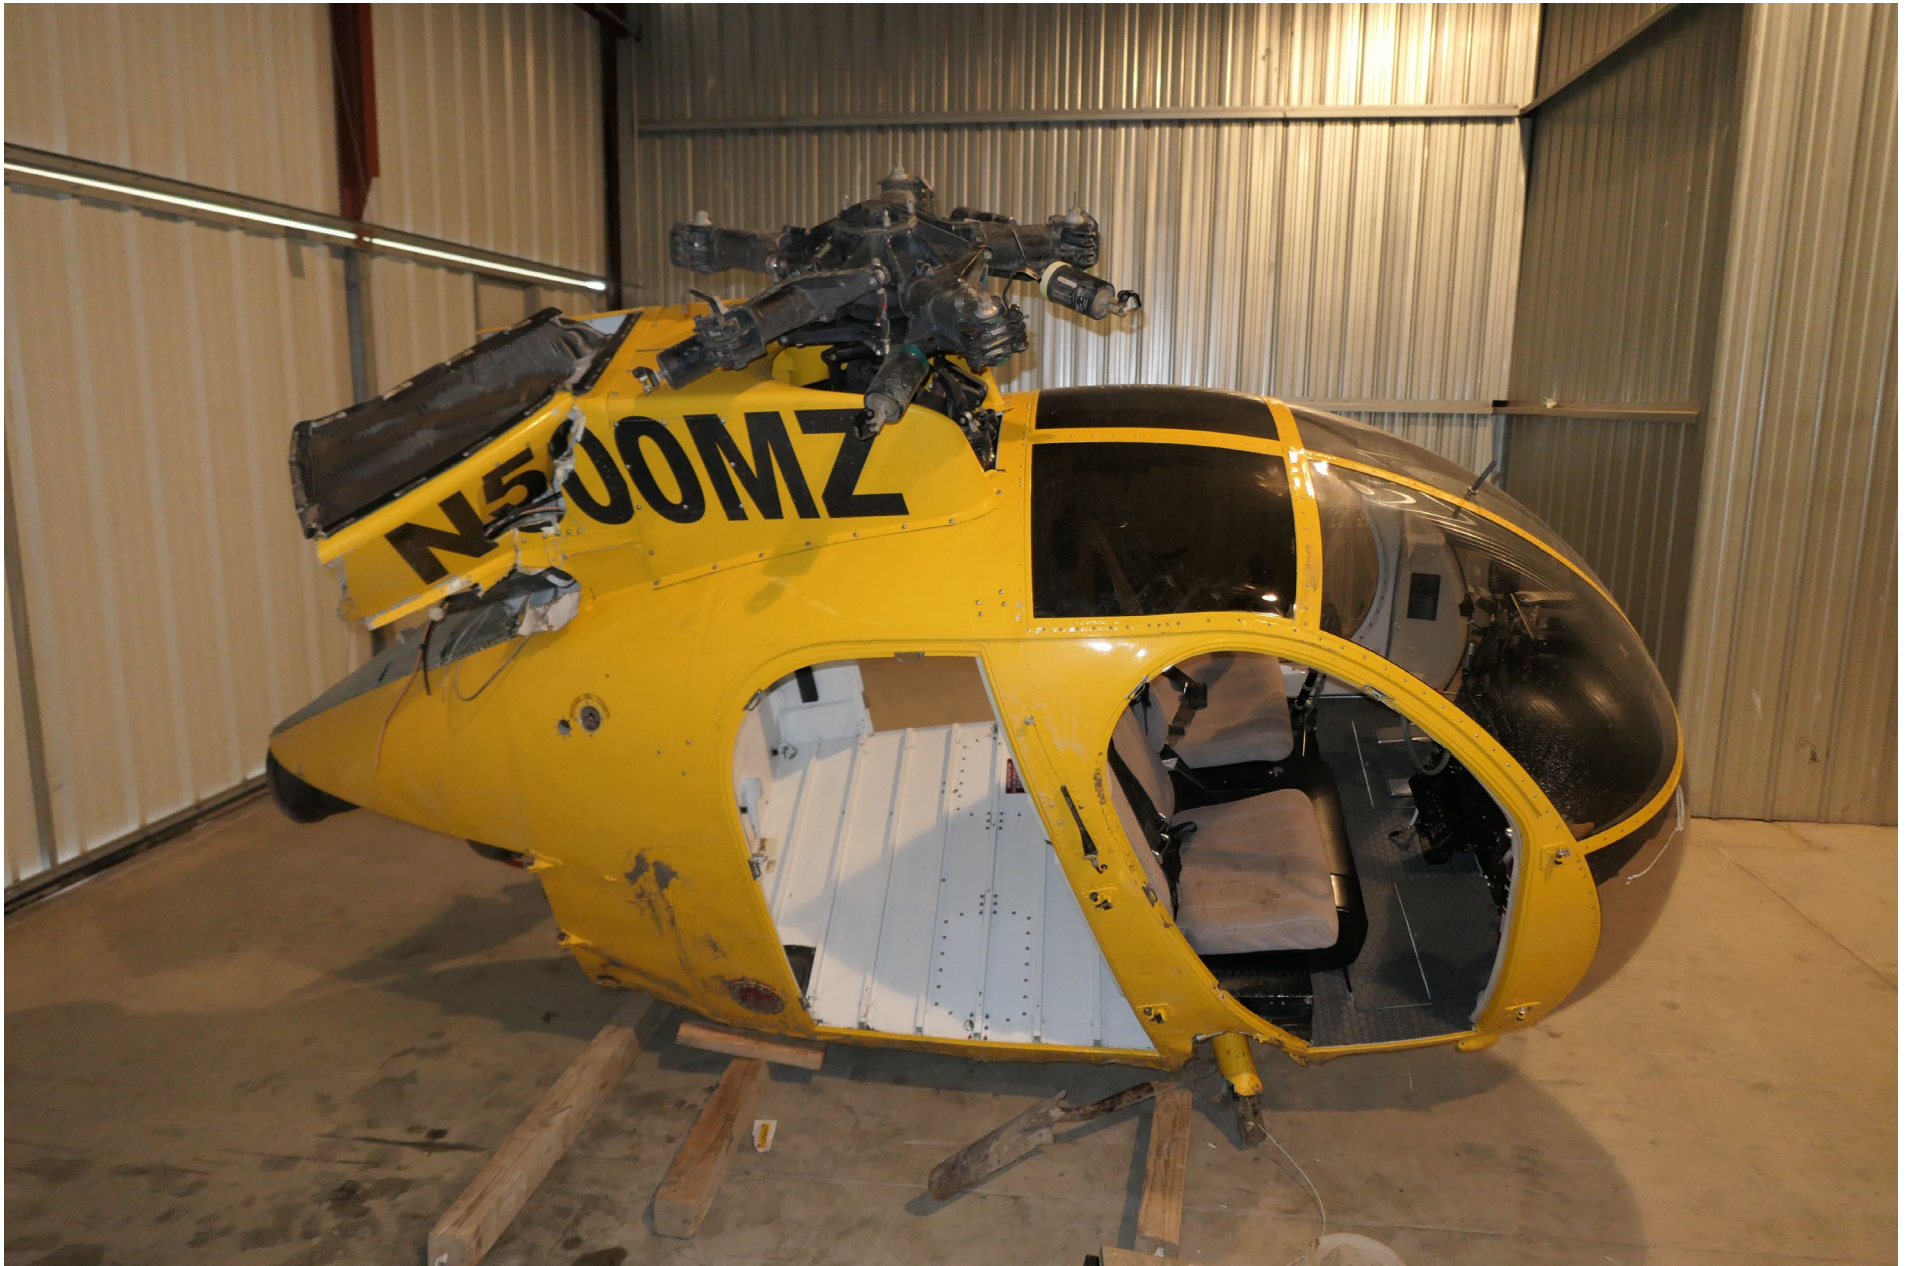
**Photo 5 – View of the right side of the fuselage after it was recovered from the accident site (courtesy of MD Helicopters).**

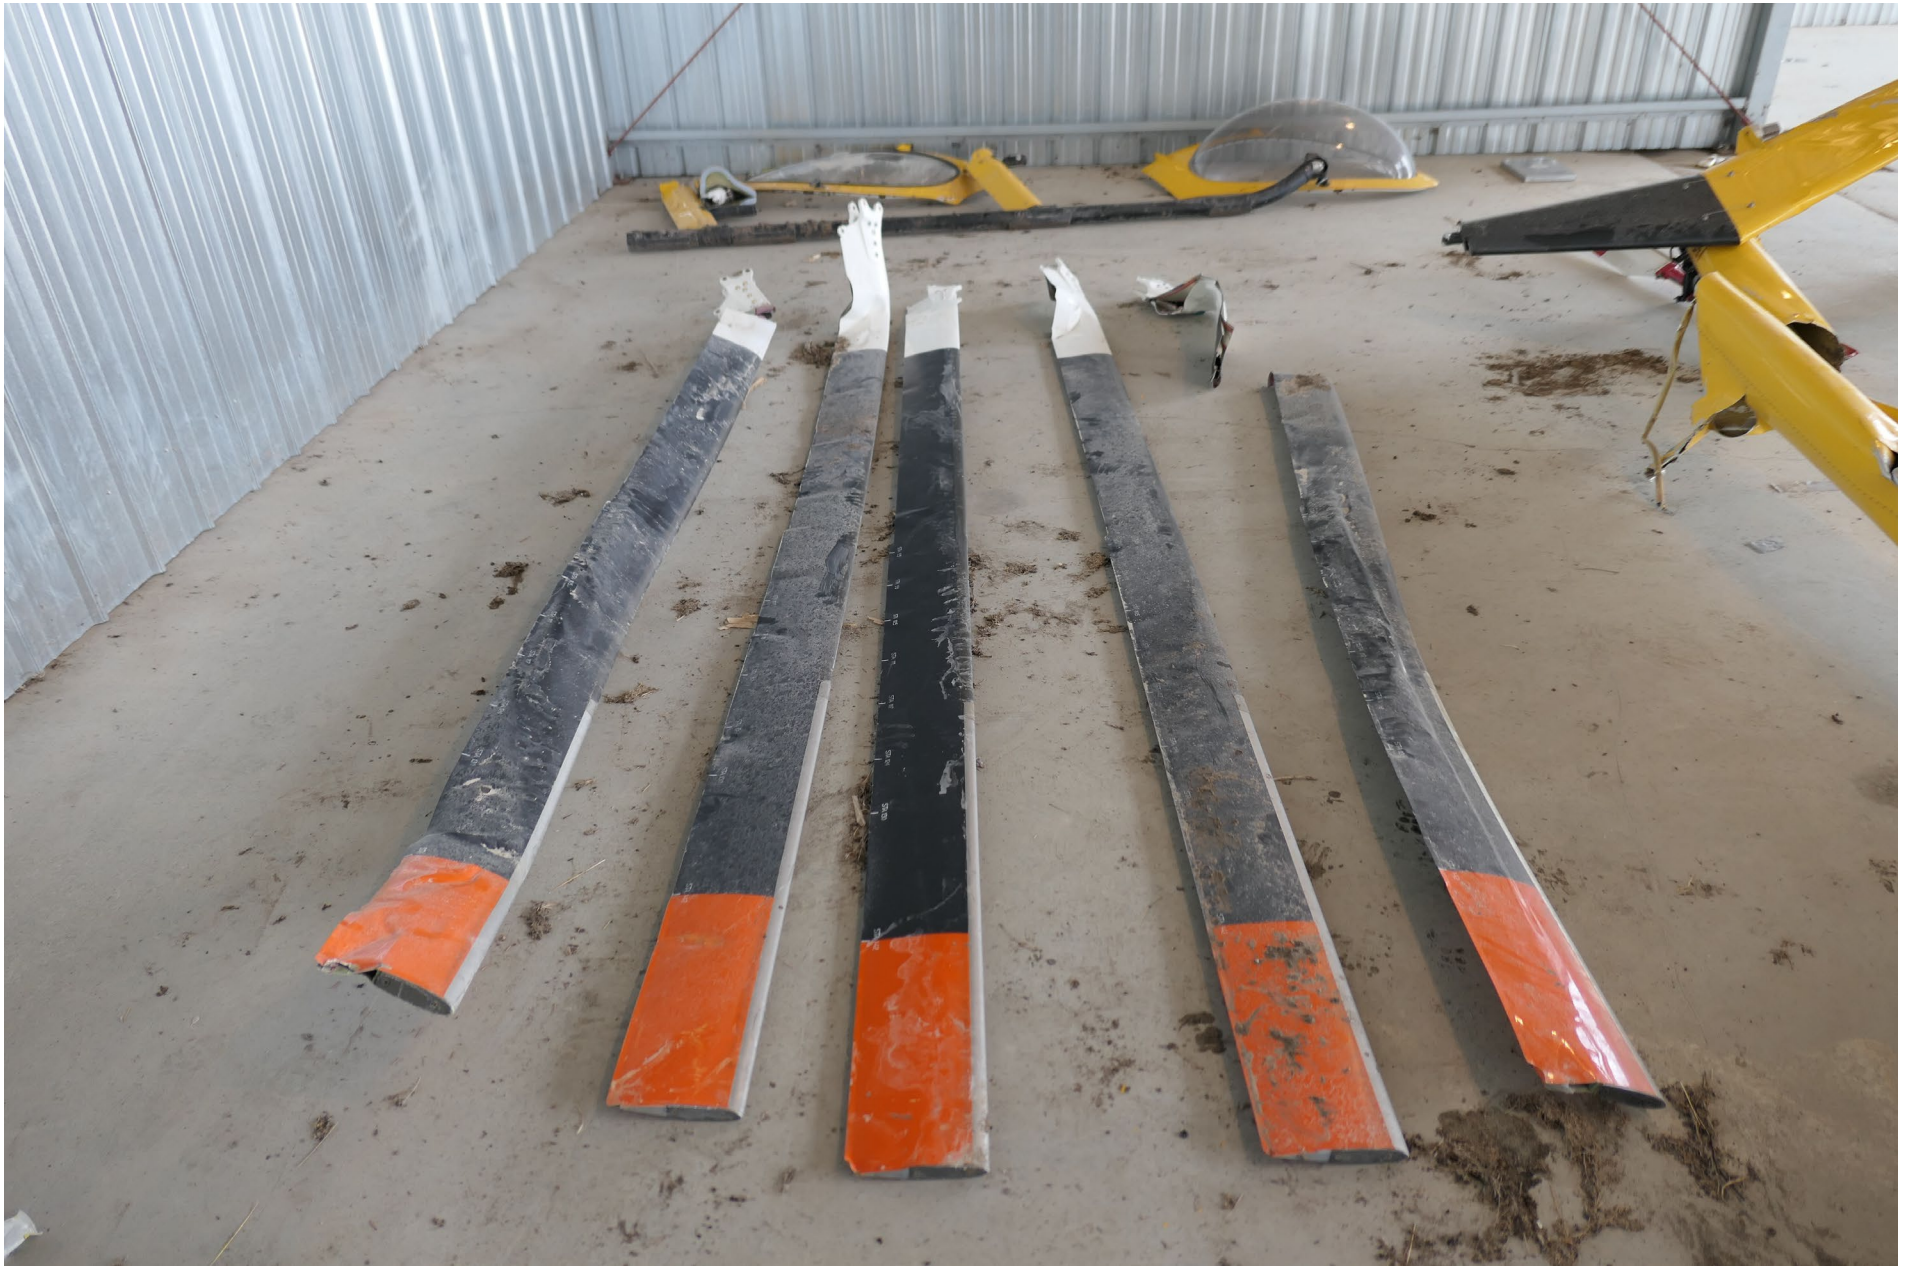
**Photo 6 – View of the main rotor blades after they were recovered from the accident site (courtesy of MD Helicopters).**

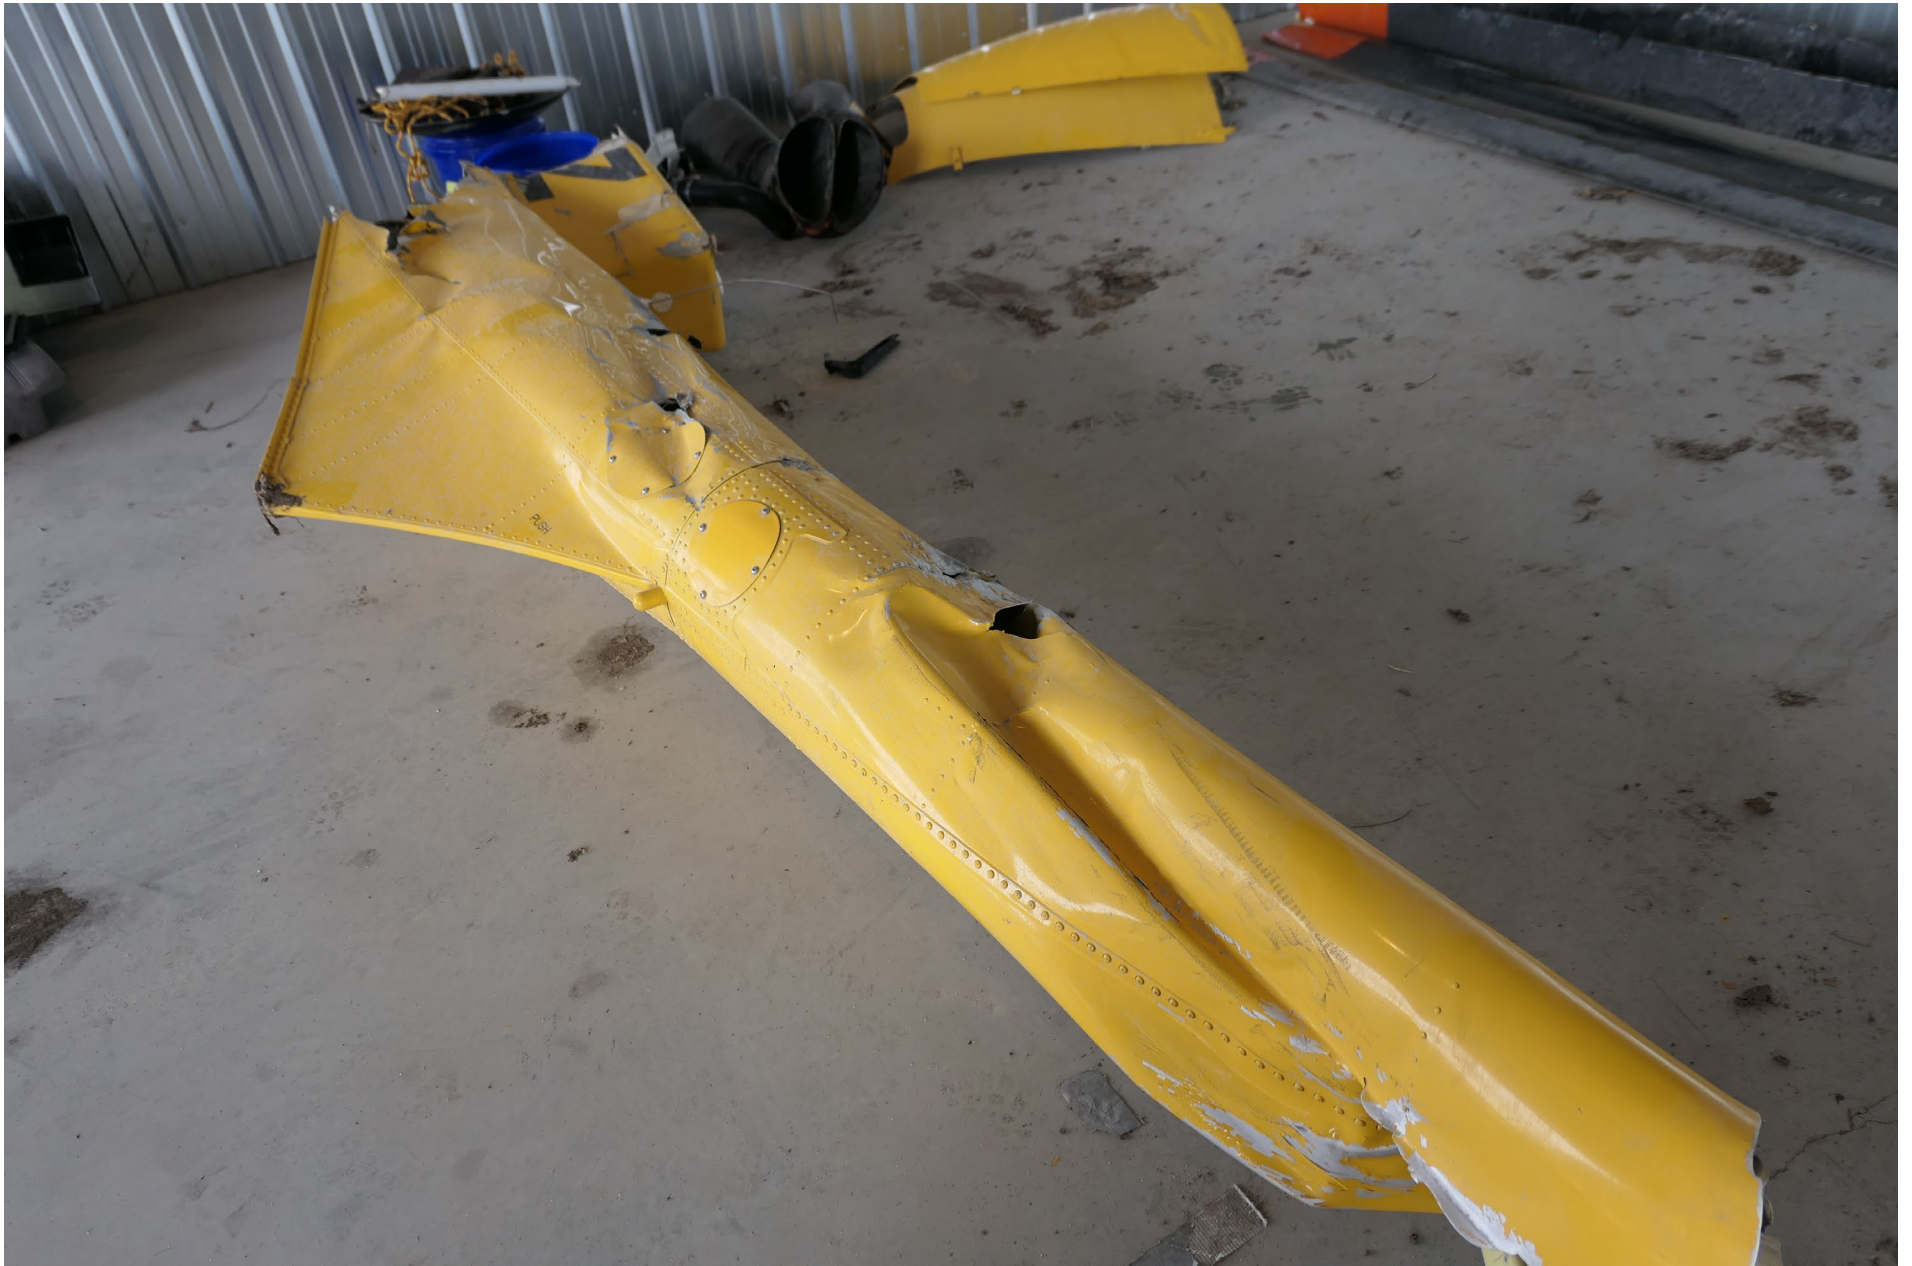
**Photo 7 – View of the tail boom after it was recovered from the accident site (courtesy of MD Helicopters).**

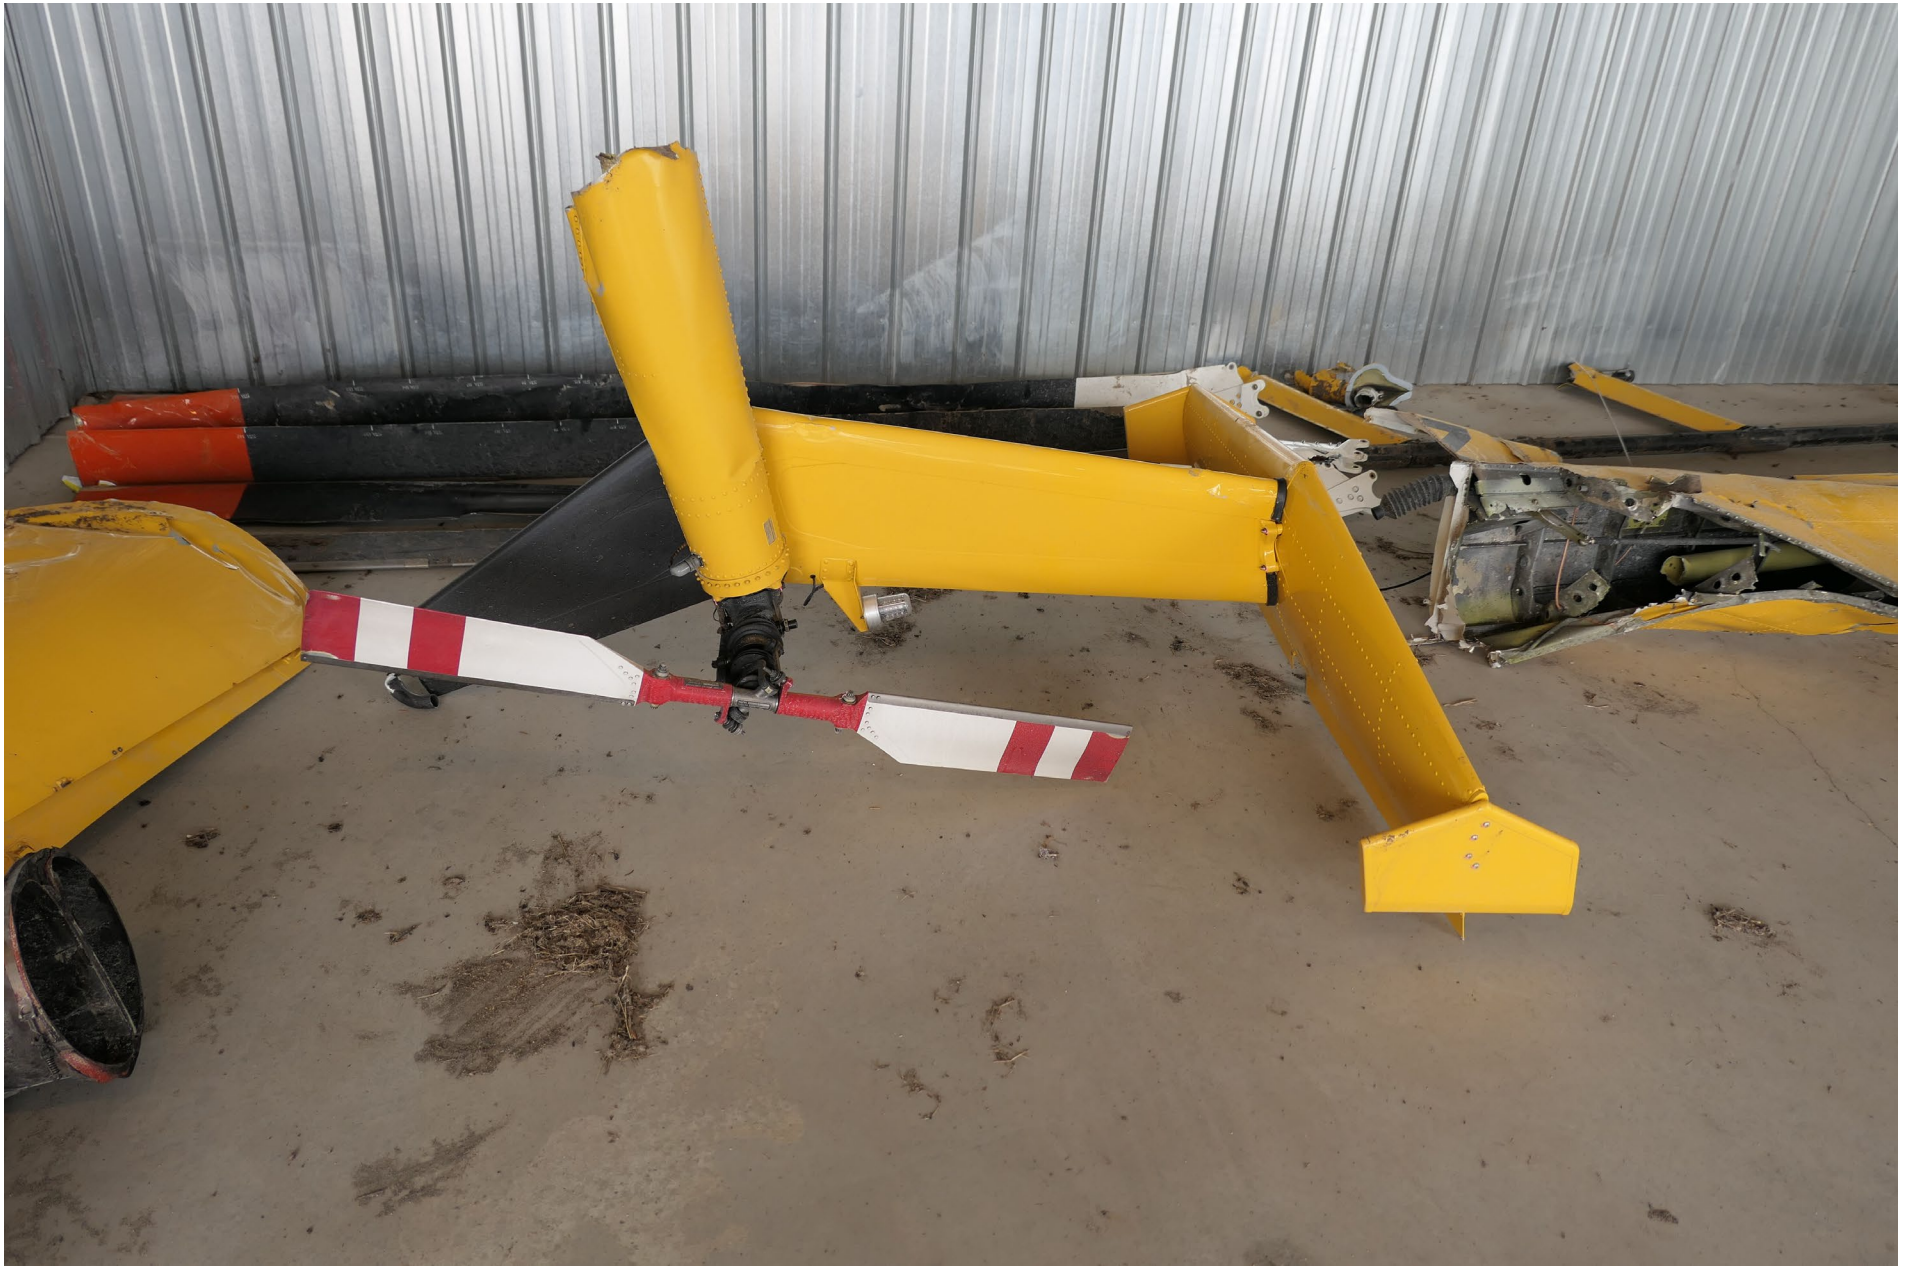
**Photo 8 – View of the tail rotor system after it was recovered from the accident site (courtesy of MD Helicopters).**

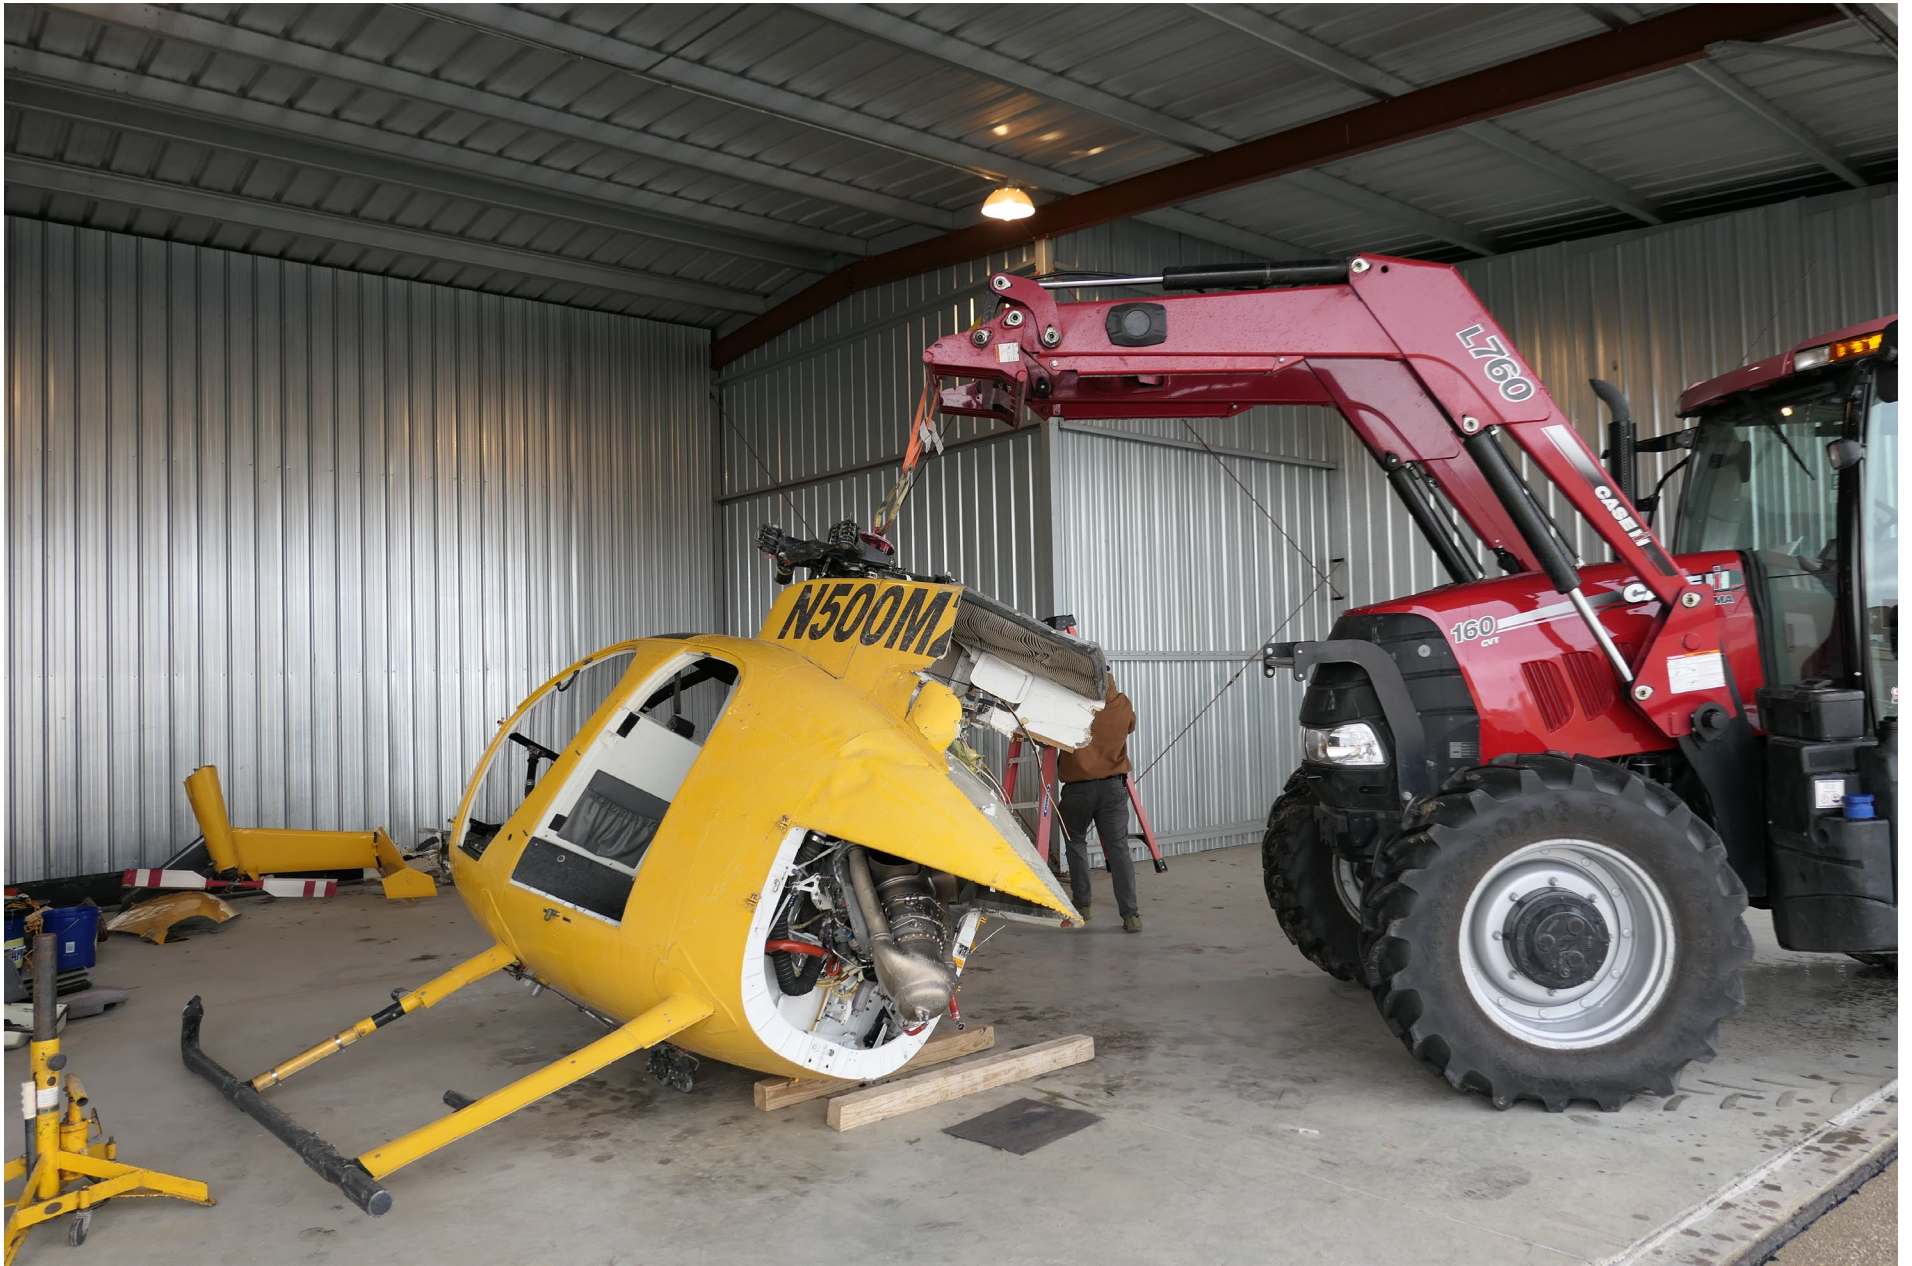
**Photo 9 – View of the fuselage being moved after it was recovered from the accident site (courtesy of MD Helicopters).**

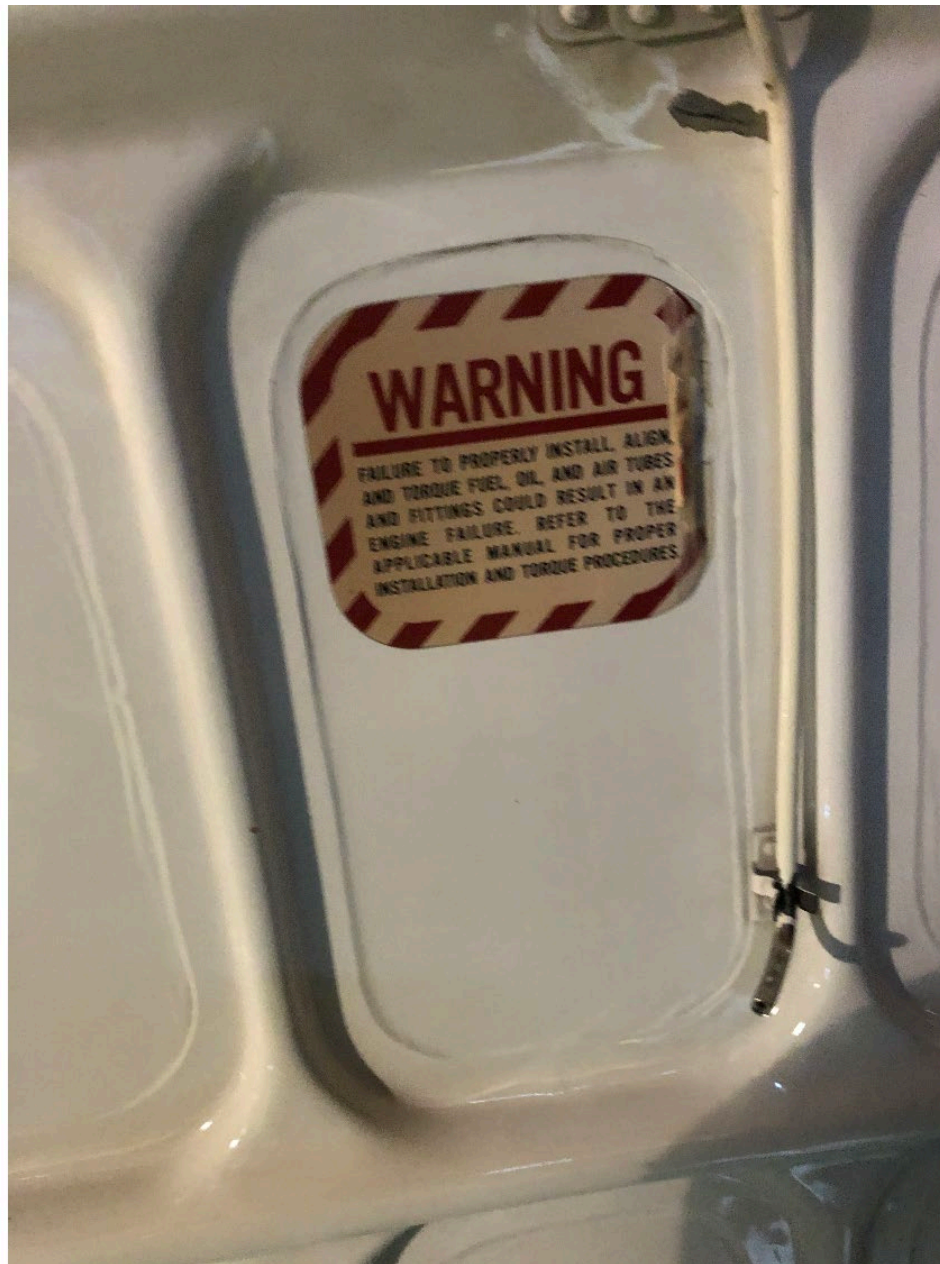
**Photo 10 – View of the required placard in the engine compartment of the accident helicopter (courtesy of Winco Powerline Services).**
