## **CEN22LA146 - N500MZ NTSB Examination Report**

## **Engine Investigation Report**

**Rolls-Royce Corporation  
Model 250-C20R/2  
Engine CAE-295832**

**Accident date: 17 March 2022  
Wreckage exam date: 5 April 2022  
Engine exam date: 20 April 2022  
Report date: 29 April 2022  
NTSB Case: CEN22LA146**

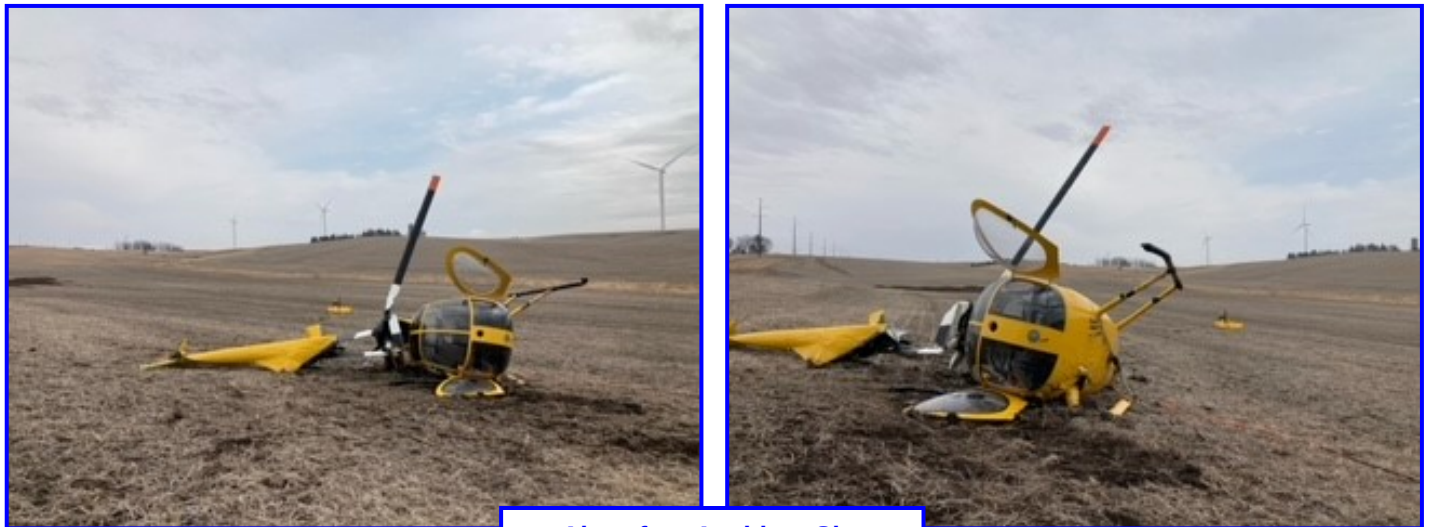
The helicopter sustained substantial damage to the fuselage, the main rotor system, and the tail rotor system. The helicopter was recovered from the accident site for a future examination of the airframe and the engine. During the recovery from the field, it was noticed by the operator that an airline on the governor to the fuel control was found not attached, via the B-nut. It appeared the B-nut had backed away to the elbow of the line.

Aircraft at Accident Site

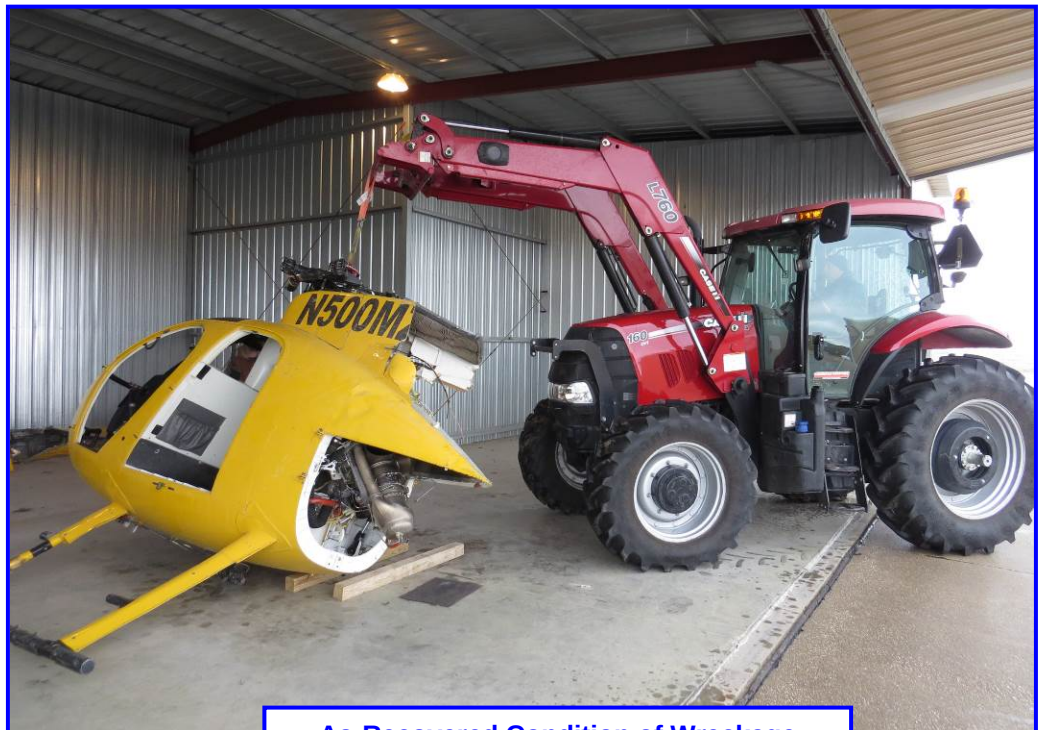
The aircraft sustained substantial damage upon impact fracturing the entire right hand skid and strut assembly. Prior to engine removal, the aircraft was positioned upright using a tractor and supported with aircraft jacks at fuselage support points. This allowed the fuselage to sit level for the purposes of the wreckage examination & engine removal.

The tail-boom and tail rotor driveshaft were severed approximately 36" forward of the tail-rotor gearbox & aft stabilizer. The tail rotor drive shaft exhibited signs of low speed rotational scoring & torsional bucking/fracture at the severed location.

As-Recovered Condition of Wreckage

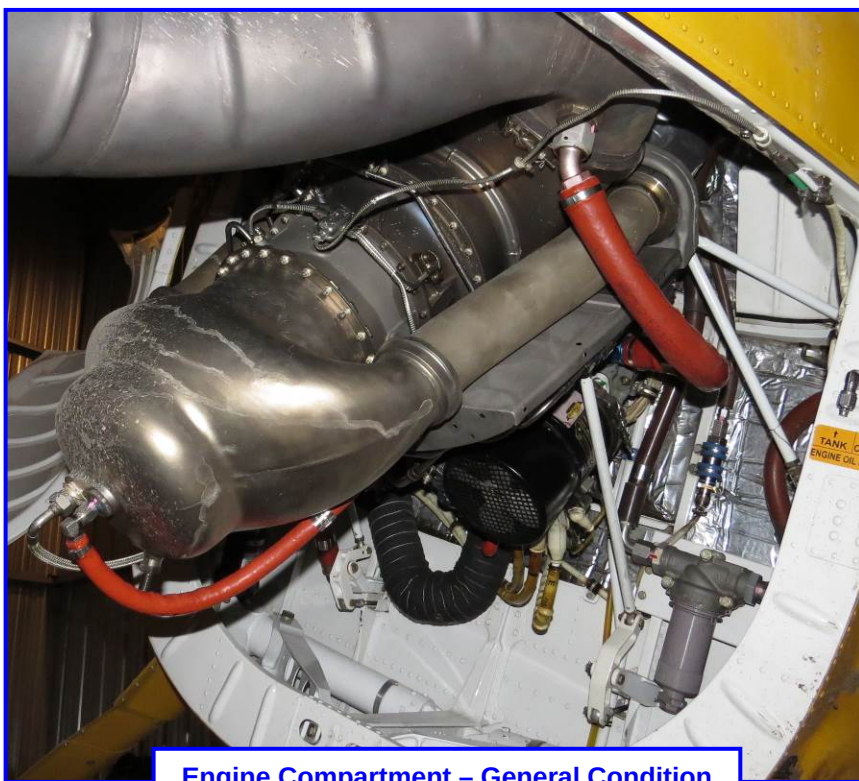
The engine remained within the engine compartment. All three mount struts were secure with no sign of bending, fracture, or lateral displacement. The engine exterior did not reveal any obvious signs of damage from impact forces, internal engine failure, or evidence of fire.

Engine Compartment – General Condition

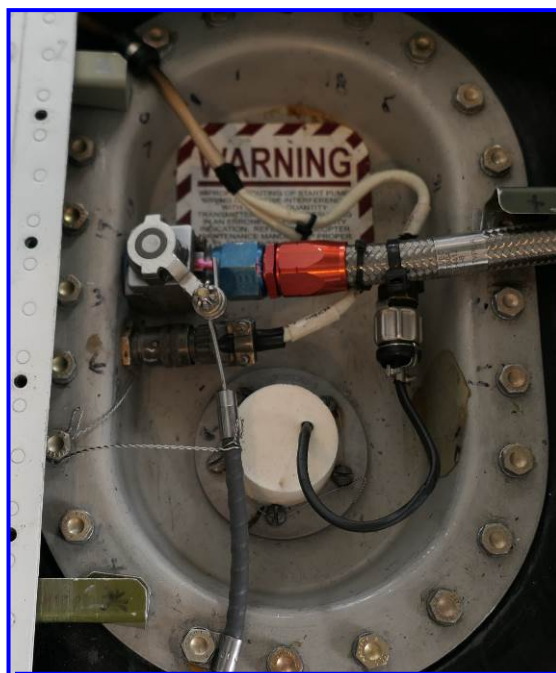
In conjunction with the airframe fuel system vacuum check, the airframe fuel tank was accessed to verify functionality of the fuel cut-off valve, condition of the fuel start boost pump, & presence/condition of fuel in the tank. The shut-off valve was reaching its full open/close travel positions via the cockpit push/pull knob control on the instrument panel.

Accessing Fuel Tank – Shutoff Valve

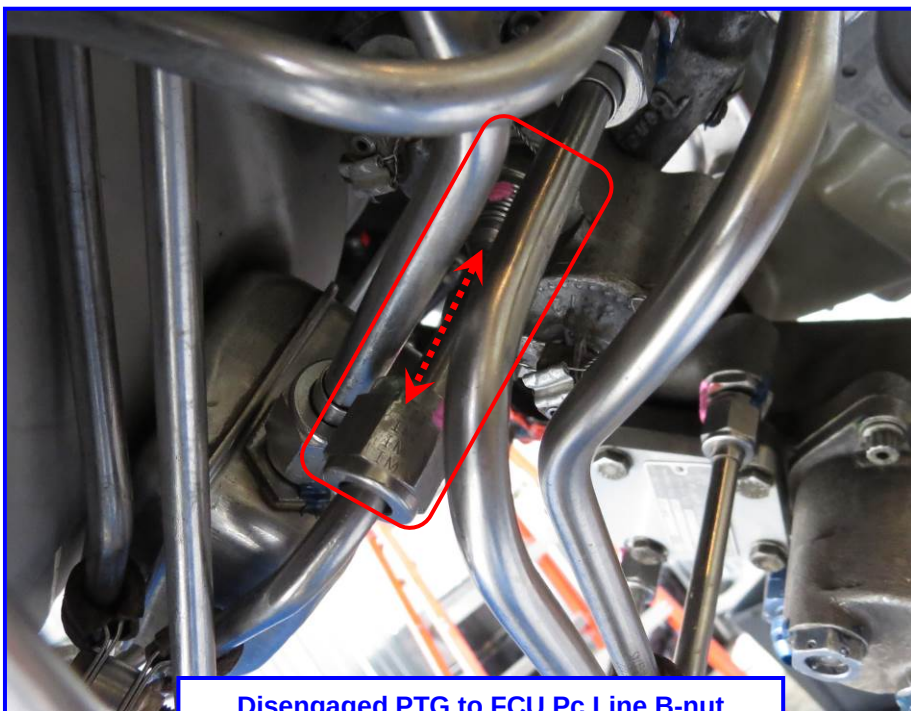
The engine B-nuts and fittings were checked by hand for proper torque. All B-nuts except for the Pc tube connection at the FCU were found to be at least hand tight and marked with a variety of torque paint colors.

Disengaged PTG to FCU Pc Line B-nut

- All B-nuts with the exception of the Pc tube connection at the FCU were found to be at least hand tight & most marked with torque paint.
  - Discrepancies were noted & confirmed with regards to presence of torque paint striping & subsequent insufficient torque/tightening of the Pc tube B-nut at the FCU.

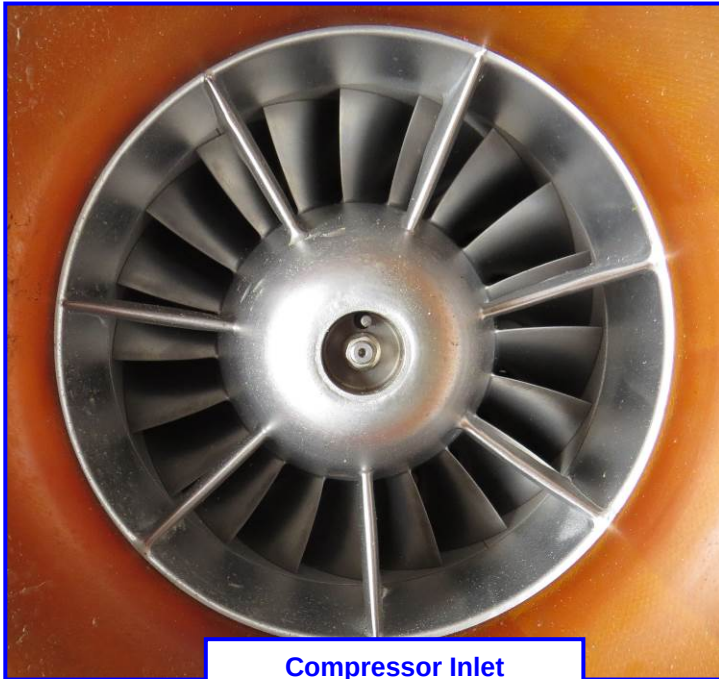
The 4th-stage turbine blades appeared undamaged when inspected as did the surrounding turbine sections and exhaust plenum. The compressor inlet was also undamaged and exhibited no indication of FOD ingestion.

Compressor Inlet

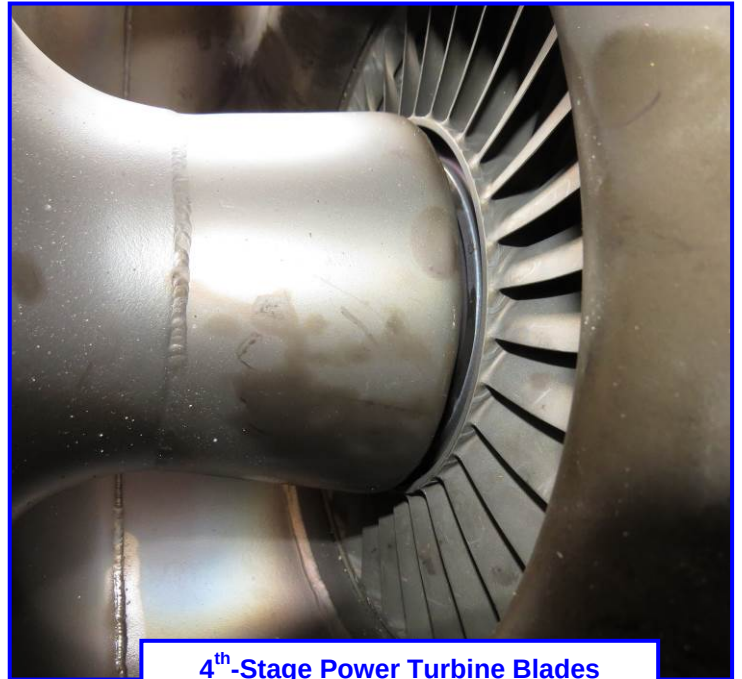
4<sup>th</sup>-Stage Power Turbine Blades

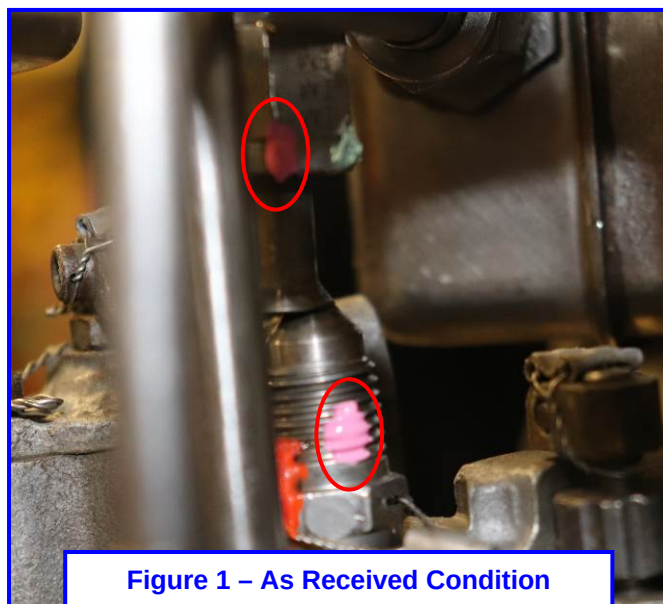
- (1) Both the B-nut & union fitting on the FCU displayed presence of multiple torque paint markings, presumably from prior maintenance. The presence of continuous pink torque paint observed on the intact connections confirms the most recent installation by the length of striping on the union fitting threads. (Figure 1)

Figure 1 – As Received Condition

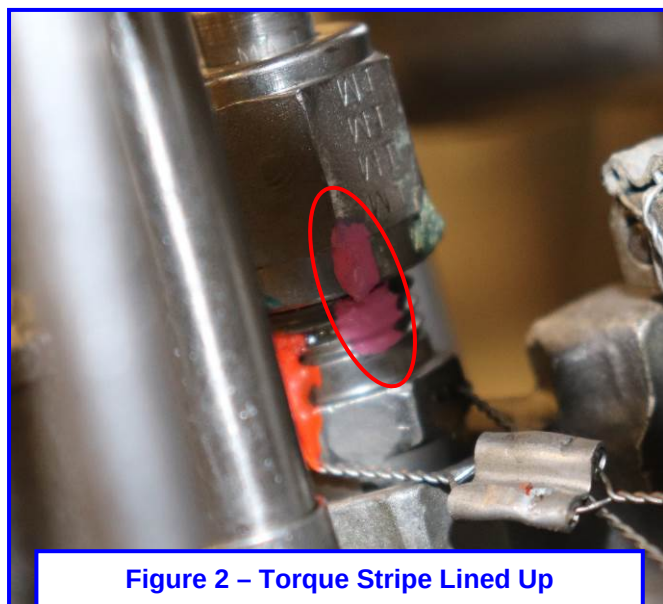
- (2) The B-nut was threaded down to the point where both ends of the torque stripe were “touching” and in alignment. This is likely what the mechanic observed following FCU installation. The engine exam determined this position to be ½ turn loose. (Figure 2)
- (3) The Pc system air leak check was performed with the B-nut condition shown in Figure 2. A considerable leak was detected.
- (4) The B-nut was run down to the full extent of travel using the OMM specified B-nut torque adapter (wrench) and torqued per the requirements. The nut travelled 5 additional “flats” from its location in Figure 2 to its final torque position. An additional observation was the amount of torque stripe squeeze out upon reaching its full travel. (Figures 3 and 4)
- (5) The Pc system air leak check was performed again with no leaks detected at the subject location.

Figure 2 – Torque Stripe Lined Up

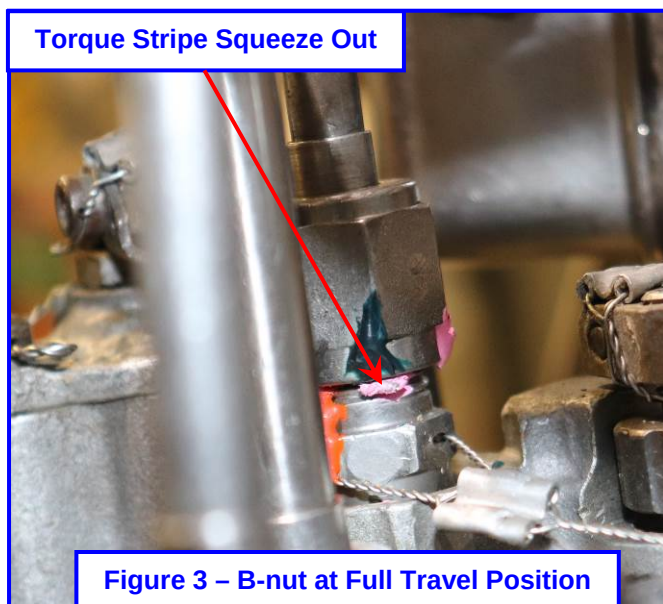
Figure 3 – B-nut at Full Travel Position

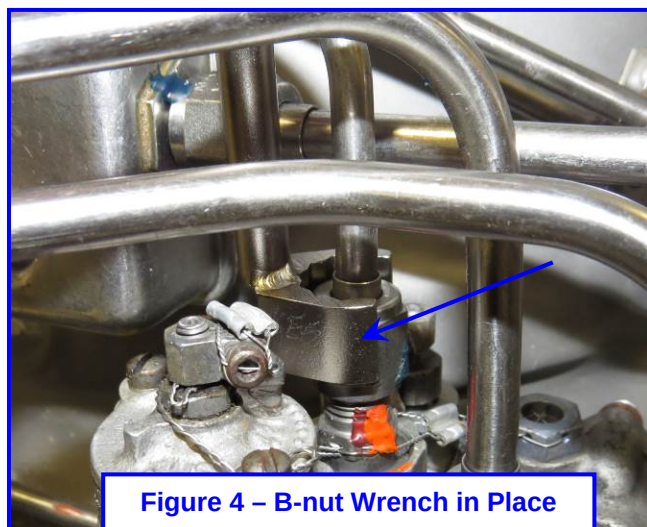
Additionally, the mechanic stated that an angle head open end wrench was used to put on the b-nuts. A “crow’s foot” was then attached to a torque wrench, to torque the b-nuts to specifications. The mechanic stated that while torquing the specific B-nut, the FCU was contacted by the torque wrench and a false torque reading was likely provided.

Figure 4 – B-nut Wrench in Place

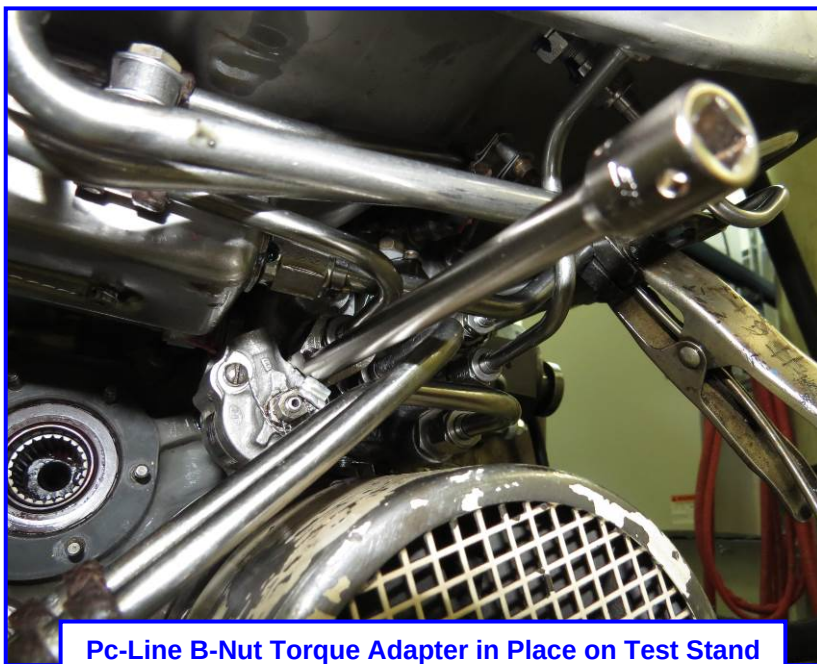
Prior to performing the standard performance test, the Pc tube B-nut was run down to the same position shown previously in Figure 2. This was intended to replicate its position following the FCU replacement on the aircraft. The engine started & during acceleration, with the starter still engaged, the engine abruptly went to an idle/sub-idle condition. Examination revealed the subject B-nut connection had separated (backed off) at the FCU presenting a similar scenario as that during the mishap flight. The B-nut was refitted & tightened using the OMM specified P/N 23083893 B-nut torque adapter wrench. The engine subsequently performed satisfactorily on the test cell.

Pc-Line B-Nut Torque Adapter in Place on Test Stand

- The engine performed satisfactorily on the test cell.
  - The “partial B-nut engagement”, presumably similar to that of the mishap event, was configured on the test stand. The engine responded in a manner similar to that of the event.
