N500MZ accident  
Anthony Brucie  
3/17/2022

**NTSB Case Number: CEN22LA146**

Subject: N500MZ ADAIR, IA / ENGINE FAILURE / 03/17/2022 / 1430 CDT

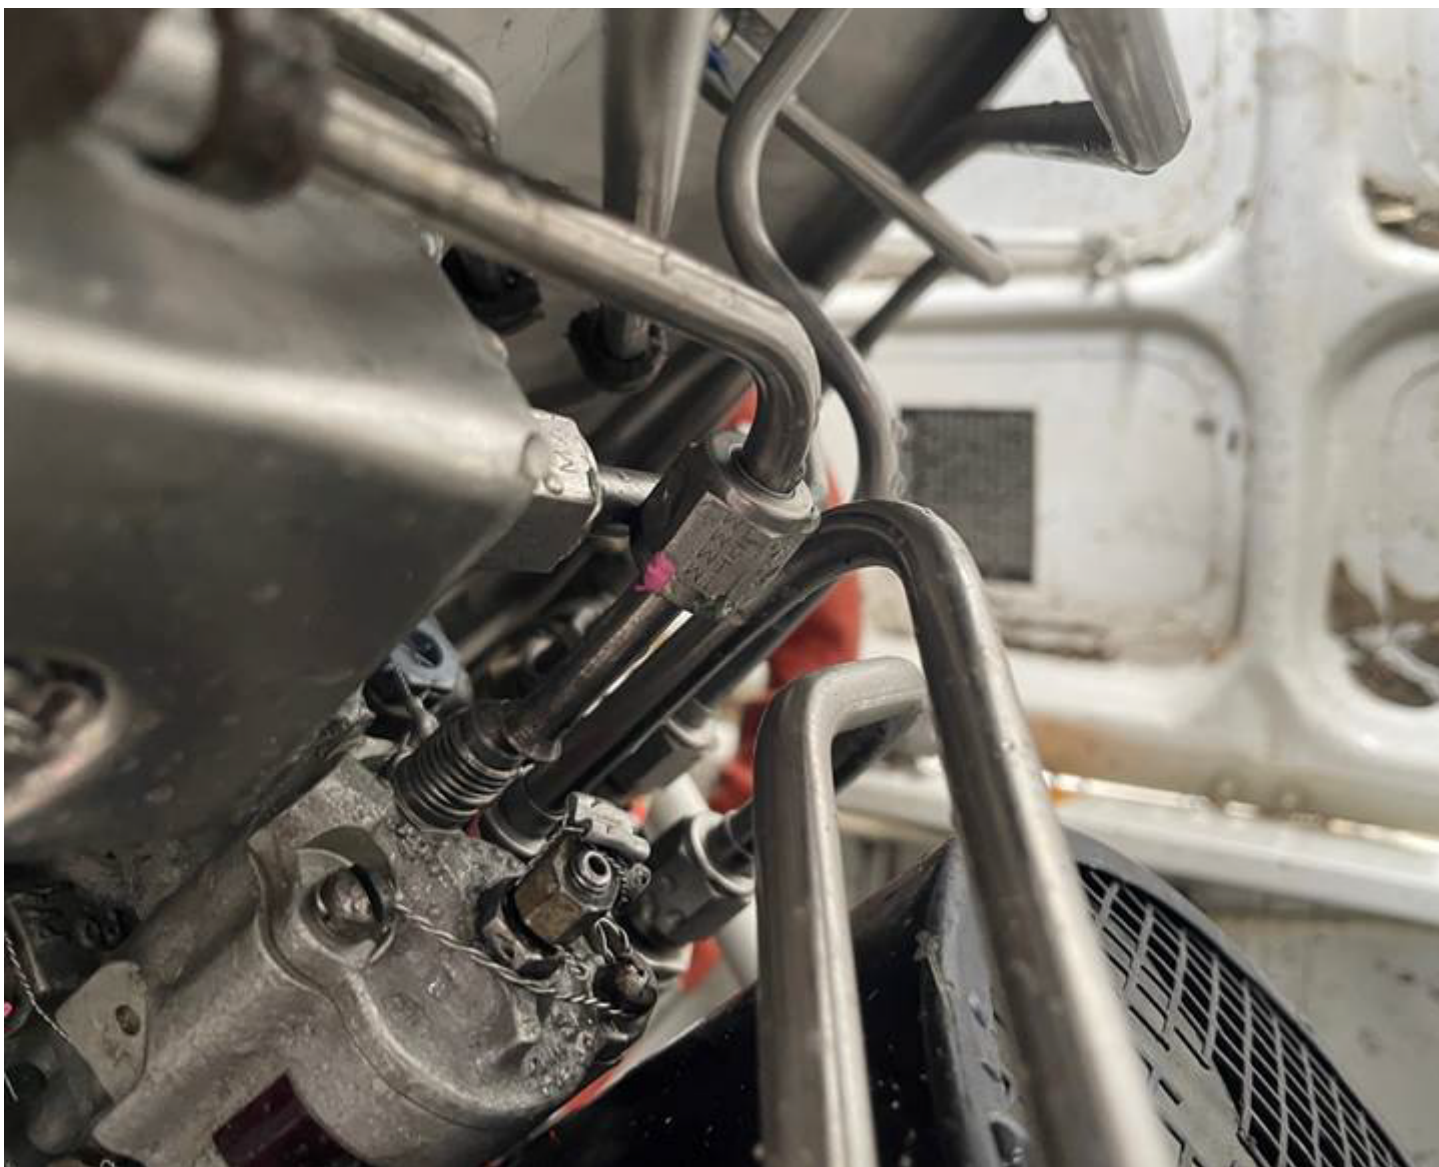
During this visual observation, our Director of Maintenance noted a PC airline connecting the T on the governor to the fuel control was not attached via the b-nut which had backed away to the elbow of the line. The nut and threads had torque stripping matching the remaining intact stripes that were placed on after a fuel control change that occurred on 3/16. Following this fuel control replacement, the pilot and mechanic performed necessary leak checks and noted no anomalies. The mechanic performed torque-wrench adjustments on the required b-nuts of the system post-installation on 3/16, taking the nuts to between 55 and 80 lbs as indicated in the manual. The following morning post leak-checks, the torque stripes were applied. The pilot and mechanic narrative goes into additional detail about the pilots inspection of the system and the mechanics, however, it would be plausible that the b-nut in the image below, although installed and torque-striped, may have been inadvertently missed in the full torqueing of all nuts. The result of this line losing its integrity and reduction of airflow is deregulation of the engine and uncommanded roll to idle, which is what occurred.
