# National Transportation Safety Board

CEN22LA152

## **ENGINE EXAMINATION**

Location: Ash Flat, Arkansas  
Date: March 5, 2022  
Time: 1615 CST  
2115 UTC  
Airplane: Bellanca 17-30A, N8869V

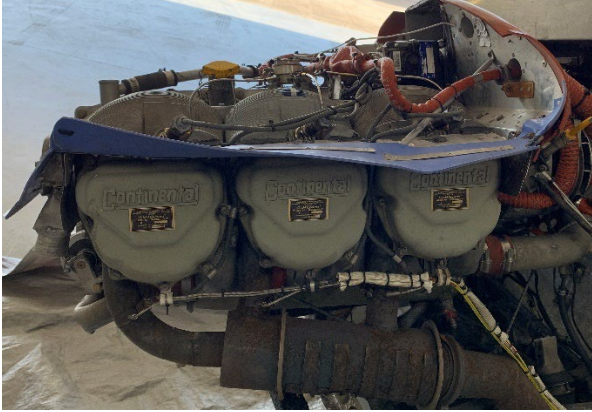
**Figure 1 Left Side of Engine**

The engine remained attached to the airframe largely through fuel lines and engine controls. The mixture and throttle arms remained properly secured. Engine control continuity was established from the cockpit controls to the throttle body. Both mixture and throttle arms moved without interference.

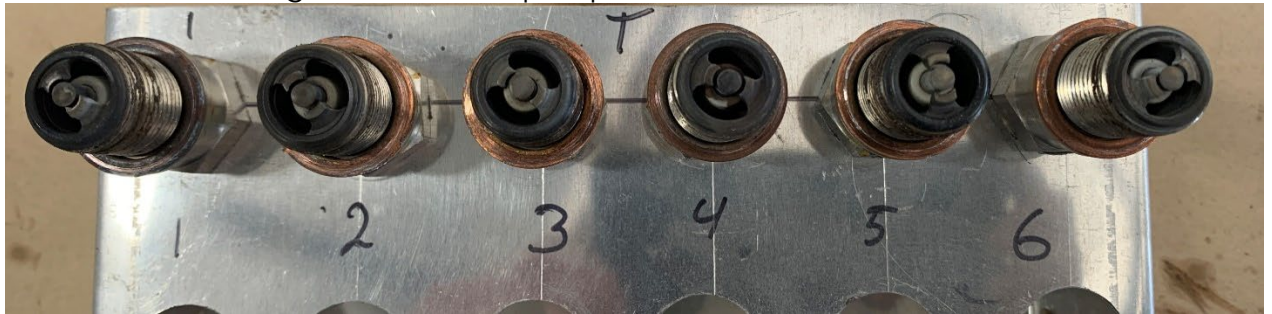
**Figure 3 Top Bank of Spark Plugs**

The engine was then separated from the airframe. The top bank of spark plugs, rocker box covers, and engine driven fuel pump were removed.

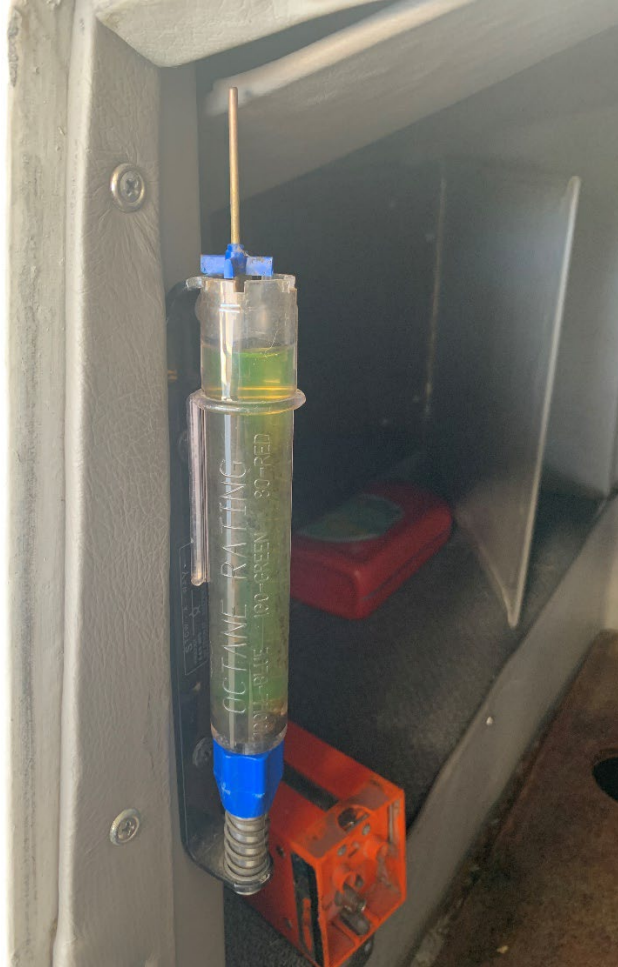
**Figure 4 Fuel Tester with Water**

Using a power tool, the magneto would not produce spark. The ignition harness was then removed and small amount of water drained out. Further opening the magneto timing port resulted in several ounces of water draining from the magneto. The magneto produced spark at the distributor when using a small wire to conduct the charge. The ignition harness was reinstalled and the magneto produced spark at each terminal. The airplane wreckage had been stored outside and partially tarped, however when opening the baggage compartment, a fuel tester was full of water suggesting that the source of water was likely from being stored outside.

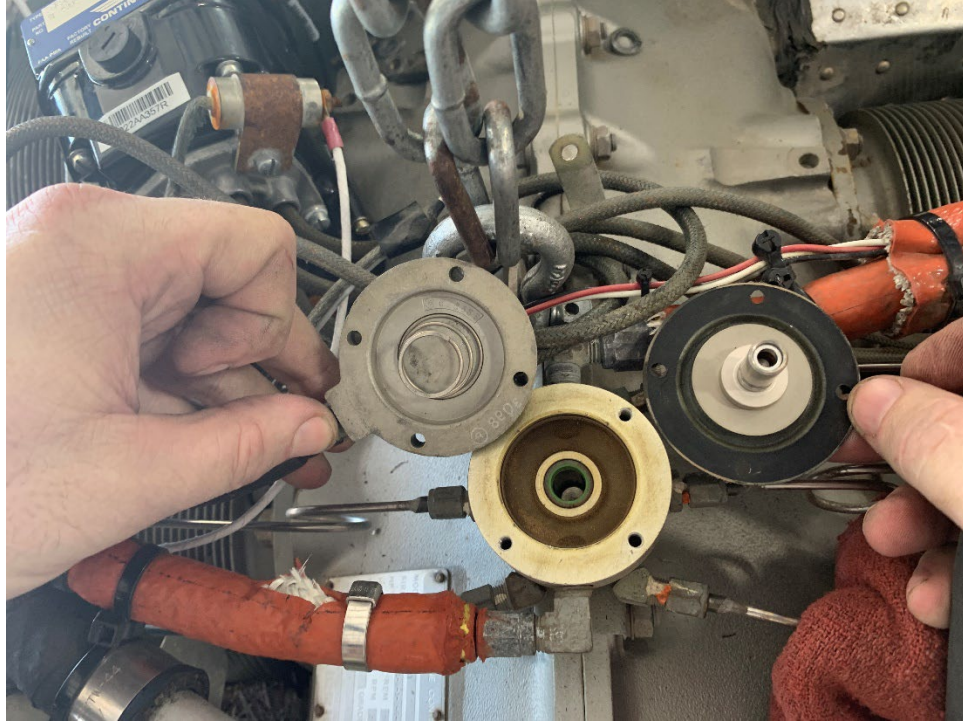
**Figure 5 Fuel Divider**

The fuel divider was opened. The diaphragm was intact and the fuel screen was clear.

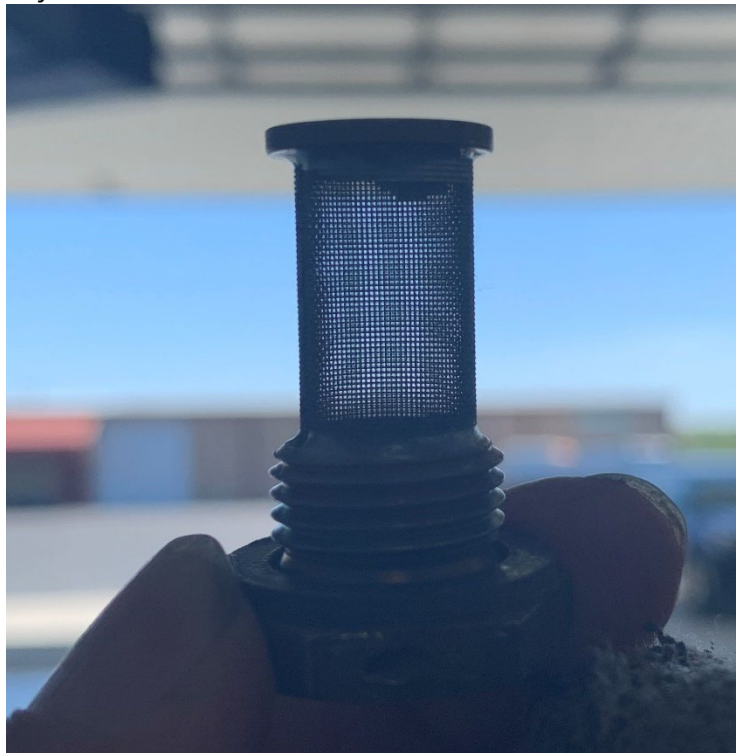
**Figure 6 Throttle Body Fuel Screen**

The throttle body fuel screen was removed and found to be clear of debris.

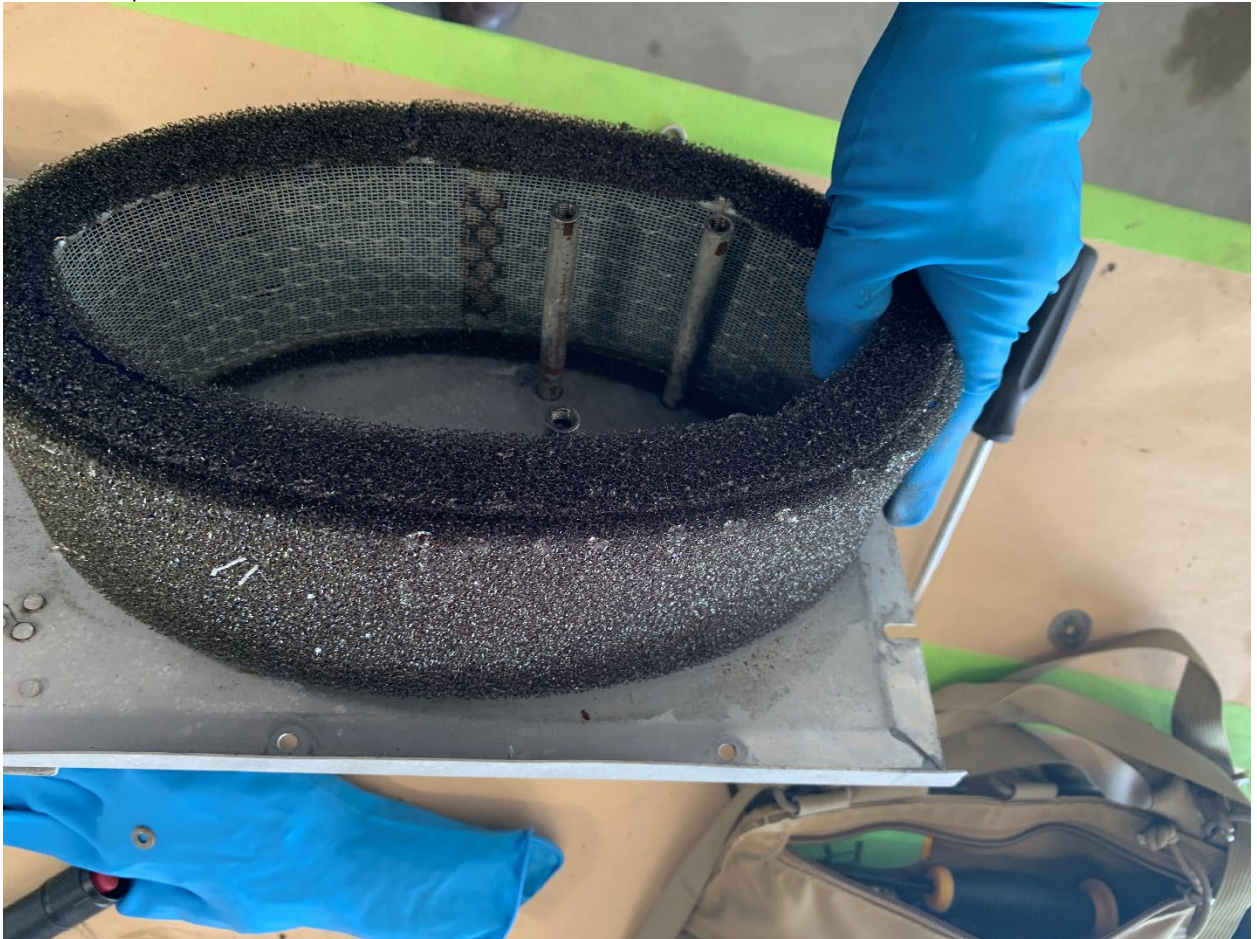
**Figure 7 Brackett Air Filter**

The airplane was modified via STC with a Brackett Air Filter which removed removed and opened. No obstructions were found in the filter.

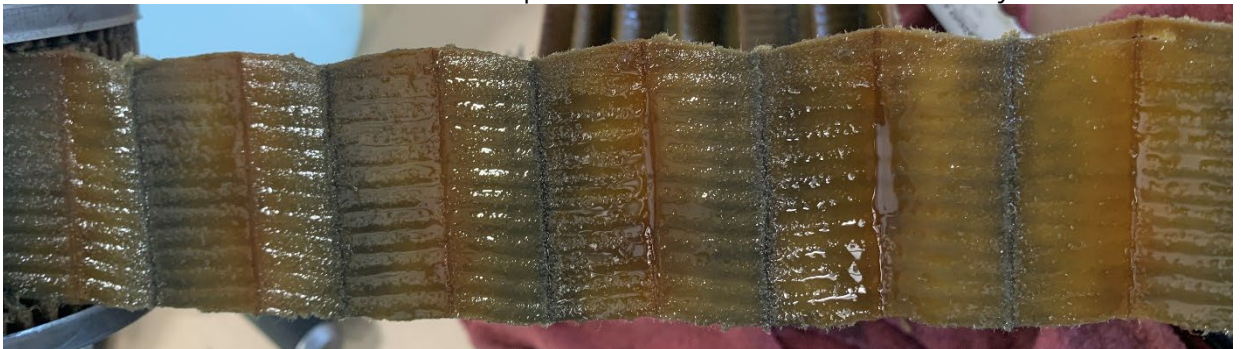
**Figure 8 Oil Filter Element**

The oil filter was removed and cut open. The filter did not contain any debris.

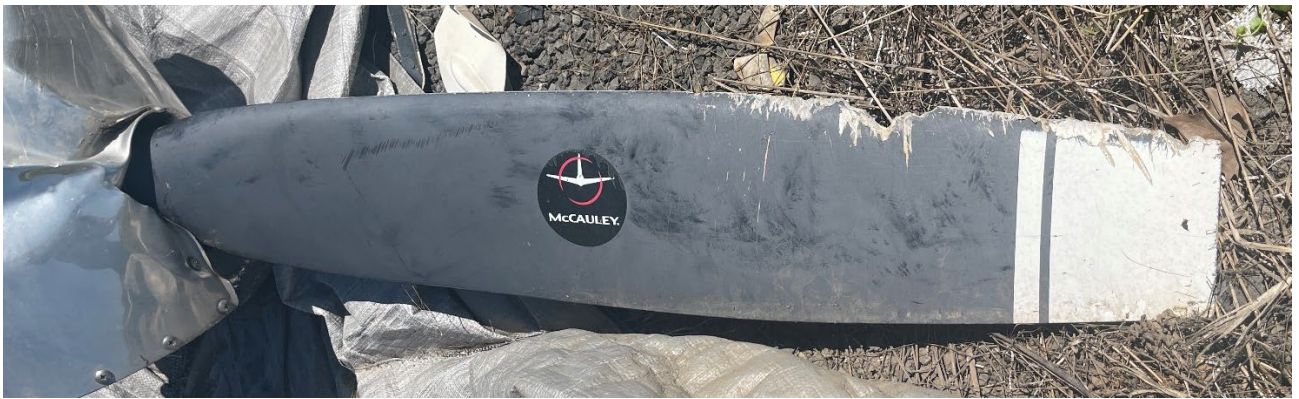
**Figure 9 Blade A**

Blade A had several chunks of metal missing from the leading edge along with chordwise scratches.

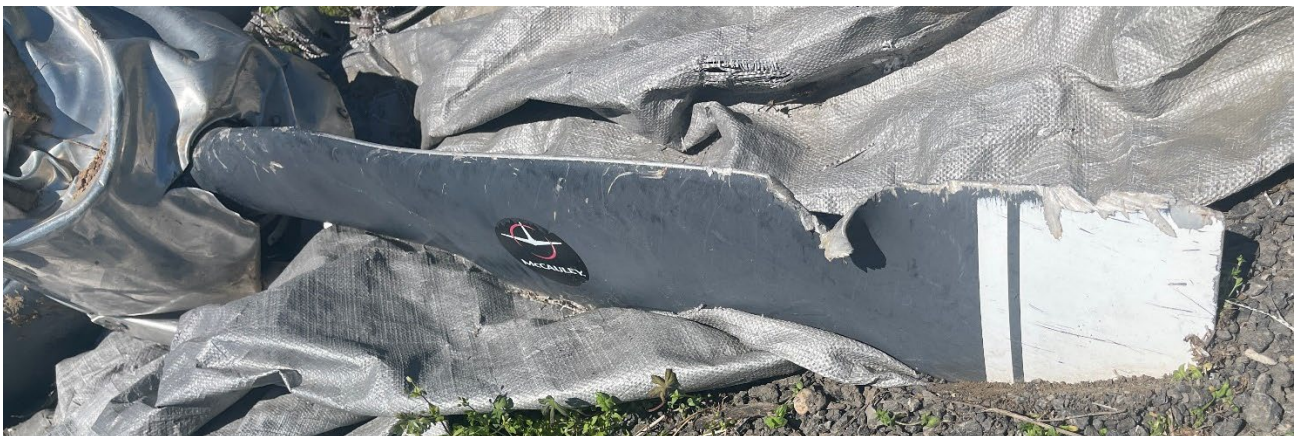
**Figure 10 Blade B**

Blade B had several gouges and was partially torn. Chordwise scratches could also be seen.

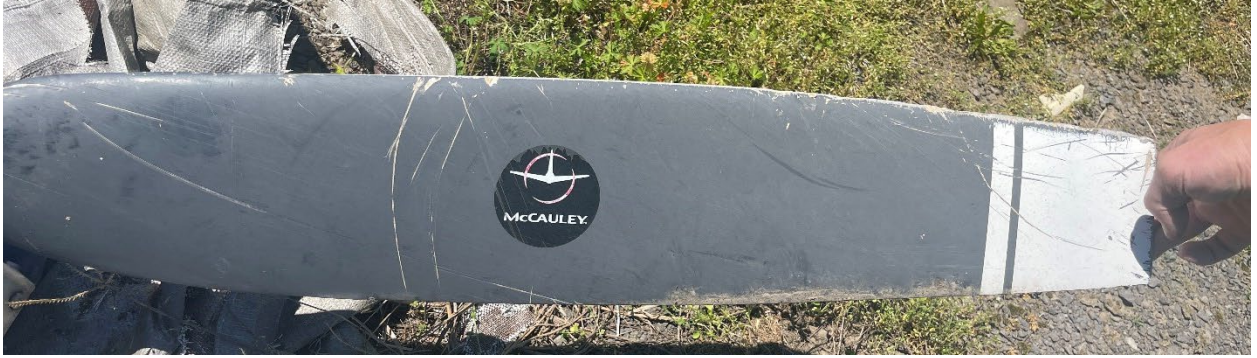
**Figure 11 Blade C**

Blade C was relatively undamaged when compared to the other two blades. It had damaged to its leading edge with chordwise scratches.
