# National Transportation Safety Board

CEN22LA152

## VIDEO FILES

Specialist's Factual Report

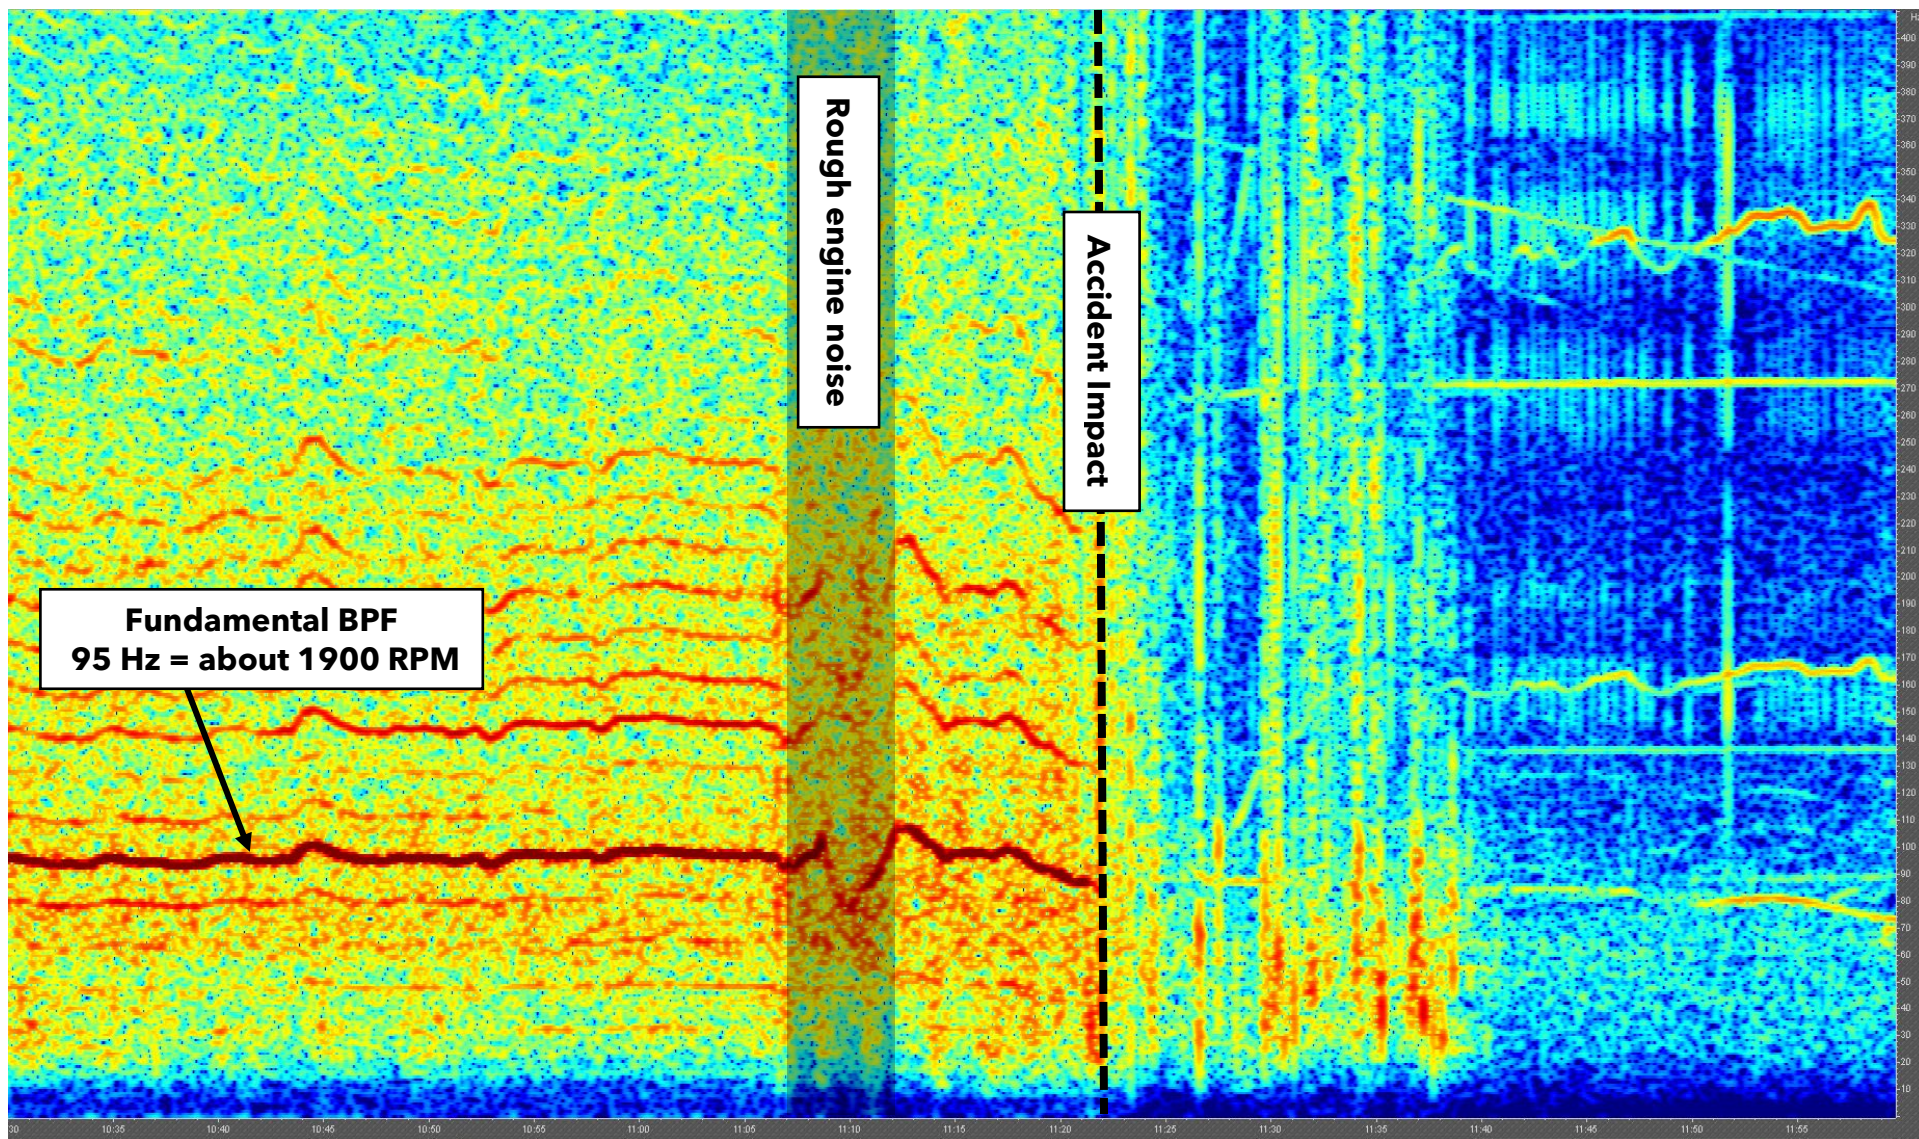
**Figure 1.** 3D spectrogram of audio from video file 2 - 10:30 to 12:01 video elapsed time.

The fundamental blade passage frequency from 10:30 to 11:06 video elapsed time remained relatively constant at about 95 Hz, as annotated in Figure 1. Using equation 1, this represents an engine speed of about 1900 RPM.

From 11:07 to 11:12, popping sounds consistent with a rough engine were noted and the spectrogram shows a variation in the BPF and sound intensity during this time. The cause of the variation in BPF and sound intensity could not be determined by this study.

At 11:13, the popping engine noise ceased and the BPF was 105 Hz, which represents an engine speed of about 2100 RPM.

The BPF decreased from 105 Hz to 86 Hz (or about 1700 RPM) from 11:13 to the time of the accident impact at 11:22. During this time, the video showed the aircraft was in an increasing left bank and losing altitude.

Audio from a video recording was used to estimate the speed of the aircraft's engine before the accident. As the aircraft passed over the runway 22 markings at CVK, the speed of the engine was about 1900 RPM. 15 seconds before the accident, a variation in the BPF and sound intensity consistent with a rough operating engine were noted, the cause of which could not be determined in this study. When the rough engine noises ceased and nominal sound intensity returned 9 seconds before the accident, the engine speed was about 2100 RPM. The engine speed gradually decreased to 1700 RPM at the time of the accident. The study determined that the engine was operating at the time of impact.
