# National Transportation Safety Board

CEN22LA153

Group Chair's Factual Report

Location: Olive Branch, Mississippi  
Date: March 23, 2022  
Time: 1028 central daylight time (CDT)  
1528 coordinated universal time (UTC)  
Airplane: Piper PA-46-600TP, S/N 4698190, N627PR

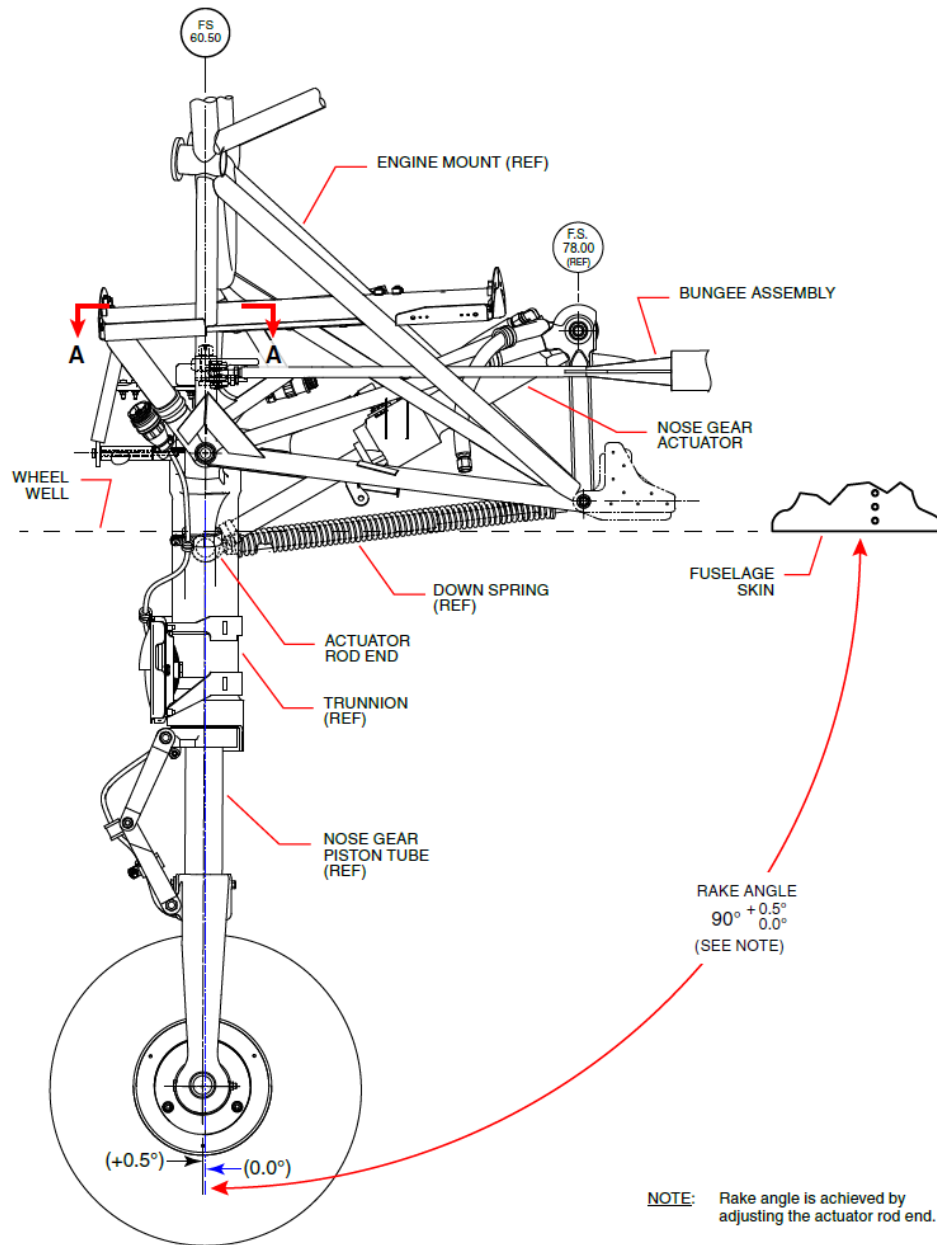
The NLG rake angle on the M600 is defined as the angle between the lower fuselage skin and the centerline of the NLG strut. The rake angle is set at the factory to be 90° with a tolerance of +0.5°/0.0°. Service Letter 1286 issued on August 18, 2020, provides instructions for inspection and adjustment of NLG steering components including rake angle (Figure 4). The Service Letter has been revised 4 times since, but the rake angle has not changed.

**Figure 4.** NLG rake angle drawing from Piper Service Letter 1286A

At a rake angle of  $90^{\circ}$  for the M600, the steering axis passes through the NLG axle and intersects the ground coincident with the center of the tire contact patch with the airplane stationary (zero trail). At a rake angle of  $90.5^{\circ}$  for the M600, the steering axis still passes through the NLG axle but intersects the ground slightly forward of the center of the tire contact patch with the airplane stationary (positive trail). Examination of the structural response of a landing gear at wheel touchdown shows that the gear will deflect aft initially due to wheel spin-up loads and then undergo a damped oscillation about its equilibrium point. The deflection can be as much as a few inches for tall landing gear on a heavy airplane.

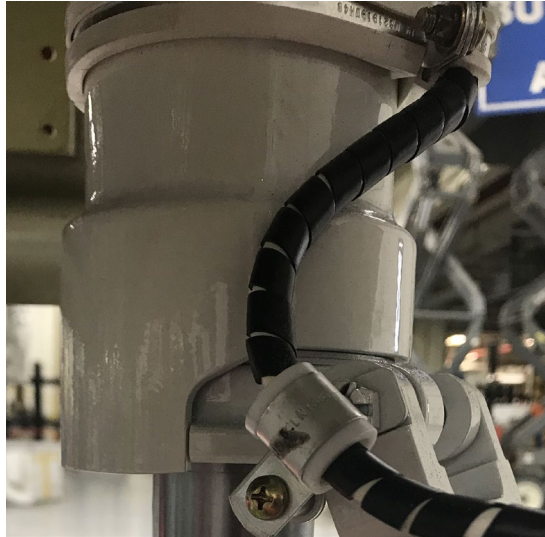
If the NLG is externally turned beyond the left or right placard limits, mechanical stops will engage where portions of the NLG and steering mechanism come into contact. If turned beyond limits to the right, a machined stop on the lower portion of the rotating strut assembly will contact a machined stop on the lower end of the stationary trunnion assembly, Figure 7. The right stops will engage when the NLG tire is turned about 36° right. Further turning to the right may damage the machined stops and will load the strut-trunnion interface but will not affect the steering arm or steering horn. If turned beyond limits to the left, the steering arm left

**Figure 7.** M600 right turn mechanical stop between trunnion and strut just prior to engagement

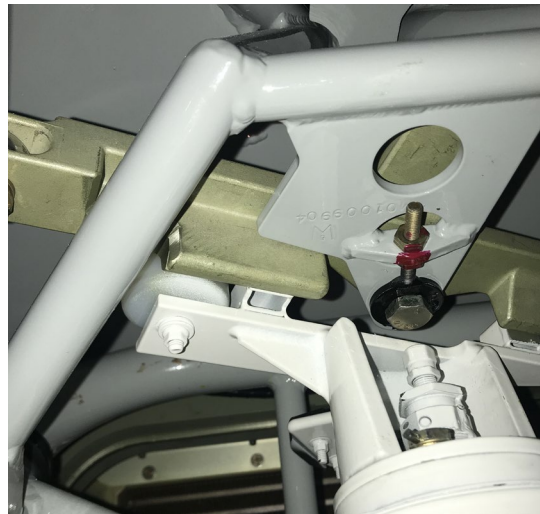
flange aft face will contact the steering arm mount plate on the engine mount, Figure 8. The left stops will engage when the NLG tire is turned about 30.5° left. Further turning to the left may damage the steering arm or mount plate or may apply a torsional load to the steering horn installed on top of the NLG strut. The rudder primary and secondary mechanical stops do not allow the mechanical turn limit stops to engage through pilot input at the rudder pedals. There are machined stops on the left side of the lower strut and trunnion assemblies similar to those on the right. These stops can only engage during NLG retraction as the strut rotates 90° to stow in the wheel well.

**Figure 8.** M600 left turn mechanical stop between engine mount and steering arm just prior to engagement

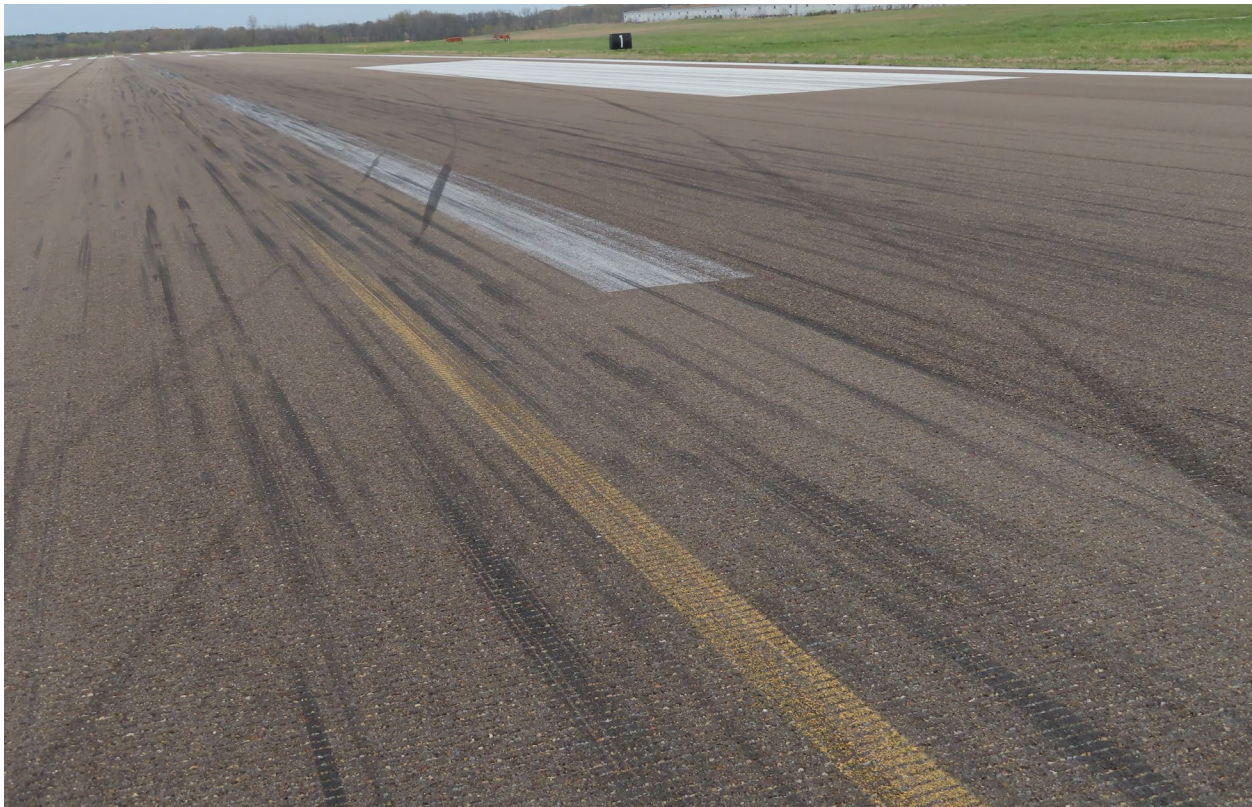
The first evidence of runway marking from the accident airplane was a light rubber transfer mark with the tread pattern evident from the LMLG that began about 760 feet from the runway 18 threshold and about 17 feet left of the centerline. The LMLG rubber transfer mark was continuous until it departed the right side of the runway and varied in intensity. There was a light rubber transfer mark with the tread pattern evident from the NLG that began about 900 feet from the runway 18 threshold and about 10 feet left of the centerline. The NLG rubber transfer mark was mostly continuous until it departed the right side of the runway and varied in intensity. The LMLG and NLG rubber transfer marks were aligned, separated by about 80 inches, and drifted to the left until about 1140 feet from the threshold when they veered sharply to the right (Figure 10). A rubber transfer mark from the RMLG was not discernable until about 1170 feet from the runway 18 threshold and was not continuous to the departure point. At the point where the RMLG mark became evident, the perpendicular distance between the RMLG and NLG marks measured 51 inches and between the LMLG and NLG measured 106 inches. Throughout the right veer the LMLG rubber transfer mark varied from moderate to heavy intensity with the tread pattern evident consistent with moderate to heavy braking. The NLG rubber

transfer mark during the veer was initially of moderate intensity with the tread pattern evident but transitioned to heavy intensity with no tread pattern evident consistent with a skidding tire. Between the centerline and the departure point, the NLG skipped once and transitioned to light intensity with a tread pattern just before the departure. The RMLG rubber transfer mark was sporadic from its beginning to departure with moderate intensity. At the runway centerline the perpendicular distance from the RMLG to NLG measured 33 inches and from the LMLG to NLG measured 119 inches. Between the centerline and the right edge, the perpendicular distance from the RMLG to NLG measured 41 inches and between the LMLG and NLG measured 107 inches. At the departure point the perpendicular distance between each MLG and the NLG measured 82 inches. The airplane departed the right side of runway 18 centered about 1330 feet from the threshold (Figure 11). There was no disturbance of the grass for about 10 feet beyond the runway edge. From this point forward there were 3 deep ruts in the grass and each had the tread pattern evident in the mud. The NLG rut stopped after about 68 feet and the airplane came to rest about 80 feet further along the path. The path through the grass was essentially straight until the NLG rut disappeared and veered a small amount right after.

**Figure 10.** Rubber transfer marks on runway (viewed opposite direction of travel)

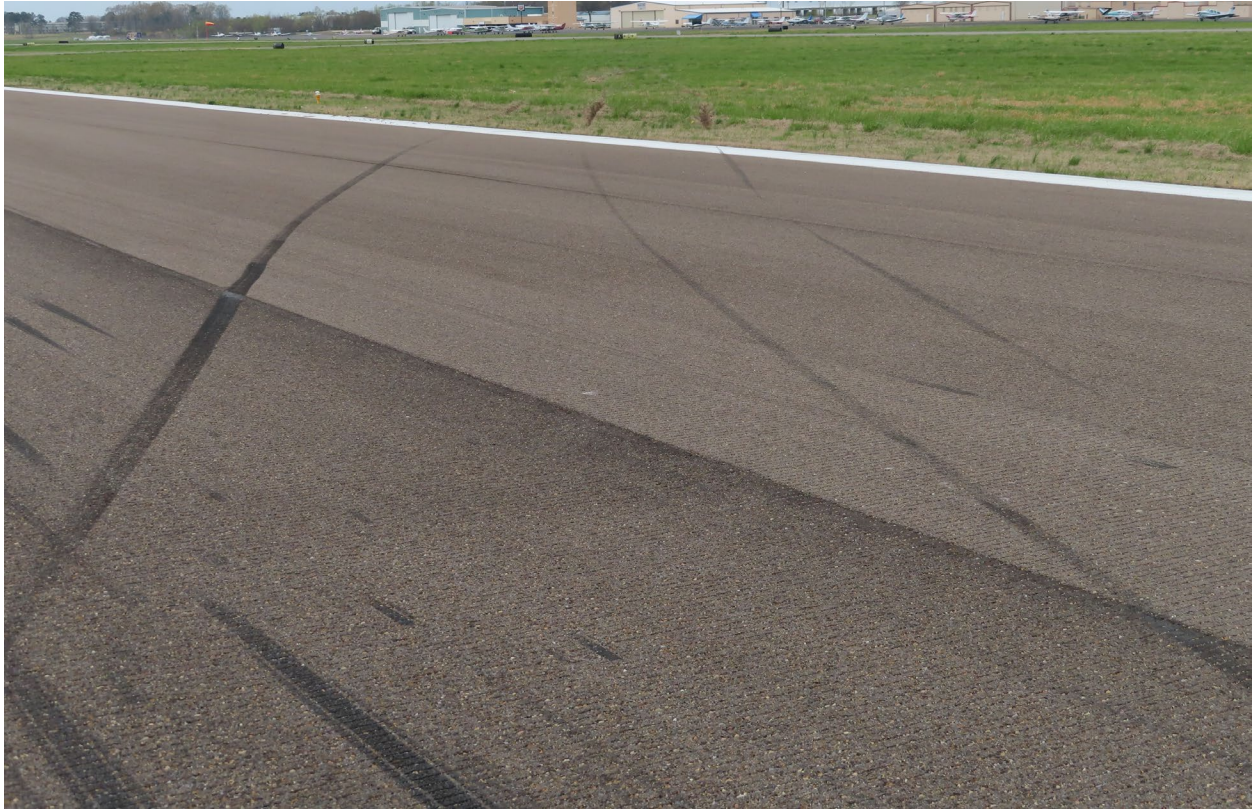
**Figure 11.** Rubber transfer marks and ruts in grass at departure point (viewed in direction of travel)

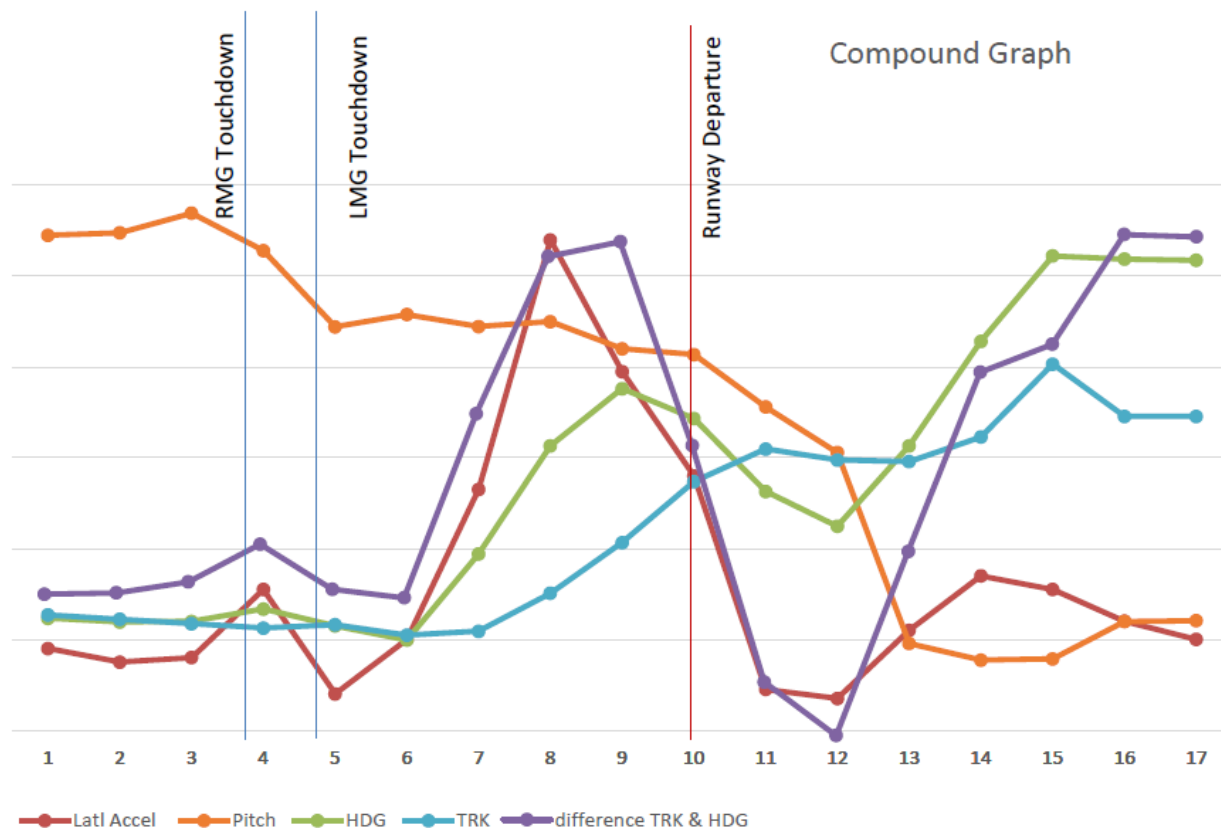
Piper plotted the lateral acceleration, pitch, heading, track, and the calculated difference between heading and track for the accident landing from the SD card at the request of the NTSB, Figure 12. The y-axis values are not displayed on this plot to show the relational differences in the parameters but were obtained from the raw data. The RMLG and LMLG touchdown points were established with the wheel speed information contained in the internal CMC data. The timing of the internal dataset is slightly different from the log data. The runway departure timing was estimated based on the airplane position information. The NLG touchdown can be estimated based on the pitch parameter. The RMLG touched down first at a recorded indicated airspeed about 76 kts followed by the LMLG about 1 second later at a recorded indicated airspeed about 74 kts. The NLG touched down about 1-2 seconds after the RMLG. Starting about 2 seconds after LMLG touch down the heading and track diverge with the nose to the right of the track that continues until runway departure indicating the airplane is in a skid. The maximum divergence occurs about 1 second prior to runway departure when the heading is about 223° and the track is about 195°. At the same time the lateral acceleration increases to a maximum of about 0.88 g about 2 seconds prior to runway departure confirming the airplane is in a left skid. The airplane departed the runway about 6 seconds after the RMLG touchdown at a ground speed about 47 kts with the heading and track mostly aligned. The pitch parameter shows a sharp decrease about 2 seconds after runway departure indicating collapse of the NLG.

**Figure 12.** Plot of data from N627PR accident landing
