## PA46 Operational & Maintenance Information, Nose Gear Steering

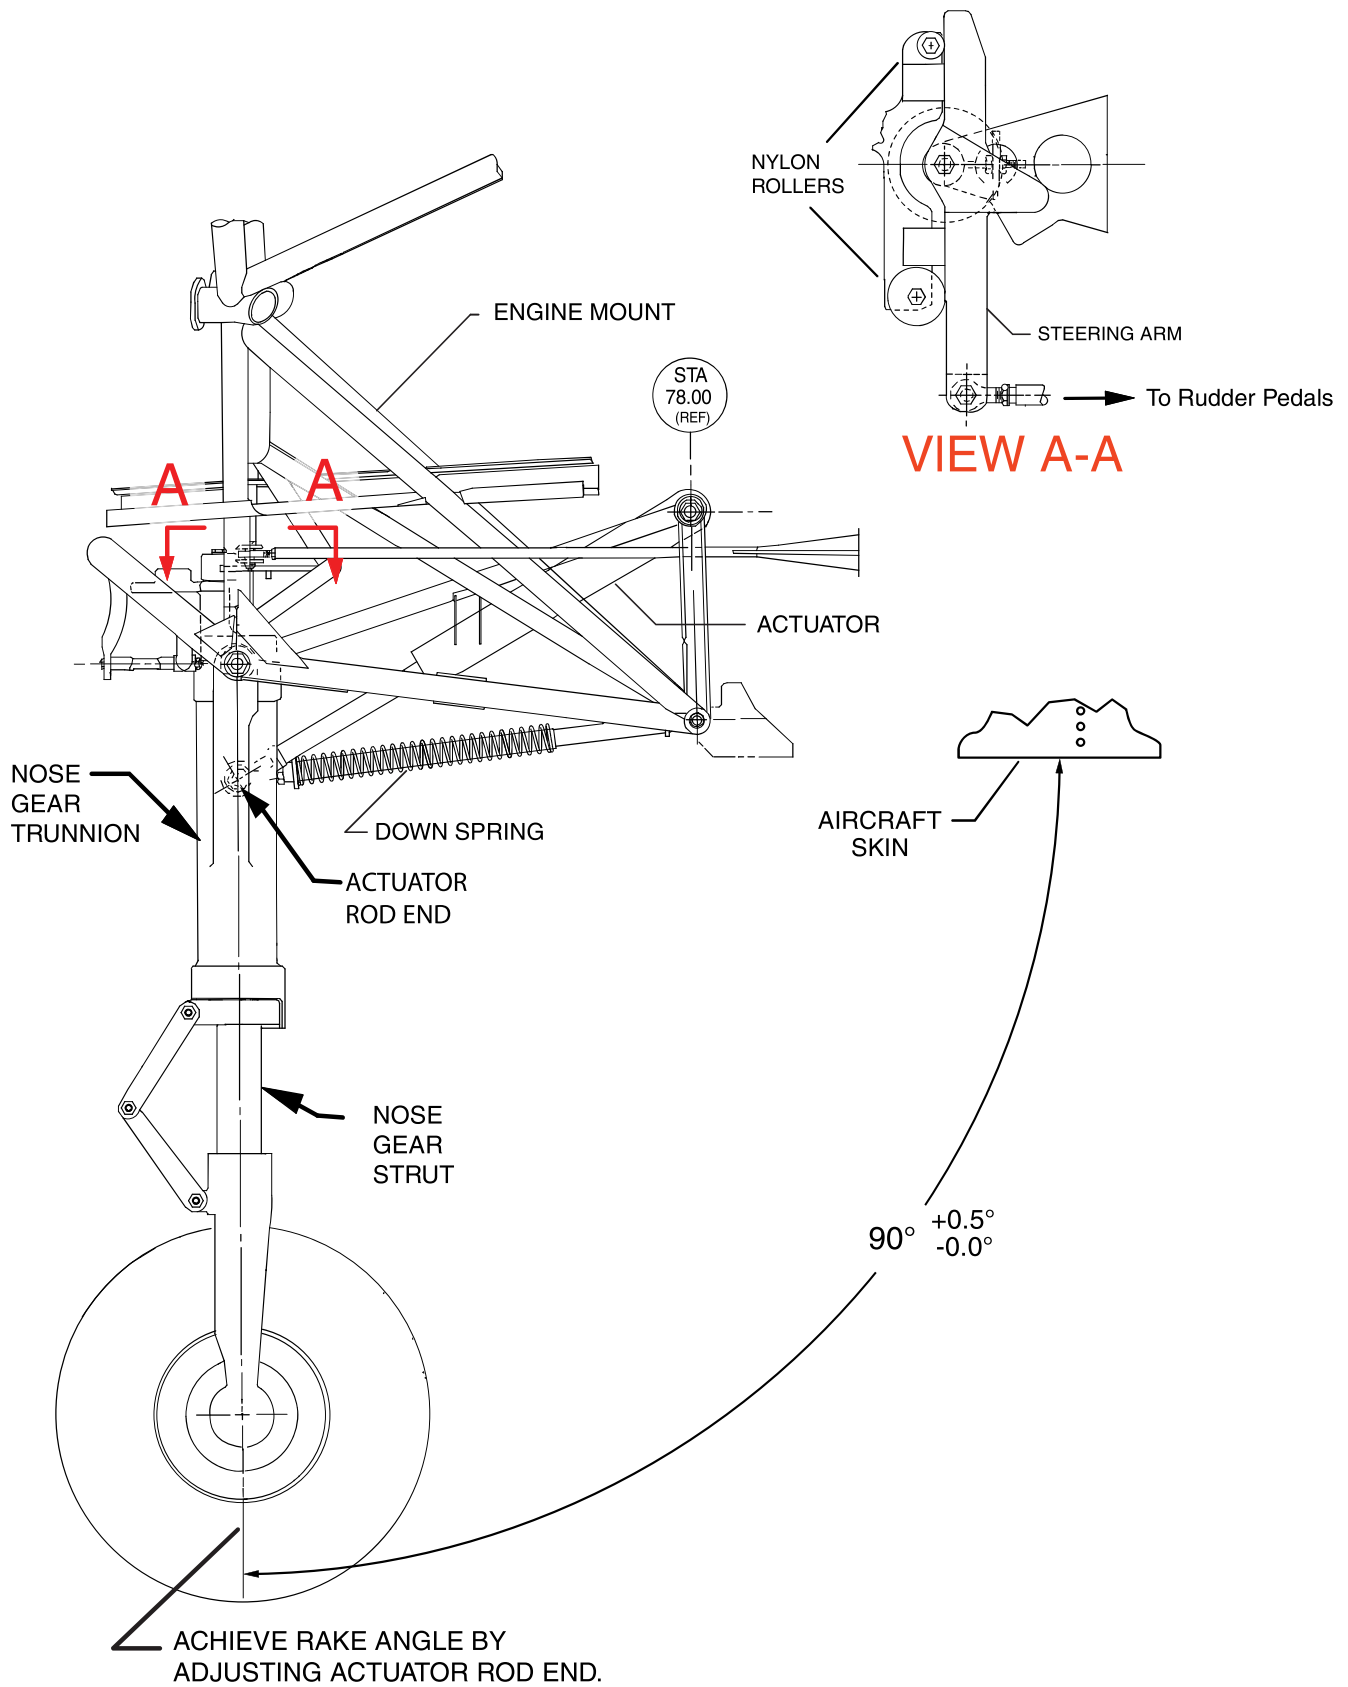
Figure 1

The proper nose gear rake angle for all Malibu models is zero to one-half degree forward from vertical, measured using the airframe lower skin just aft of the nose gear doors as a horizontal datum with the aircraft on jacks. In other words, the relative angle between the lower (belly) skin and the nose gear strut should range from 90.0 degrees to 90.5 degrees. See figure 1.

A rake angle outside of this range may result in dynamic instability, creating steering forces that exceed the pilot’s ability to control. This angle is set by adjusting thread engagement in the nose gear actuator’s rod end bearing as described in the maintenance manual.

Left side view of Malibu Nose Gear

The nose gear rake angle is properly adjusted and verified at the factory and should be inspected and/or adjusted by an FAA-licensed mechanic according to the schedule and instructions in the maintenance manual, any time the pilot experiences poor steering, or there is replacement or service to the nose gear trunnion, the nose gear actuator, or the engine mount.
