# National Transportation Safety Board

CEN22LA153

## **PIPER PA46 RUNWAY EXCURSIONS STUDY**

April 20, 2026

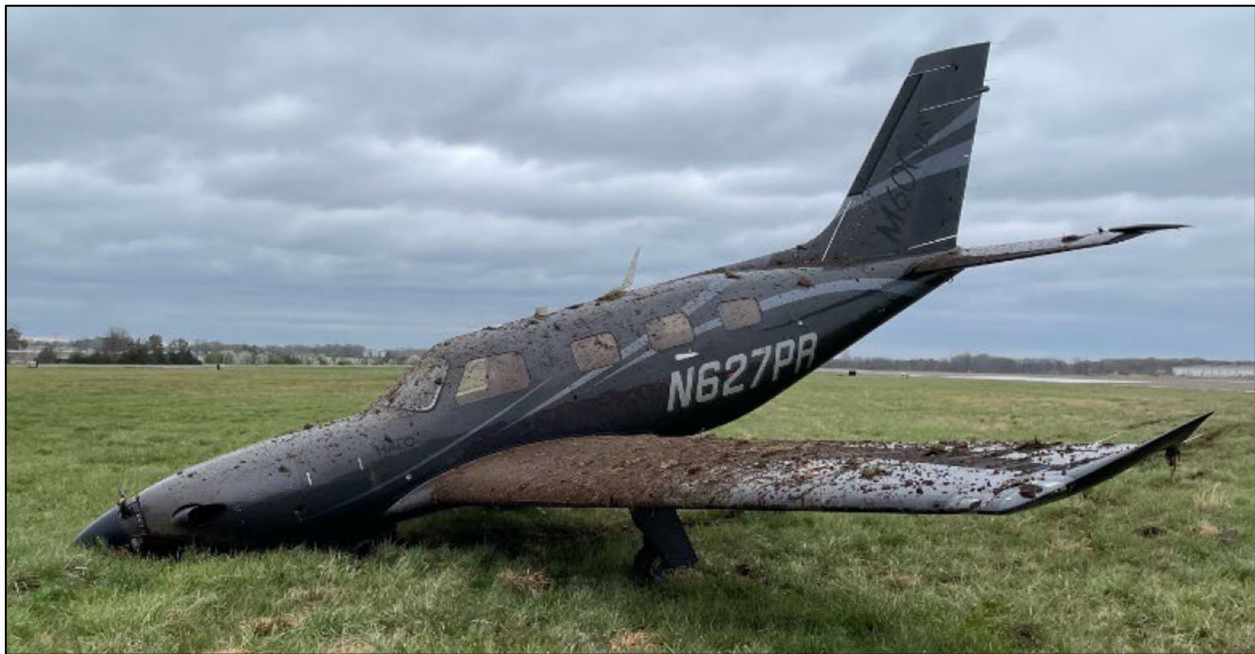
**Figure 2b.** Photograph of N627PR after the accident.

The airplane exited the right side of the runway and continued across wet and muddy grass. The nose landing gear (NLG) collapsed, and the airplane came to rest nose down. The airplane departed the runway about 1,330 ft from the threshold and about 570 ft after touchdown. The engine mount sustained substantial damage.

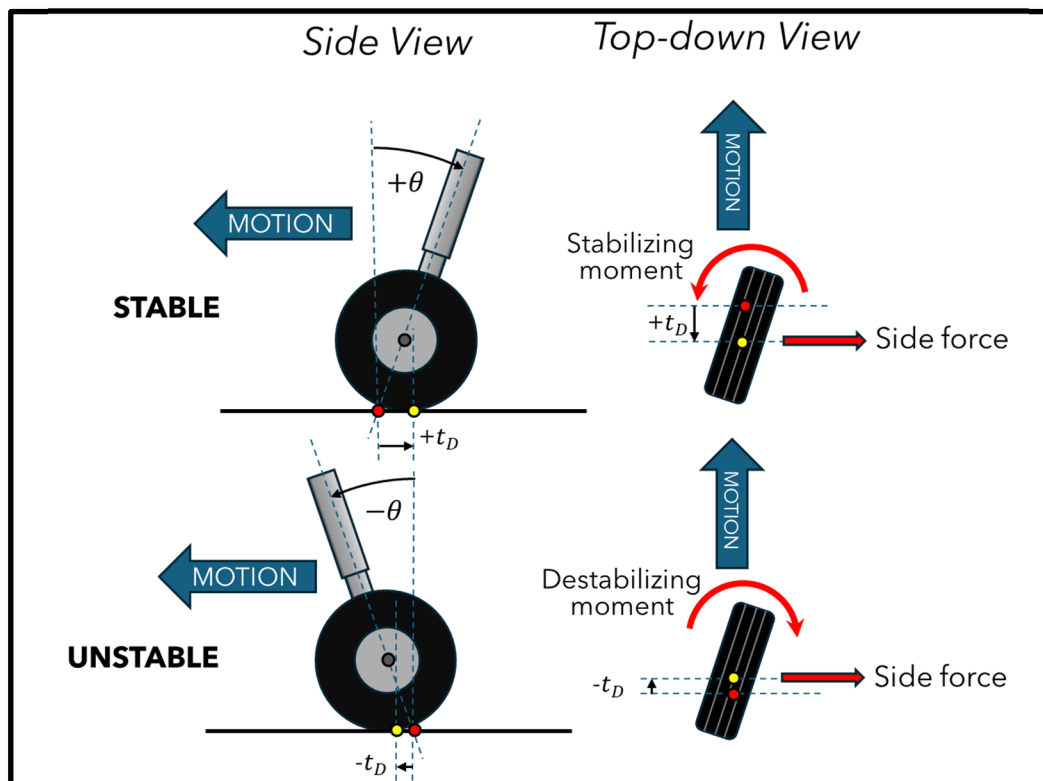
**Figure 6.** Effect of  $\theta$  and  $t_D$  on self-aligning moment of NLG.

force acting at the yellow dot creates a moment (torque)<sup>12</sup> about the red dot that will act to yaw the tire back towards the zero-yaw condition. This moment is said to be “self-aligning,” and the situation is directionally stable.

The situation depicted in the bottom half of Figure 6 corresponds to a NLG with zero offset and a negative caster angle ( $-\theta$ ). In this case, the red dot is aft of the yellow dot and the dynamic trail is negative ( $-t_D$ ). Hence, when the tire is yawed, the resulting side force acting at the yellow dot creates a moment about the red dot that will act to yaw the tire further away from the zero-yaw condition. The moment is *not* self-aligning, and the situation is directionally unstable.

As noted above, the PA46 NLG is designed with zero offset and zero caster angle ( $\theta = 0^\circ$ ), and consequently  $t_M = 0$ . However, it should be noted that  $t_M = 0$  will only be achieved, even with  $\theta = 0^\circ$ , when the longitudinal axis of the airplane is parallel to the runway surface (i.e., pitch angle =  $0^\circ$ ). If the pitch angle is negative, then the airplane will sit slightly nose-down on the runway, and the caster angle *relative to the runway* will be negative, moving the rotation axis of the NLG relative to the NLG tire contact point aft. This is destabilizing (see the bottom image in Figure 6). Consequently,

conditions that could lower the pitch angle on the runway (such as low NLG tire pressure or strut extension, or a higher than anticipated vertical load on the NLG) can decrease the directional stability of the NLG. Conditions that raise the pitch angle on the runway introduce a positive caster angle (relative to the runway) and can increase the directional stability of the NLG.

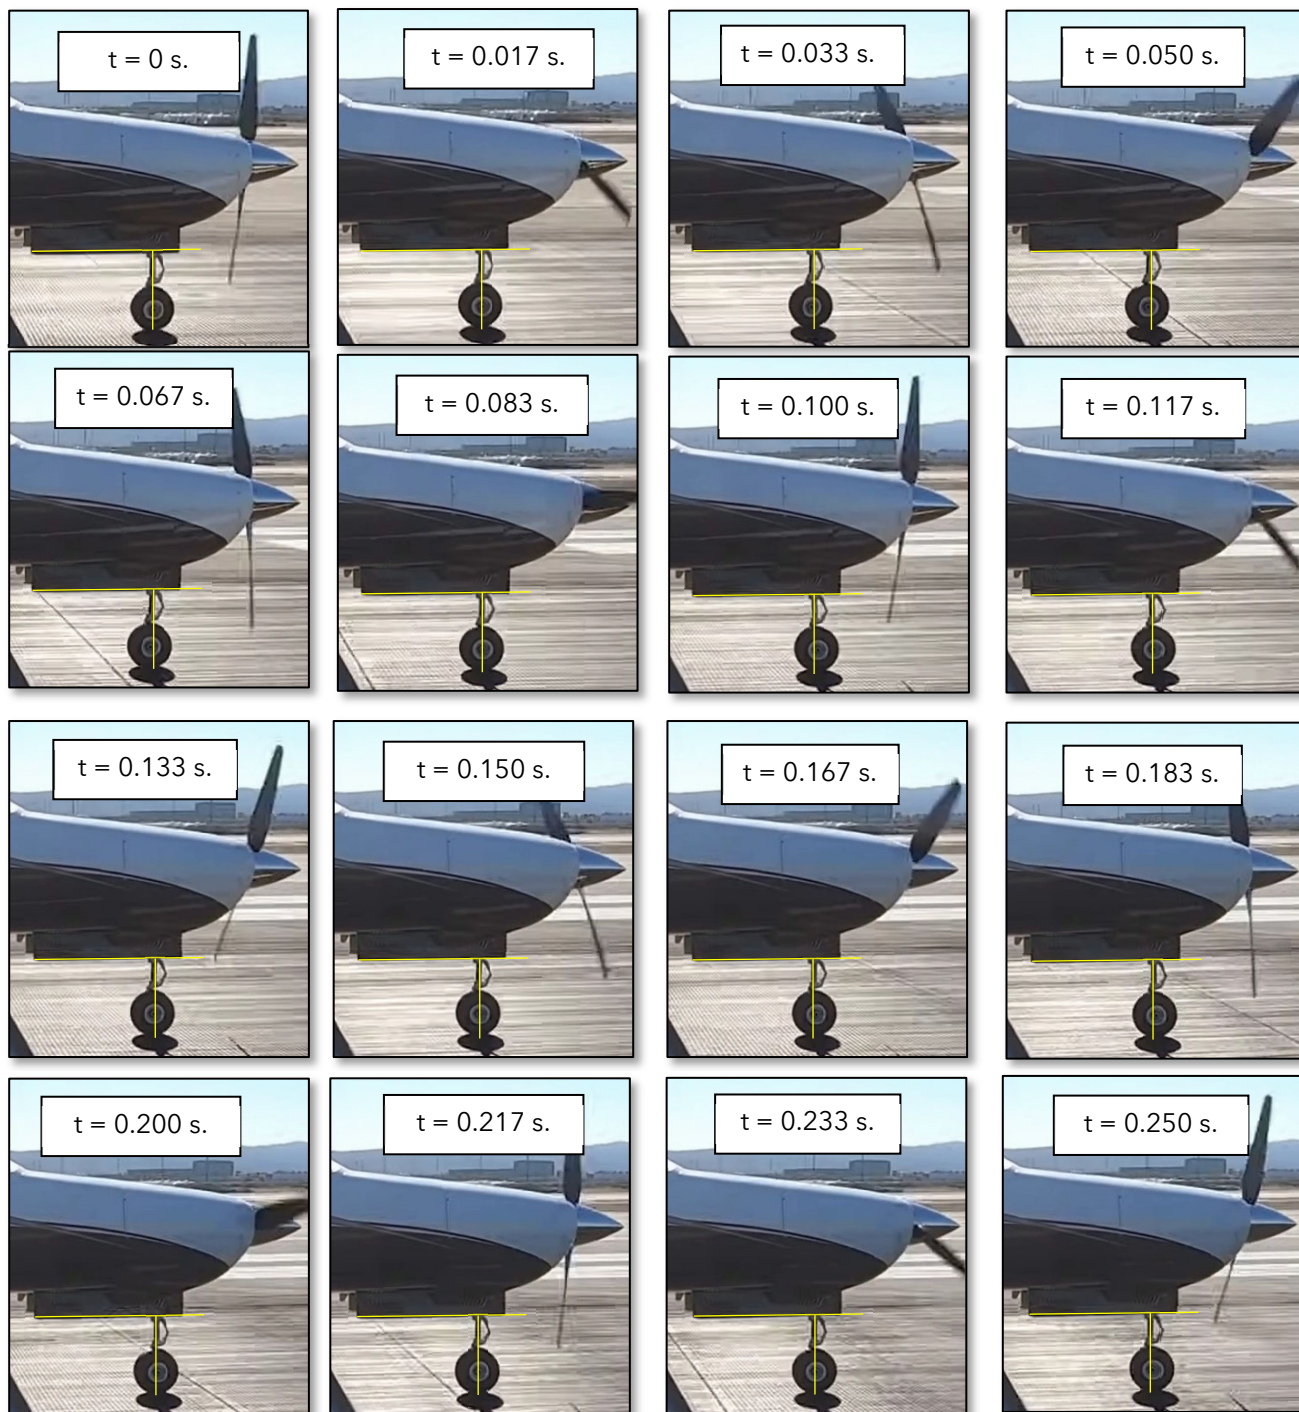
Figure 16 makes it clear that the aft deflection and damped oscillation of the NLG strut on touchdown described in References 1 and 5 occurs, and that the initial aft deflection of the strut introduces a negative caster ( $\theta$ ) and mechanical trail ( $t_M$ ) angle that reduces the dynamic trail ( $t_D$ ) of the NLG tire, reducing its directional stability (see Equation [2]). What is not clear is whether the time during which this condition exists is long enough to introduce a divergence in the steering angle of the NLG ( $\phi$ ), particularly since during the oscillation of the NLG  $\theta$  and  $t_M$  will at times be positive, increasing the dynamic stability of the NLG. The structural dynamics portrayed in the video and Figure 16 occur on every landing, but since the veer events examined in this *Study* are relatively rare, the deflection of the NLG strut cannot by itself explain them (for example, the landing shown in the video did not result in a veer event). The aft deflection of the NLG strut and consequent momentary reduction in  $t_M$  might temporarily contribute to a loss of directional stability, but additional factors (such as a negative pitch angle or a significant reduction in  $t$  at large  $\alpha$ , for example) must be present in order to sustain the instability long enough to result in a divergence in  $\phi$  and a veer event.

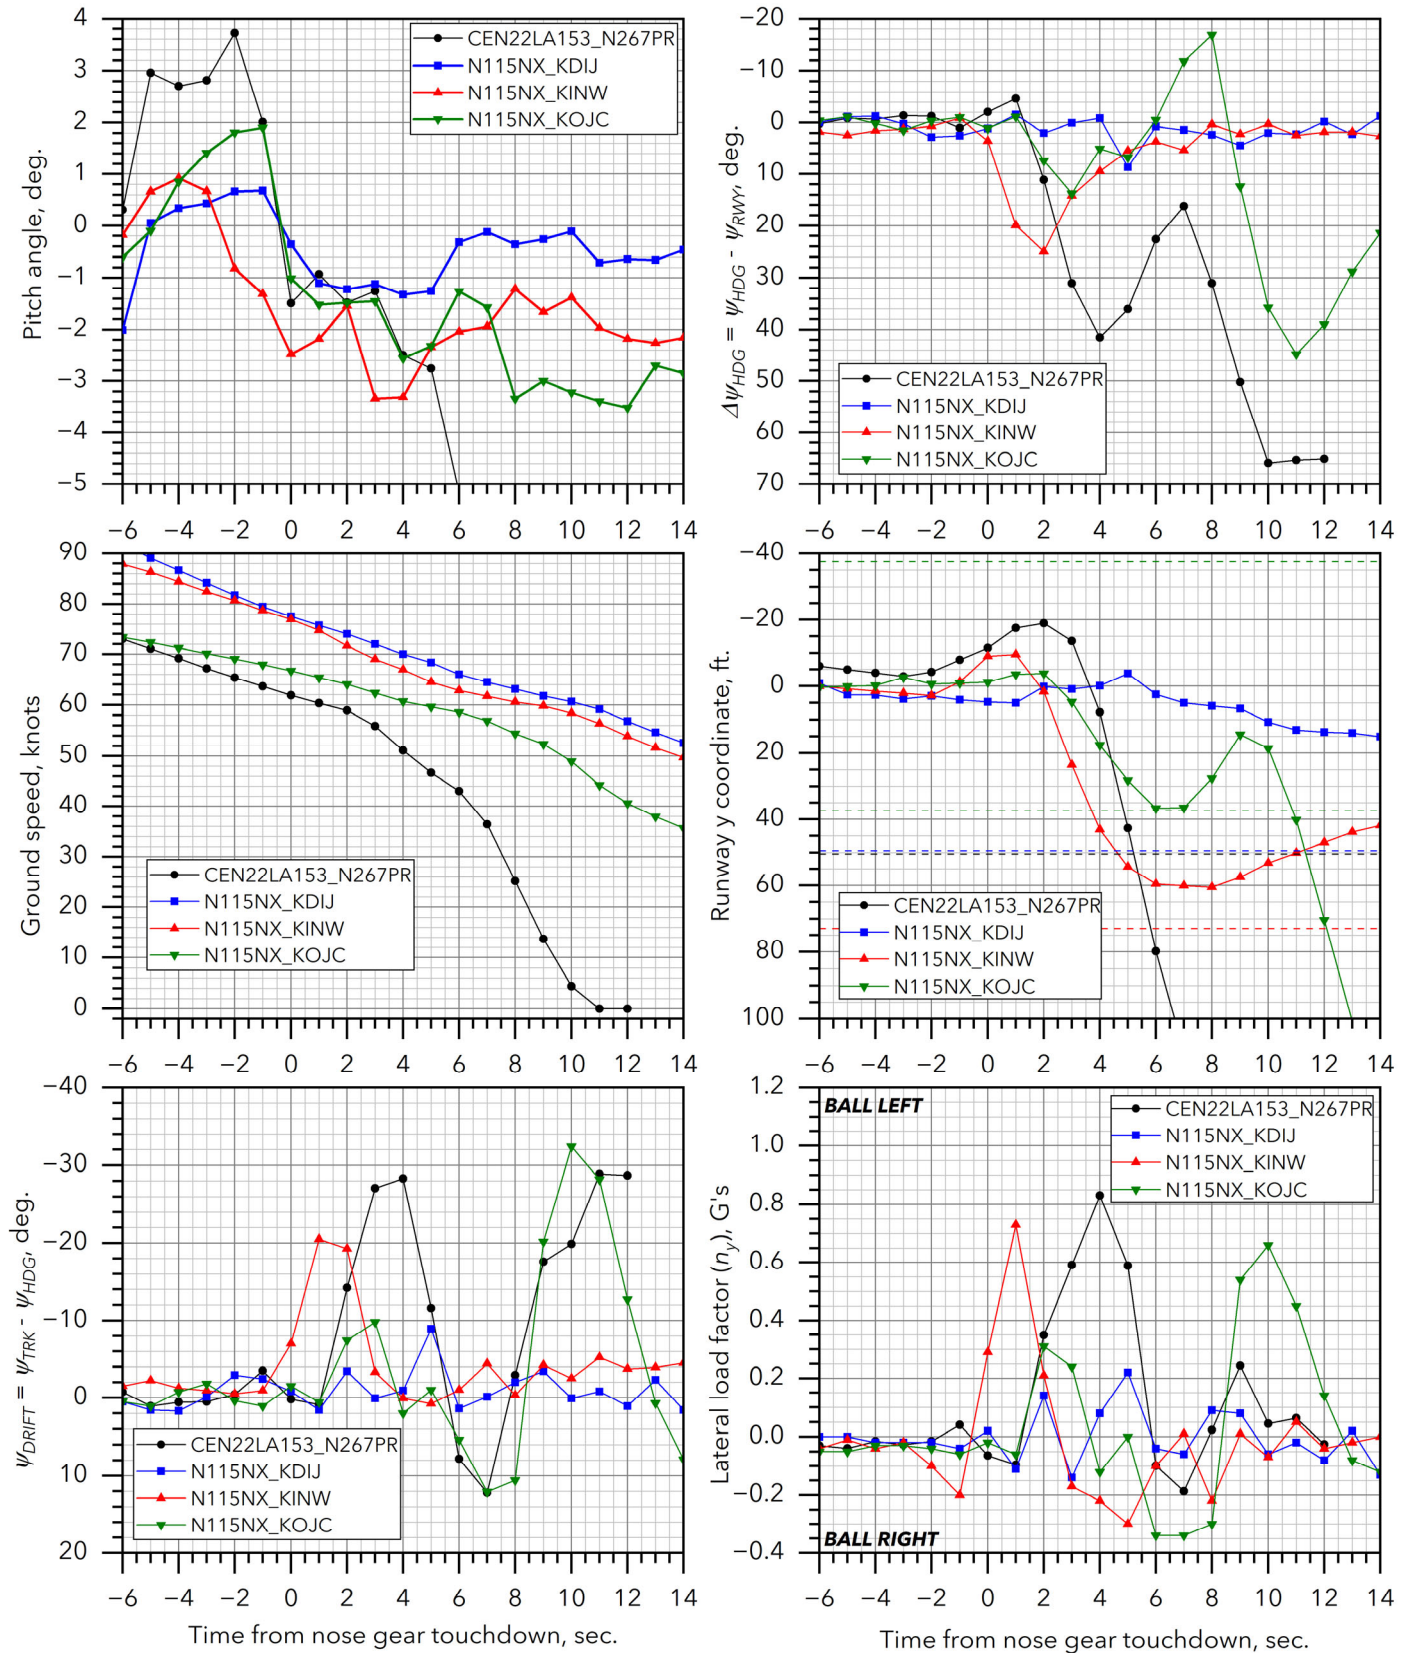
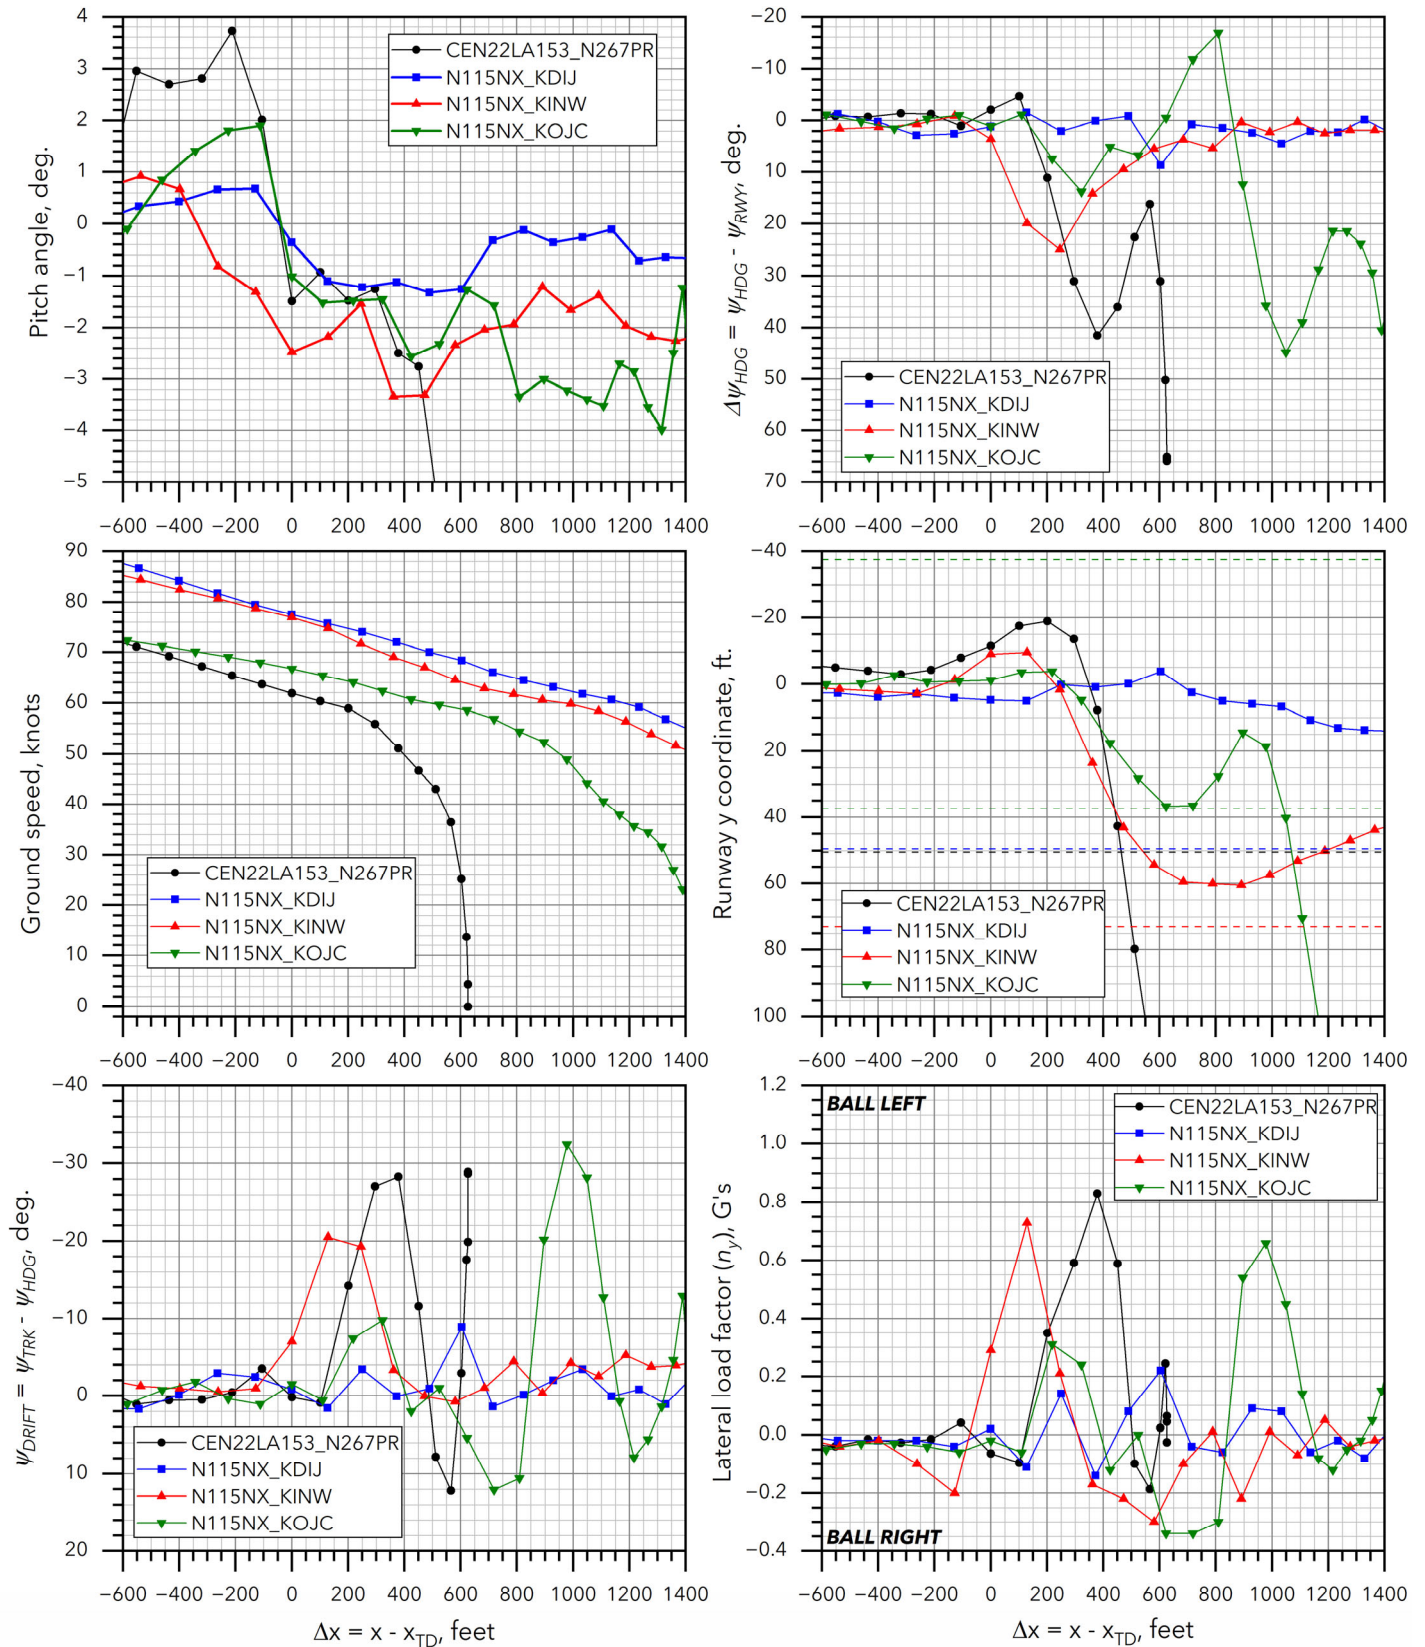
**Figure 17d.** Comparison of flight parameters for different M600 veer events as a function of  $\Delta t$  (4 of 4).

As noted above, the motions of the airplanes in the CEN22LA153 accident and the N115NX\_KOJC event (which involved a Piper engineering flight test pilot) exhibit remarkable similarities (see Figures 17d and 18d). Piper's February 24, 2021 letter to the PA46 Owner Community (Reference 22; see Appendix A) acknowledges the N115NX\_KOJC event, stating that

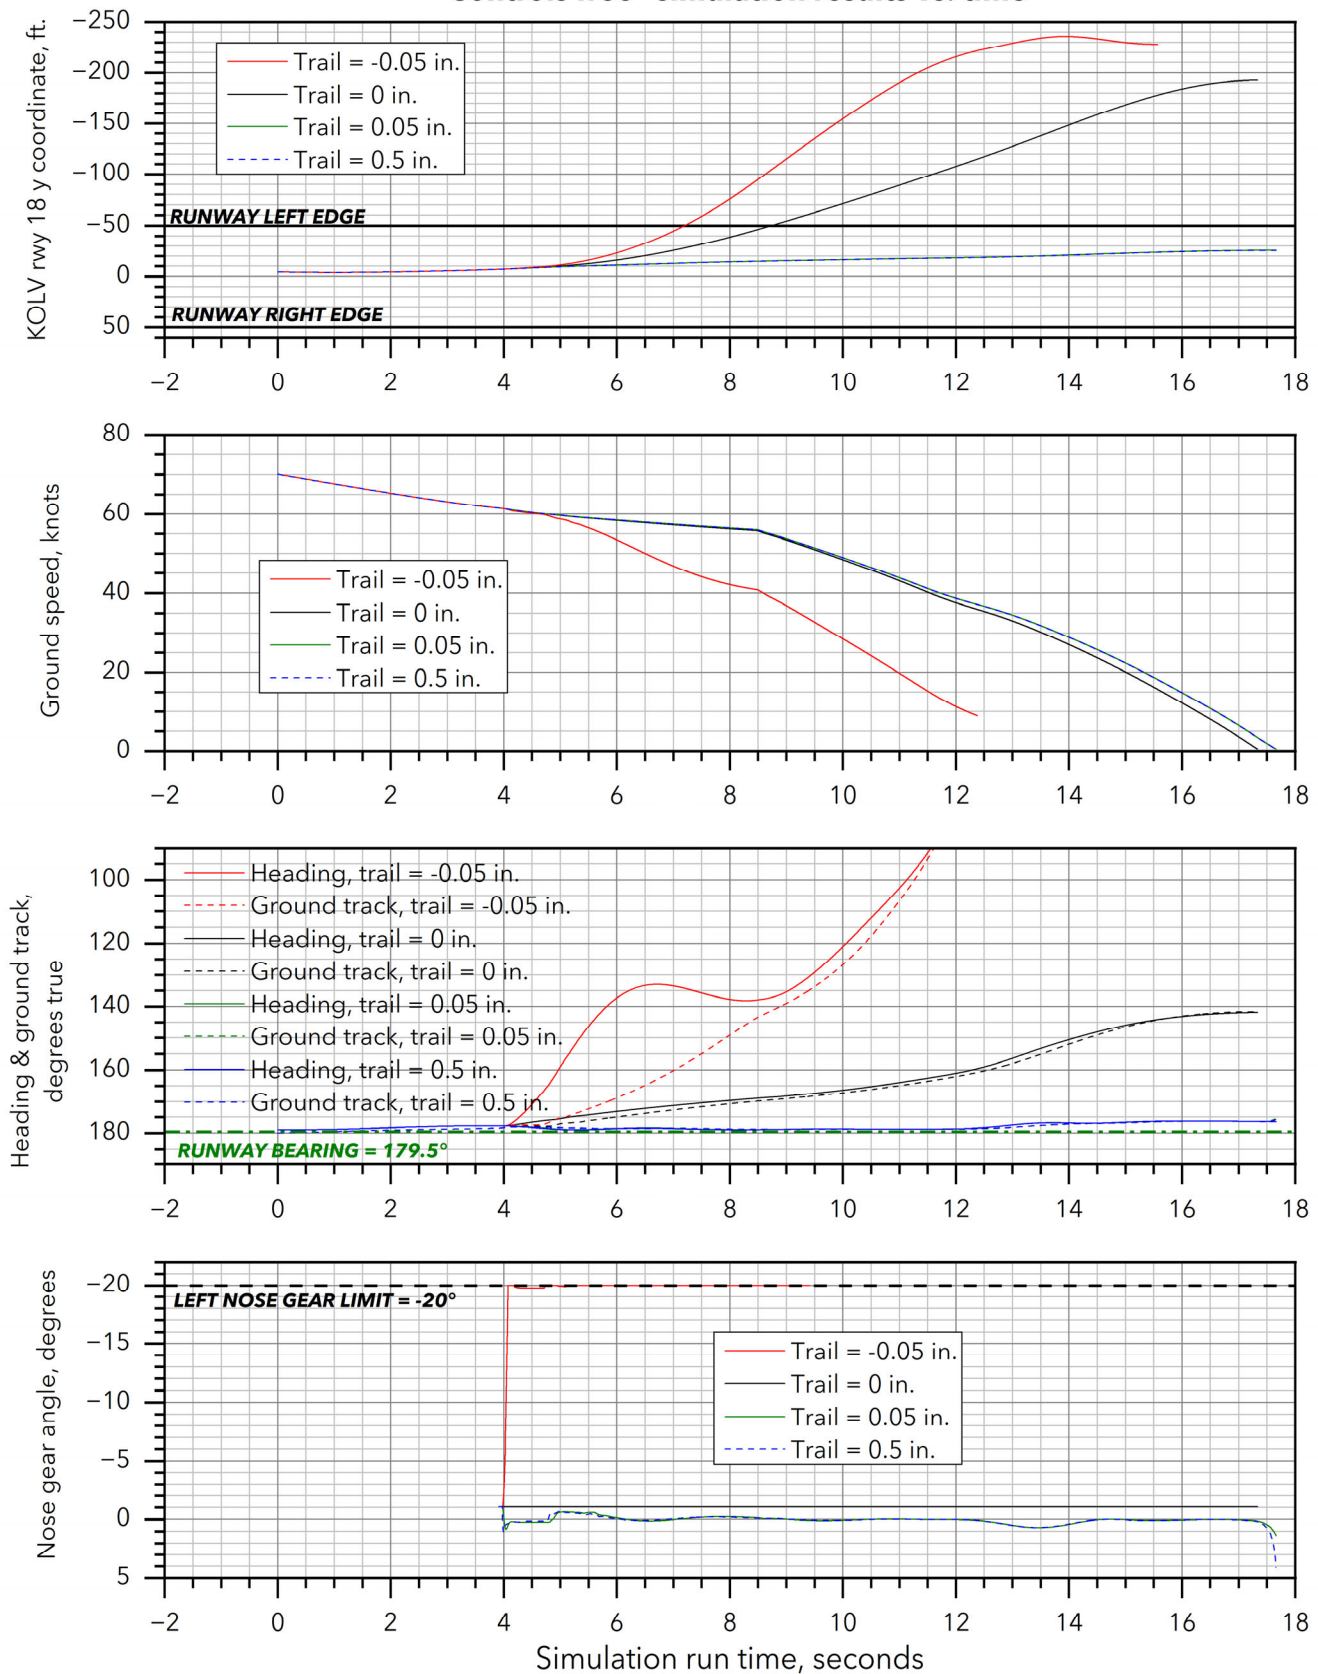
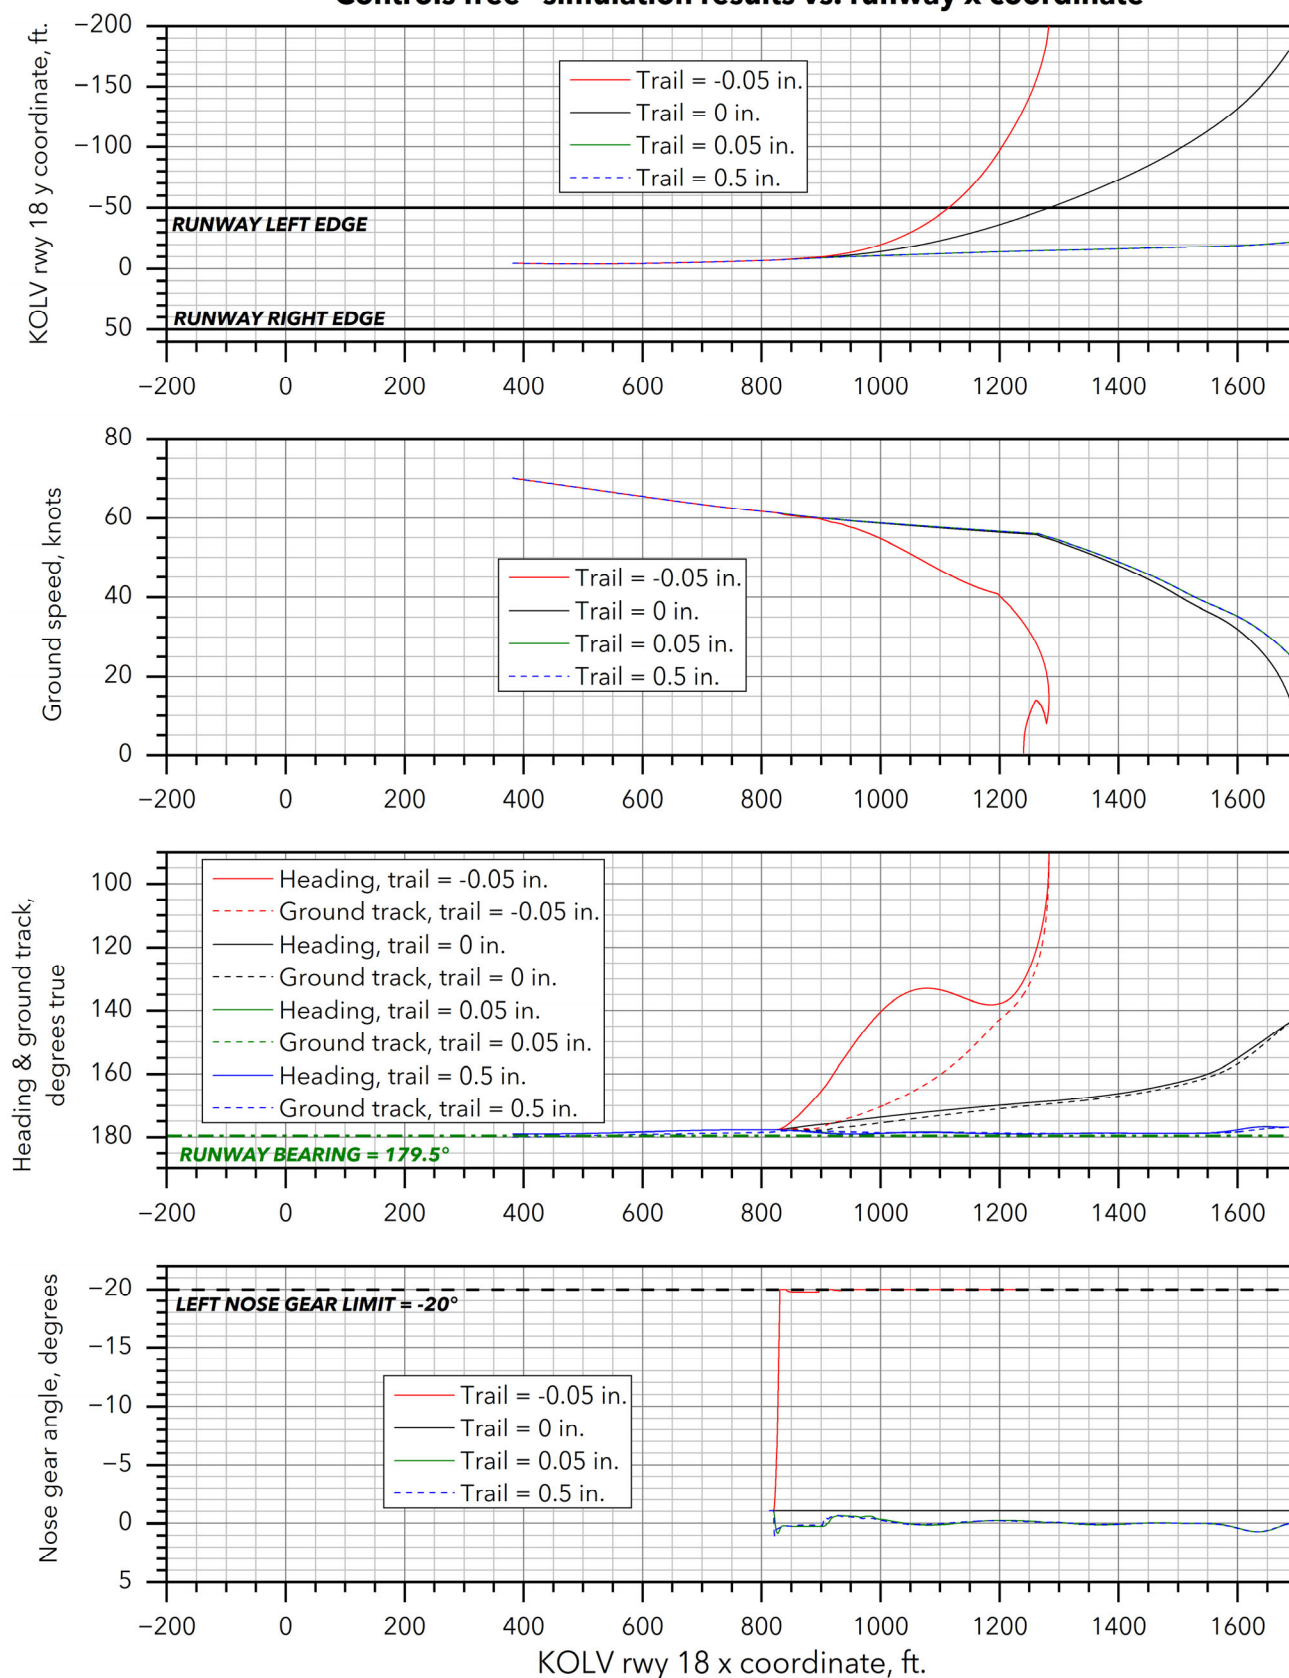
**Figure 19a.** "Controls-free" simulation results vs. time.

As noted above, Figure 19 indicates that with no opposing pedal inputs from the pilot, a directionally unstable NLG ( $t_D < 0$ ) swings to full deflection within a fraction of a second after NLG touchdown, whereas a directionally stable NGL ( $t_D > 0$ ) tends to remain centered. Only the sign, and not the magnitude, of  $t_D$  has a noticeable effect on the behavior of the NLG; the NLG response (and that of the airplane) are almost identical for both  $t_D = 0.5$  inches and  $t_D = 0.05$  inches. For  $t_D = -0.05$  inches, the NLG deviates full left immediately after it touches down, and the airplane yaws hard left. For a neutrally stable NLG ( $t_D = 0$ ), the response of the gear and airplane lies between that of the stable and unstable conditions, with the NLG remaining centered but the airplane drifting left under other influences (such as small differences in the braking force between left and right main gear tires).
