RE: Petition for Reconsideration NTSB Accident Number CEN22LA153

**Re: Piper Aircraft, Inc. Petition for Reconsideration and Modification of Findings, Analysis and Determination of Probable Cause, and Request for Oral Presentation: Accident Number CEN22LA153, Olive Branch, Mississippi, March 23, 2022, Aviation Investigation Final Report with Probable Cause and Findings, (the "NTSB Report").**

| Title : | REVIEW OF NTSB REPORT CEN22LA153 | |

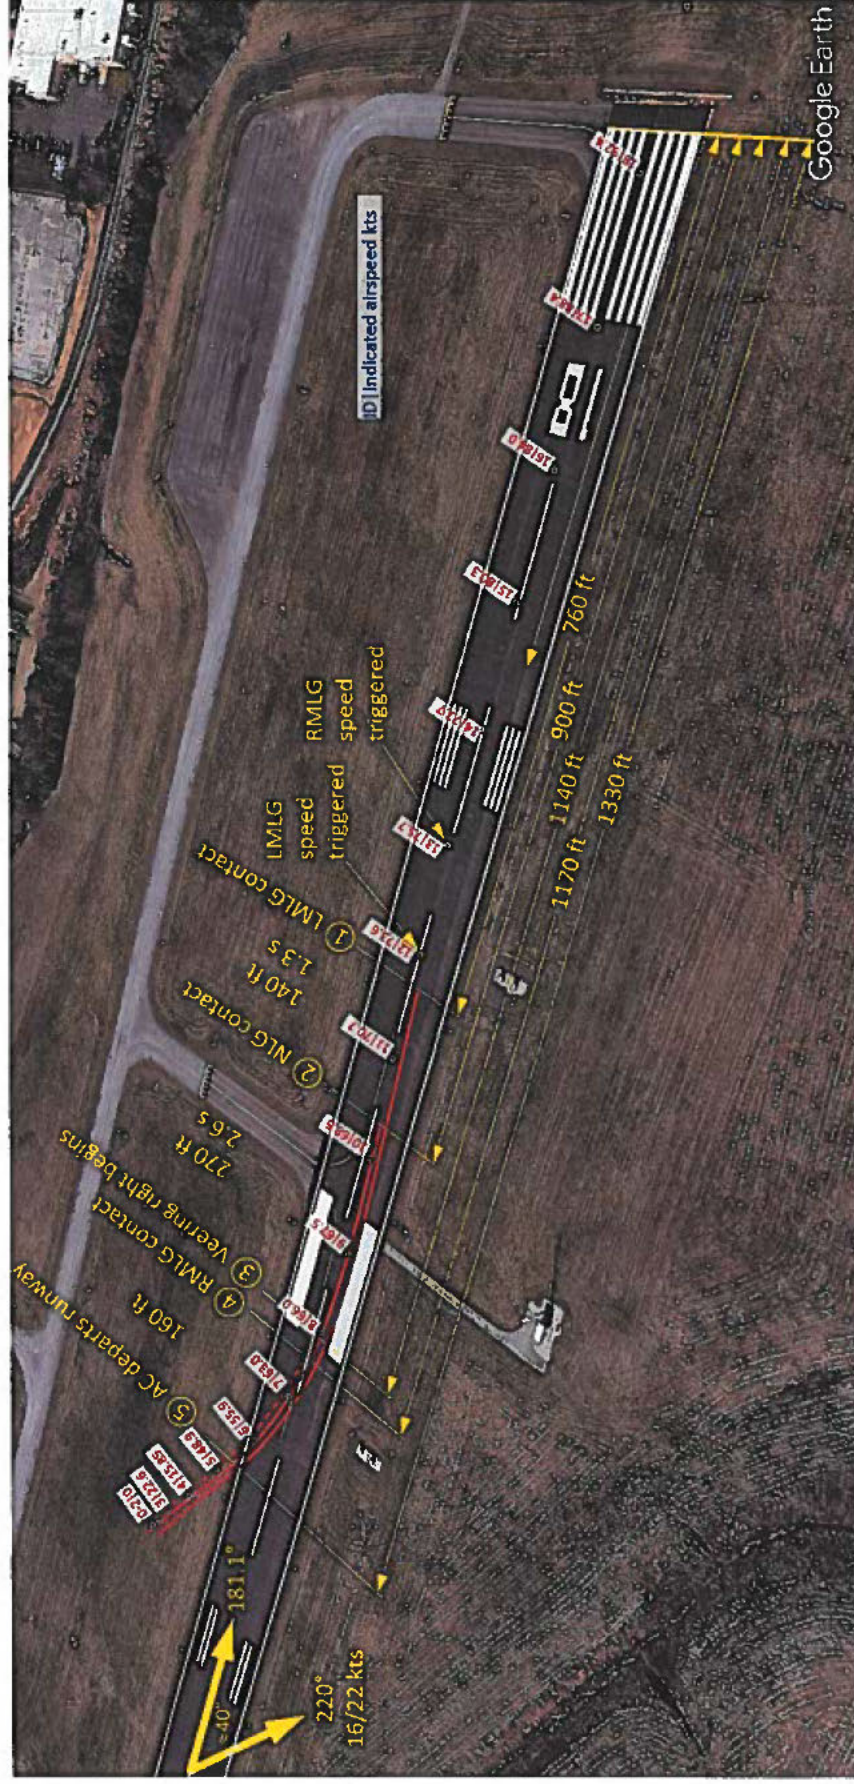
Figure 1: A "Google Earth" screen capture showing event-markers based on the photographic and electronic evidence superimposed on the accident scene. The labels along the position markers show the Indicated airspeed in knots. Each is spaced 1-second apart. Timestep (or ID) 18 means 18-sec before airplane came to complete stop, and so forth.

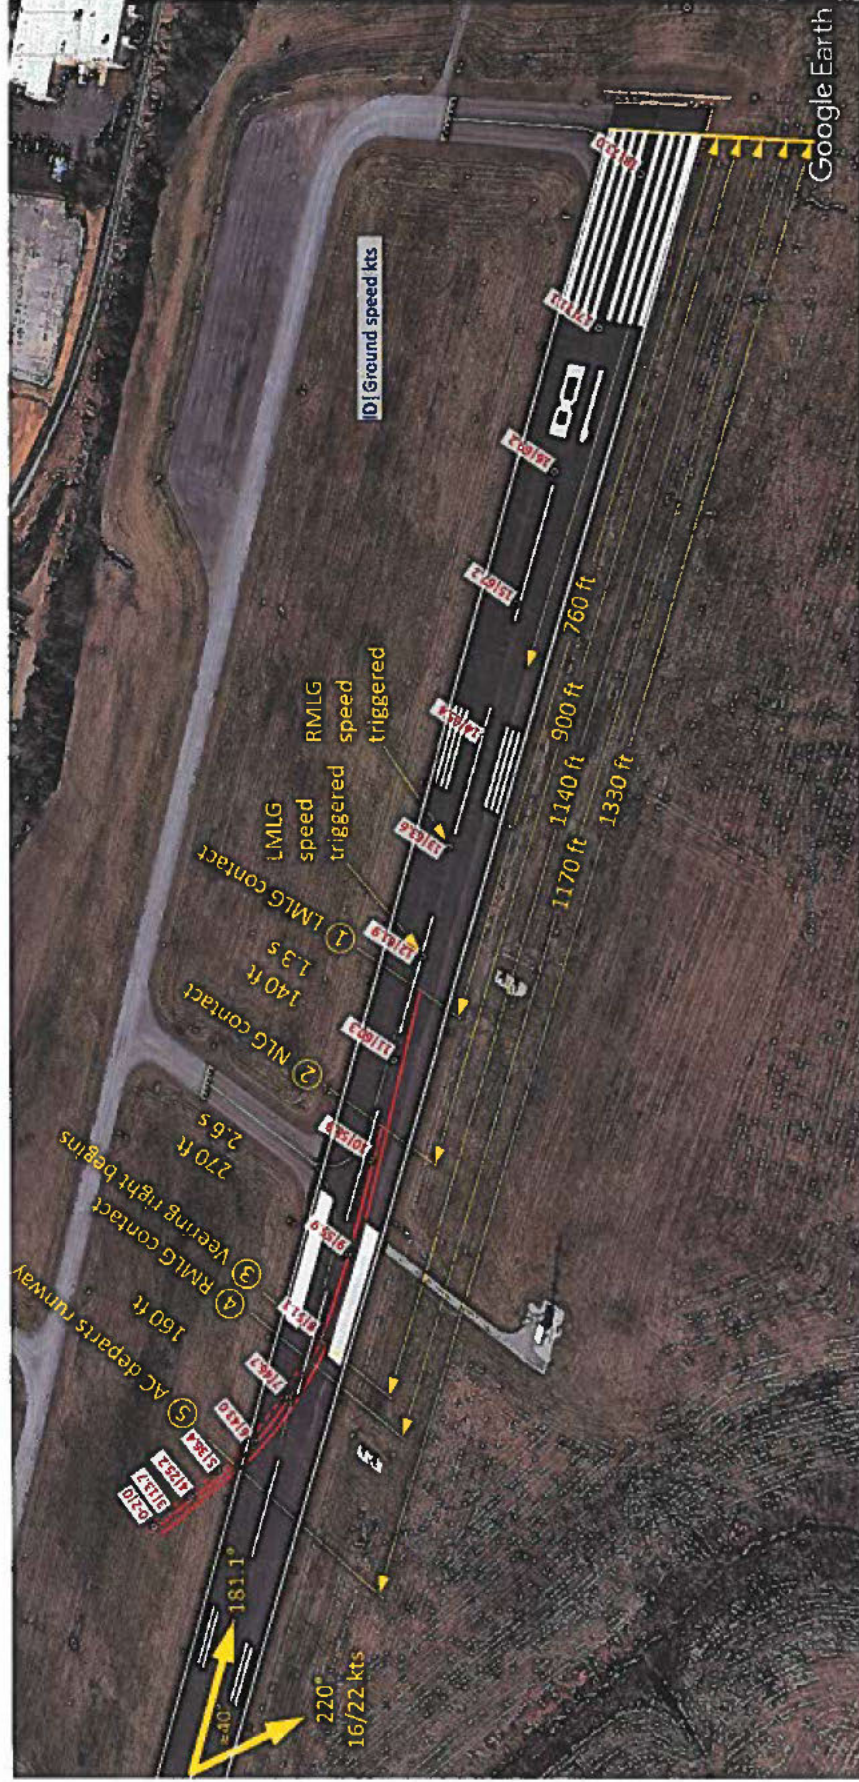
Figure 2: A "Google Earth" screen capture showing event-markers based on the photographic and electronic evidence superimposed on the accident scene. The labels along the position markers show the ground speed in knots. Each is spaced 1-second apart. Timstep (or ID) 18 means 18-sec before airplane came to a complete stop, and so forth.

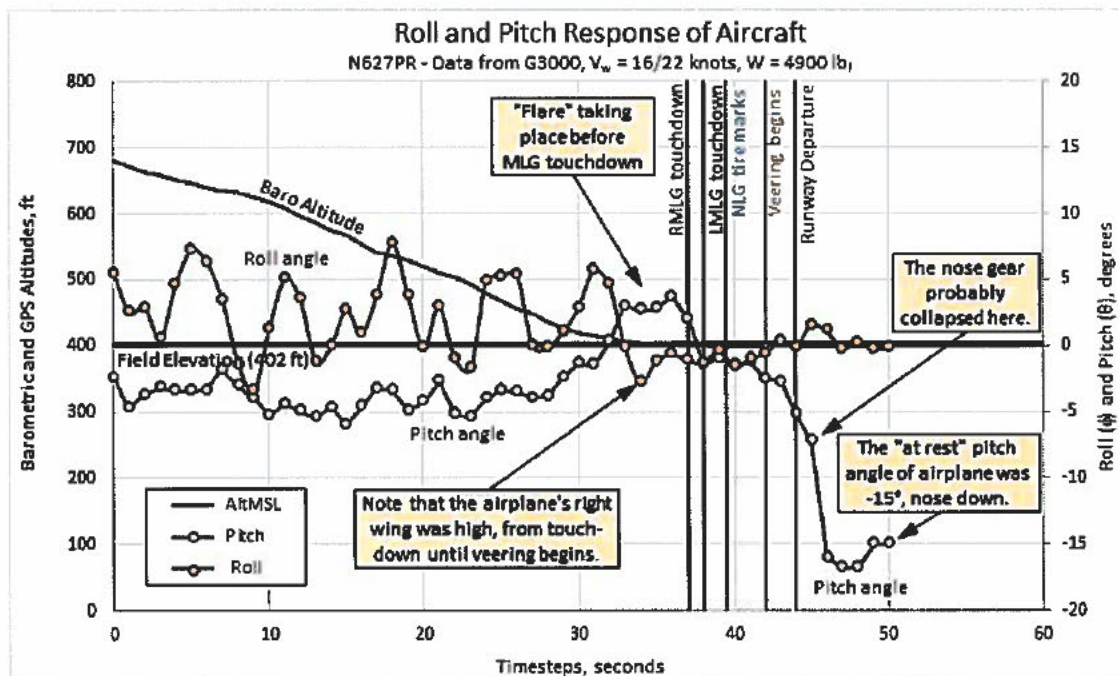
Selected data collected by the G3000 in the final 50 seconds before the airplane came to rest was plotted (see Figure 3, Figure 4, and Figure 5). Figure 3 shows a time history of the roll and pitch angles of the aircraft, the final 50 seconds before it came to rest. It also co-plots the time history of the barometric altitude to help the reader further putting things in context. The barometric altitude uses the left vertical scale. The roll and pitch angle curves use the right vertical scale. Also, they feature circular markers; each is separated by 1 second and represents a specific timestep. Among other things, the graph shows flare taking place

just before touchdown of the main landing gear. It shows the airplane being about 3° right-wing high some 3-seconds before the RMLG touches down, and remaining so (albeit diminishing) until veering right begins. It also shows where the NLG may have collapsed and the final fuselage pitch-down angle of -15°.

Figure 3: A 50-sec time history of accident per G3000. The altitude curve uses the left vertical scale, and the roll and pitch angles use the right vertical scale.

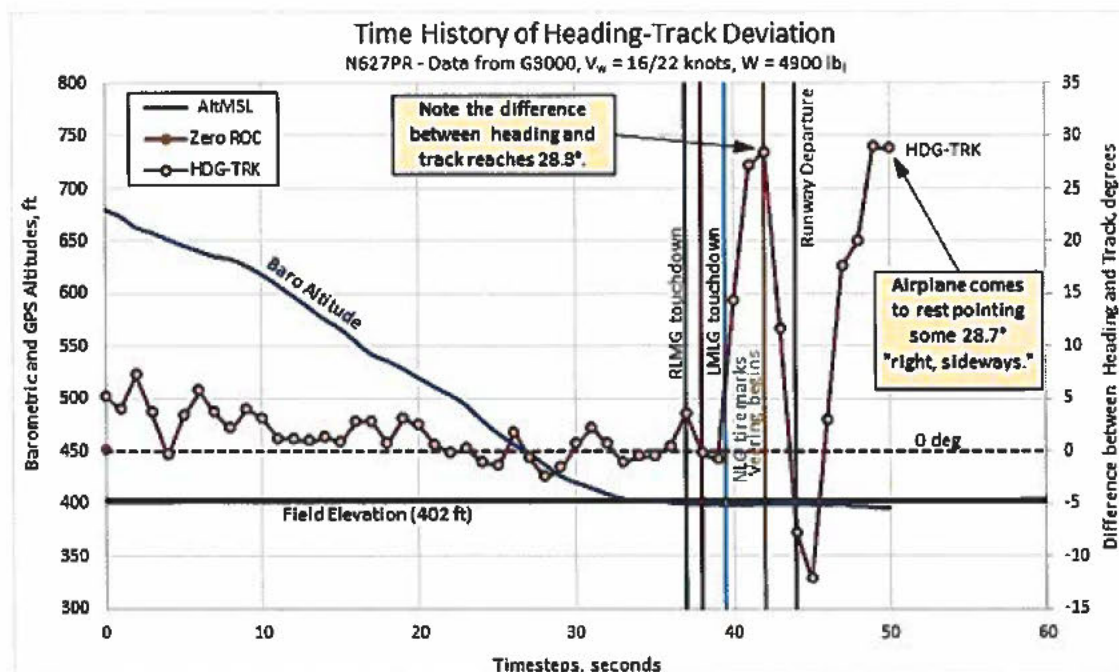
Figure 4: A 50-sec time history of accident per G3000. The altitude curve uses the left vertical scale, and the HDG-TRK curve (in degrees) uses the right vertical scale.

Figure 4 reveals a time history of the *heading* (HDG: direction in which the nose points) and *ground track* (TRK: direction in which the CG moves). Ideally, these should be one and the same. By plotting the difference between the two, a large deviation is visible during the accident. At the time when veering right begins its magnitude reaches 28.3°. This shows an airplane responding to the combination of challenging crosswind conditions and improper control inputs. This is so because the demonstrated crosswind limit for the aircraft is 17 knots [8], but max crosswind component on scene was 14 knots.

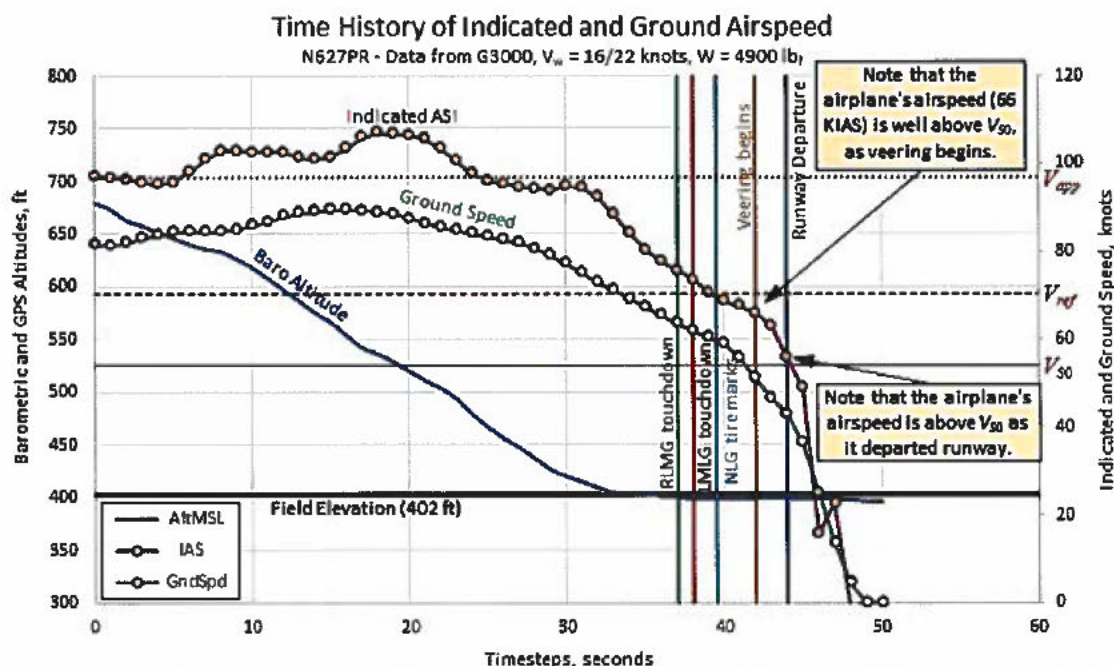
Figure 5 shows a time history of the indicated airspeed (in KIAS) and ground speed (in KTAS, knots true airspeed<sup>5</sup>). The graph shows the airplane approaching at indicated airspeed greater than 97 KIAS, up until some 20 seconds before the airplane came to rest. The airspeed labelled " $V_{so}$ " (see the bottom horizontal red line) represents the *stalling speed* of the airplane in the landing configuration. This has the landing gear extended and flaps deflected 41°.

Figure 5: A 50-sec time history of accident per G3000. The altitude curve uses the left vertical scale, and the airspeeds use the right vertical scale.
