# Aviation Investigation Final Report

| <b>Location:</b> | Olive Branch, Mississippi | <b>Accident Number:</b> | CEN22LA153 |
| <b>Date &amp; Time:</b> | March 23, 2022 10:38 Local | <b>Registration:</b> | N627PR |
| <b>Aircraft:</b> | Piper Aircraft Inc Pa-46-600Tp | <b>Aircraft Damage:</b> | Substantial |

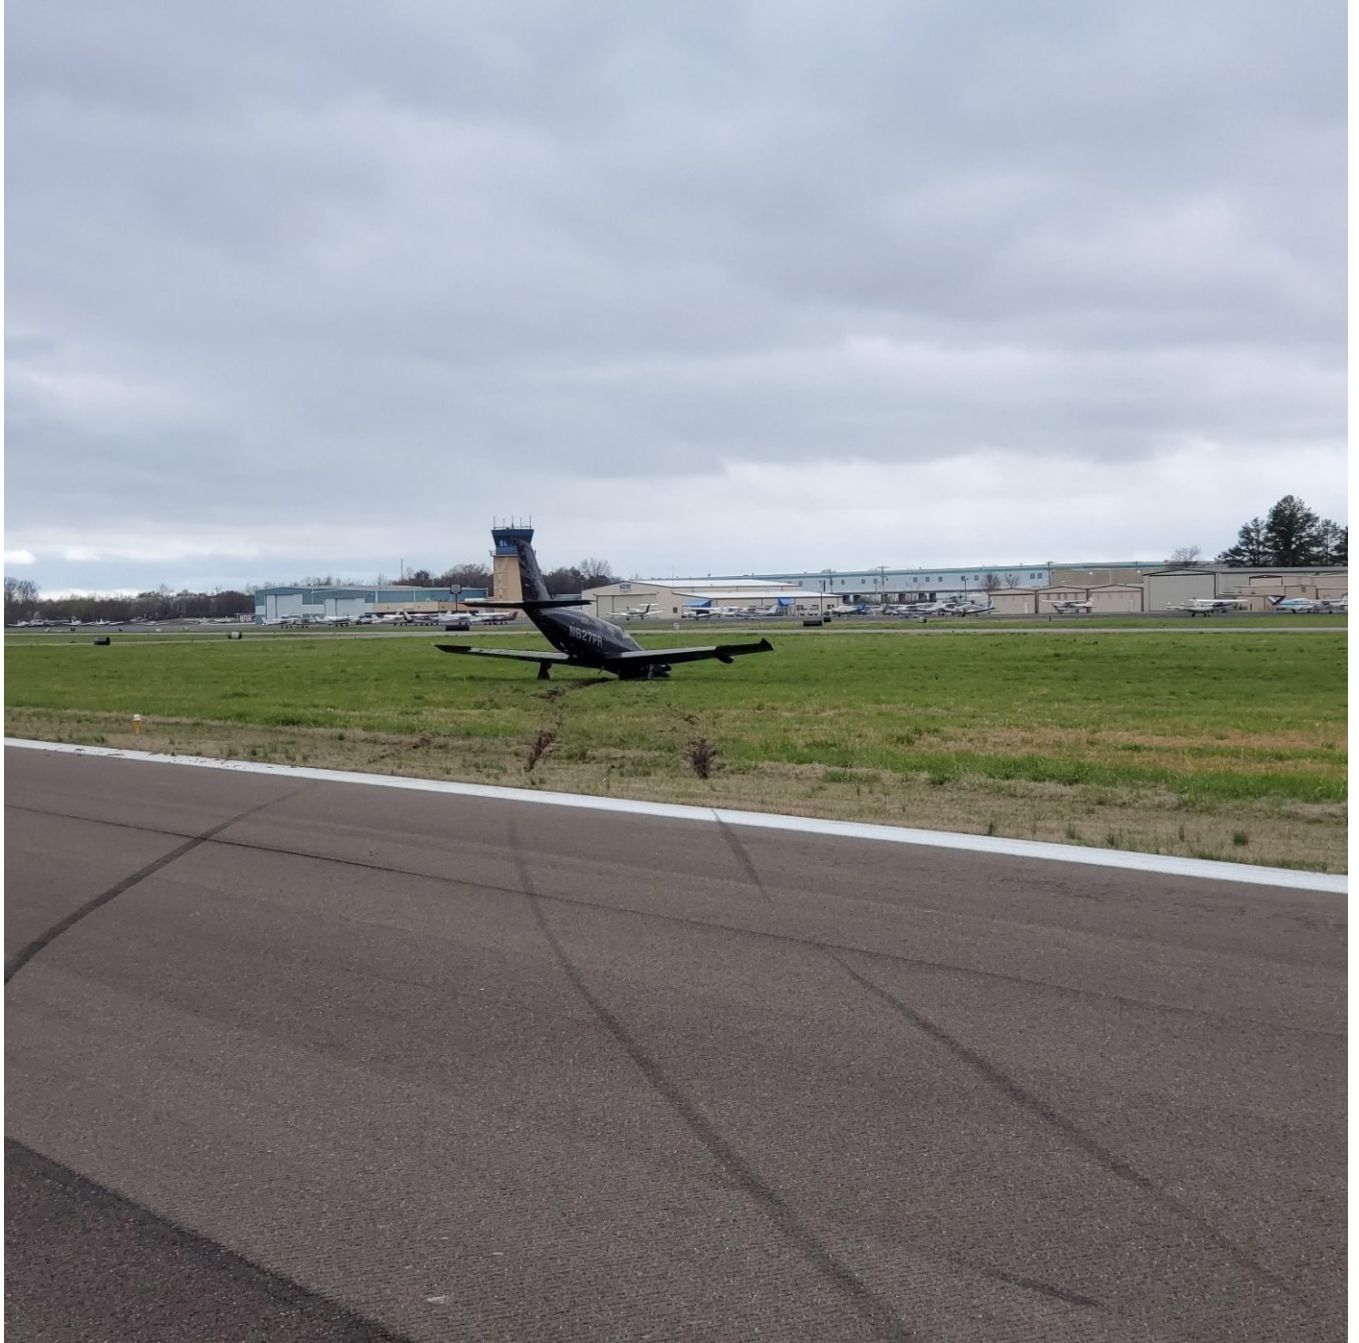
The airplane exited the right side of the runway and continued across wet and muddy grass when the nose gear collapsed, and the airplane came to rest nose down. (See figure 1.) The airplane departed the runway about 1,330 ft from the threshold and about 570 ft after touchdown. The engine mount sustained substantial damage.

Figure 1. Accident airplane (Source: OLV airport operations).

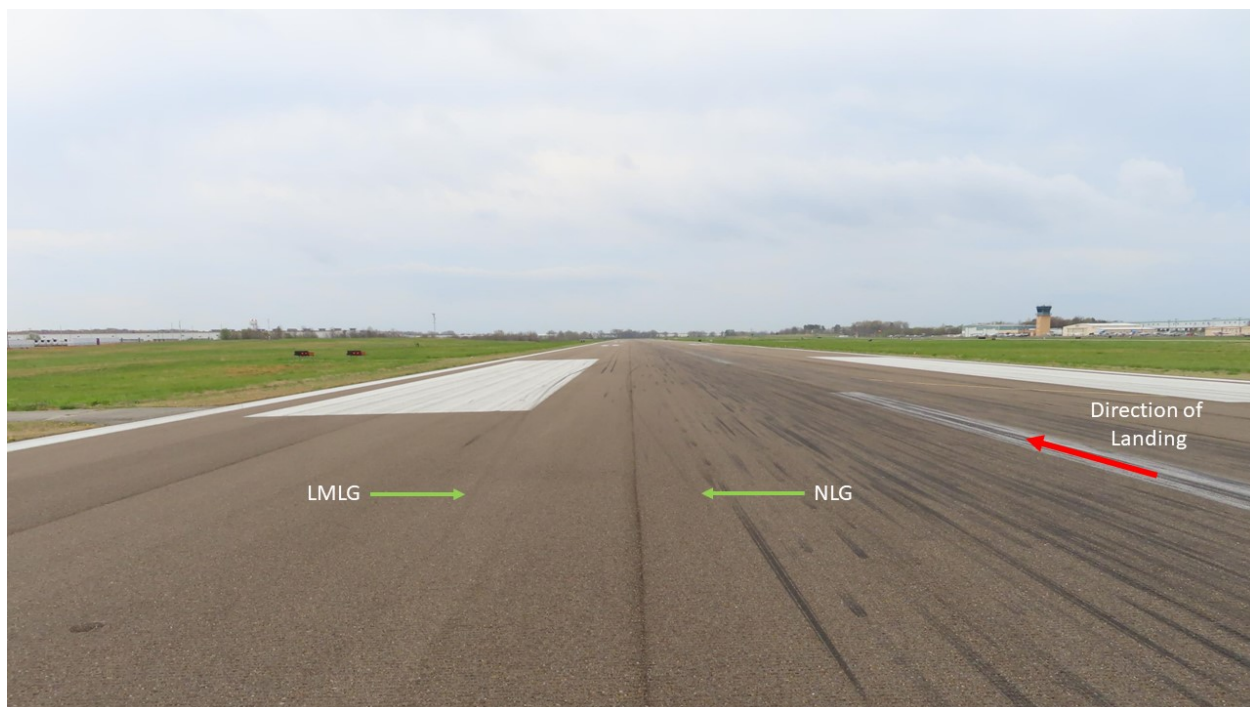
Examination of the runway surface revealed a light rubber transfer mark consistent with the LMLG that began about 760 ft from the runway 18 threshold and about 17 ft left of the centerline. The transfer mark was continuous until it departed the right side of the runway and varied in intensity. A light rubber transfer mark with the tread pattern evident, consistent with the NLG, began about 900 ft from the threshold and about 10 ft left of the centerline. The mark was mostly continuous until it departed the right side of the runway and varied in intensity. The LMLG and NLG rubber transfer marks were aligned, separated by about 80 inches, and drifted to the left until about 1,140 ft from the threshold when they veered sharply to the right. (See figures 3 and 4.)

Figure 3. Initial touchdown runway markings (Source: Piper Aircraft, ~~Inc.~~, annotated by NTSB).

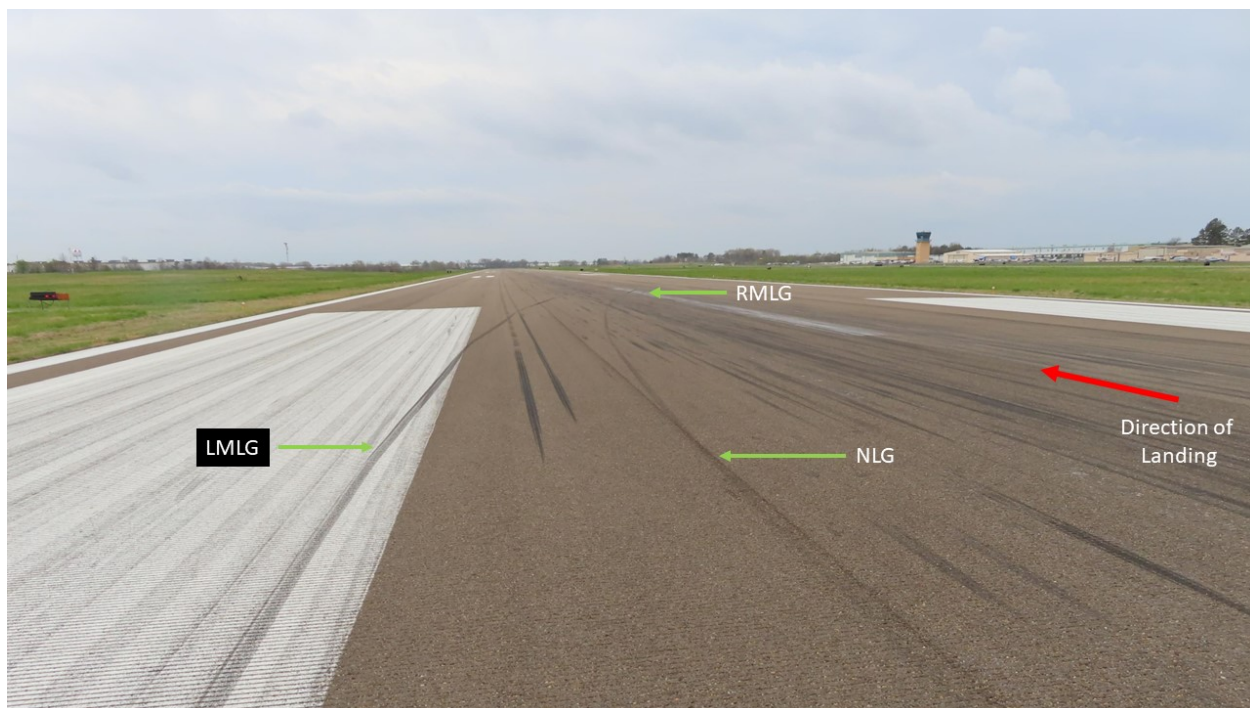
Figure 4. Runway markings (Source: Piper Aircraft, ~~Inc.~~, annotated by NTSB).

A rubber transfer mark from the RMLG was not discernable until about 1,170 ft from the runway threshold and was not continuous to the departure point. At the point where the RMLG mark became evident, the perpendicular distance between the RMLG and NLG

marks measured 51 inches and between the LMLG and NLG measured 106 inches. Throughout the right veer, the LMLG rubber transfer mark varied from moderate to heavy intensity with the tread pattern evident consistent with moderate to heavy braking. The NLG rubber transfer mark during the veer was initially of moderate intensity with the tread pattern evident but transitioned to heavy intensity with no tread pattern evident, consistent with a skidding tire.

Between the centerline and the departure point, the NLG skipped once and transitioned to light intensity with a tread pattern just before the departure. The RMLG rubber transfer mark was sporadic from its beginning to departure with moderate intensity. At the runway centerline, the perpendicular distance from the RMLG to NLG measured 33 inches and from the LMLG to the NLG measured 107 inches. At the departure point, the perpendicular distance between each MLG and the NLG measured 82 inches. The airplane departed the right side of the runway, about 1,330 ft from the threshold. There was no disturbance of the grass for about 10 ft beyond the runway edge, after which there were three deep ruts in the grass; each rut displayed a tire tread pattern in the mud. The NLG rut stopped about 68 ft from the initial point, and the airplane came to rest about 80 ft further along the path.

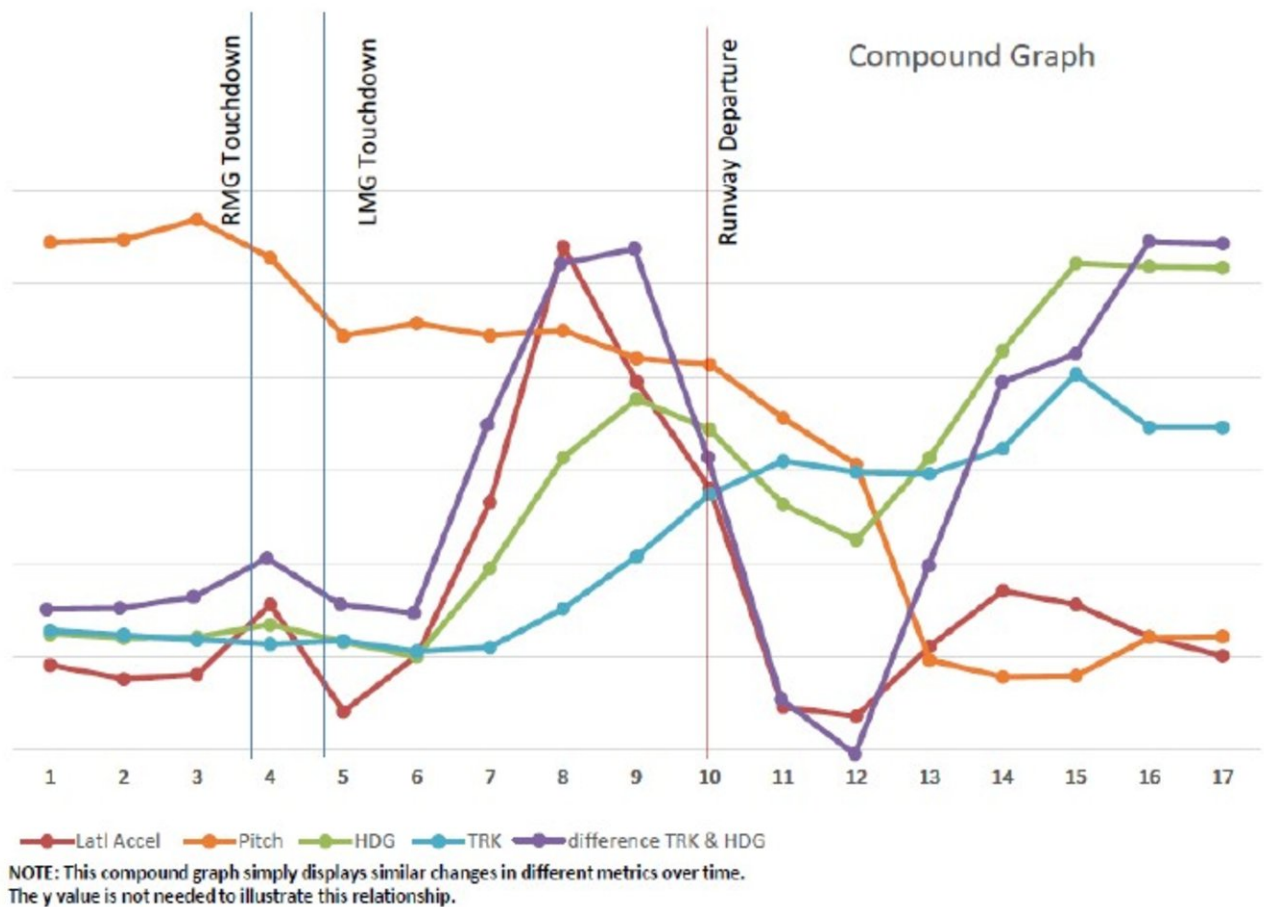
The Garmin G3000 Integrated Avionics System on the airplane records certain flight parameters at a rate of 1 hertz for each flight. A maintenance-oriented data set (CMC data) is recorded and stored internally on the unit, and flight-oriented data (log data) is recorded directly to an SD card. Both the CMC and log data for the accident flight were downloaded from the airplane. According to the data (see figure 5), the right main landing gear (RMLG) touched down first at a recorded indicated airspeed about 76 kts,

followed by the LMLG about 1 second later at a recorded indicated airspeed about 74 kts. The NLG touched down about 1 to 2 seconds after the RMLG. Starting about 2 seconds after LMLG touchdown, the heading and track diverged, with the nose to the right of the track that continued until near the runway departure location, indicating that the airplane was in a skid. The maximum divergence occurred about 1 second before runway departure when the heading was about 223° and the track was about 195°. At the same time, the lateral acceleration increased to a maximum of about 0.88 g about 2 seconds before runway departure, also consistent with the airplane in a left skid. The airplane departed the runway about 6 seconds after the RMLG touchdown at a ground speed about 47 kts with the heading and track mostly aligned. The pitch parameter showed a sharp decrease about 2 seconds after runway departure, consistent with a collapse of the NLG.

Figure 5. Plot of Garmin data from accident landing (Source: Piper Aircraft Inc.).

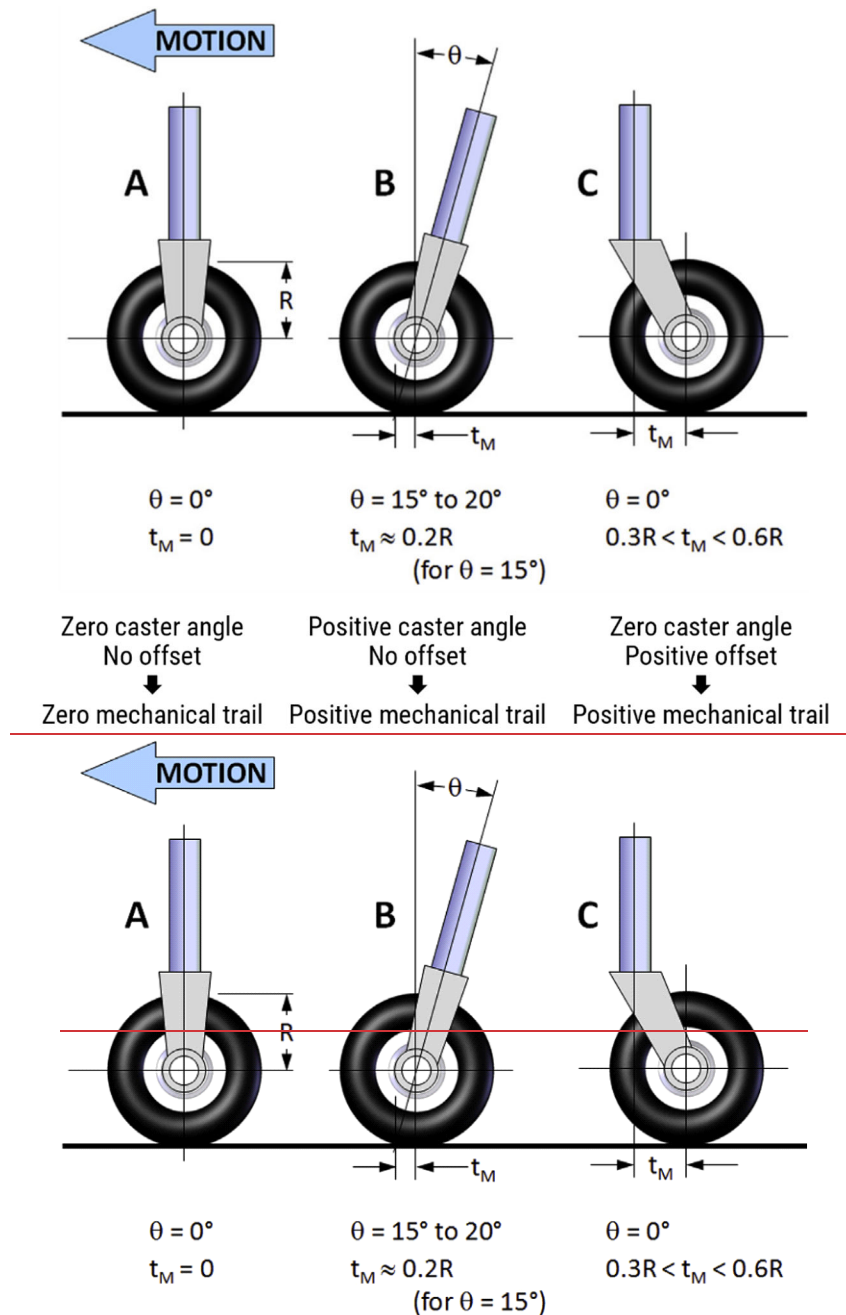
~~NLG trail refers to the location of the steering axis in relation to the vertical axis through the axle and can be positive, neutral, or negative. Neutral trail (see figure 6. Item A)~~

occurs when the steering axis is vertical and coincident with the vertical axis and axle location resulting in minimum steering forces required and no appreciable torque about the steering axis when the wheel is rolling (neutral dynamic stability). This configuration has neutral static stability. Positive trail (see figure 6. Item B) occurs when the steering axis intersects the ground forward of the vertical axis and results in a self-aligning torque about the steering axis when the wheel is rolling (positive dynamic stability). This configuration requires increased steering forces and is statically unstable if not restrained. Negative trail (see figure 6. Item B except angle is aft) occurs when the steering axis intersects the ground aft of the vertical axis and results in a torque about the steering axis that acts to increase the turn angle (negative dynamic stability) and is typically not used for NLG. This configuration requires increased steering forces and is considered statically unstable if not restrained. One way of obtaining trail on a NLG is to angle the NLG strut to some value known as the rake angle. A positive rake angle results in positive trail, a neutral rake angle results in neutral trail, and a negative rake angle results in negative trail.

Another way to achieve positive trail on the NLG is through the use of offset. In this scenario the axle is moved aft of the steering axis through the design of the lower end of the landing gear (see figure 6. Item C) and is similar to the front wheels on a shopping cart. This configuration has neutral static stability and positive dynamic stability but is more susceptible to shimmy than neutral trail landing gear. For a landing gear with offset and zero rake the trail is the horizontal distance between the location of the axle and the vertical centerline (steering axis) of the landing gear.

Figure 6. Nose landing gear Caster angle ( $\theta$ ) and mechanical trail ( $t_M$ ) for several nose landing gear configurations (Source: reproduced in part from Snorri Gudmundsson, General Aviation Aircraft Design: Applied Methods and Procedures, First Edition, Elsevier, Inc., 2014).
