# Aviation Investigation Final Report

| <b>Location:</b> | Olive Branch, Mississippi | <b>Accident Number:</b> | CEN22LA153 |
| <b>Aircraft:</b> | PIPER AIRCRAFT INC PA-46-600TP | <b>Aircraft Damage:</b> | Substantial |

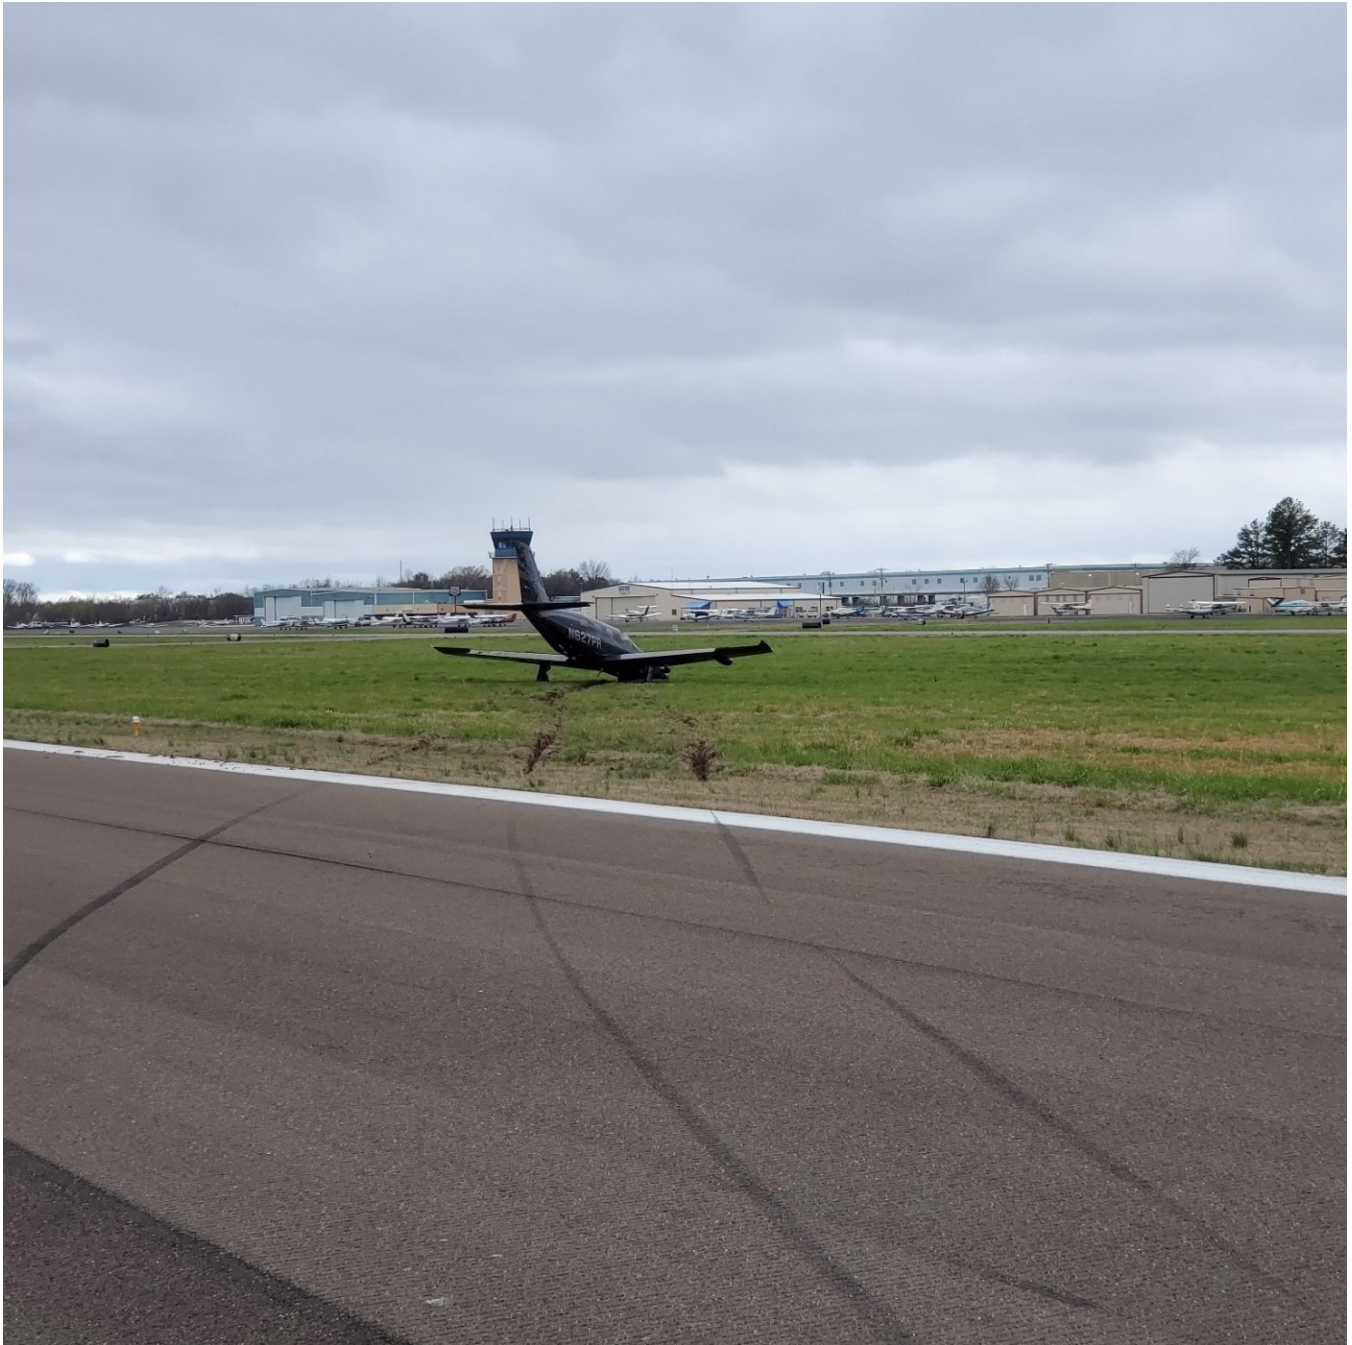
The airplane exited the right side of the runway and continued across wet and muddy grass when the nose gear collapsed, and the airplane came to rest nose down. (See figure 1.) The airplane departed the runway about 1,330 ft from the threshold and about 570 ft after touchdown. The engine mount sustained substantial damage.

Figure 1. Accident airplane (Source: OLV airport operations)

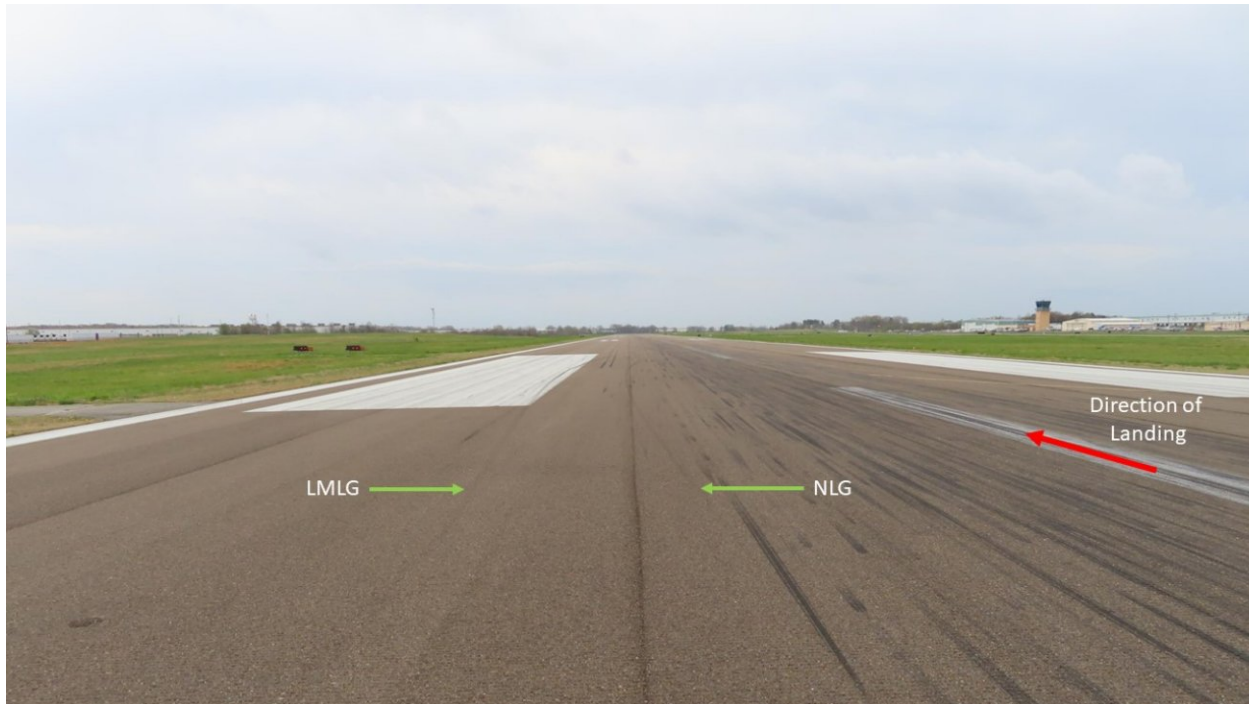
Examination of the runway surface revealed a light rubber transfer mark consistent with the LMLG that began about 760 ft from the runway 18 threshold and about 17 ft left of the centerline. The transfer mark was continuous until it departed the right side of the runway and

varied in intensity. A light rubber transfer mark with the tread pattern evident, consistent with the NLG, began about 900 ft from the threshold and about 10 ft left of the centerline. The mark was mostly continuous until it departed the right side of the runway and varied in intensity. The LMLG and NLG rubber transfer marks were aligned, separated by about 80 inches, and drifted to the left until about 1,140 ft from the threshold when they veered sharply to the right. (see figures 3 and 4.)

Figure 3. Initial touchdown runway markings (Source: Piper Aircraft, Inc., annotated by NTSB)

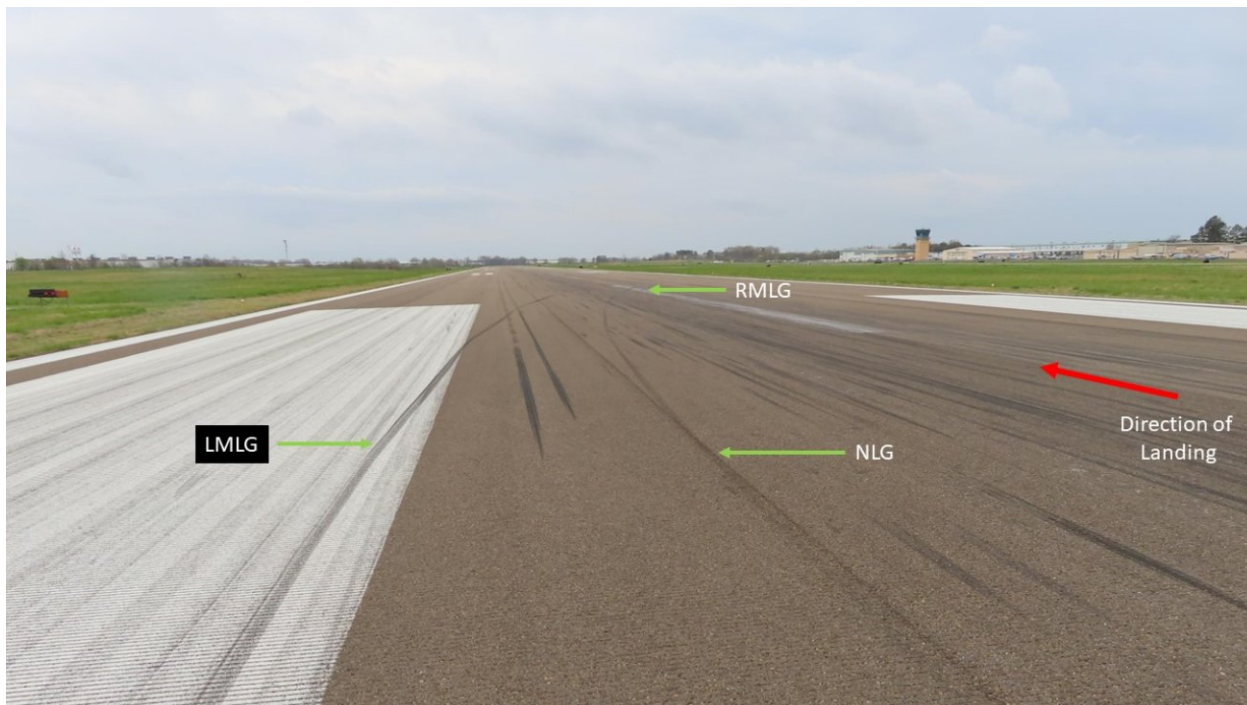
Figure 4. Runway markings (Source: Piper Aircraft, Inc., annotated by NTSB)

A rubber transfer mark from the RMLG was not discernable until about 1,170 ft from the runway threshold and was not continuous to the departure point. At the point where the RMLG mark became evident, the perpendicular distance between the RMLG and NLG marks measured 51 inches and between the LMLG and NLG measured 106 inches. Throughout the right veer, the LMLG rubber transfer mark varied from moderate to heavy intensity with the tread pattern evident consistent with moderate to heavy braking. The NLG rubber transfer mark during the veer was initially of moderate intensity with the tread pattern evident but transitioned to heavy intensity with no tread pattern evident, consistent with a skidding tire.

Between the centerline and the departure point, the NLG skipped once and transitioned to light intensity with a tread pattern just before the departure. The RMLG rubber transfer mark was sporadic from its beginning to departure with moderate intensity. At the runway centerline, the perpendicular distance from the RMLG to NLG measured 33 inches and from the LMLG to the NLG measured 107 inches. At the departure point, the perpendicular distance between each MLG and the NLG measured 82 inches. The airplane departed the right side of the runway, about 1,330 ft from the threshold. There was no disturbance of the grass for about 10 ft beyond the runway edge, after which there were three deep ruts in the grass; each rut displayed a tire tread pattern in the mud. The NLG rut stopped about 68 ft from the initial point, and the airplane came to rest about 80 ft further along the path.

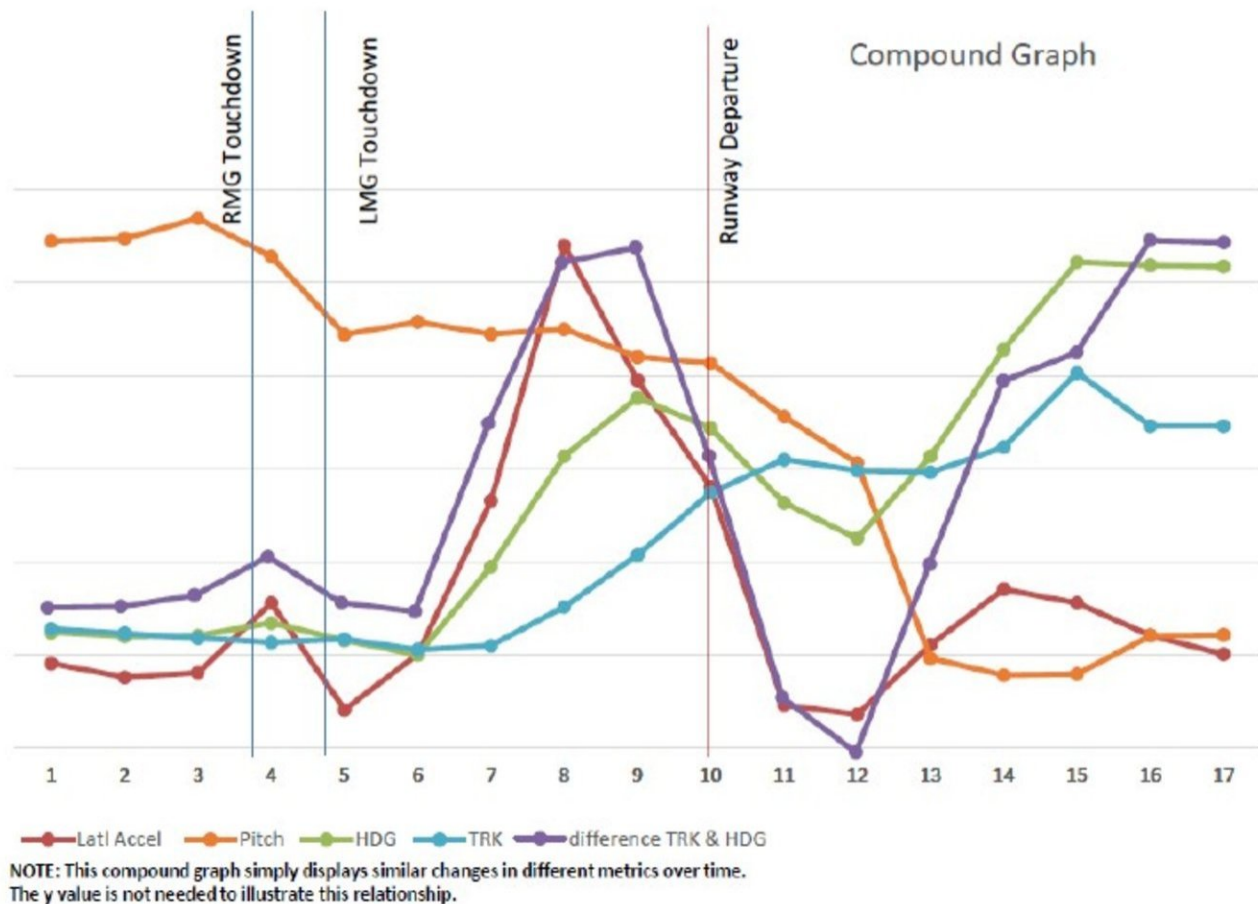
A review of the airplane's avionics data revealed that the RMLG touched down first, followed by the LMLG about 1 second later, consistent with a right crosswind landing. The NLG touched down about 1 to 2 seconds after the RMLG. Starting about 2 seconds after LMLG touchdown, the heading and track diverged, with the nose to the right of the track, until near the runway

departure location, indicating that the airplane was in a skid. The maximum divergence occurred about 1 second before the runway excursion, when the heading was about 223° and the track was about 195°. At the same time, the lateral acceleration increased, also consistent with the airplane being in a left skid. The airplane departed the runway with the heading and track mostly aligned.

The Garmin G3000 Integrated Avionics System on the airplane records certain flight parameters at a rate of 1 hertz for each flight. A maintenance-oriented data set (CMC data) is recorded and stored internally on the unit, and flight-oriented data (log data) is recorded directly to an SD card. Both the CMC and log data for the accident flight were downloaded from the airplane. According to the data (see figure 5), the right main landing gear (RMLG) touched down first at a recorded indicated airspeed about 76 kts, followed by the LMLG about 1 second later at a recorded indicated airspeed about 74 kts. The NLG touched down about 1 to 2 seconds after the RMLG. Starting about 2 seconds after LMLG touchdown, the heading and track diverged, with the nose to the right of the track that continued until near the runway departure location, indicating that the airplane was in a skid. The maximum divergence occurred about 1 second before runway departure when the heading was about 223° and the track was about 195°. At the same time, the lateral acceleration increased to a maximum of about 0.88 g about 2 seconds before runway departure, also consistent with the airplane in a left skid. The airplane departed the runway about 6 seconds after the RMLG touchdown at a ground speed about 47 kts with the heading and track mostly aligned. The pitch parameter showed a sharp decrease about 2 seconds after runway departure, consistent with a collapse of the NLG.

Figure 5. Plot of Garmin data from accident landing (Source: Piper Aircraft Inc.)

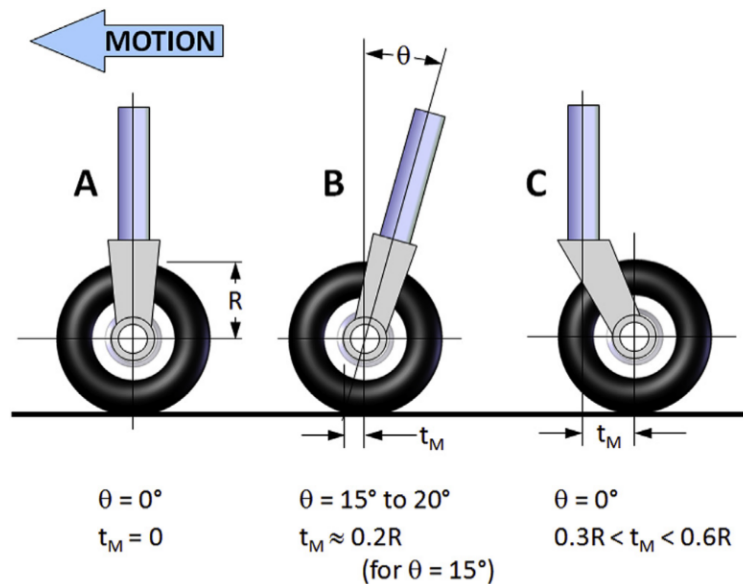
NLG trail refers to the location of the steering axis in relation to the vertical axis through the axle and can be positive, neutral, or negative. Neutral trail (see figure 6. Item A) occurs when the steering axis is vertical and coincident with the vertical axis and axle location resulting in minimum steering forces required and no appreciable torque about the steering axis when the wheel is rolling (neutral dynamic stability). This configuration has neutral static stability. Positive trail (see figure 6. Item B) occurs when the steering axis intersects the ground forward of the vertical axis and results in a self-aligning torque about the steering axis when the wheel is rolling (positive dynamic stability). This configuration requires increased steering forces and is statically unstable if not restrained. Negative trail (see figure 6. Item B except angle is aft)

occurs when the steering axis intersects the ground aft of the vertical axis and results in a torque about the steering axis that acts to increase the turn angle (negative dynamic stability) and is typically not used for NLG. This configuration requires increased steering forces and is considered statically unstable if not restrained. One way of obtaining trail on a NLG is to angle the NLG strut to some value known as the rake angle. A positive rake angle results in positive trail, a neutral rake angle results in neutral trail, and a negative rake angle results in negative trail.

Another way to achieve positive trail on the NLG is through the use of offset. In this scenario the axle is moved aft of the steering axis through the design of the lower end of the landing gear (see figure 6. Item C) and is similar to the front wheels on a shopping cart. This configuration has neutral static stability and positive dynamic stability but is more susceptible to shimmy than neutral trail landing gear. For a landing gear with offset and zero rake the trail is the horizontal distance between the location of the axle and the vertical centerline (steering axis) of the landing gear.

With the tire rolling straight on the runway, the frictional force generated by the NLG wheel is aligned with the longitudinal axis of the tire. Once the NLG is rotated left or right for steering, the frictional force has a component aligned along the longitudinal axis of the tire and a component aligned  $90^\circ$  to the longitudinal axis of the tire. It is this side force that can affect the stability based on the trail. Positive trail results in positive dynamic stability and negative trail results in negative dynamic stability.

Figure 6. Nose landing gear trail (Source: Reproduced in part from Snorri Gudmundsson, *General Aviation Aircraft Design: Applied Methods and Procedures*, First Edition, Elsevier, Inc., 2014)

The manufacturer redesigned the lower NLG fork area to move the axle 0.5 inches aft of the steering axis. This is equivalent to raking the NLG forward 5°, making it inherently dynamically stable. The new NLG should be dynamically stable even during aft deflection since the steering axis will remain forward of the vertical axis (center of the tire contact patch) and provide a restoring force to the NLG tire if deflected. The new NLG improves the dynamic stability of the NLG allowing the nose wheel to self-center.
