# Aviation Investigation Final Report

| <b>Location:</b> | Olive Branch, Mississippi | <b>Accident Number:</b> | CEN22LA153 |
| <b>Date &amp; Time:</b> | March 23, 2022 10:38 Local | <b>Registration:</b> | N627PR |
| <b>Aircraft:</b> | Piper Aircraft Inc Pa-46-600Tp | <b>Aircraft Damage:</b> | Substantial |

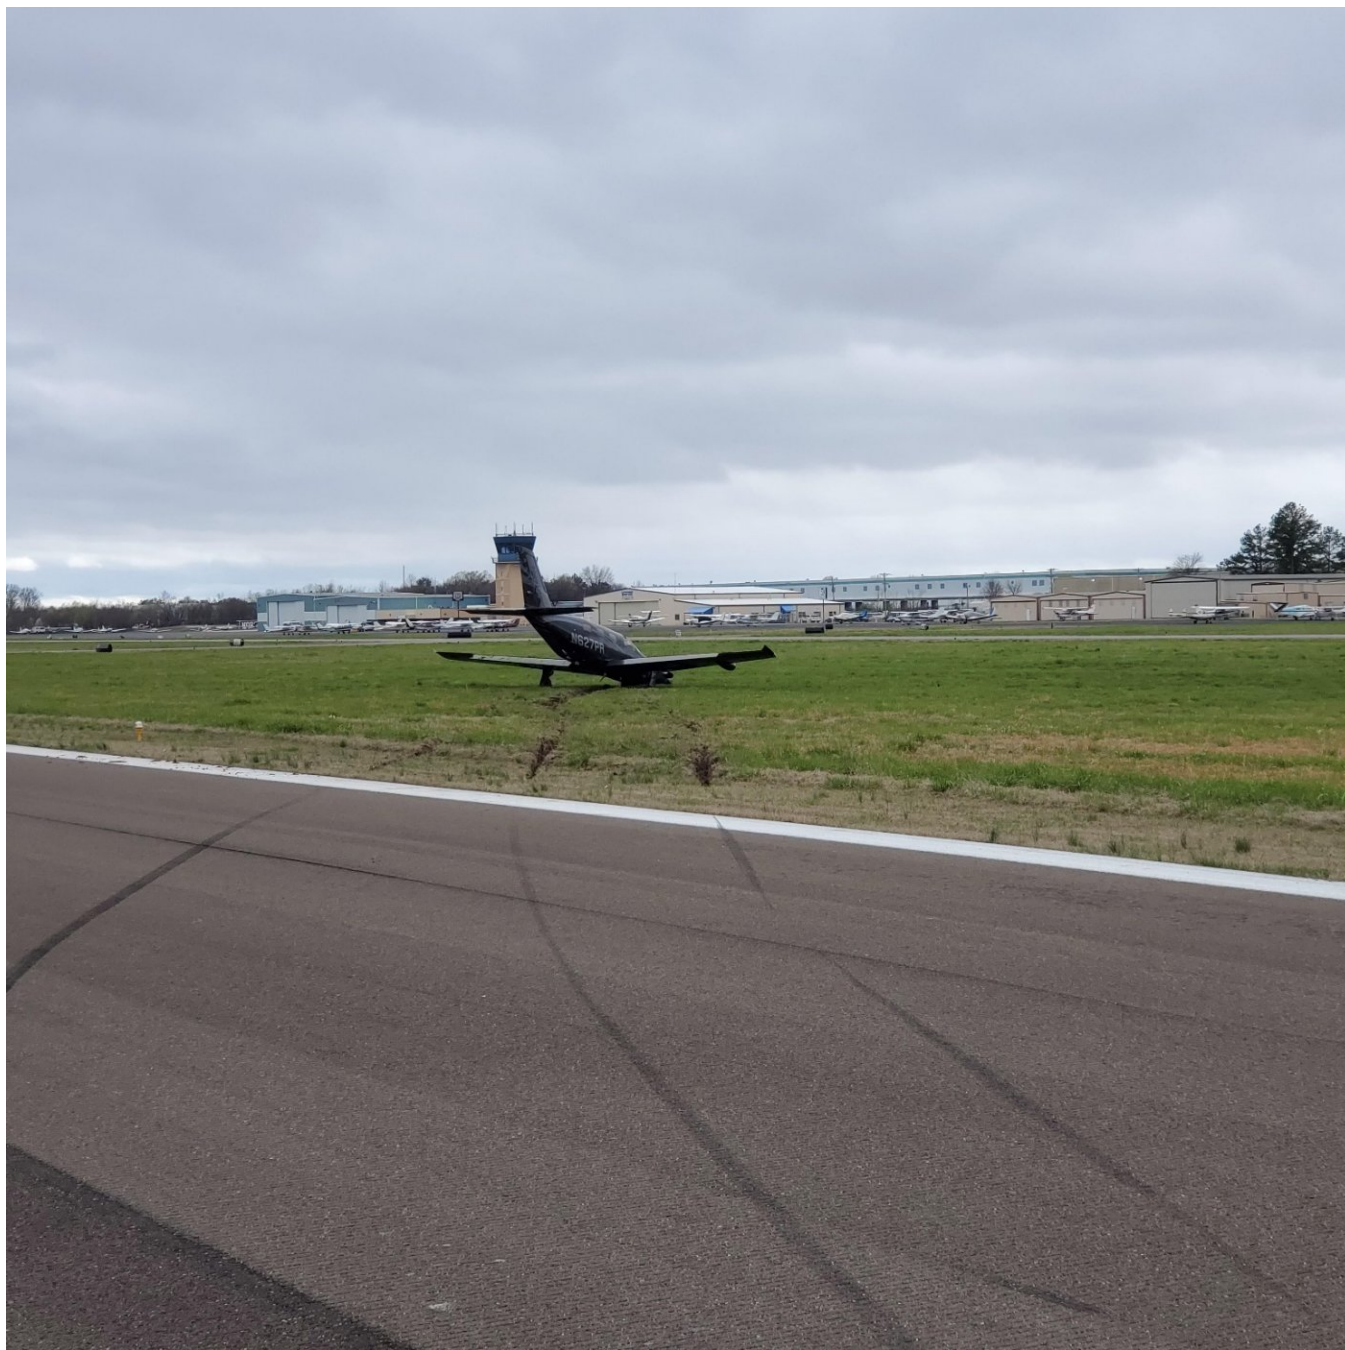
The airplane exited the right side of the runway and continued across wet and muddy grass when the nose gear collapsed, and the airplane came to rest nose down. (See figure 1.) The airplane departed the runway about 1,330 ft from the threshold and about 570 ft after touchdown. The engine mount sustained substantial damage.

Figure 1. Accident airplane (Source: OLV airport operations).

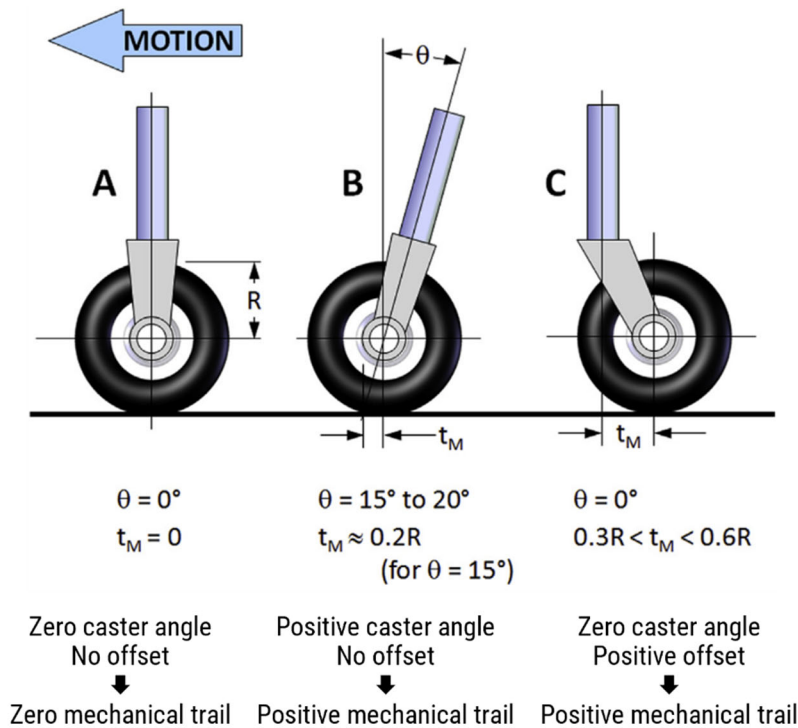
The sum of the ground reaction forces on a tire acts at the contact point of the tire. When the tire is static (not rolling), the contact point is directly under the center of the tire. The distance between the tire static contact point and the intersection of the NLG strut rotation axis with the ground line is called “static trail” or “mechanical trail” and is positive when the tire contact point is aft of the strut rotation axis. One way to vary NLG mechanical trail is to adjust the longitudinal “caster angle” of the NLG strut. A caster angle equal to zero results in zero mechanical trail (see figure 6, item A). A positive caster angle results in positive mechanical trail (see figure 6, item B), and a negative caster angle results in negative mechanical trail. Mechanical trail can also be changed through the use of offset, in which the tire axle is moved aft of the steering axis through the design of the lower end of the landing gear, similar to the front wheels on a shopping cart (see figure 6, item C). Figure 6 illustrates caster angle, offset, and the resulting mechanical trail for several NLG configurations.

Figure 6. Caster angle ( $\theta$ ) and mechanical trail ( $t_M$ ) for several nose landing gear configurations (Source: reproduced in part from Snorri Gudmundsson, *General Aviation Aircraft Design: Applied Methods and Procedures*, First Edition, Elsevier, Inc., 2014).
