**NATIONAL TRANSPORTATION SAFETY BOARD**

**INVESTIGATION SUMMARY**

**CEN22LA156**

## **B. ACCIDENT SUMMARY**

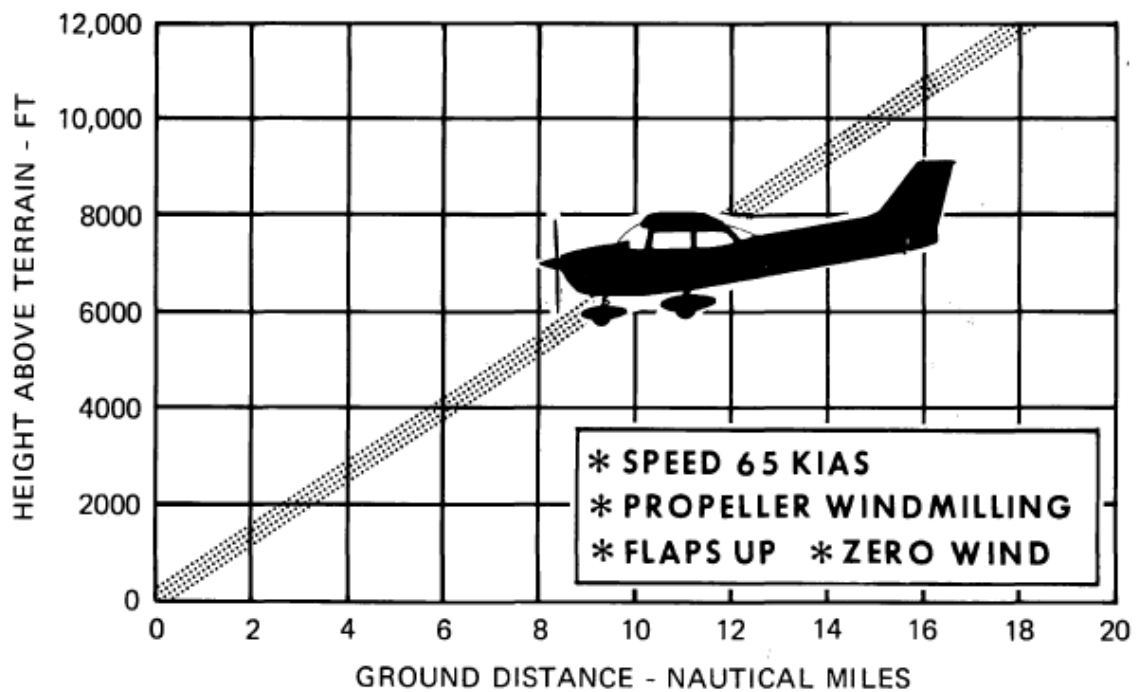
**Figure 3-1. Maximum Glide**

Max glide distance from 2,000 ft is 3 nm. Airplane actually traveled 2.75 nm.  
 Max glide distance from 3,000 ft is 5 nm. Airplane traveled 5.62 nm and made a right turning descent near at the beginning of the event.

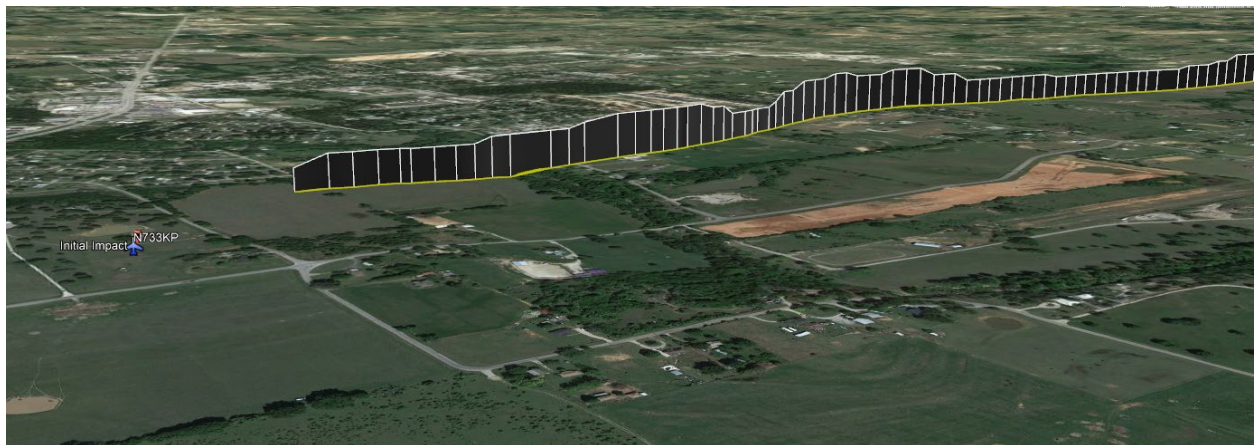
Airplane gained altitude two times during the final descent to the accident site.

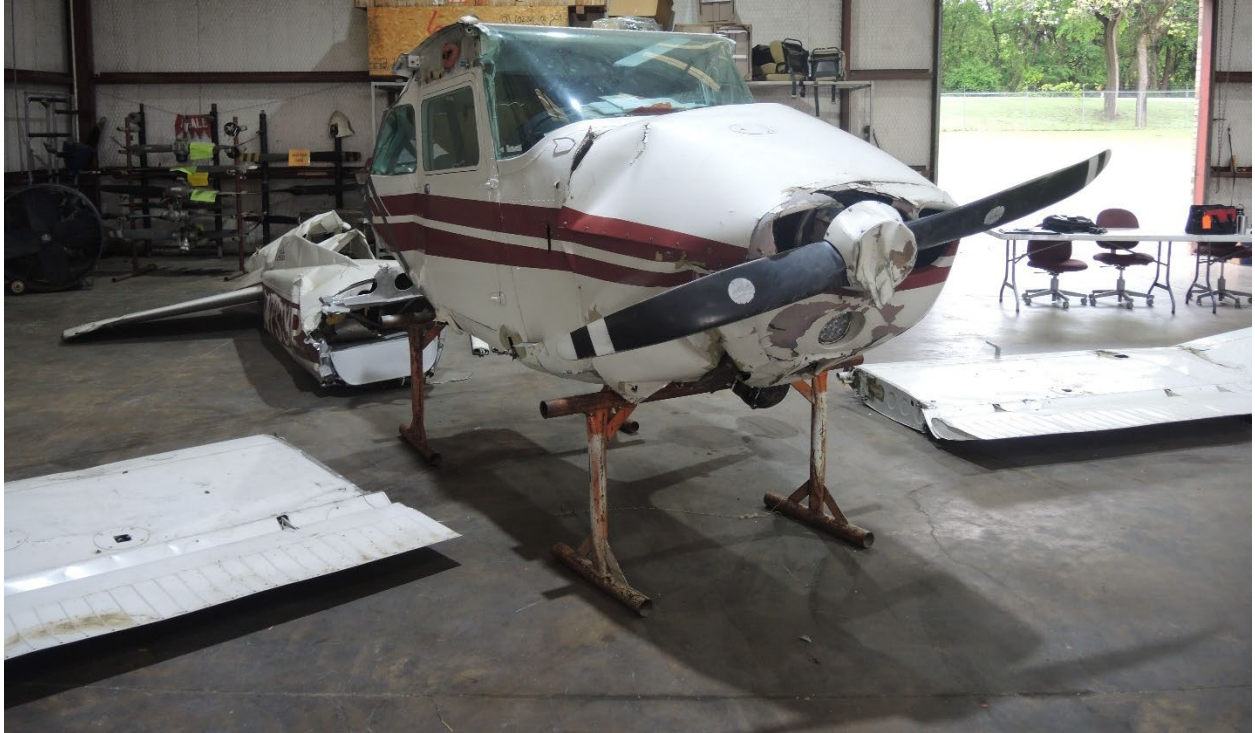
The engine remained mostly attached to the airplane, but a few of the engine mounts were impact damaged and fractured. The propeller assembly remained attached to the crankshaft and the blades were relatively straight.

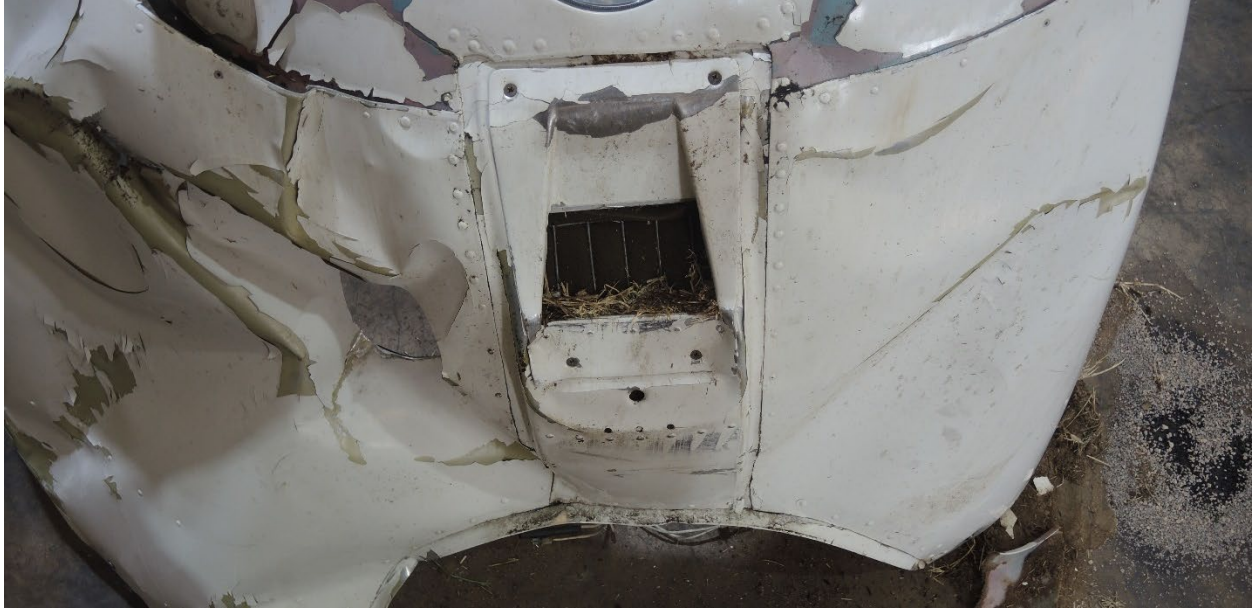
The lower cowl induction air filter was in place and undamaged with dirt and organic debris at the bottom of the filter element.

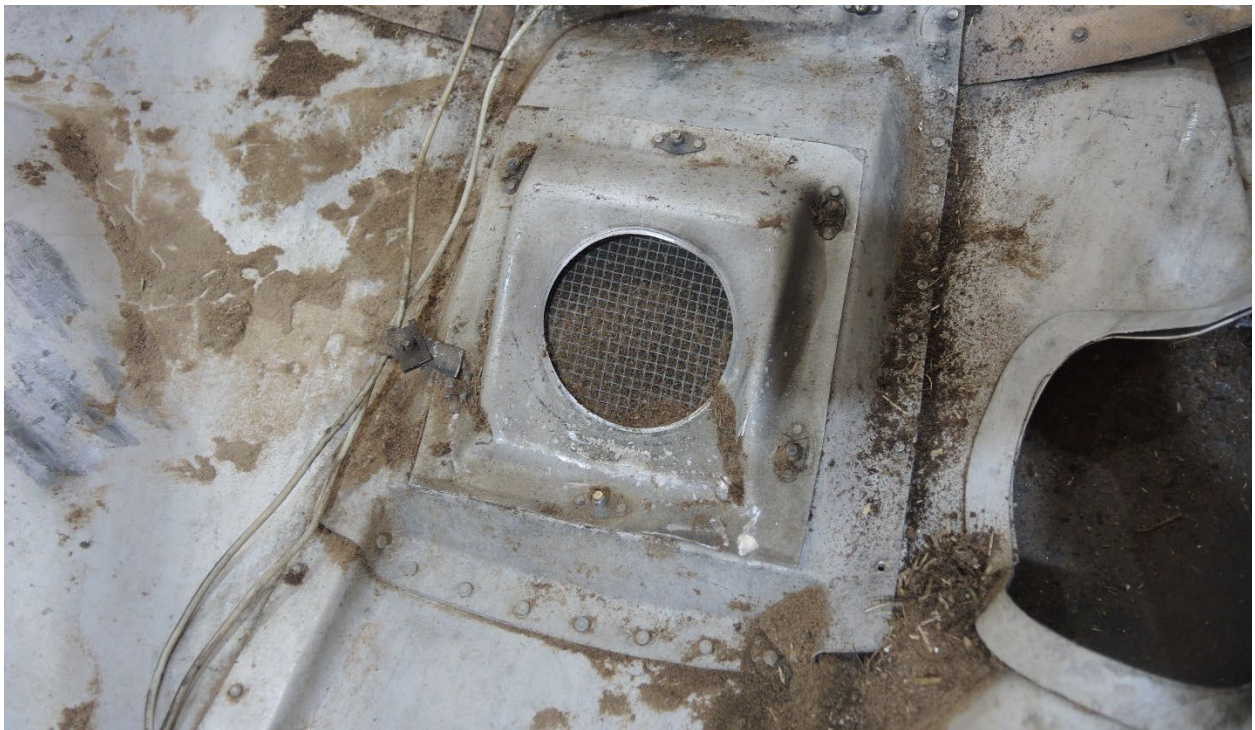
The induction air filter screen was in place and undamaged with dirt and organic debris in the filter and screen. The hose from the filter to the carburetor inlet was clear and only contained a small amount of dirt.

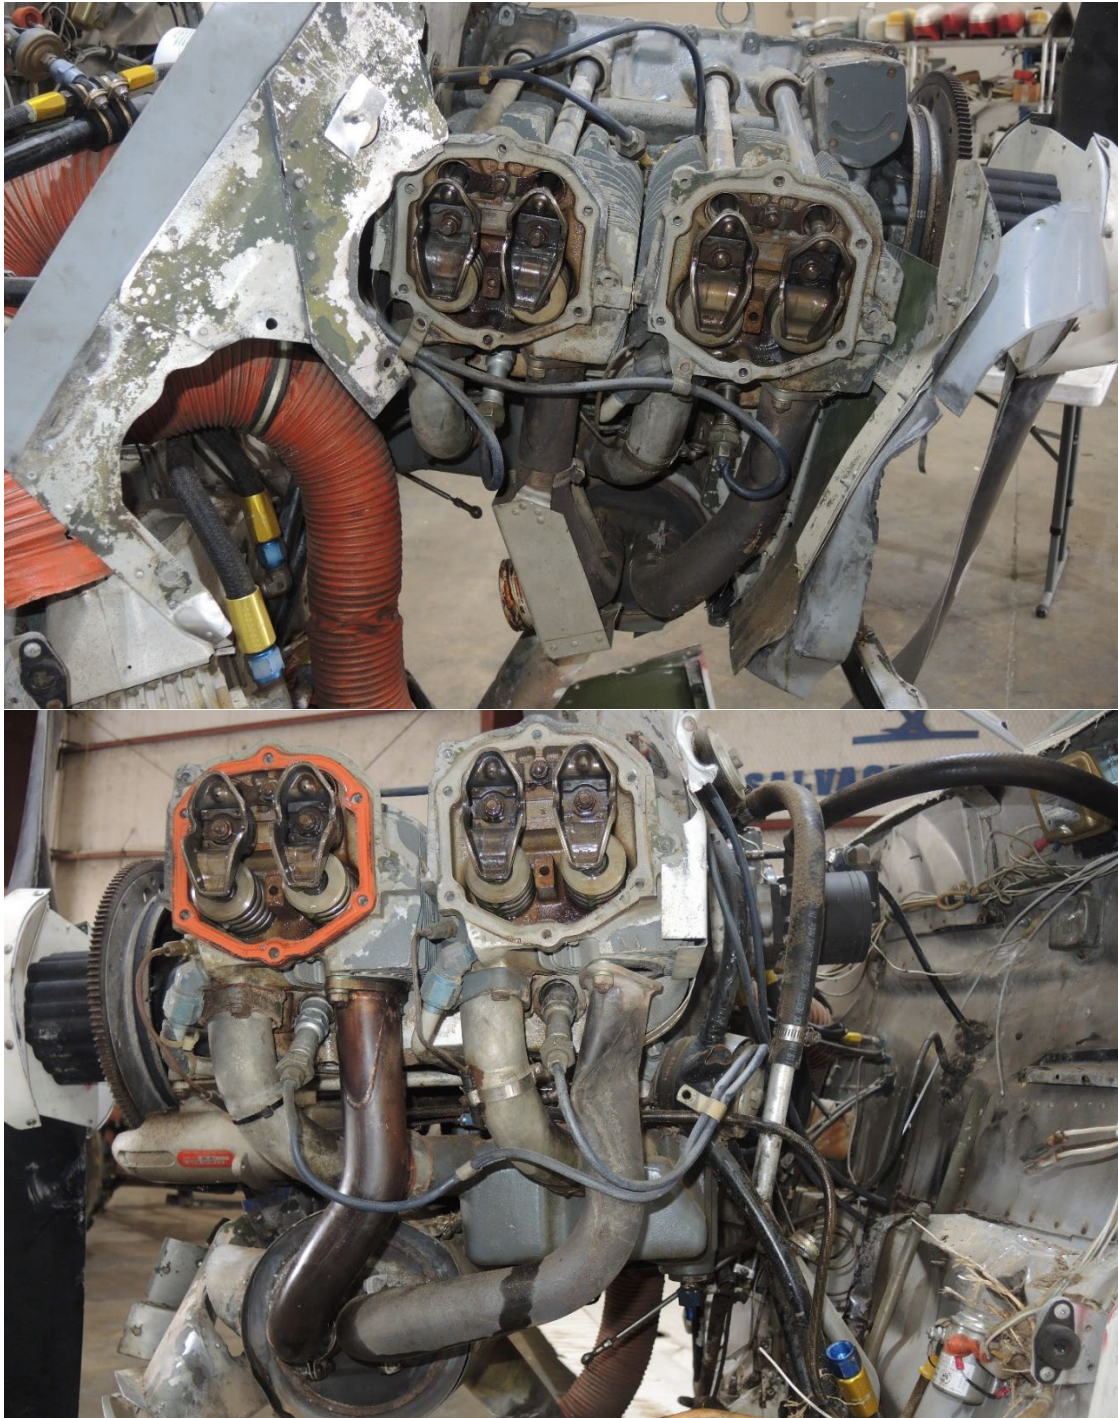
The engine case and cylinders exhibited minimal impact damage. The engine mounts were broken on the top left side. The accessory area appeared undamaged. All fuel and oil lines were intact and secure. Throttle / Mixture / Carb heat control linkages remained intact and connected. When the controls were manipulated in the cabin, the linkages moved as expected. Engine oil appeared consistent with new oil with no visible contaminants. The cylinder rocker box covers were removed, and the rocker arms were undamaged.

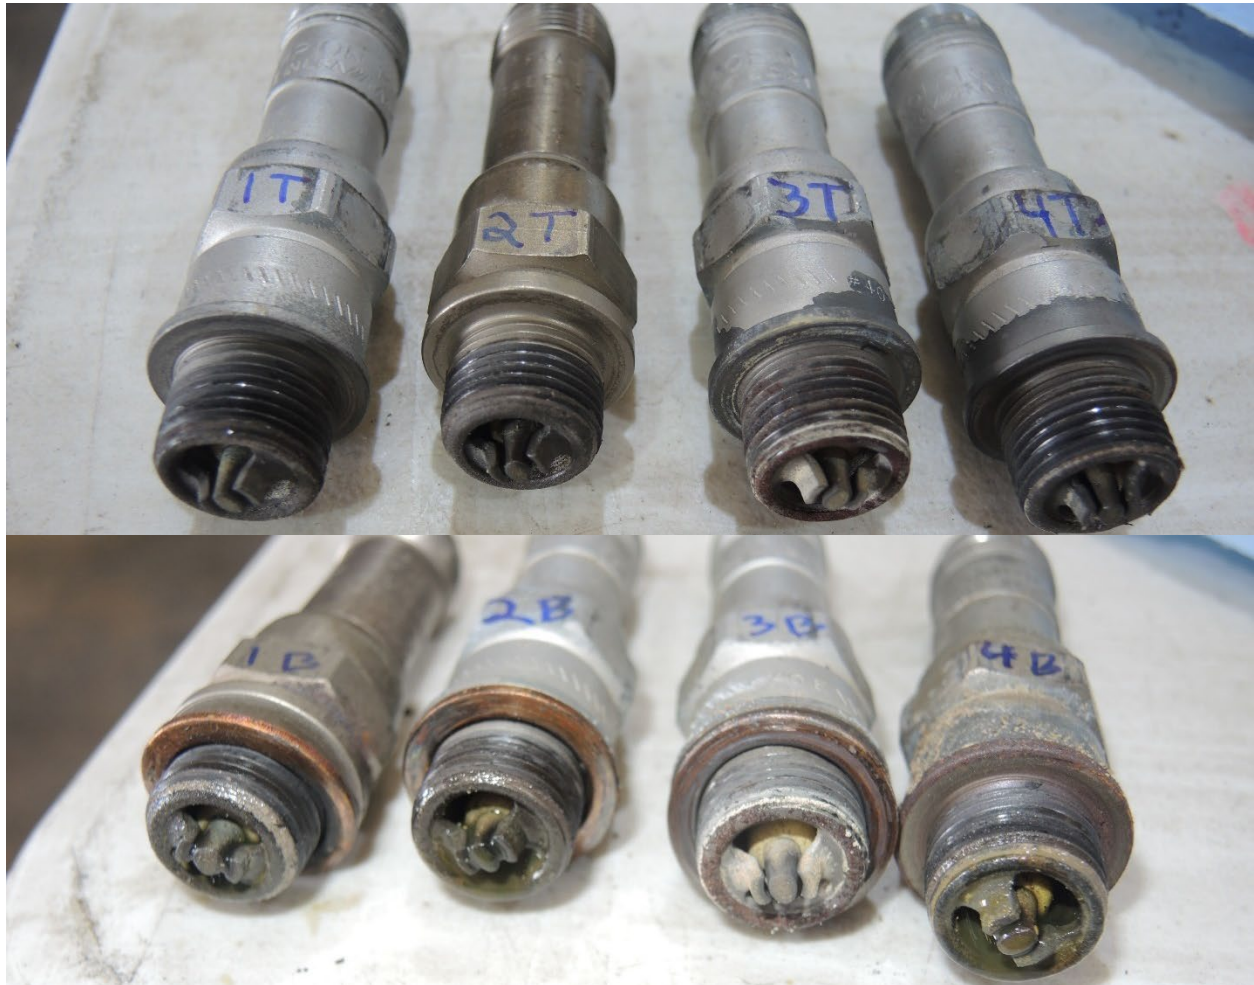
All spark plugs were removed and appeared “worn out – normal” when compared to a Champion check-a-plug chart. The No. 1 bottom and No. 2 top plugs were Tempest brand while the rest were Champion brand.

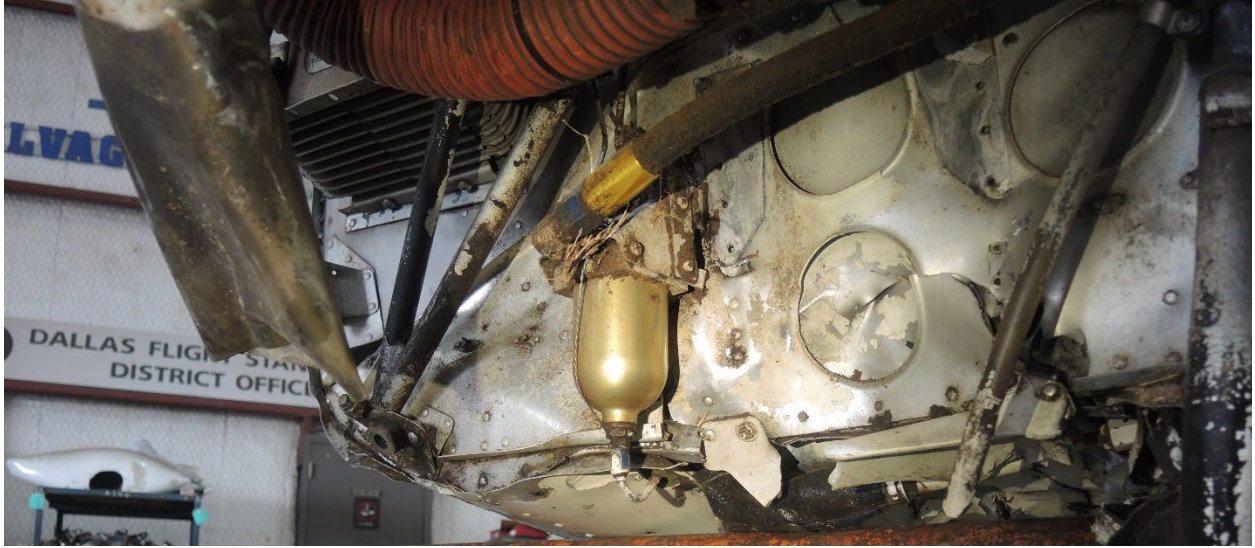
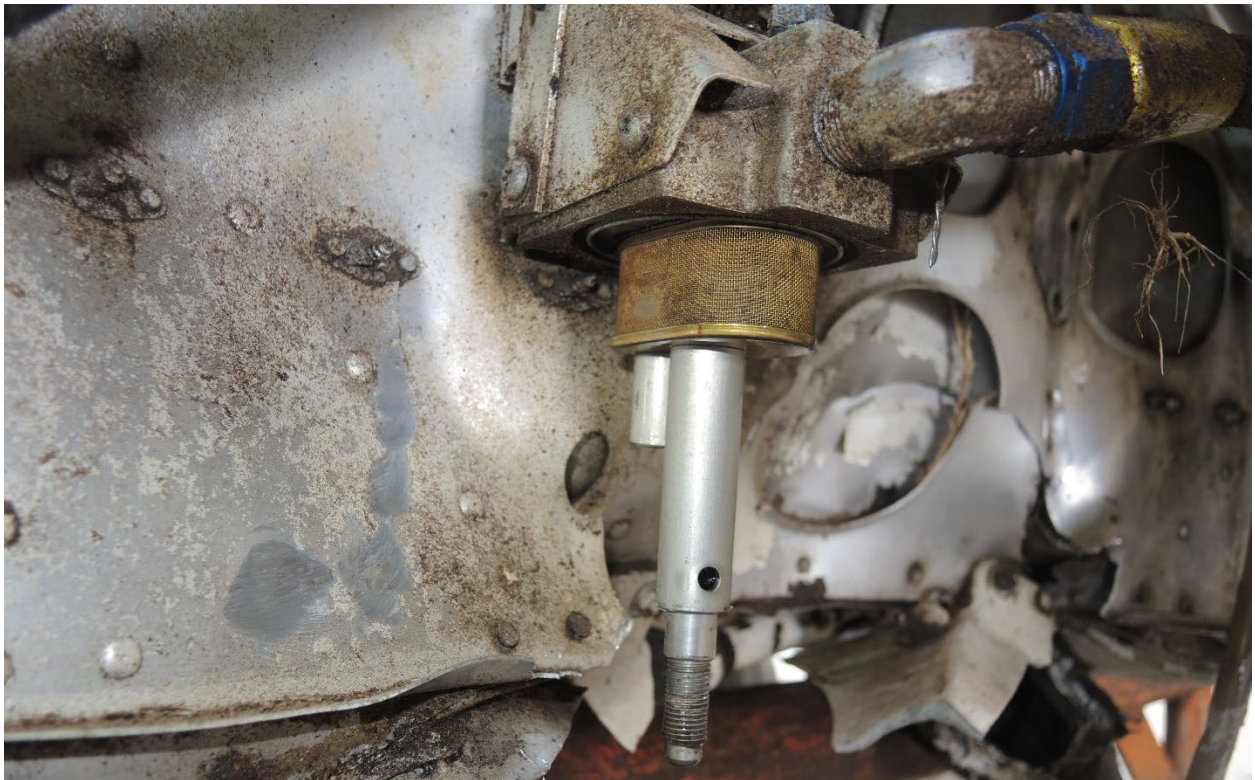
The fuel strainer remained attached to the firewall with no damage or anomalies noted. The strainer bowl was removed, and all fuel was drained into a glass jar. The fuel was blue and smelled of AvGas with no contamination noted. The fuel strainer screen was clear of contaminants.

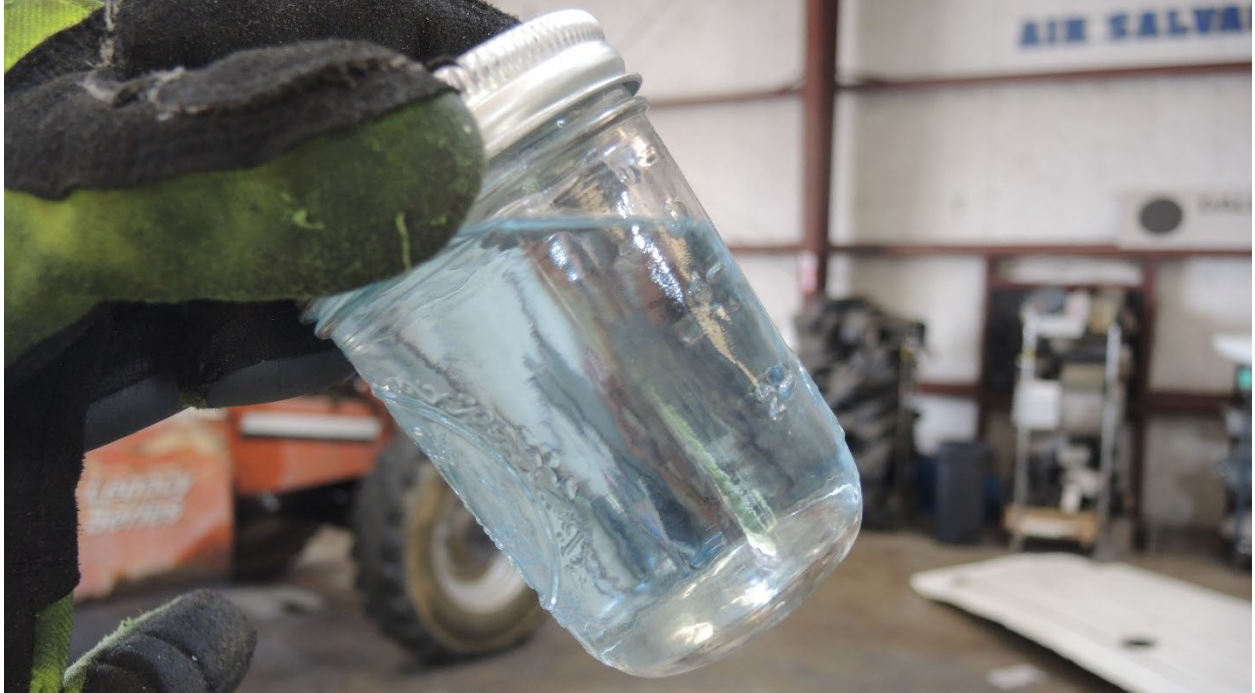
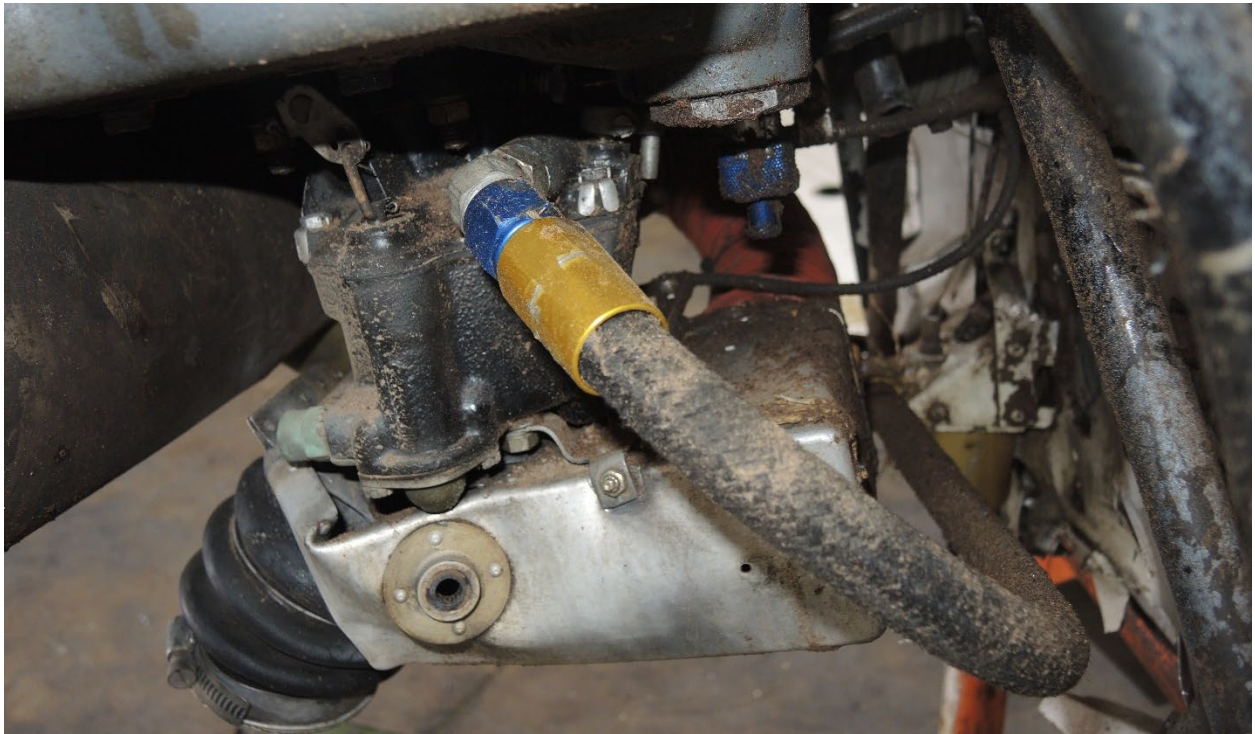
The fuel line from the strainer to the carburetor was clear of obstructions. The throttle and mixture cables were actuated from the cockpit, and both operated as expected. When the fuel selector was set to the LEFT/RIGHT/BOTH positions, air was blown through the fuel lines at the fuselage fittings; fuel ejected from the open fuel strainer each time and there were no blockages noted. Air was also blown through the fuel lines at the wing fittings; air was heard entering the fuel tanks and there were no blockages noted.

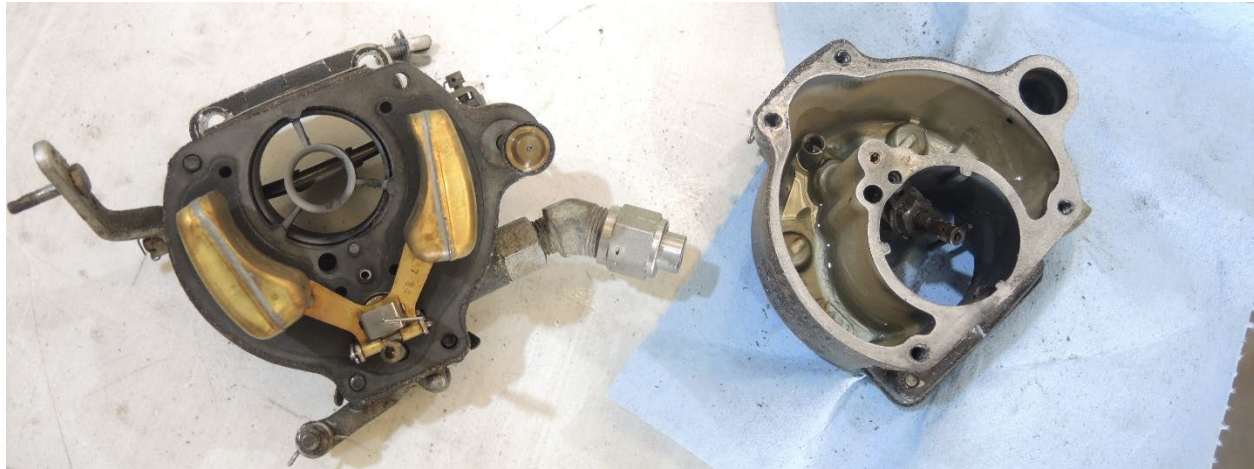
The carburetor remained attached at its mount and was intact, but sustained some impact damage to the air intake box. The fuel lines were connected and undamaged. The carburetor was removed, and the throttle arm was actuated, which verified functionally of the accelerator pump as it squirted fuel as expected. The carburetor was opened and contained 2-3 oz of blue fuel. The brass floats were intact and moved through their range of motion without restriction. When the floats were moved the needle valve was moved without issue. The venturi was clear and there were no anomalies noted.

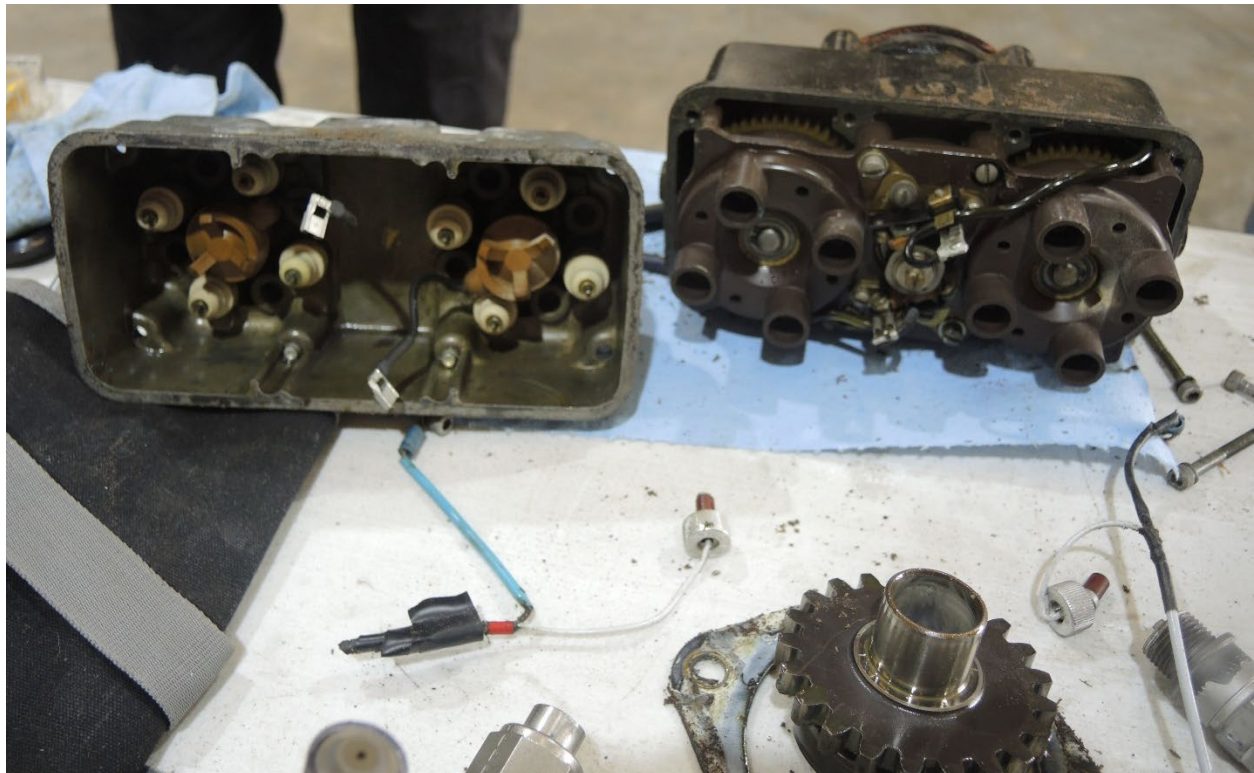
The dual magneto was removed, and the case was opened. There were no abnormalities noted.
