CEN22LA157

## INVESTIGATION PHOTOGRAPHS

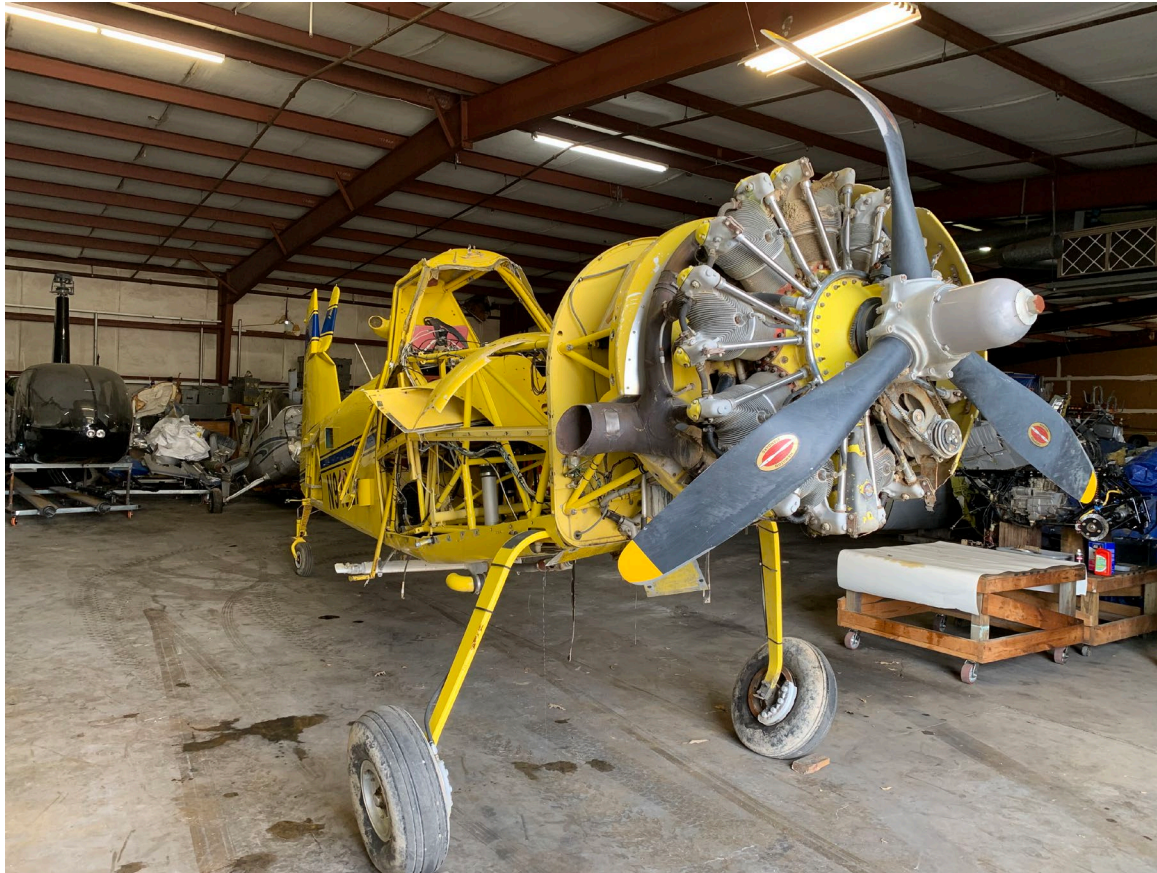
**Photograph 1 - Fuselage during postaccident examination (NTSB Photo)**

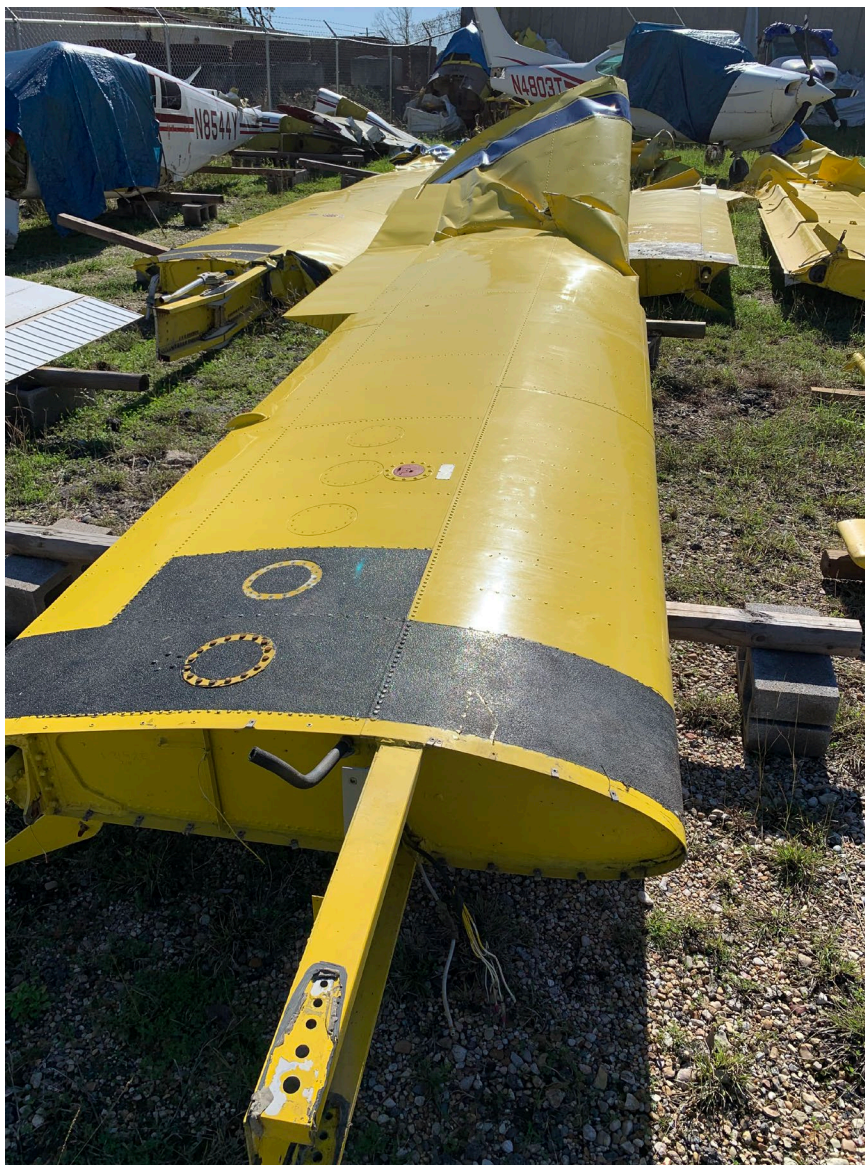
**Photograph 2 - Left wing during postaccident examination (NTSB Photo)**

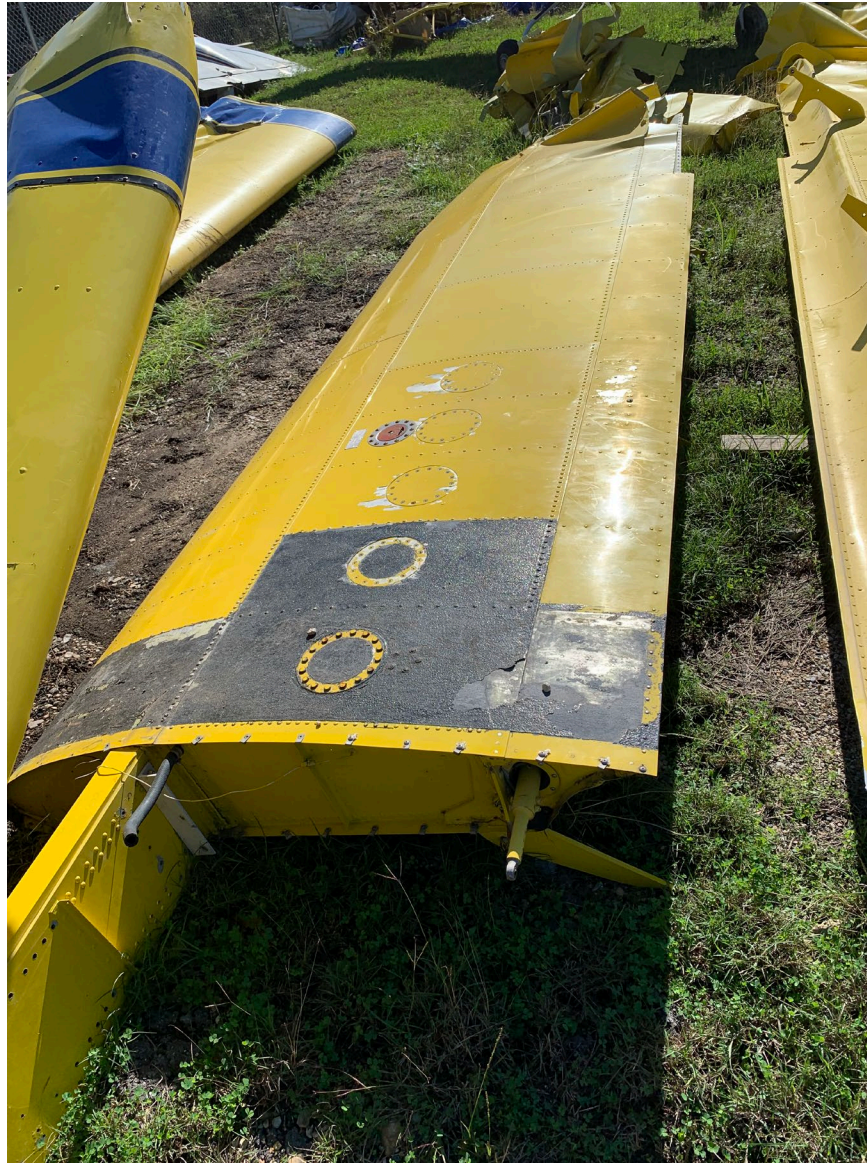
**Photograph 3 - Right wing during postaccident examination (NTSB Photo)**

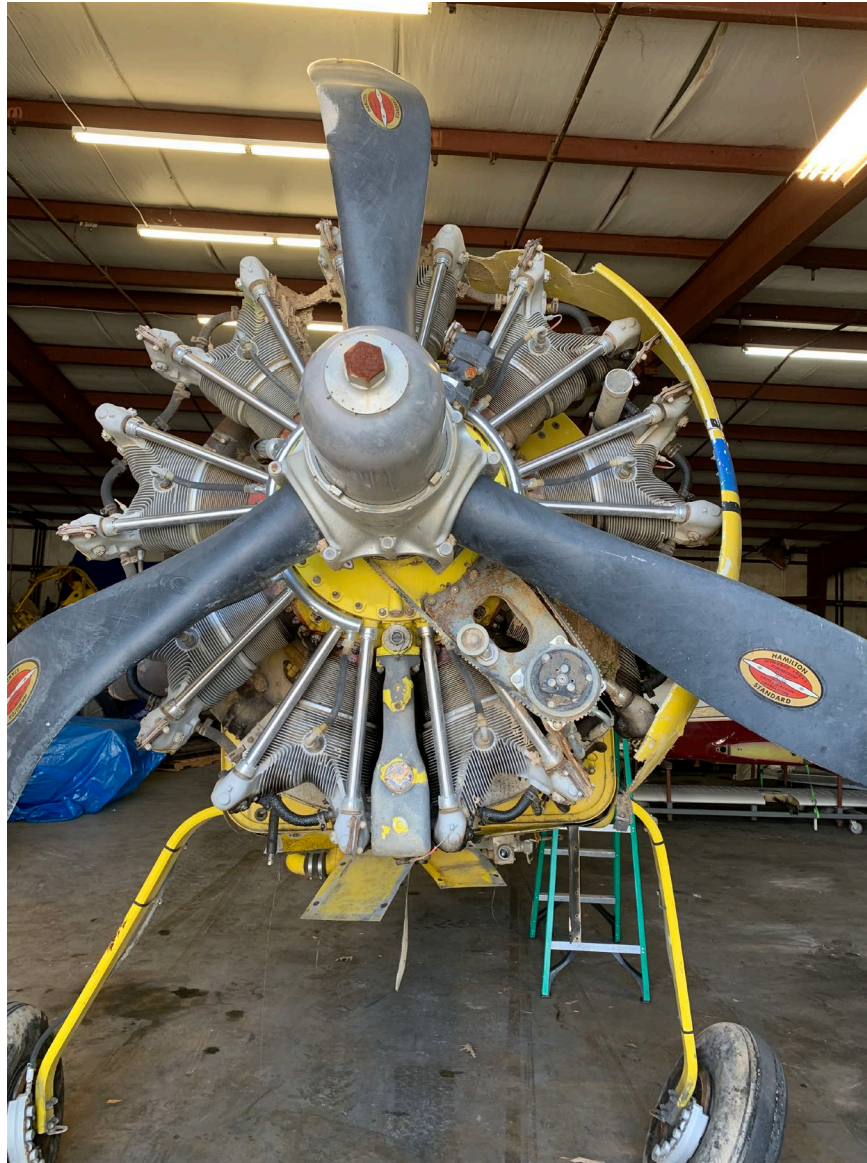
**Photograph 4 - Engine during postaccident examination (NTSB Photo)**

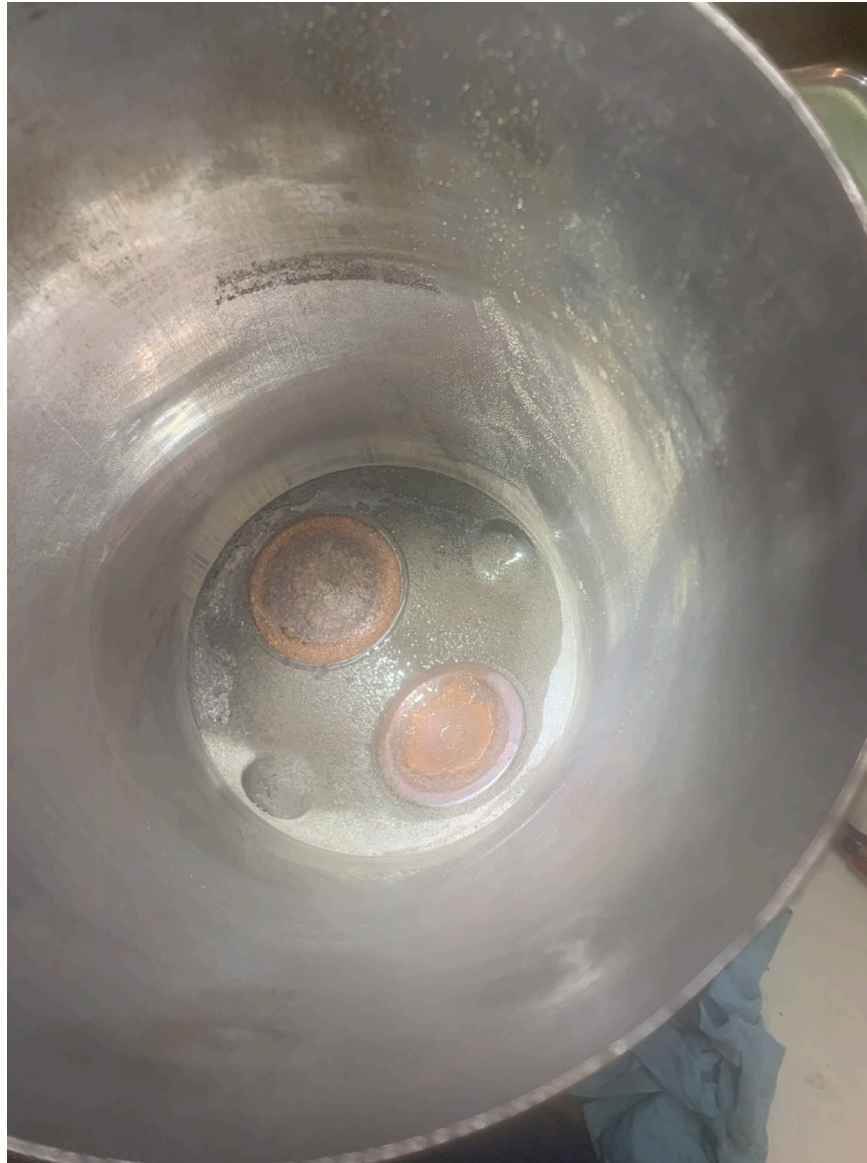
**Photograph 5 - No. 8 cylinder during postaccident examination (NTSB Photo)**

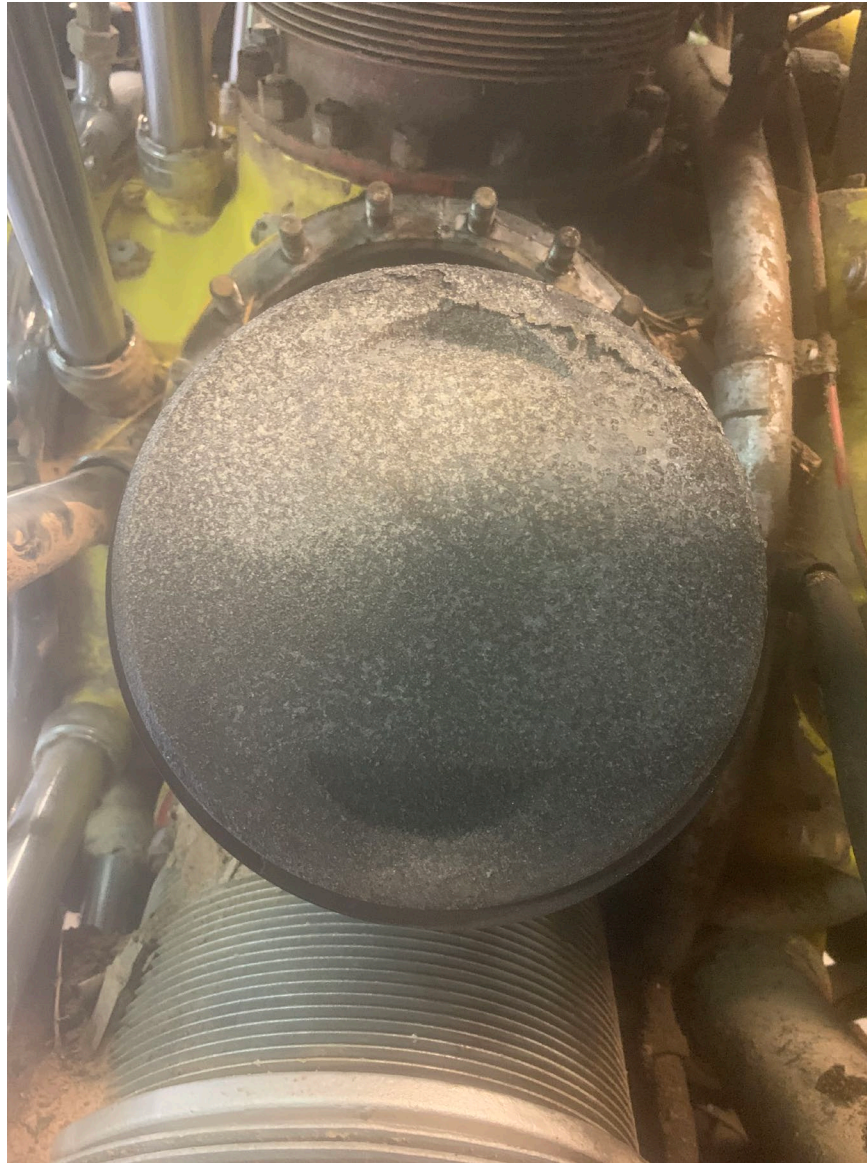
**Photograph 6 - No. 8 piston during postaccident examination (NTSB Photo)**

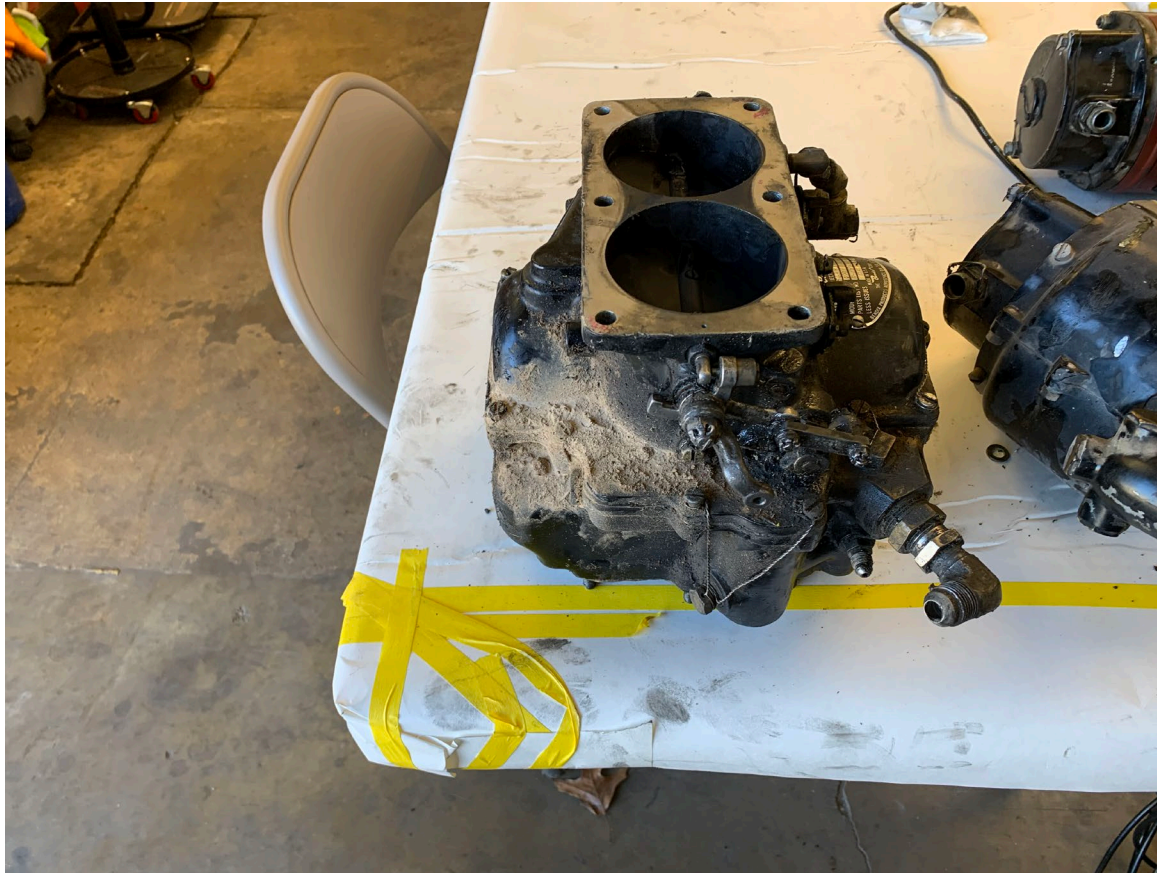
**Photograph 7 - Carburetor during postaccident examination (NTSB Photo)**
