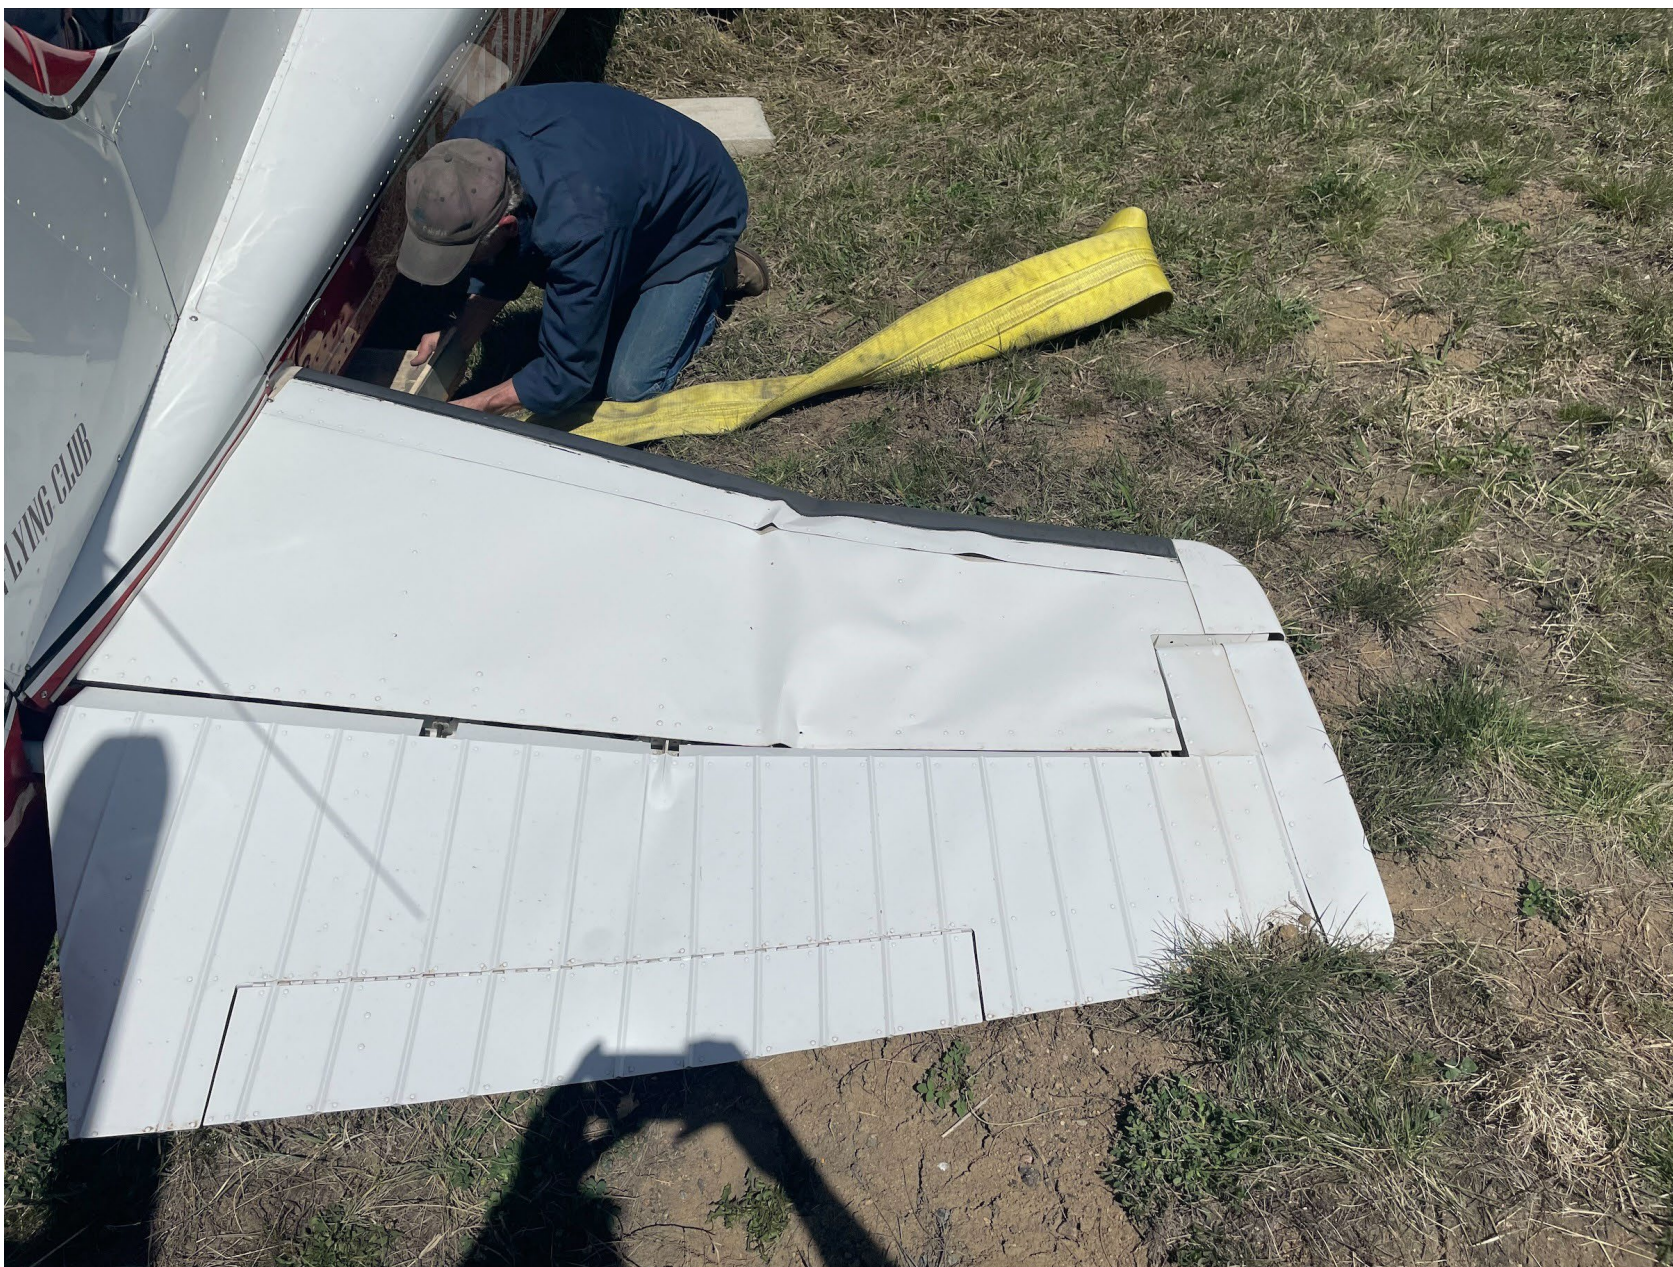
**Photo 1 – Horizontal Stabilizer Damage (Courtesy of South Metro Fire and Rescue)**

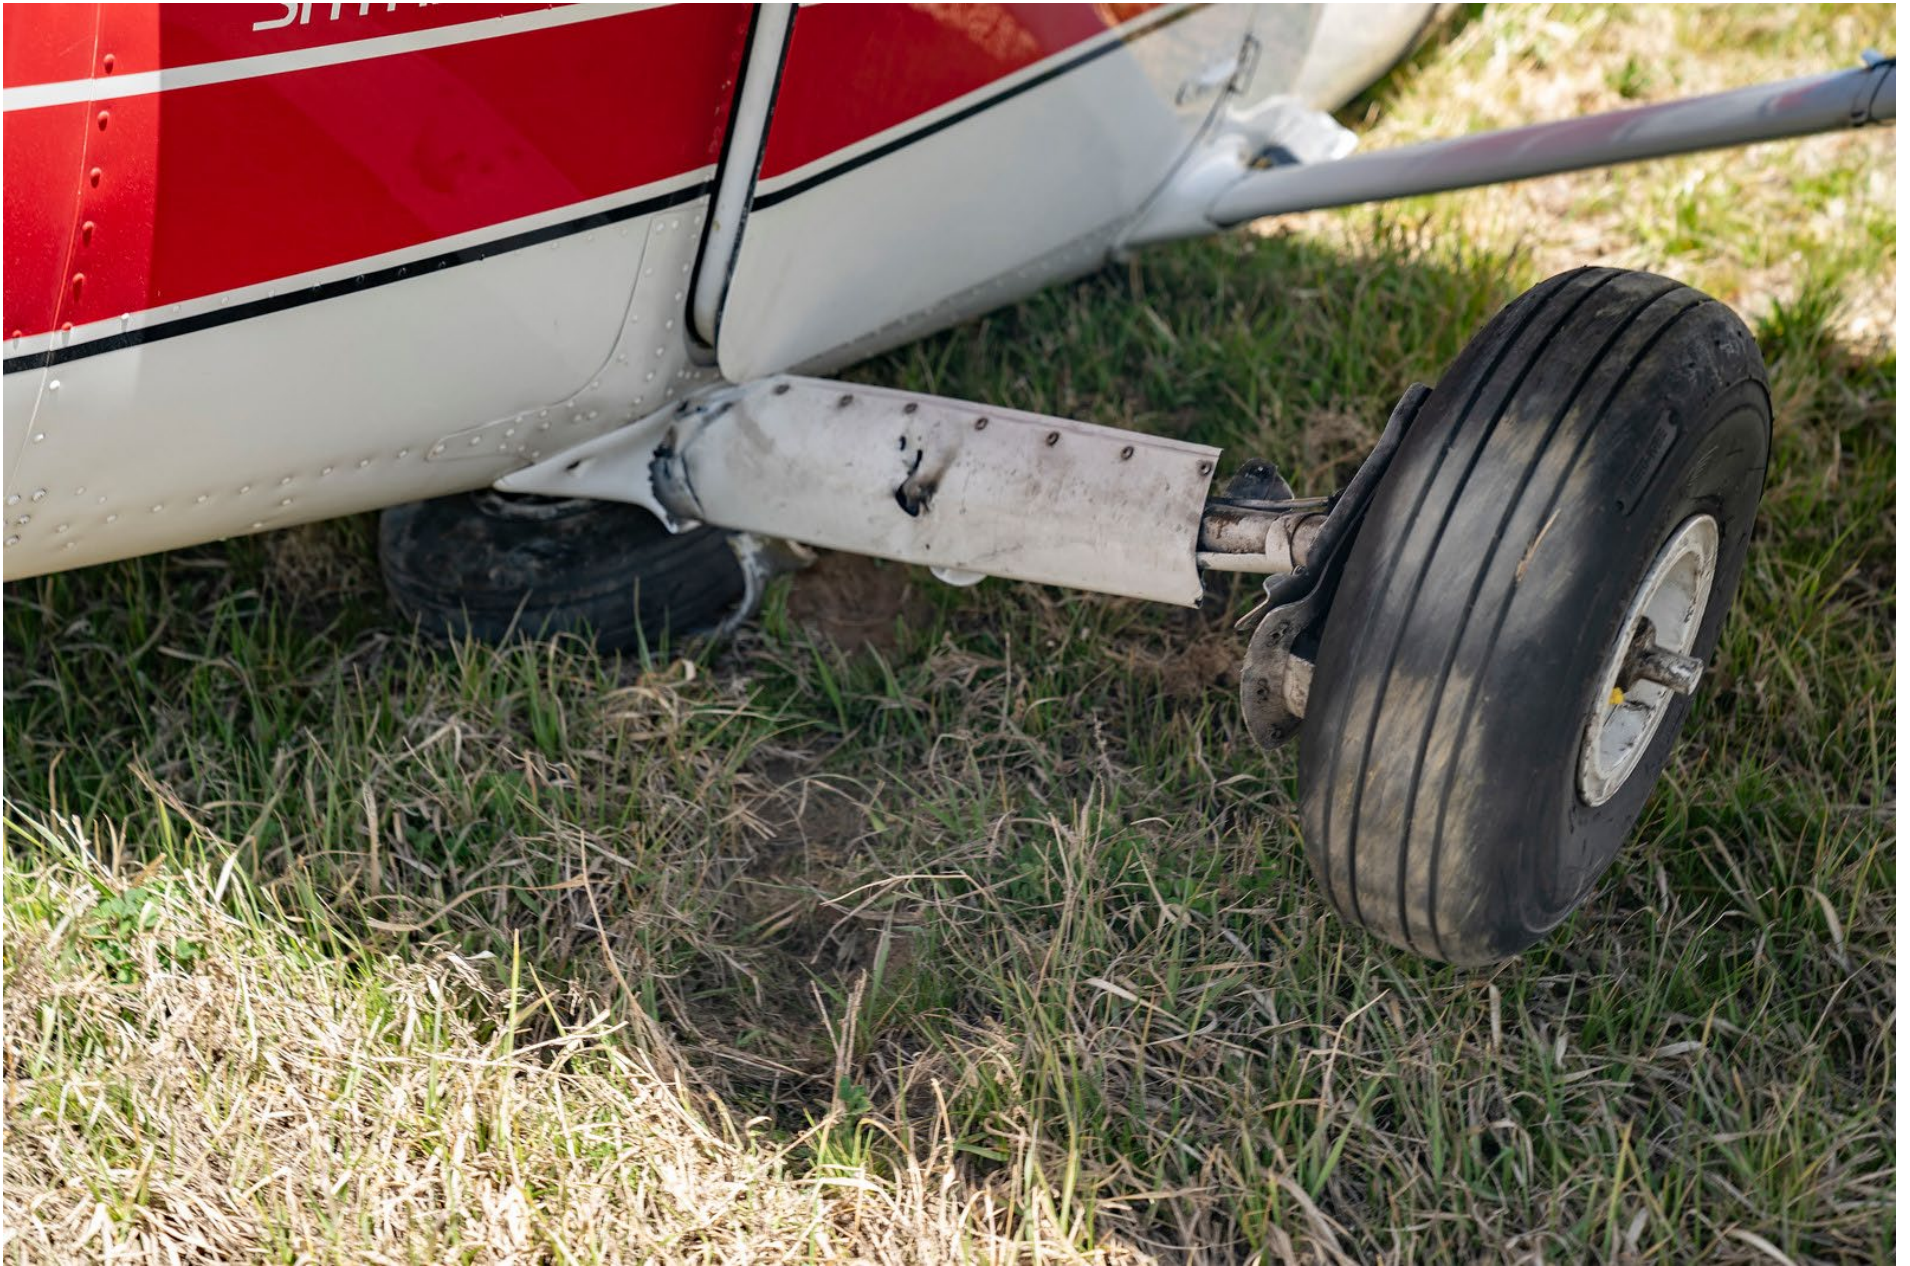
**Photo 2 – Collapsed Landing Gear (Courtesy of South Metro Fire and Rescue)**
