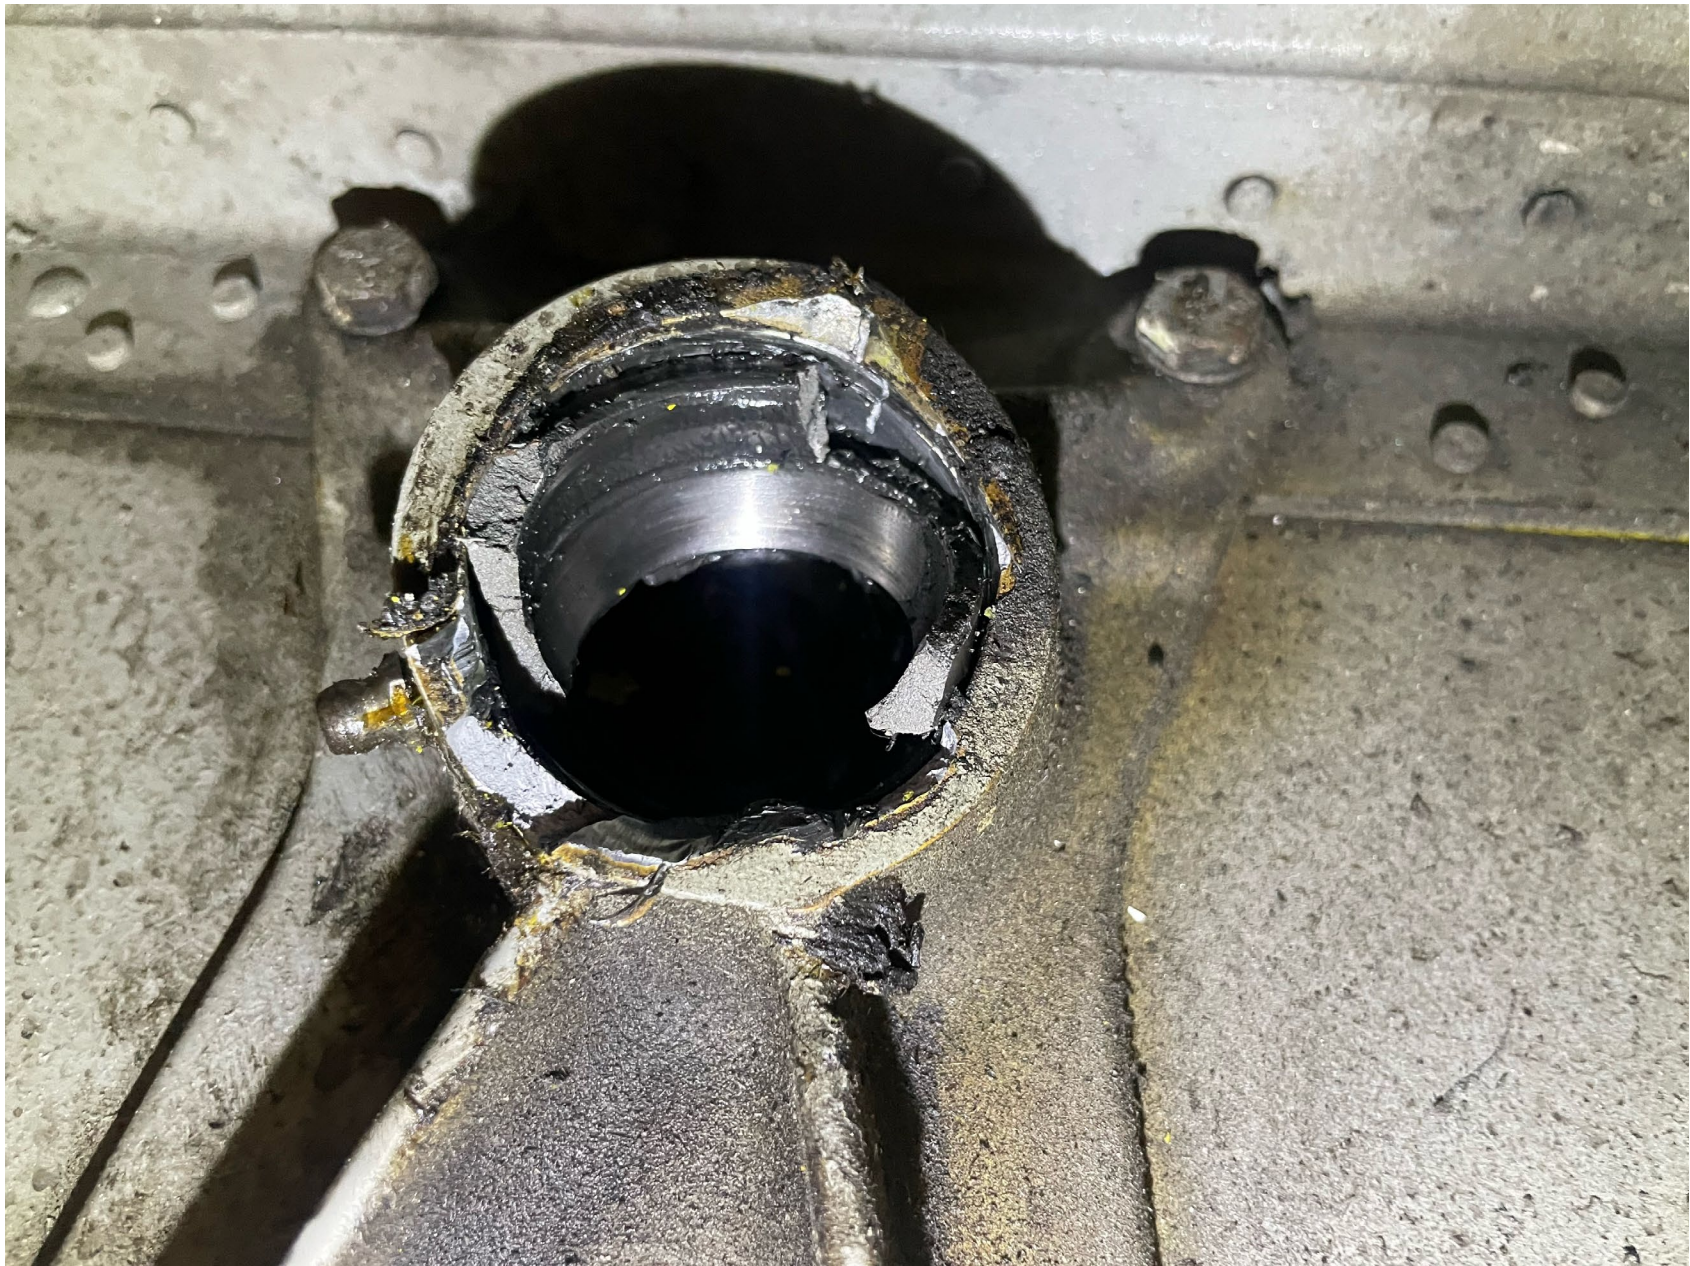
**Photo 1 – Trunnion damage to right main landing gear - Photo courtesy of Federal Aviation Administration (FAA)**

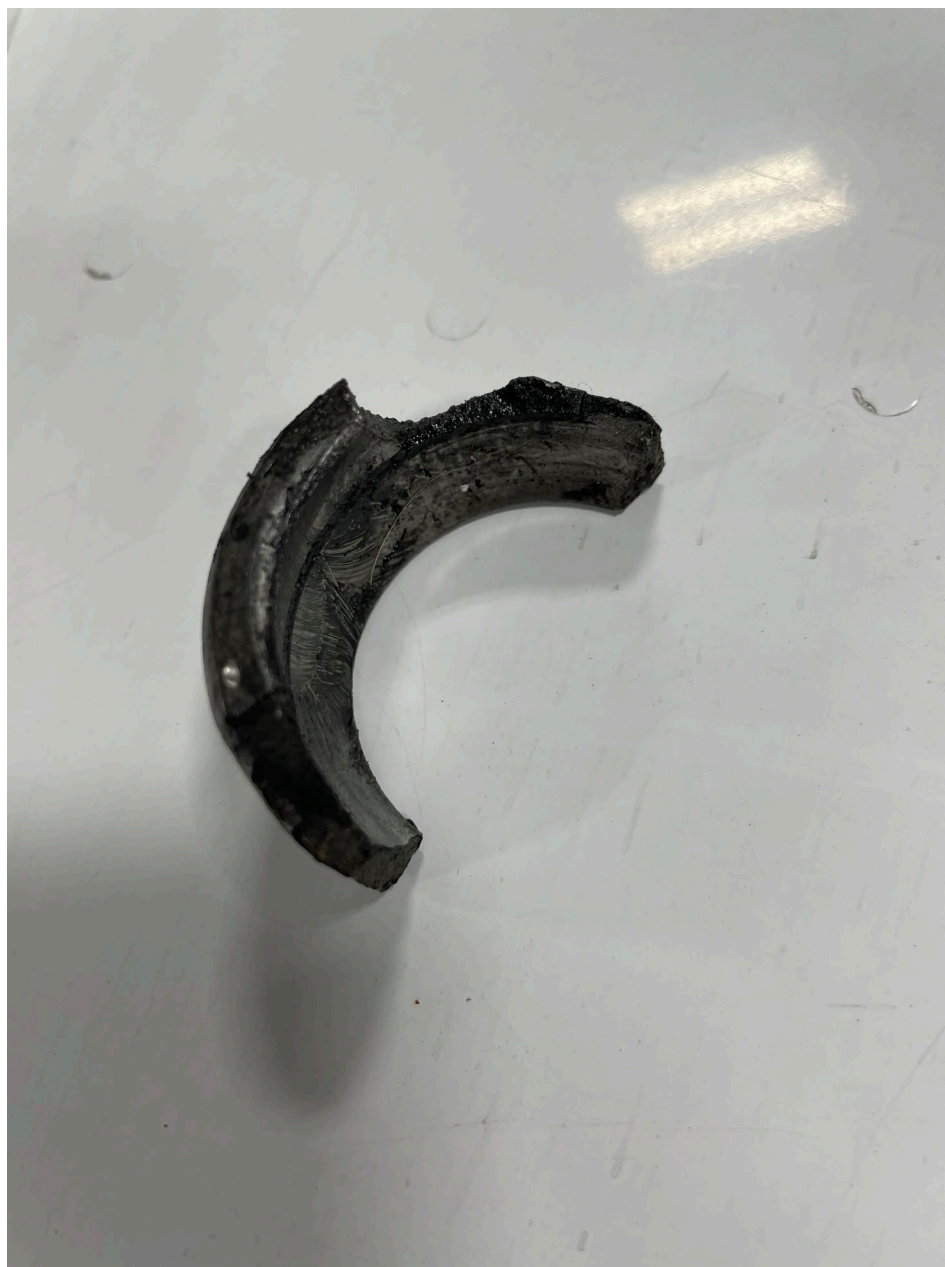
**Photo 2 – Bearing found on runway – Courtesy of FAA**

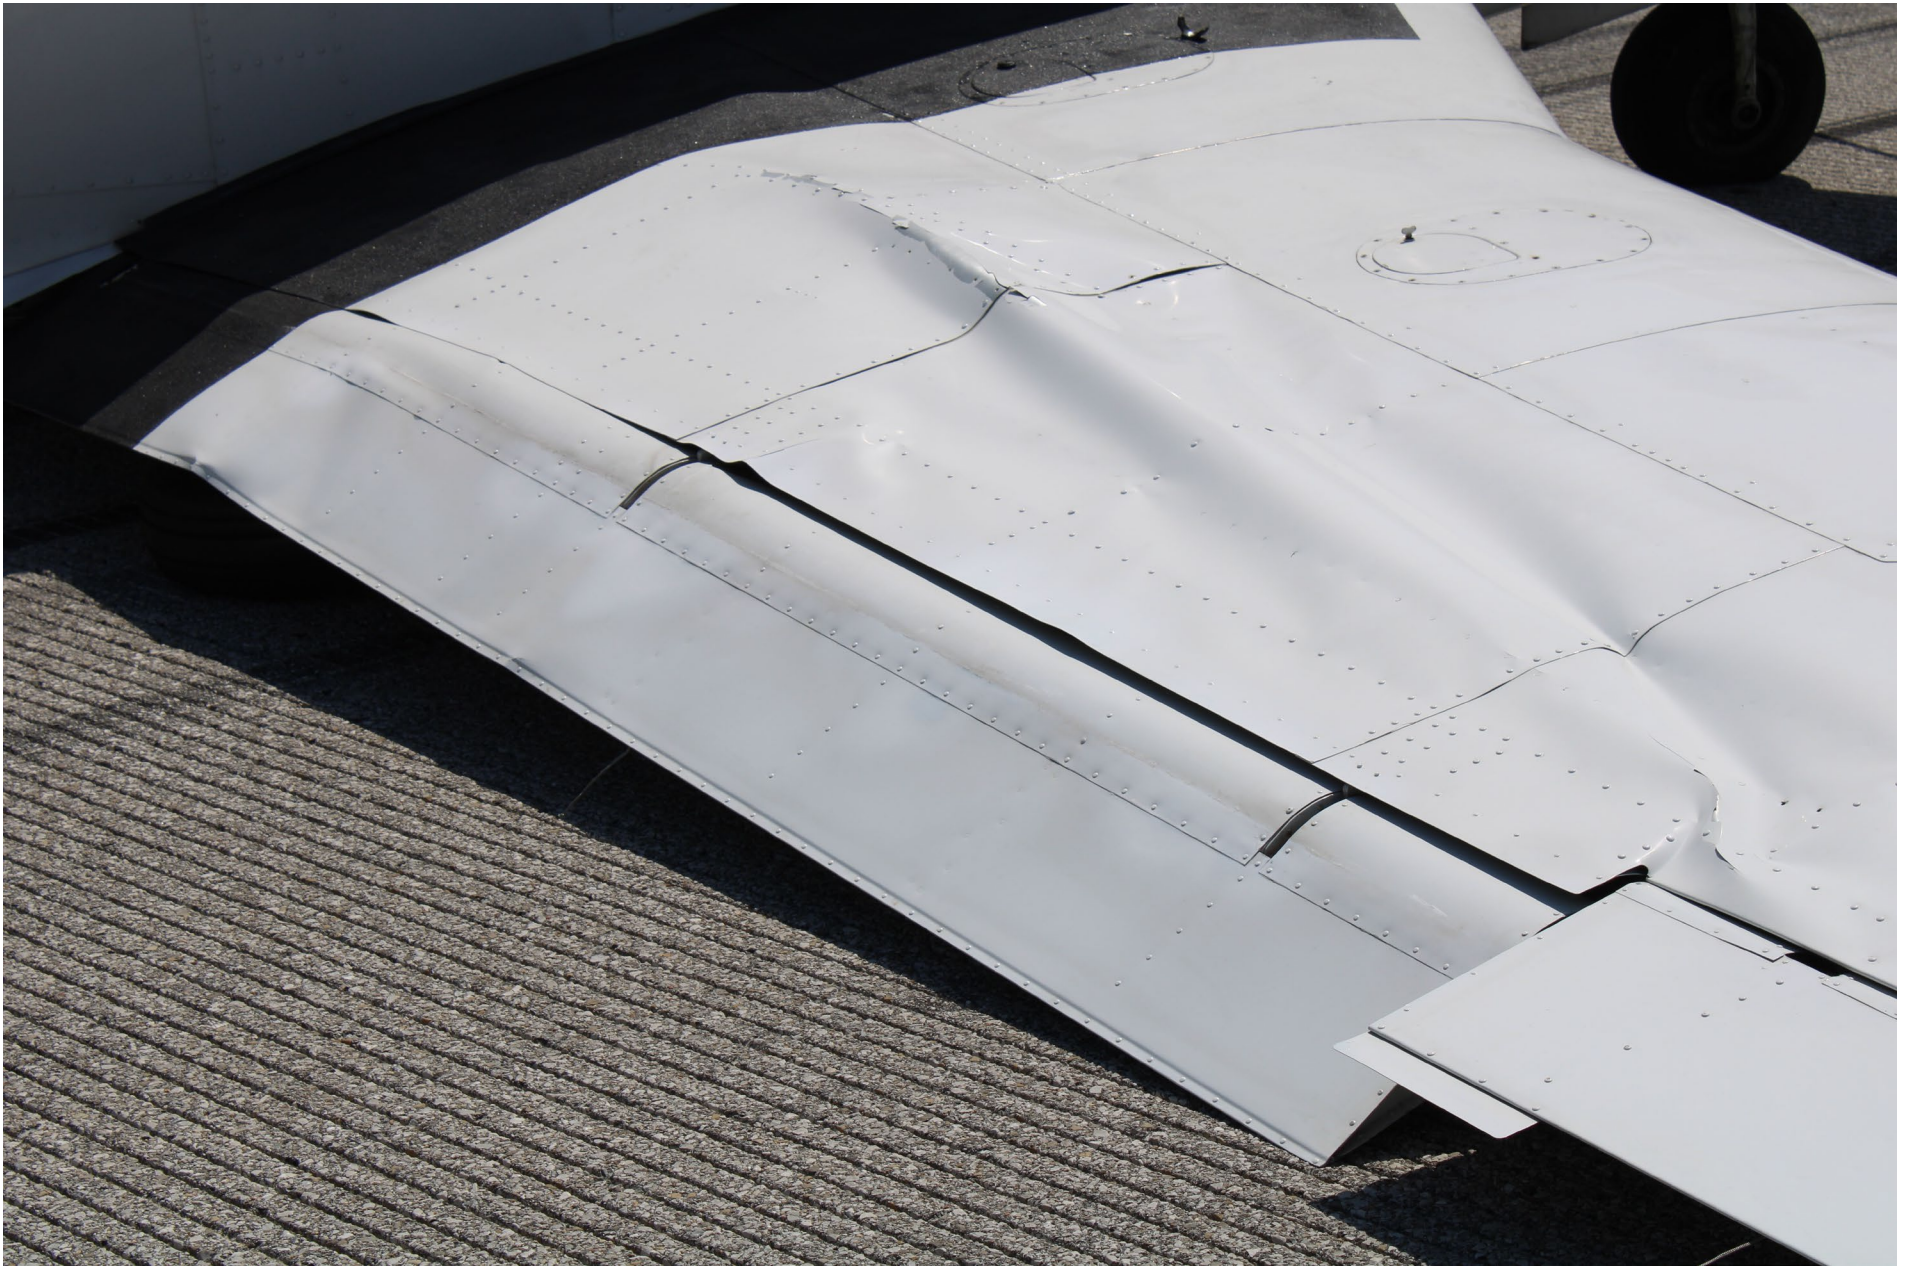
**Photo 3 – Right wing damage**
