CEN22LA186

## INVESTIGATION PHOTOGRAPHS

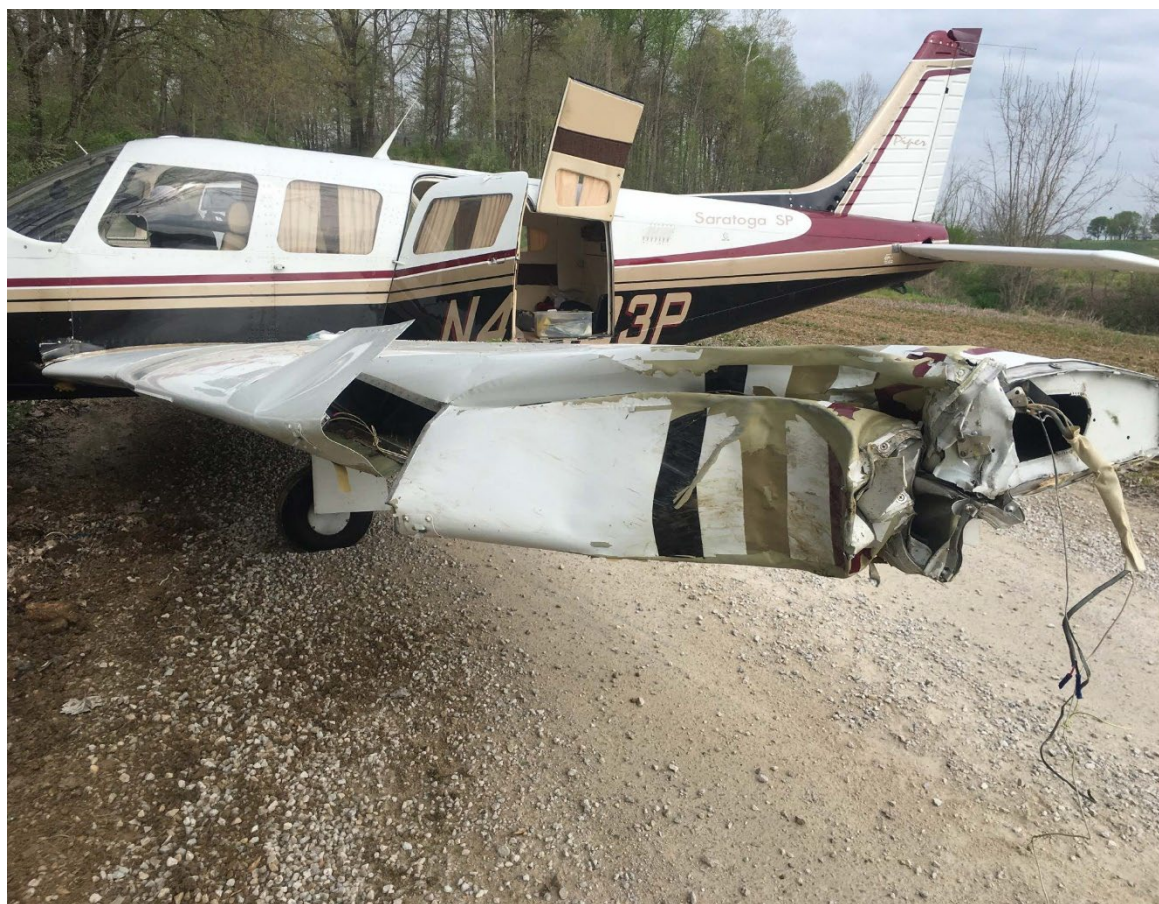
**Photograph 1 - Damage Overview (Courtesy of FAA)**

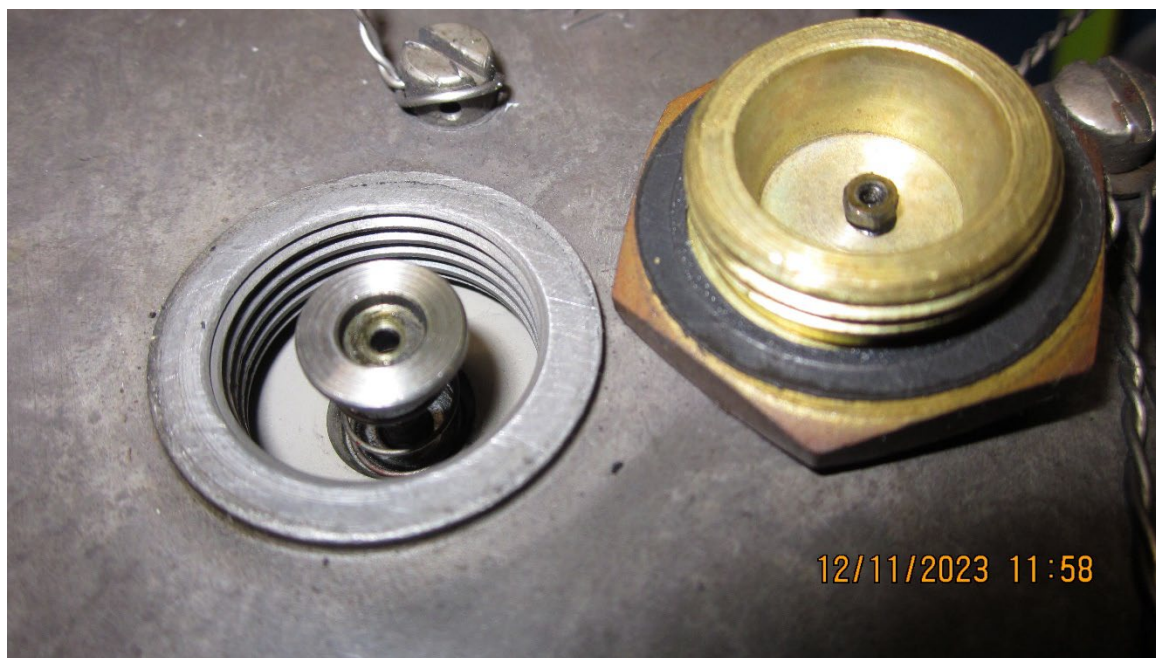
**Photograph 2 - Self Locking Nut (Courtesy of FAA)**
