## RECORD OF CONVERSATION

**Person Contacted: Steven White (FAA Lubbock FSDO – Aviation Safety  
Inspector, Airworthiness)**

**NTSB Case Number: CEN22LA189**

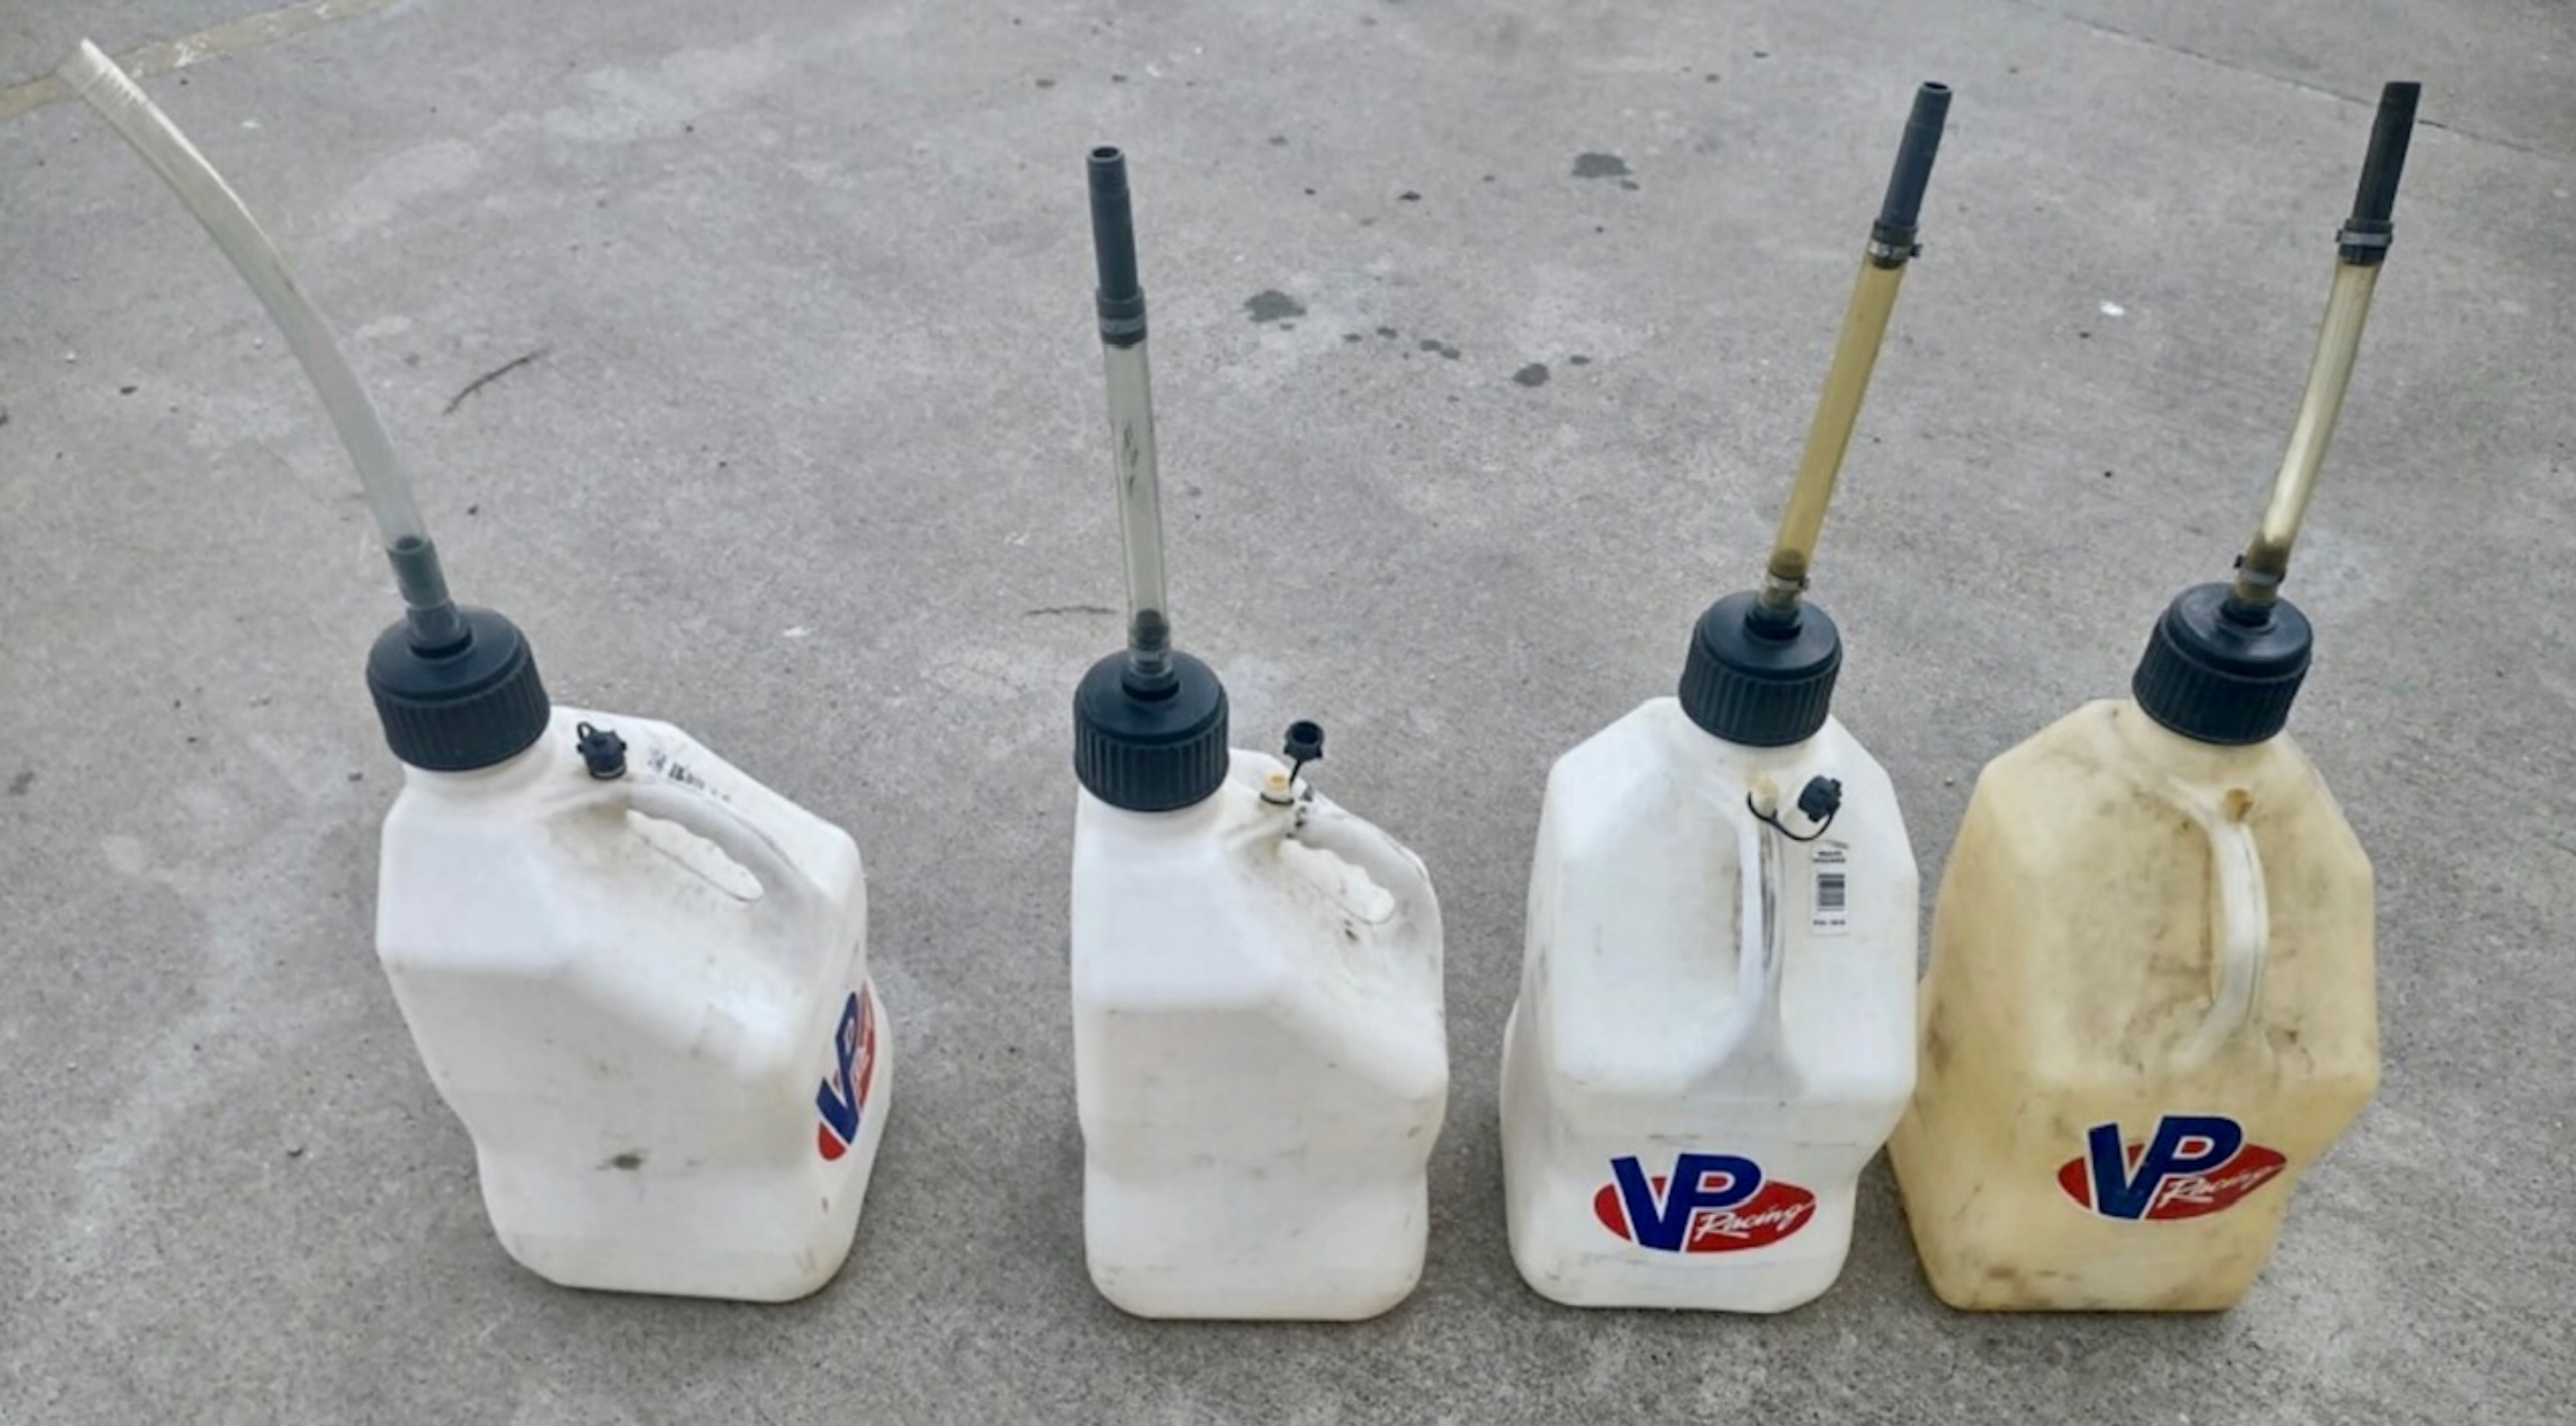
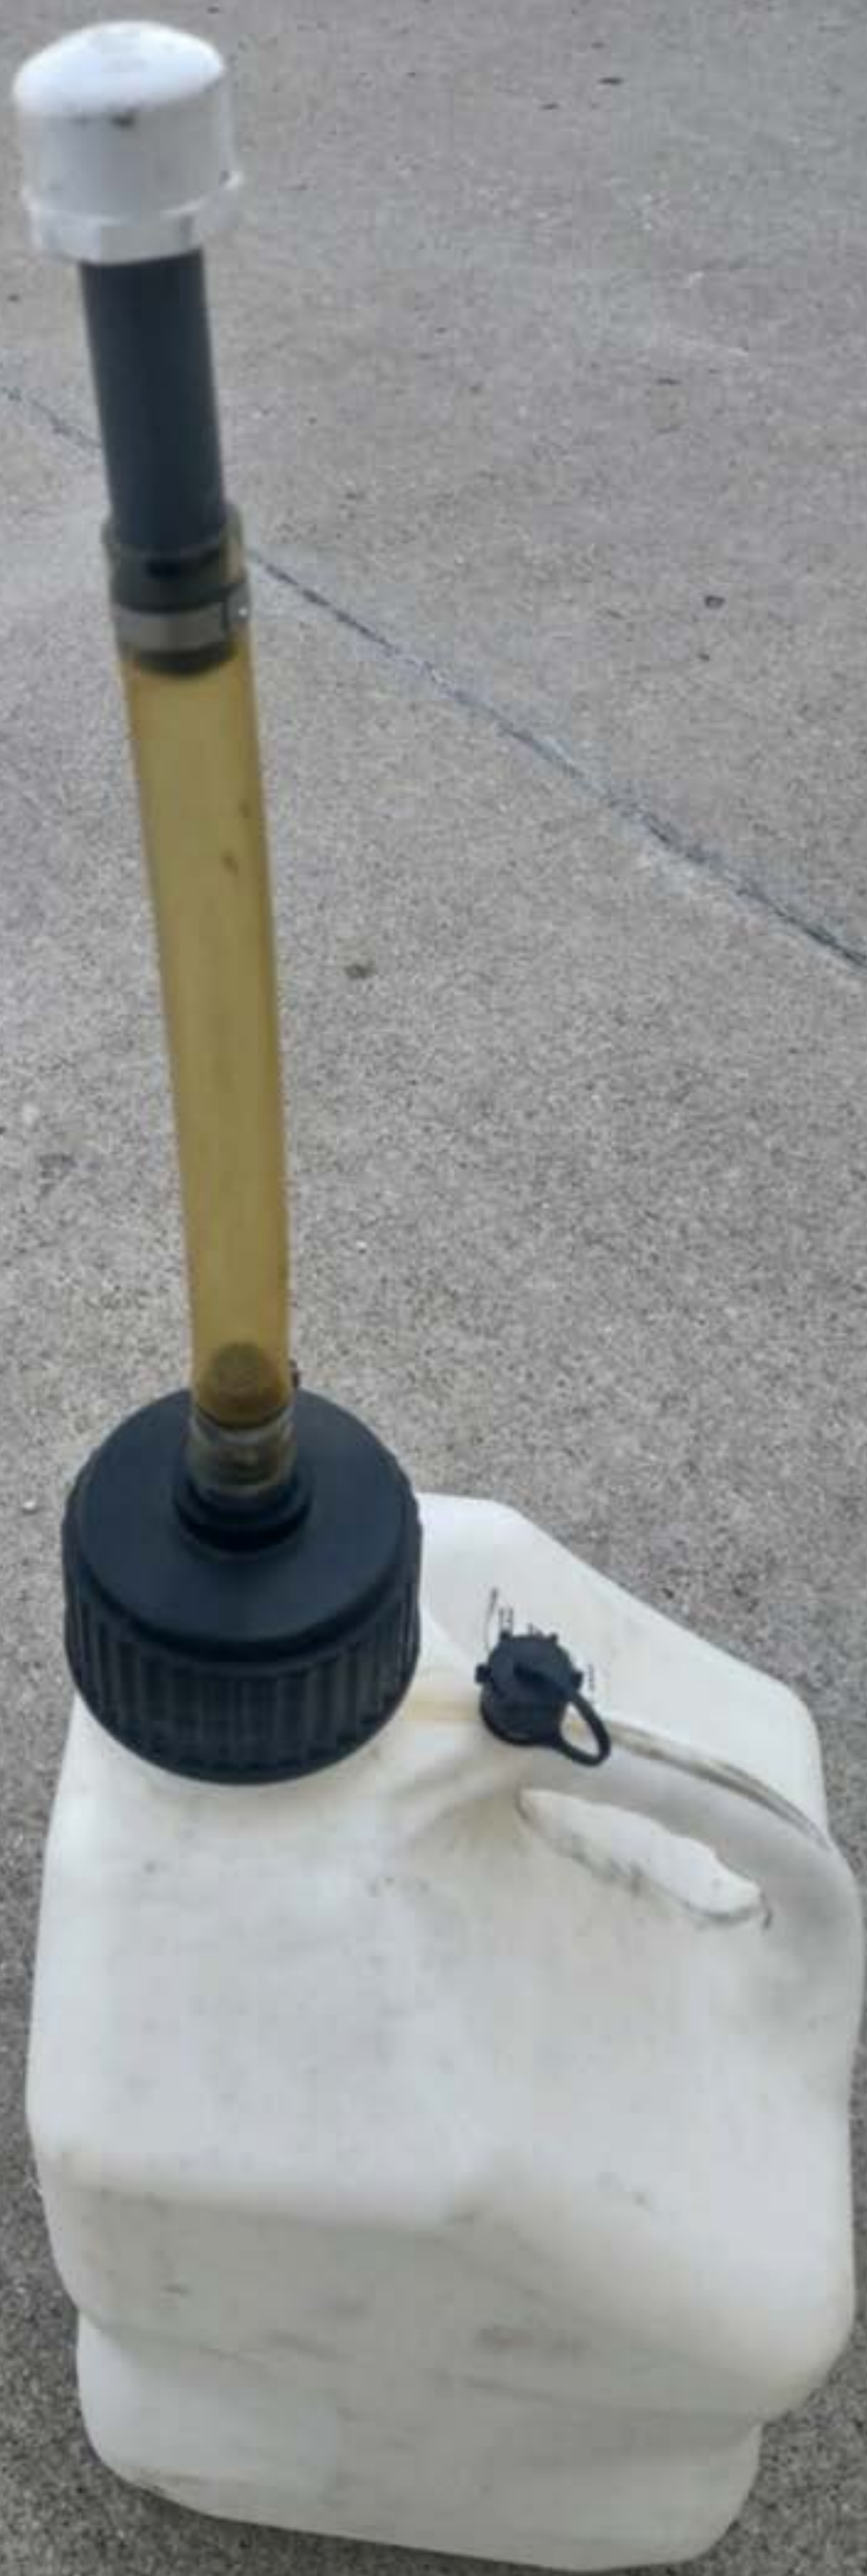
Unfortunately, I don't have any fuel receipt to show for our departure to Brownwood from Majors as it was fuel I added myself. For a few reasons, I sometimes use 100LL from Temple where my brother stores every type of race fuel imaginable, one of those being 100LL. He gets it deeply discounted through his sponsors and gives me twenty gallons at a time when I'm passing through and the best I know to do is show you how the fuel is stored and transported. When fuel was \$3.49 a gallon, a stopped the process all together but now that it's over \$5, I grab twenty gallons every time I can from him. This is also one of the reasons I believe it wasn't a fuel issue that caused our power loss is because I filled each tank to within one inch of the tab (27 gal) on both sides meaning at least 40 gallons. I not only watch the fuel enter but after it's allowed to settle, we sump both sides and it's never shown any contamination.

I remember being surprised the fuel truck didn't top off the tanks like they frequently do for me prior to any departure but both tanks were above the orange range (meaning 13 per side) and then ten was added per side resulting in what should have been over 40 gallons.
