## **NATIONAL TRANSPORTATION SAFETY BOARD**

# **NOSE GEAR EXAMINATION**

**CEN22LA191**

Location: Mankato, MN  
Date: May 3, 2022  
Aircraft: Vans RV-6A, N5060  
NTSB IIC: Samantha Link

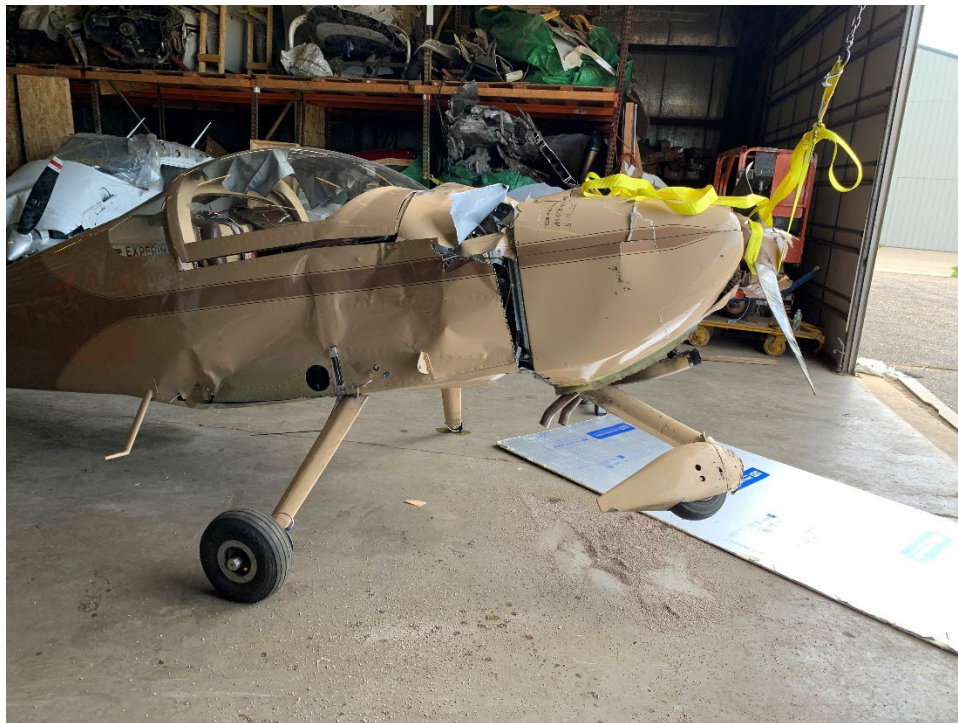
Figure 1: Right side of Nose Gear

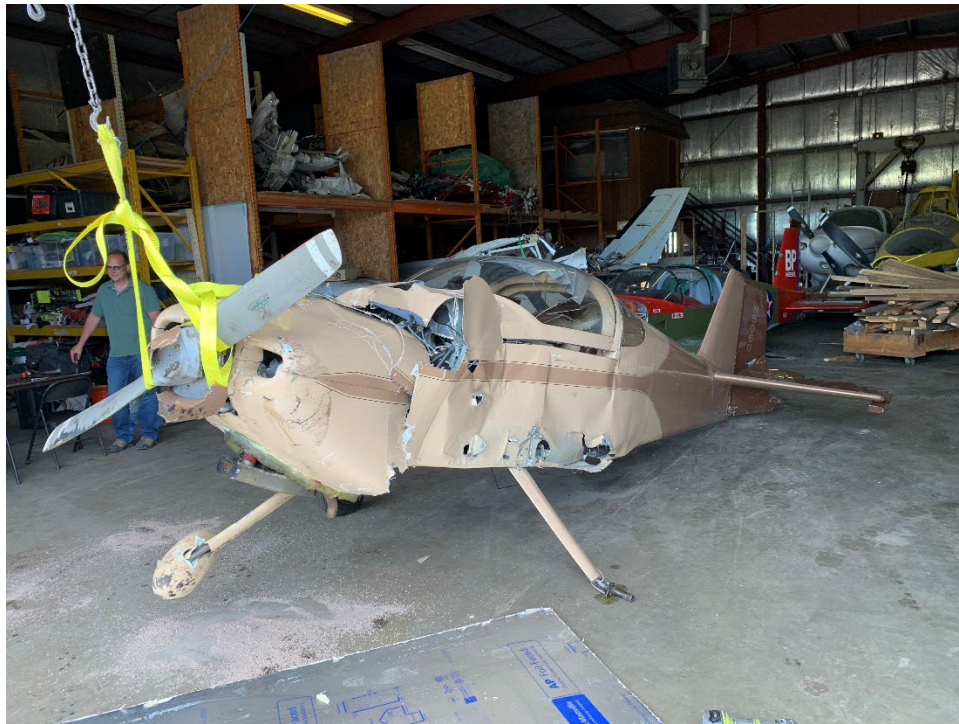
Figure 2: Left side of Nose Gear

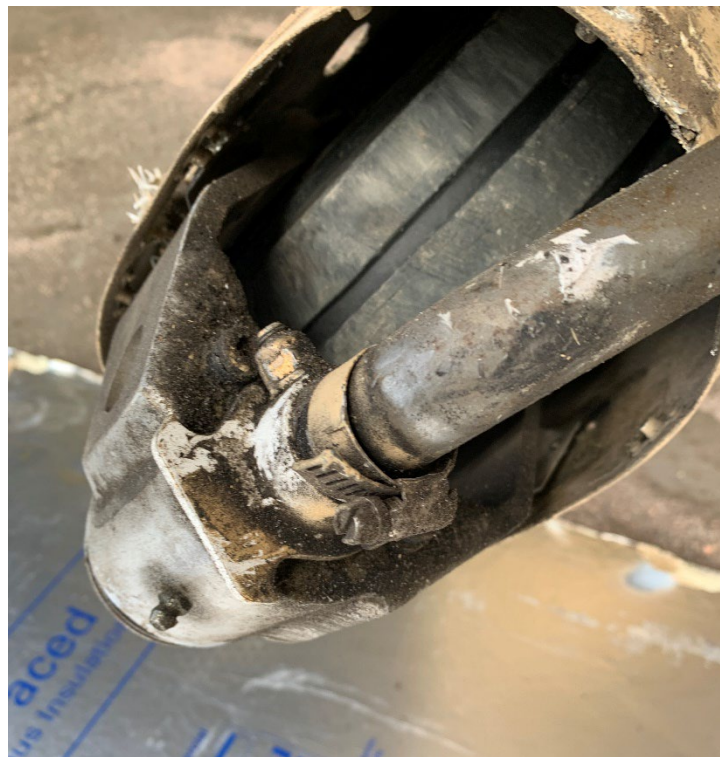
- The tension was consistent with normal.
- The nosewheel fork height was 2.8 inches.
- The nose stop flange was installed correctly per Van's Aircraft service bulletin 14-12-22.
  - The nose stop flange appeared trimmed to avoid interference with nose wheel pant.
- Breakaway tension from neutral to the left was 24-26 pounds.
- Breakaway tension from neutral to the right was 22-25 pounds.
- The spring washers were removed:
  - Grease was noted on the washers.
  - Some rust was noted in the internal space between the two washers but was otherwise unremarkable.
- The nosewheel fork was removed and was unremarkable.
- The underside of the nose stop flange exhibited wear.

Figure 3: Nose Stop Flange

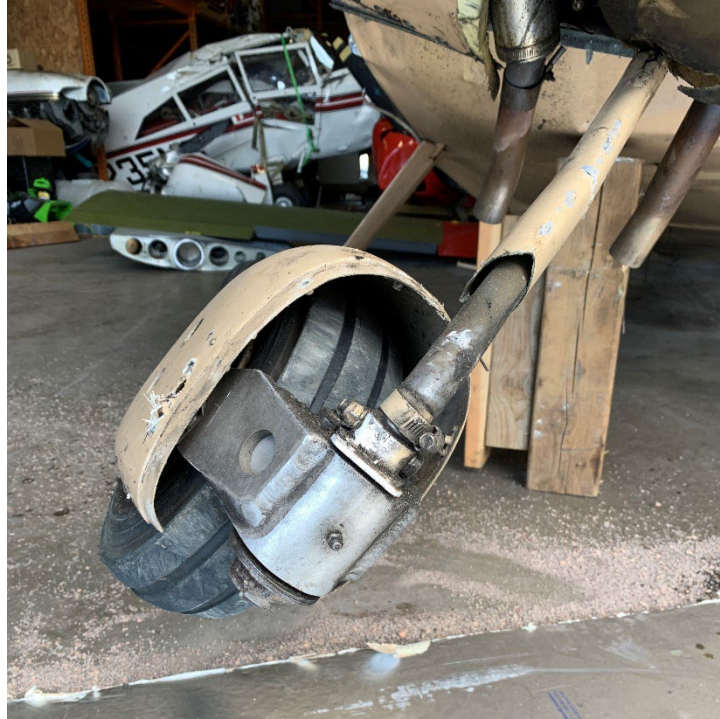
Figure 4: Front of Nose Gear

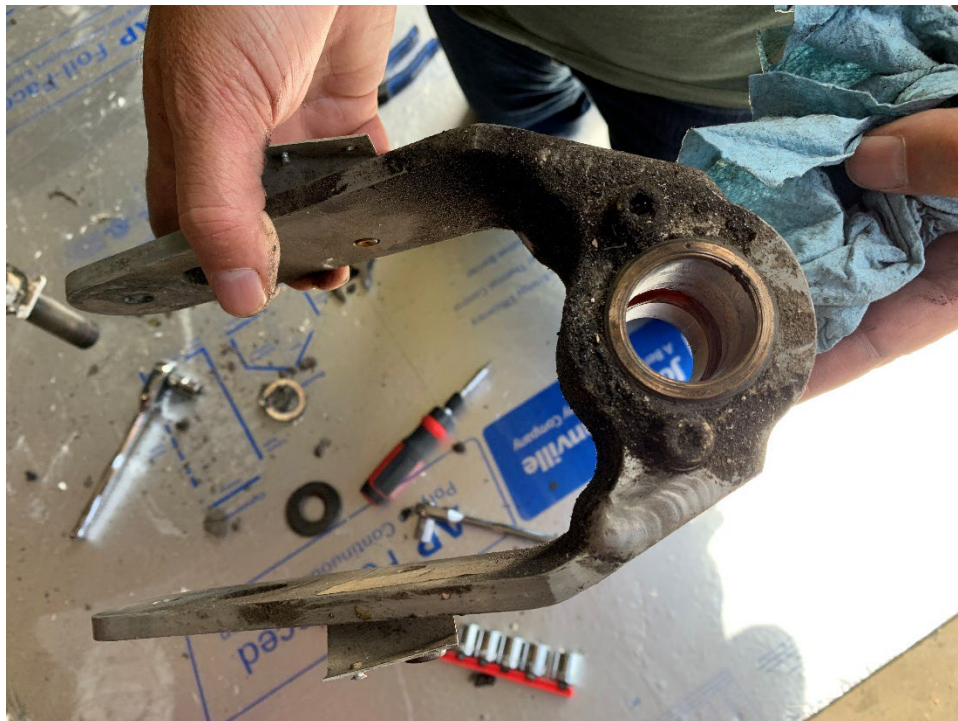
Figure 5: Nose Gear Fork
