CEN22LA202

## INVESTIGATION PHOTOGRAPHS

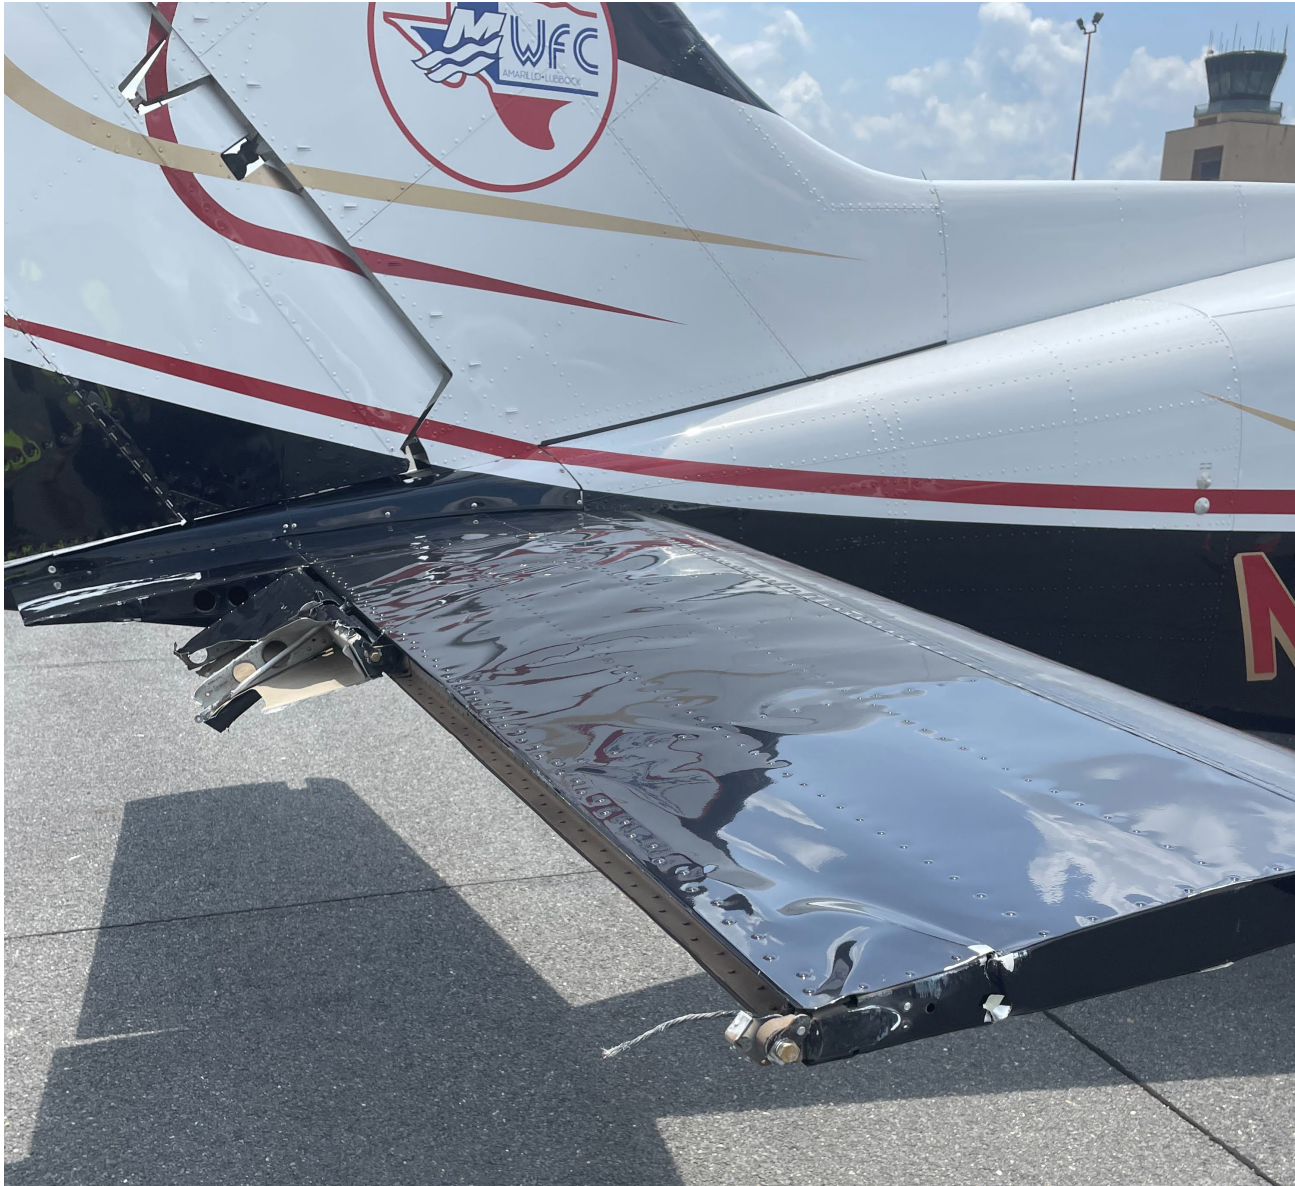
**Photograph 1 - Partially separated elevator (Courtesy of FAA)**

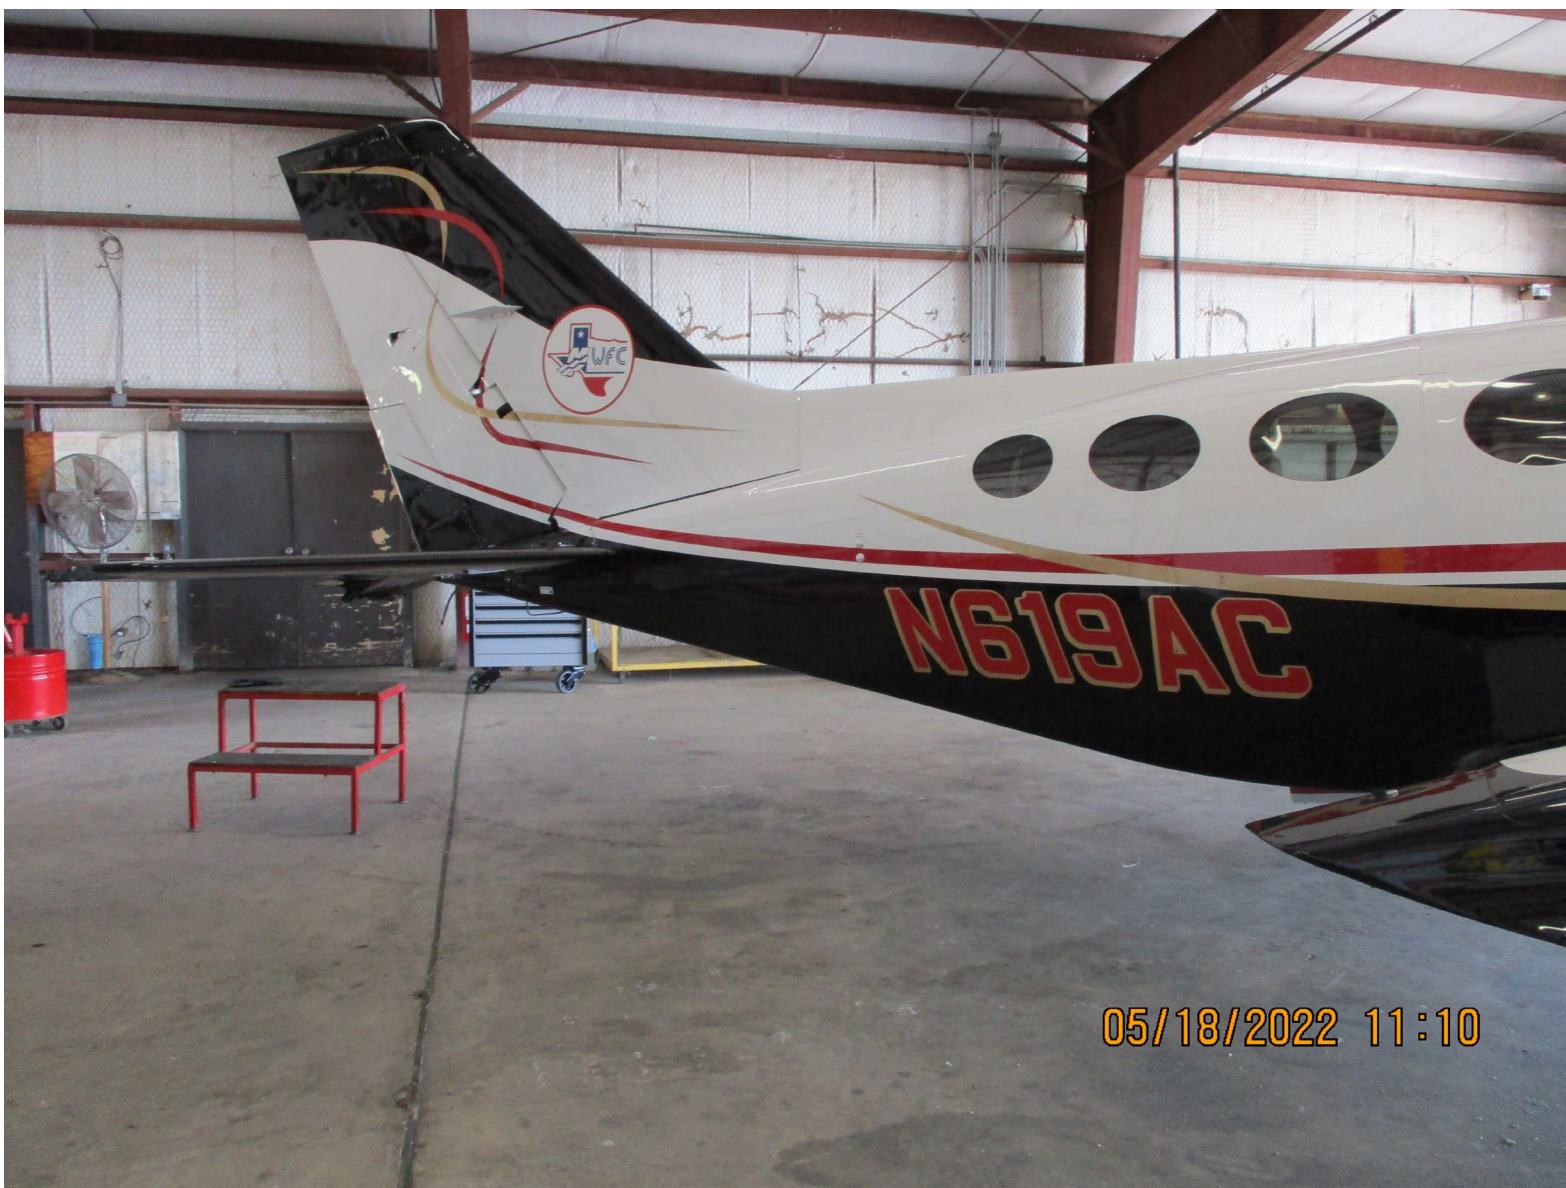
**Photograph 2 - Right side rudder damage (Courtesy of FAA)**

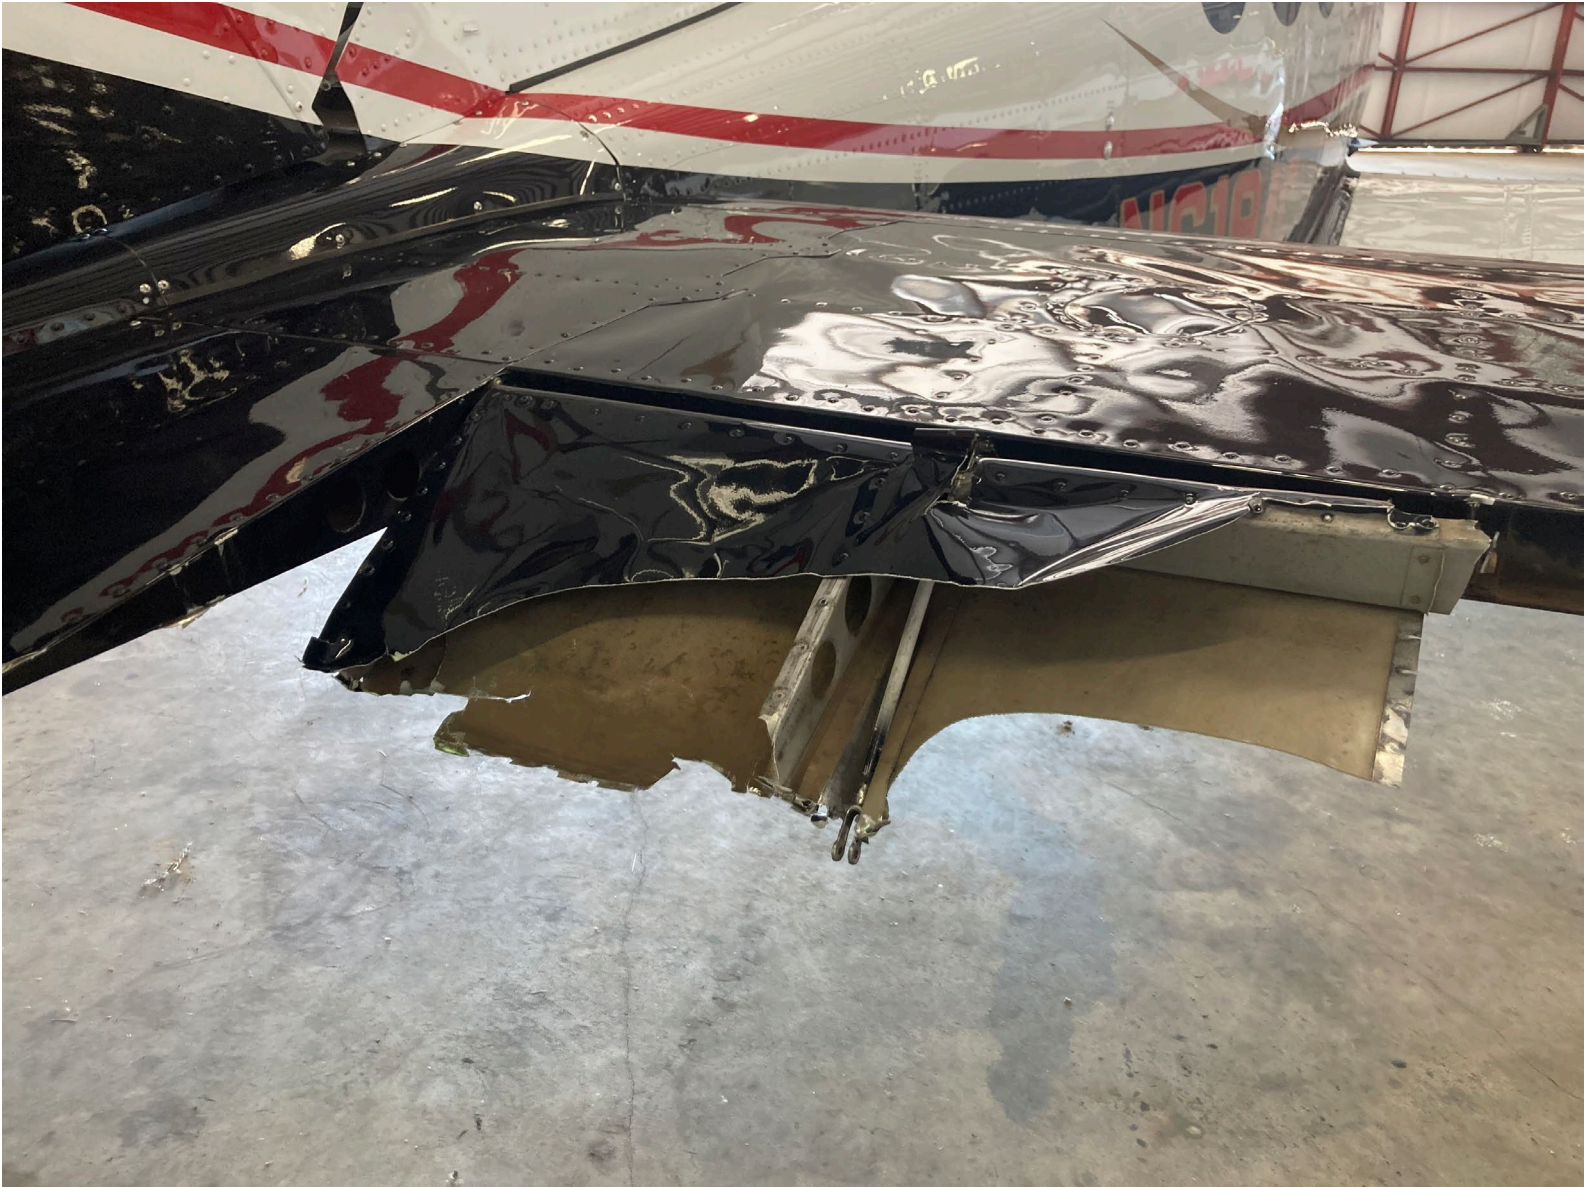
**Photograph 3 - Partially separated elevator (Courtesy of FAA)**

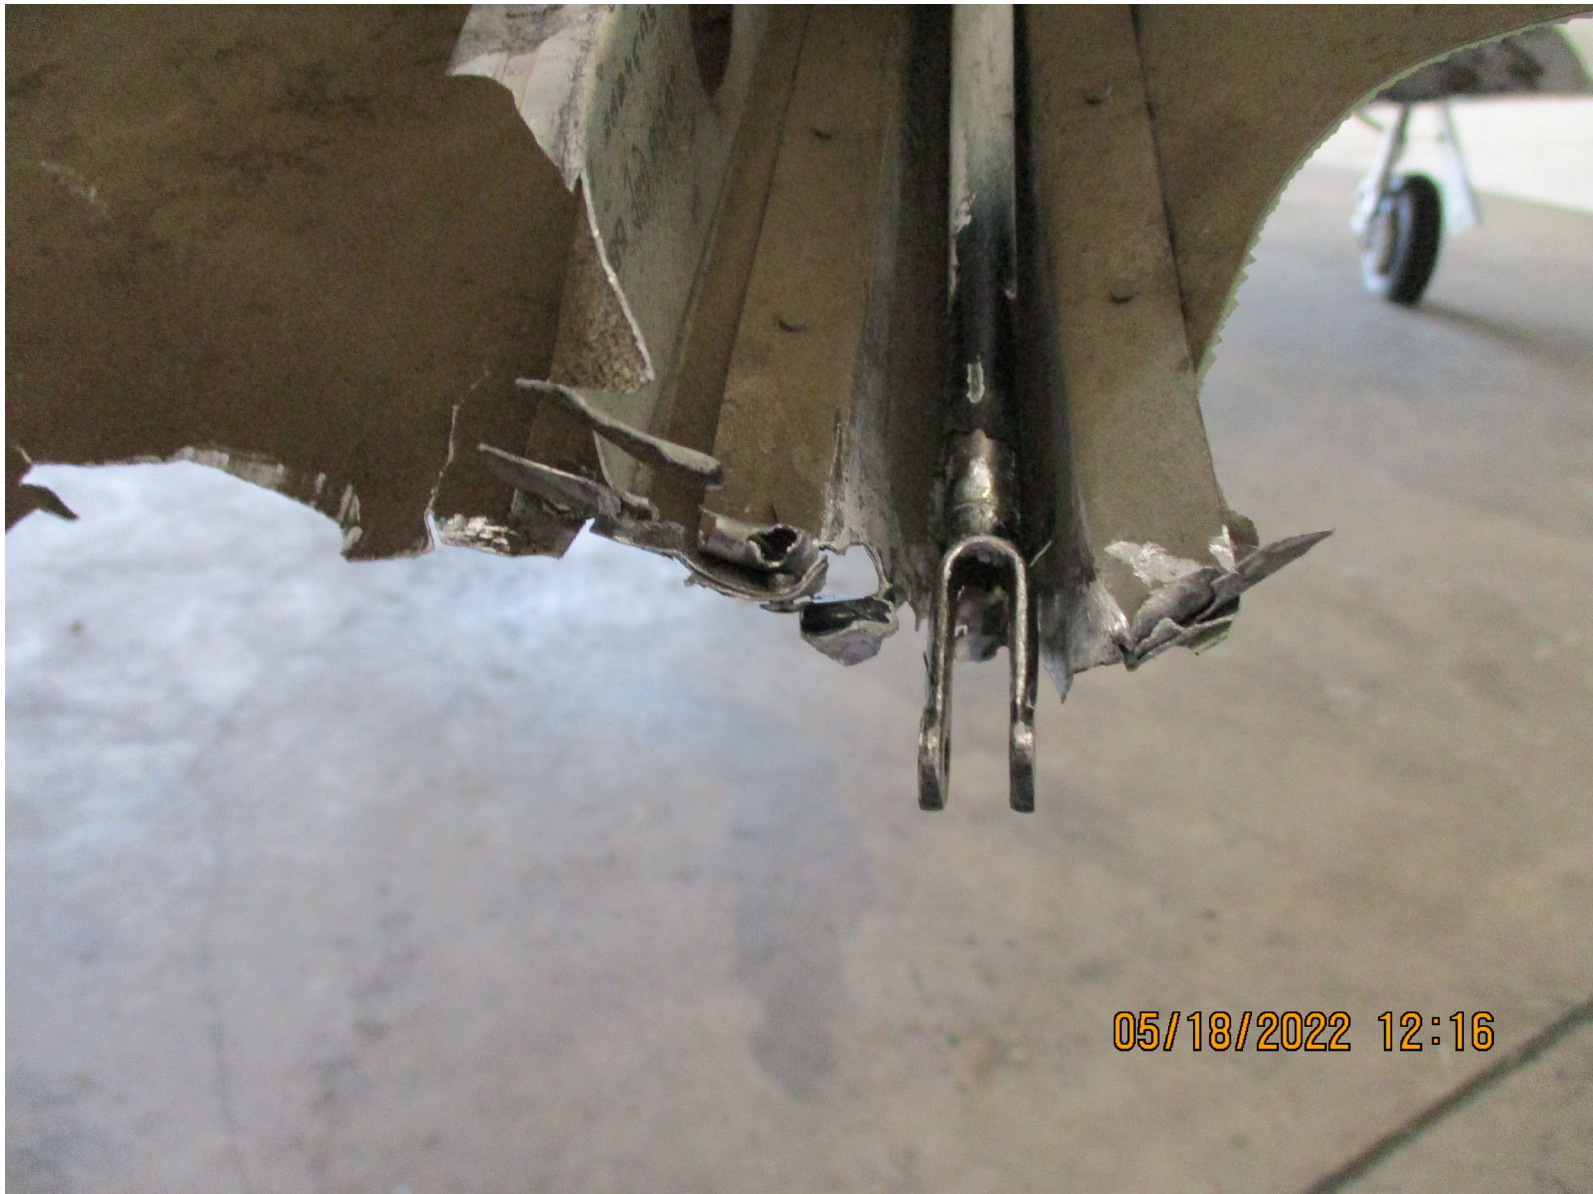
**Photograph 4 - Elevator trim push-pull tube with hardware missing (Courtesy of FAA)**
