**NATIONAL TRANSPORTATION SAFETY BOARD**

**INVESTIGATION SUMMARY**

**CEN22LA202**

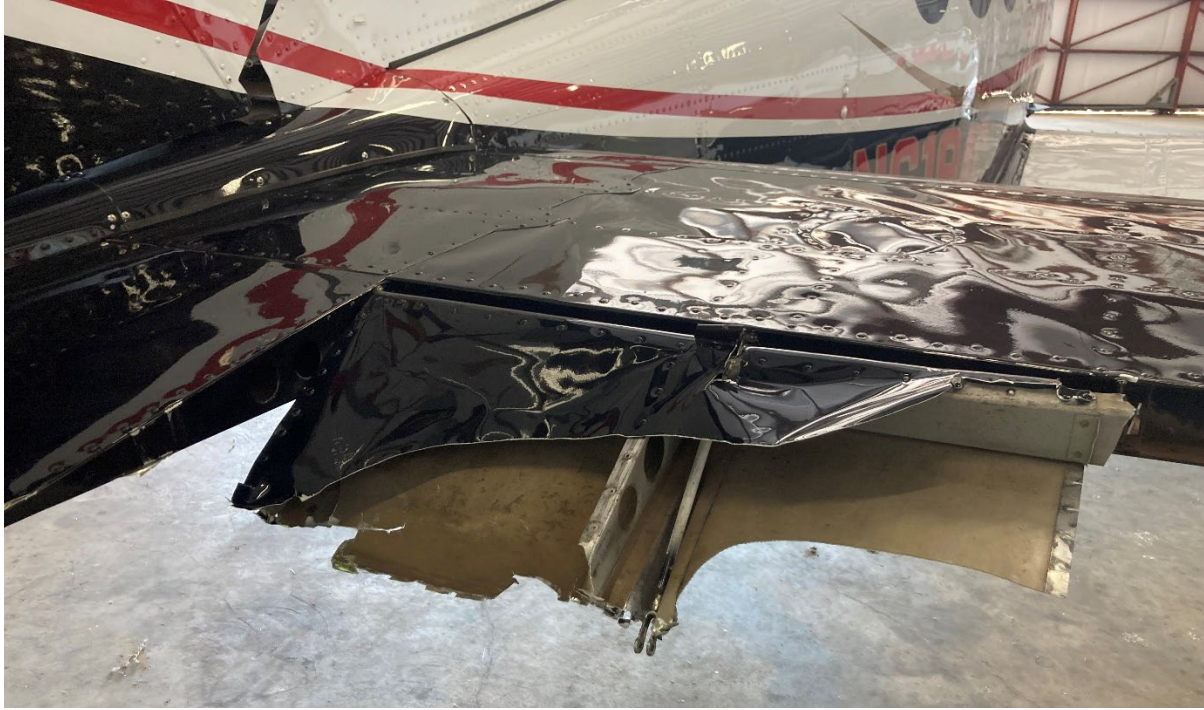
A postaccident examination of the airplane by the FAA revealed that the right elevator had mostly separated from the horizontal stabilizer. There was a small puncture on the right side of the rudder. A small portion of the elevator remained attached, as seen in Figure 1.

Figure 1. Right elevator partially separated.

The elevator trim push rod remained attached to the trim actuator; however, there was no bolt, nut, or cotter pin attached to the aft fork connection and the trim tab was missing. The pushrod did not exhibit any preaccident damage or anomalies. The remainder of right elevator and trim tab were not recovered.

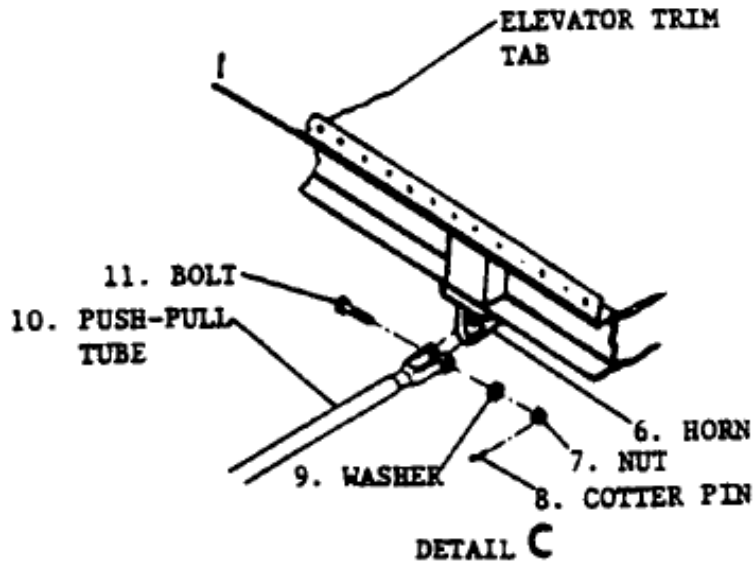
Figure 1. Cessna 421 service manual excerpt, elevator trim diagram

According to the maintenance personnel, the maintenance squawk stated that the trim tab was not in the proper position. They thought maybe the control rod arm was bottoming out inside, maybe bent. They confirmed it was not bent but needed to be re-rigged. They used the Cessna 421 maintenance manual to complete this task. The mechanic with inspector authorization (IA) was present during this work. His mechanics removed the bolt on the actuator, and he helped re-rig the trim system. The IA physically set the trim tab in the neutral position and set the trim indicator in the takeoff position. He did not check to make sure the bolt was re-installed and was cotter pinned. He checked everything else but missed that step.
