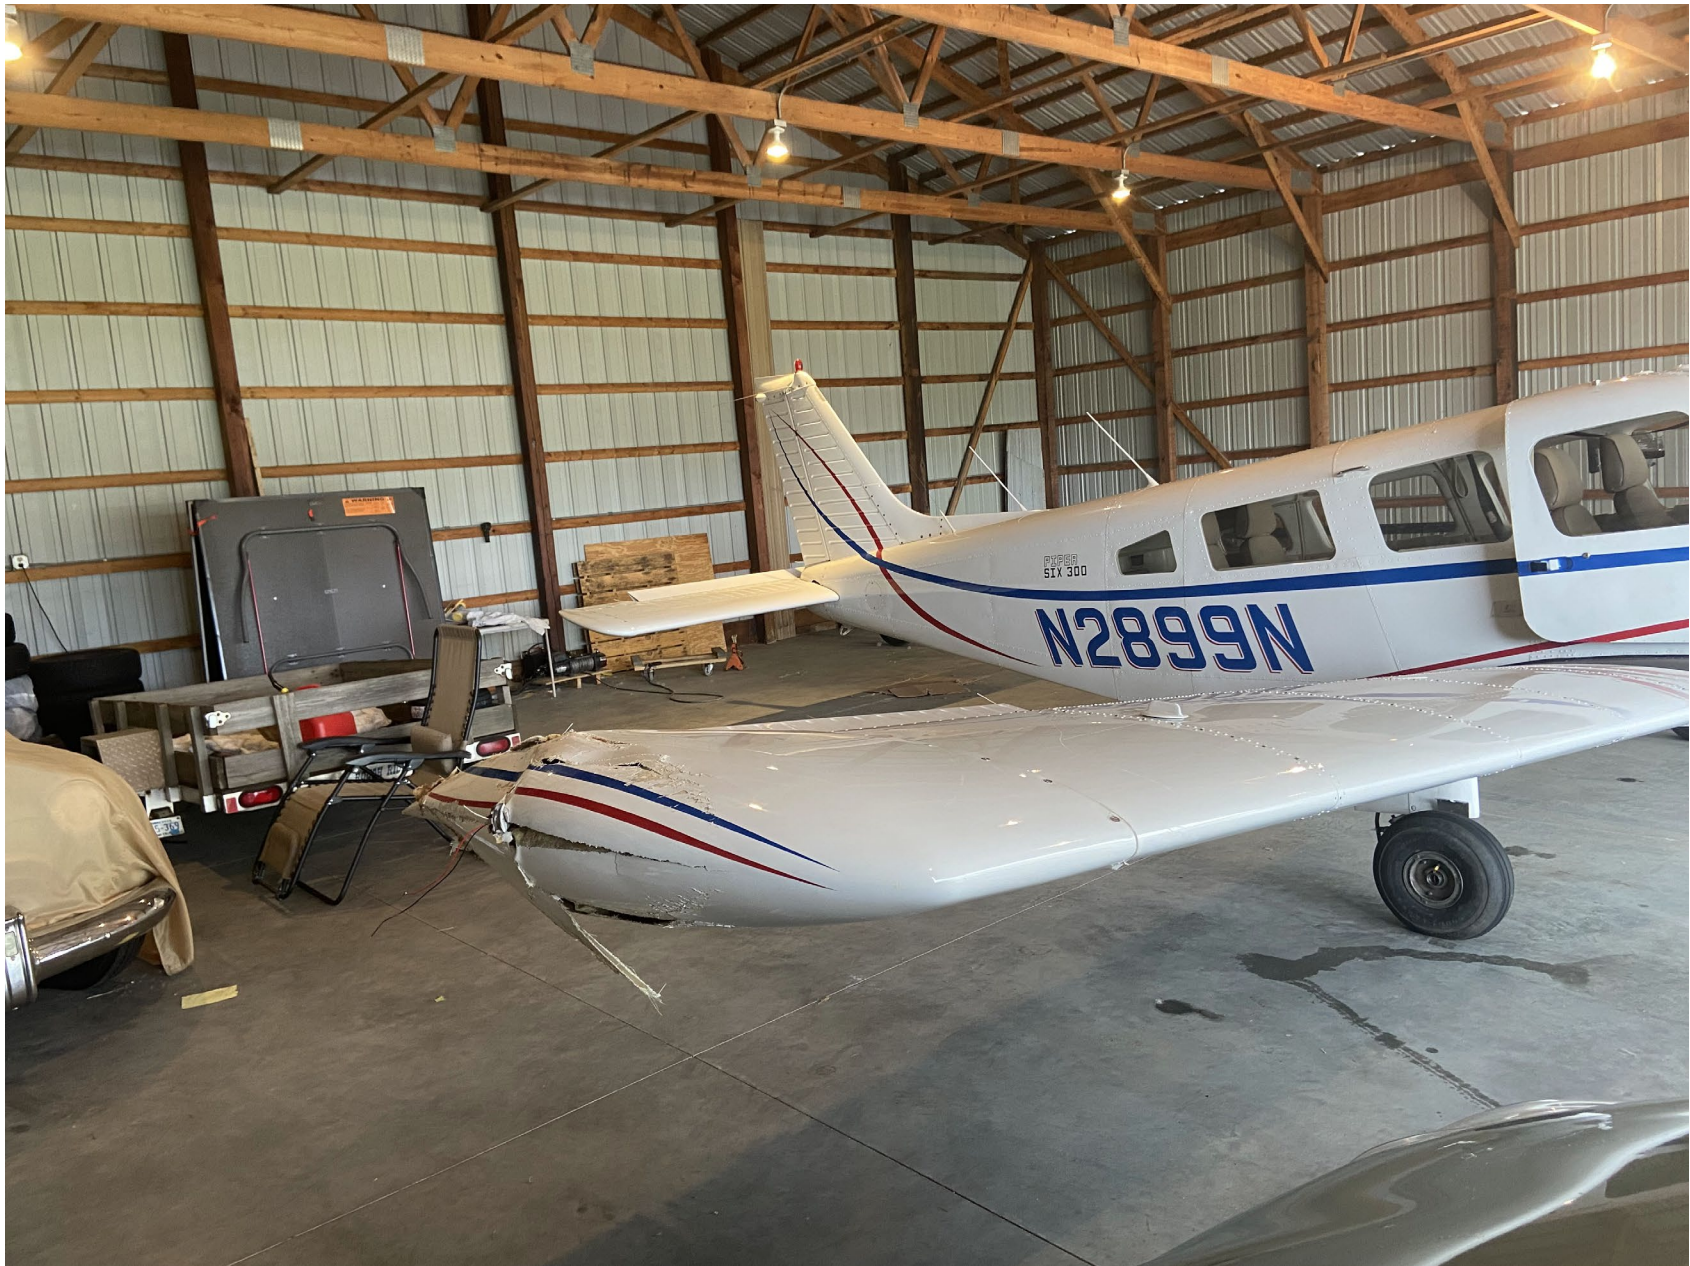
**Photo 1 – Right wing damage**

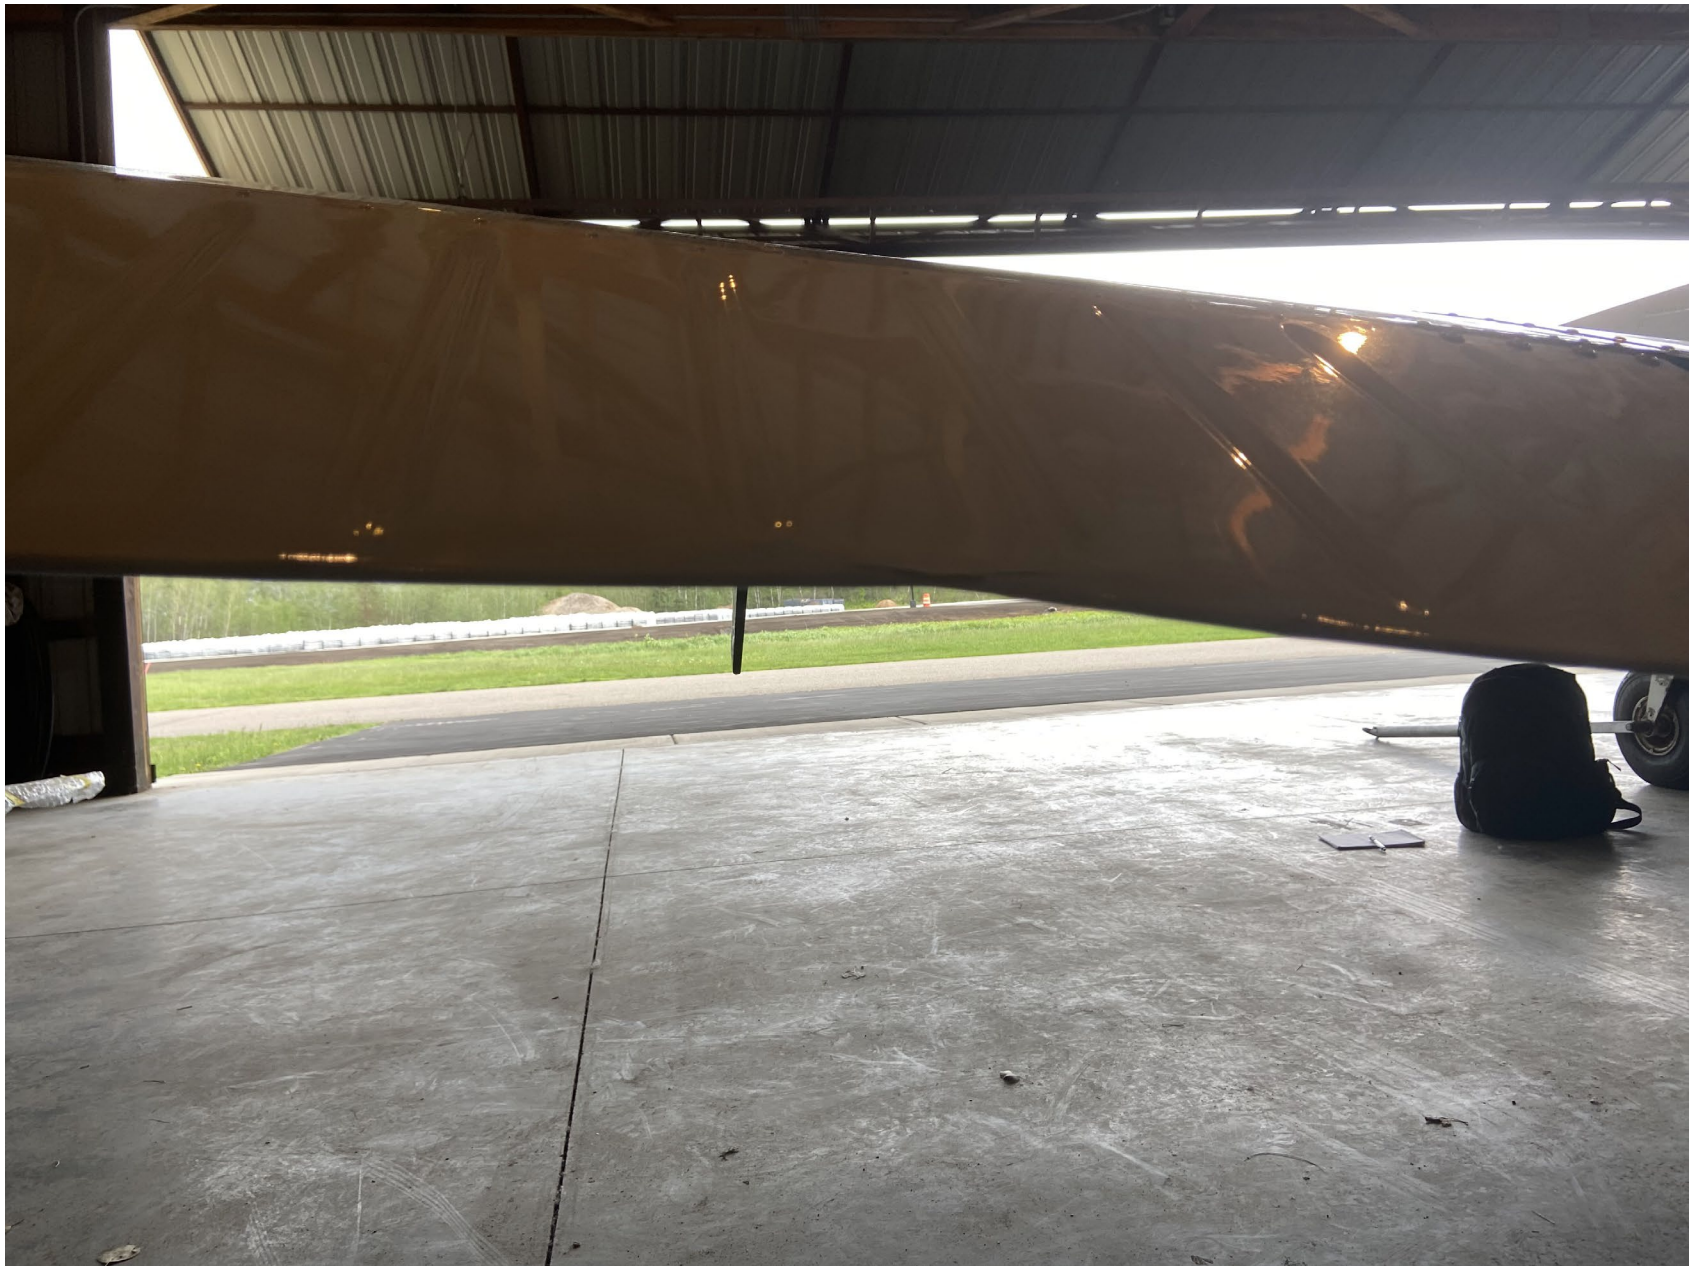
**Photo 2 – Left aileron damage**
