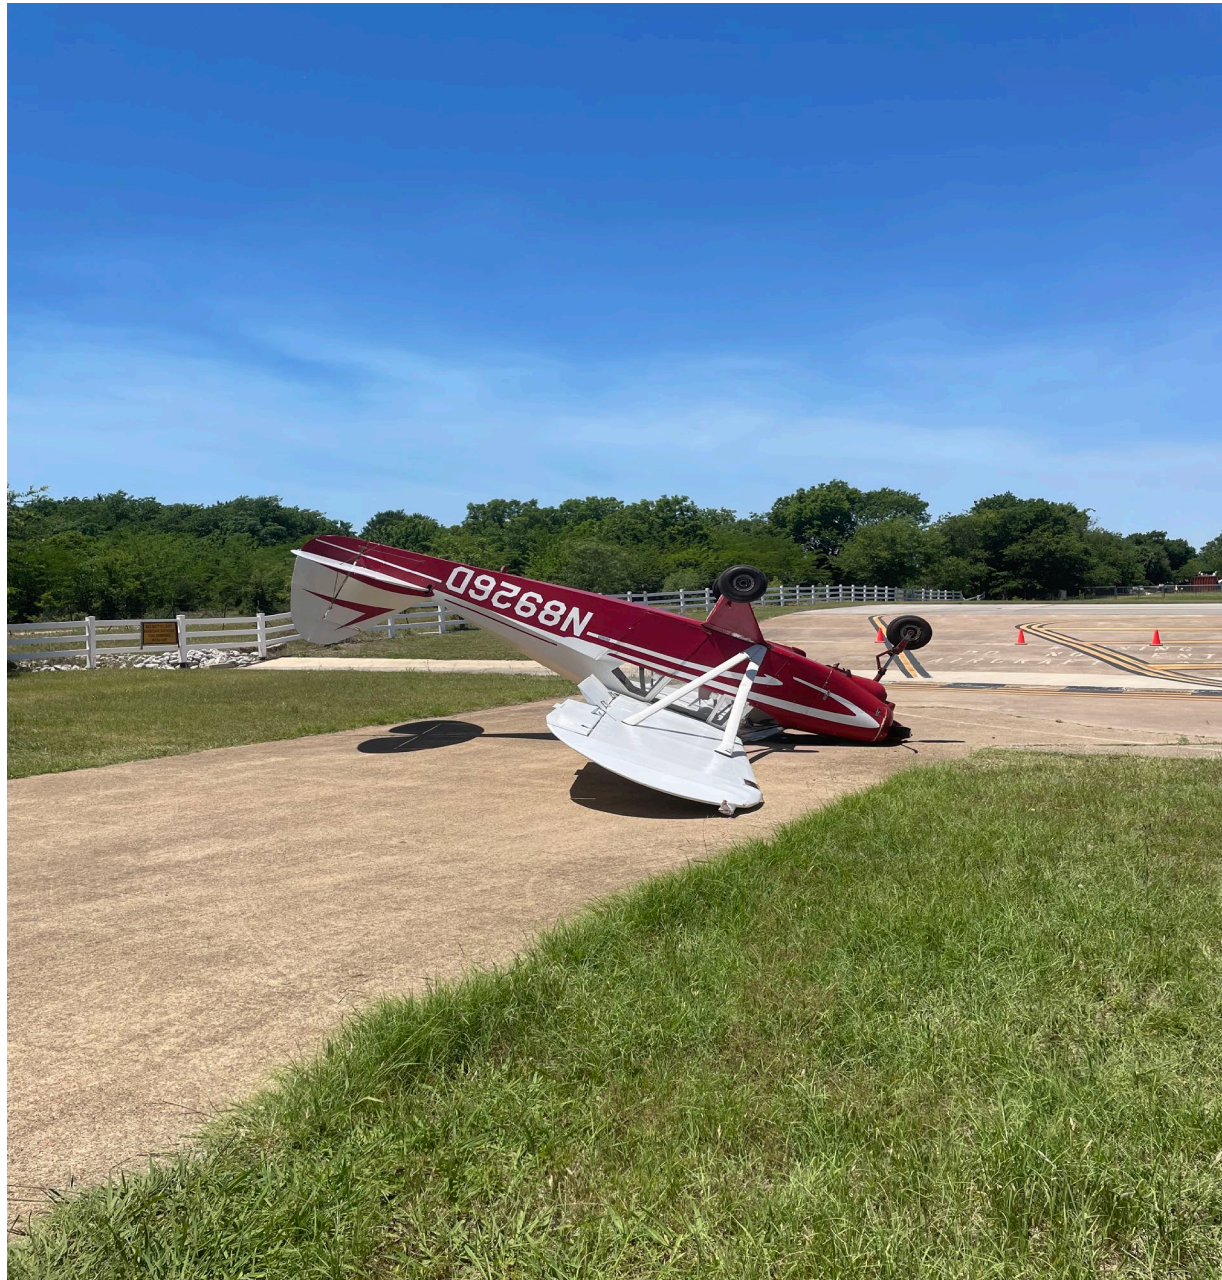
**Photo 1 – Airplane Wreckage at Accident Site (Source: FAA)**

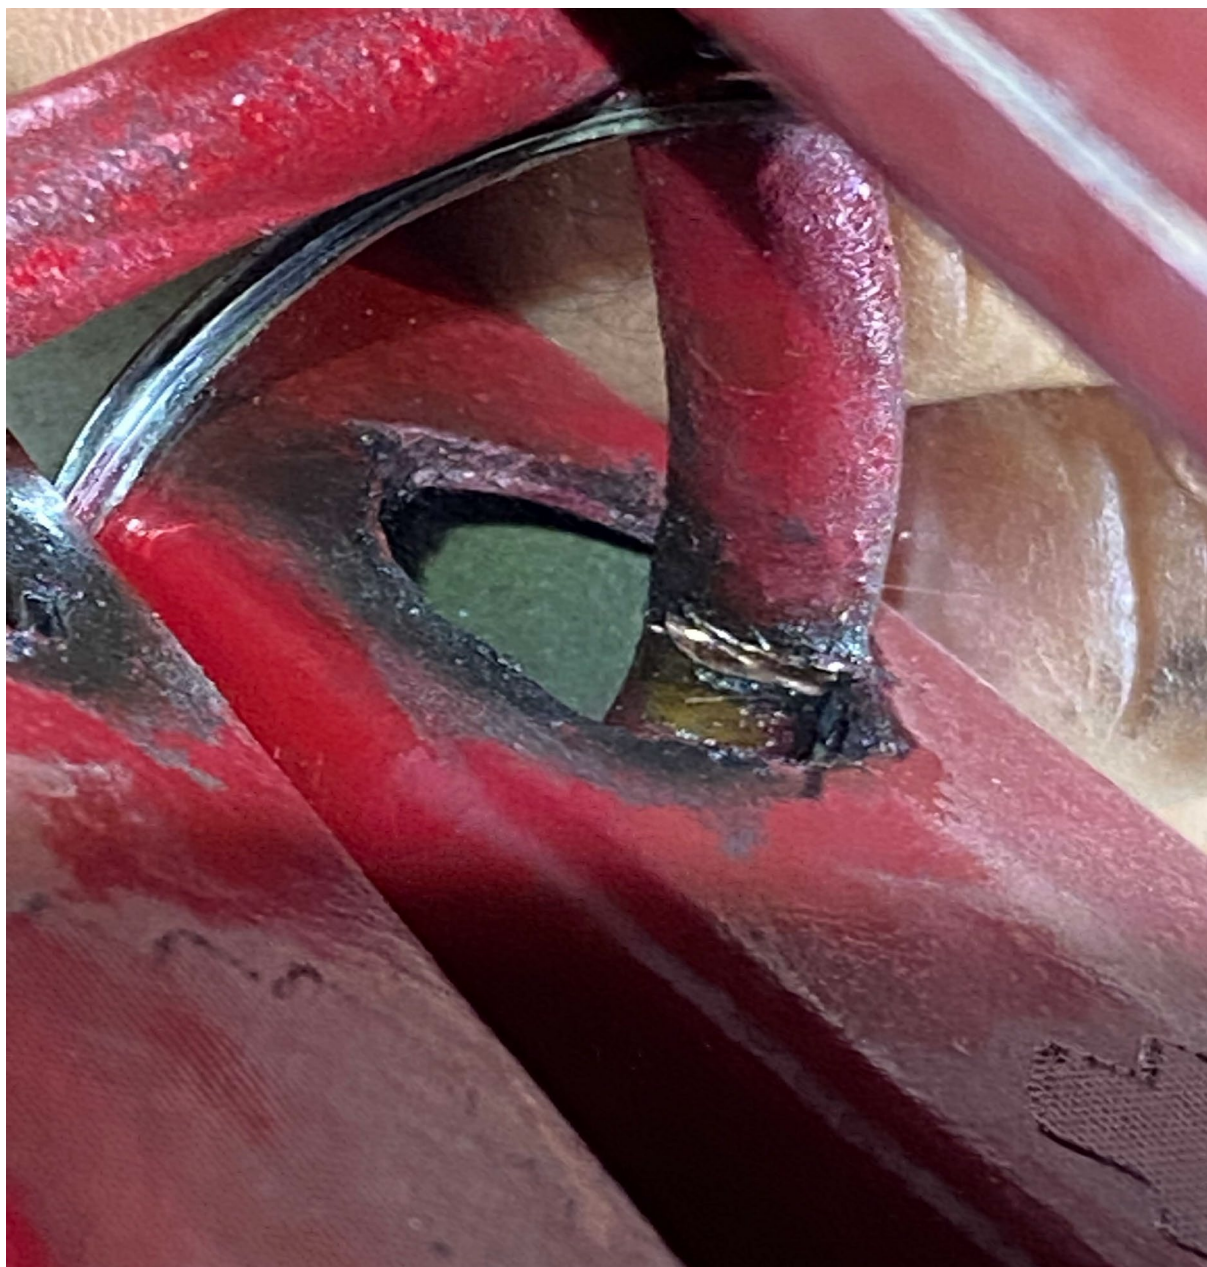
**Photo 2 – Brake Line Damage Adjacent to the Cutout Hole in the Metal Support Bulkhead (Source: FAA)**
