# National Transportation Safety Board

CEN22LA227

## **MATERIALS LABORATORY**

Factual Report 23-018

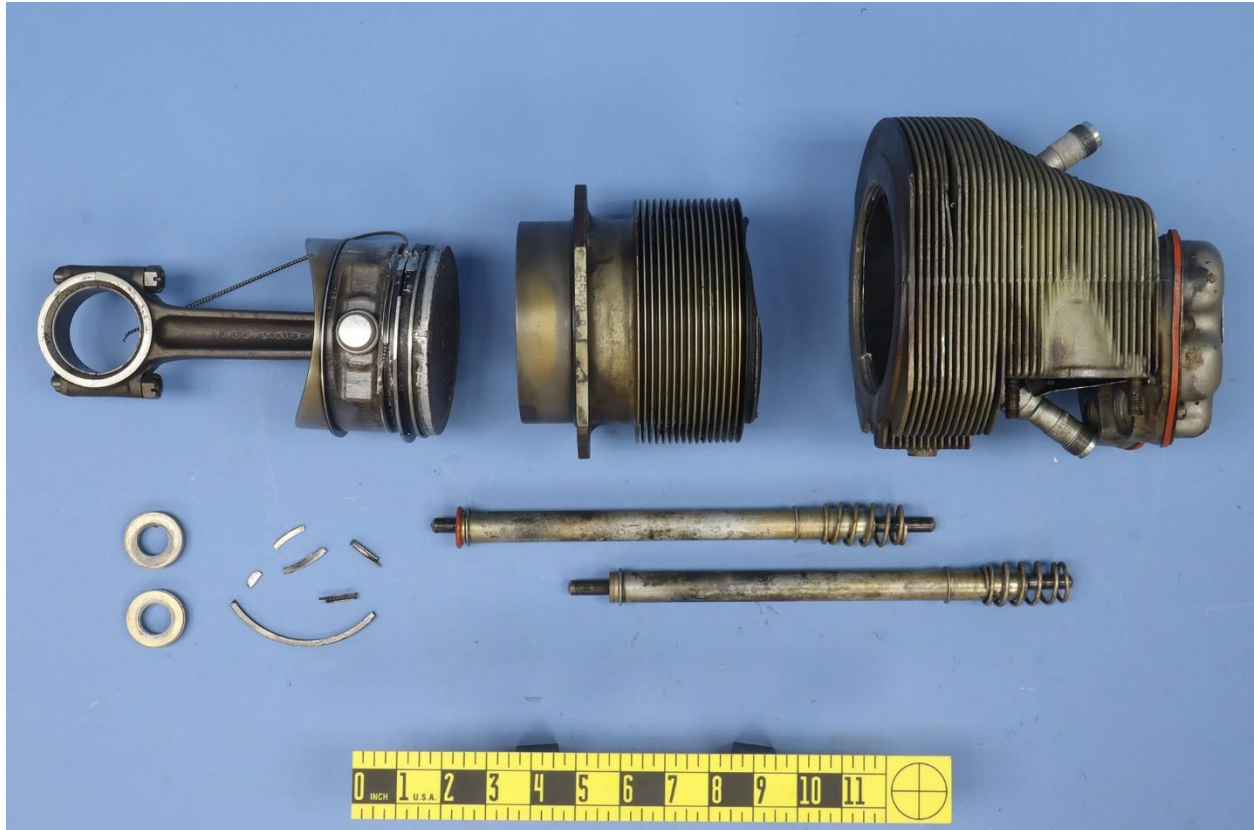
**Figure 1.** Fractured number three cylinder assembly and associated components, as received.

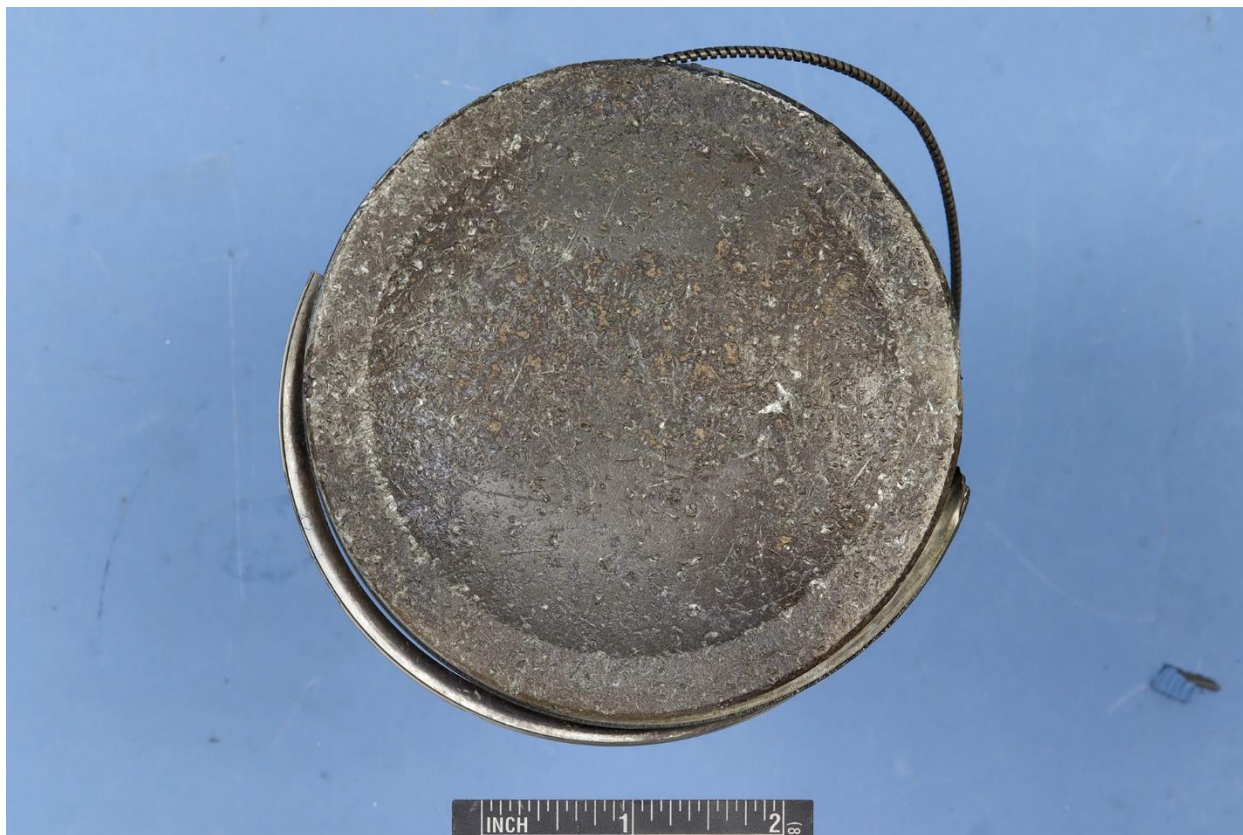
**Figure 2.** Number 3 piston crown exhibiting light pitting and impact damage.

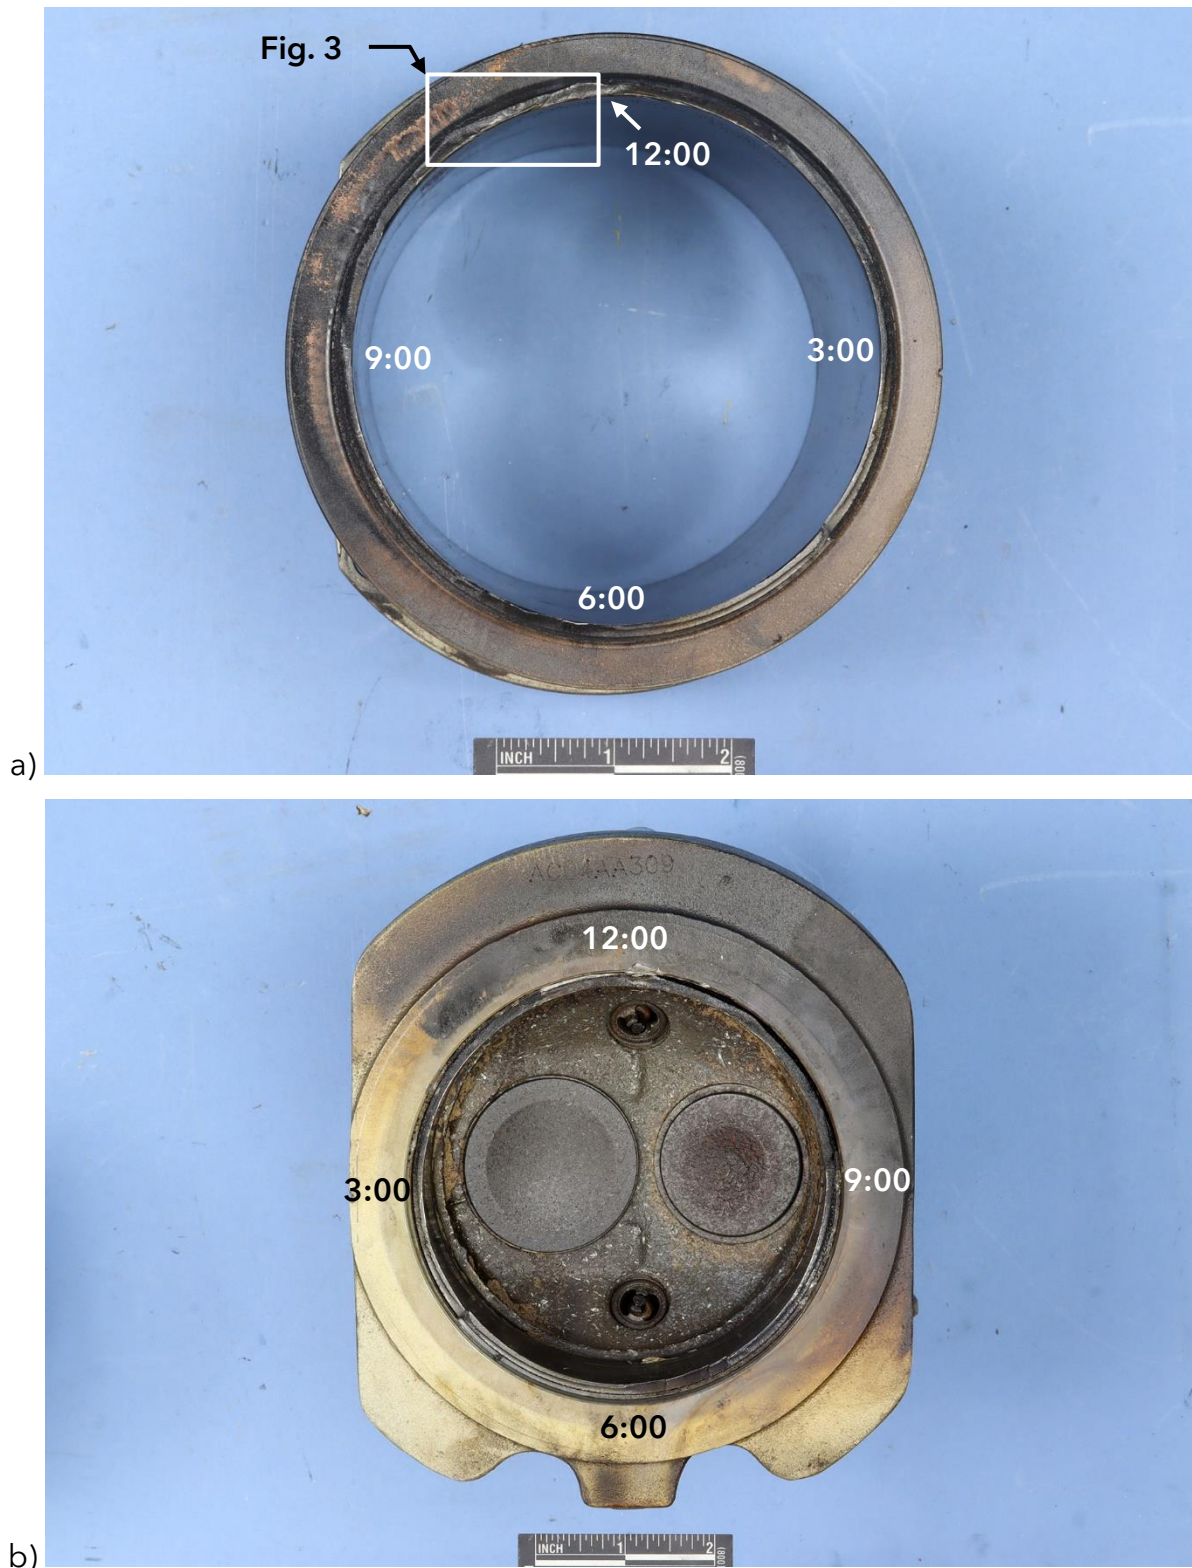
A cylinder assembly at the number 3 position on a Continental Motors TSIO-360-FB engine was submitted to the NTSB Materials Laboratory for examination along with the other components that are listed. The cylinder barrel had fractured in a smooth-walled region located between the cooling fins and the threaded section used for mounting the cylinder head. The piston crown (figure 2) was clean and exhibited light pitting and mechanical damage. The fractures on the inboard and outboard halves of the cylinder assembly are shown in figures 3a and 3b, respectively. For convenience, the cylinder was assigned clock positions as if viewed outboard looking inboard (i.e., from the rocker box toward the base of the cylinder). Approximately 75% of the fracture surface was tinted black and/or covered with lead deposits, from approximately the 6:00 position to the 3:00 position by way of 12:00. The ID edge of the fracture was worn and rounded over between the 8:00 and 4:00 positions, by way of 12:00. The inboard-facing side of the first cooling fin and adjoining material (figure 3b) was tinted black between the 7:30 position and 1:30 position (an approximately 180° arc) by way of 12:00.

**Figure 3.** Images of fracture cylinder assembly: a) Cylinder barrel (inboard side of fracture) and b) portion of barrel still threaded into cylinder head (outboard side of fracture).

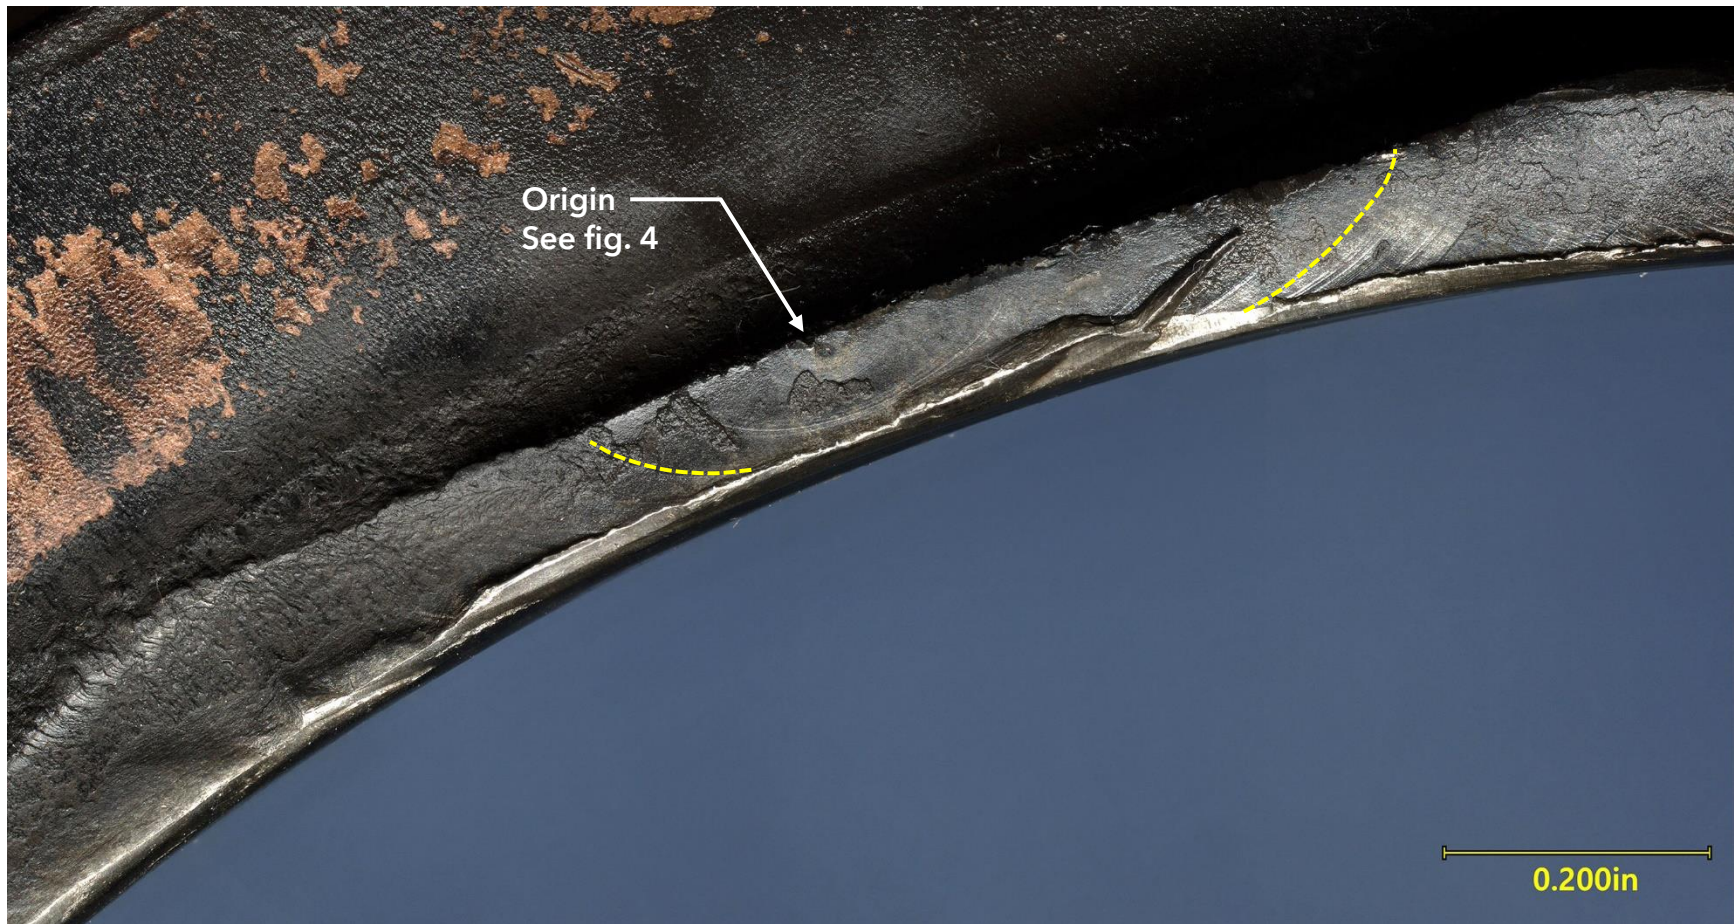
The fracture surface was examined with the aid of a stereomicroscope. Features were observed that were consistent with a fatigue crack that originated along the outer diameter surface of the barrel at a corrosion pit. Figure 4 shows the barrel-side fracture surface between the 11:00 and 12:00 positions. Curved crack

arrest marks, several of which are indicated by yellow dashed lines, exhibited curvature that was consistent with an origin along the outer diameter surface between the 11:00 and 12:00 positions. The crack arrest marks and radial lines were traced back to a corrosion pit located on the outer diameter surface, as indicated in figure 5. The pit was approximately 0.005 inch deep and 0.012 inch across. Additional smaller pits were observed on either side of the origin area. The fracture surface near the pit exhibited radial lines and flat feathery features that were consistent with crack initiation and progression due to cyclic fatigue. The barrel wall thickness was measured on a digital optical image accounting for the rounding of the ID edge. The wall thickness measured approximately 0.103 inch.

**Figure 4.** Image of the barrel-side fracture surface between the 11:00 and 12:00 positions showing curved crack arrest marks, several of which are indicated by yellow dashed lines. The curvature is consistent with an origin along the outer diameter surface.

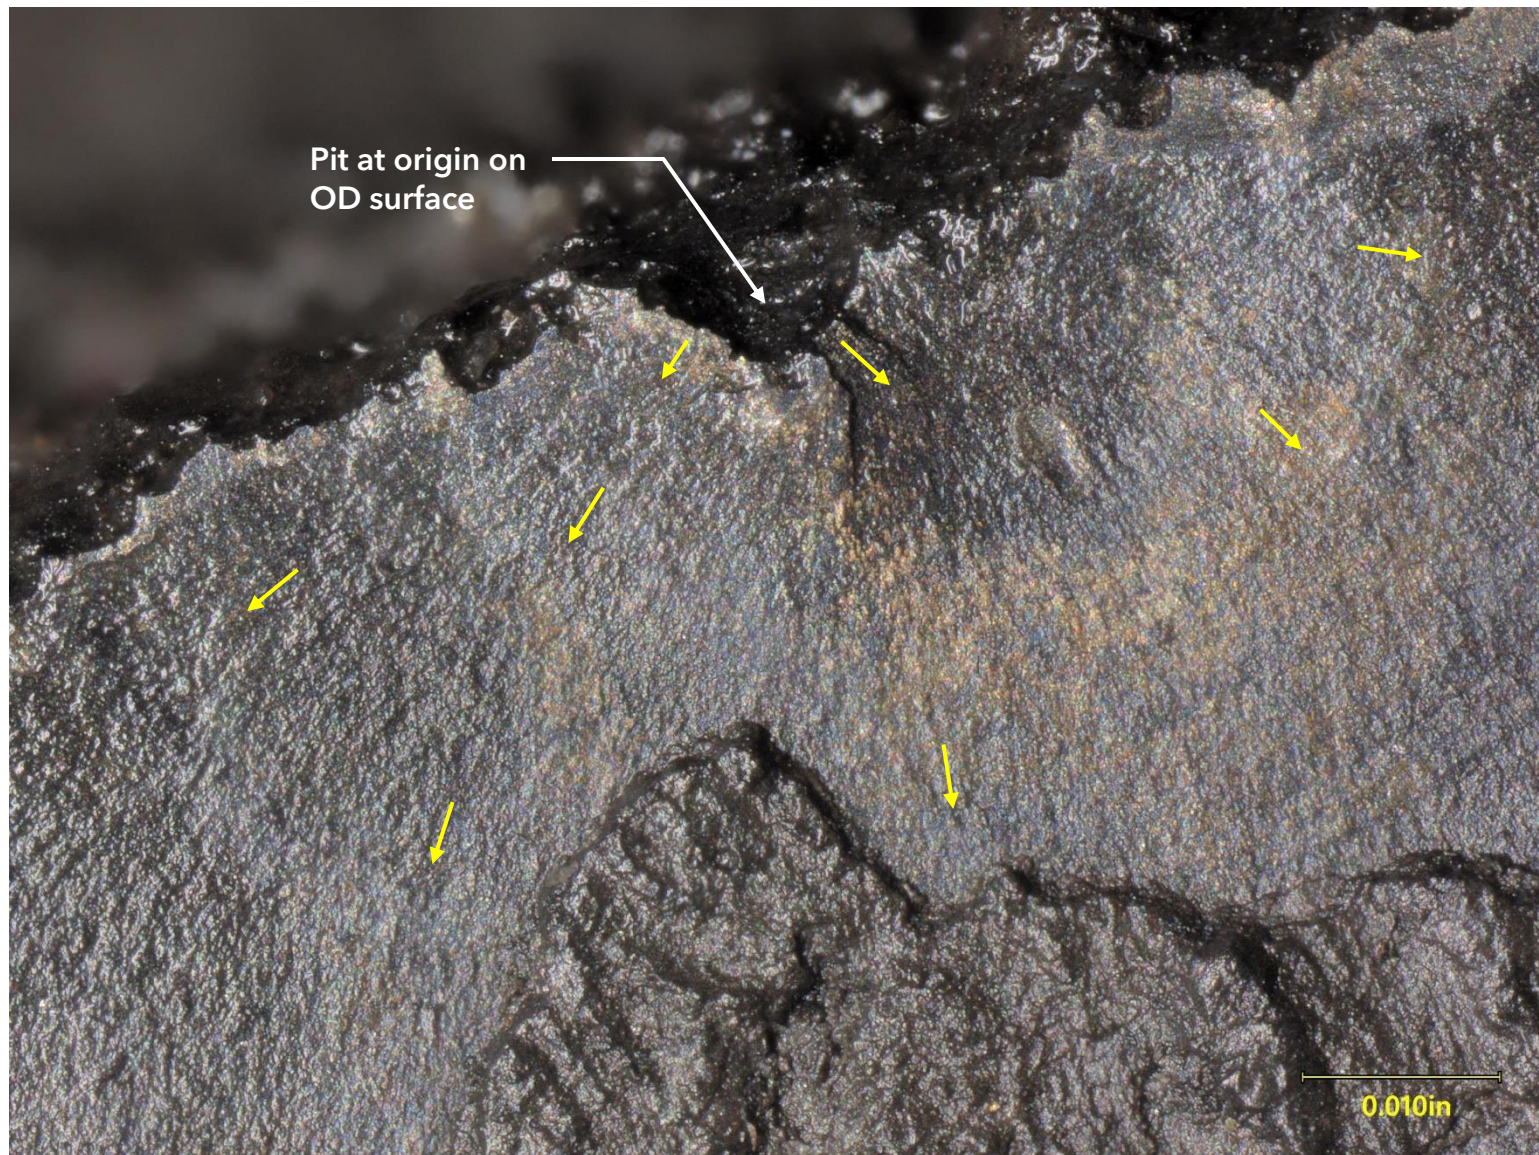
**Figure 5.** Image of the OD corrosion pit on the outer diameter surface of the cylinder barrel with flat feathery fracture features radiating away from the pit, consistent with cyclic fatigue. Yellow arrows indicated the local direction of crack progression.
