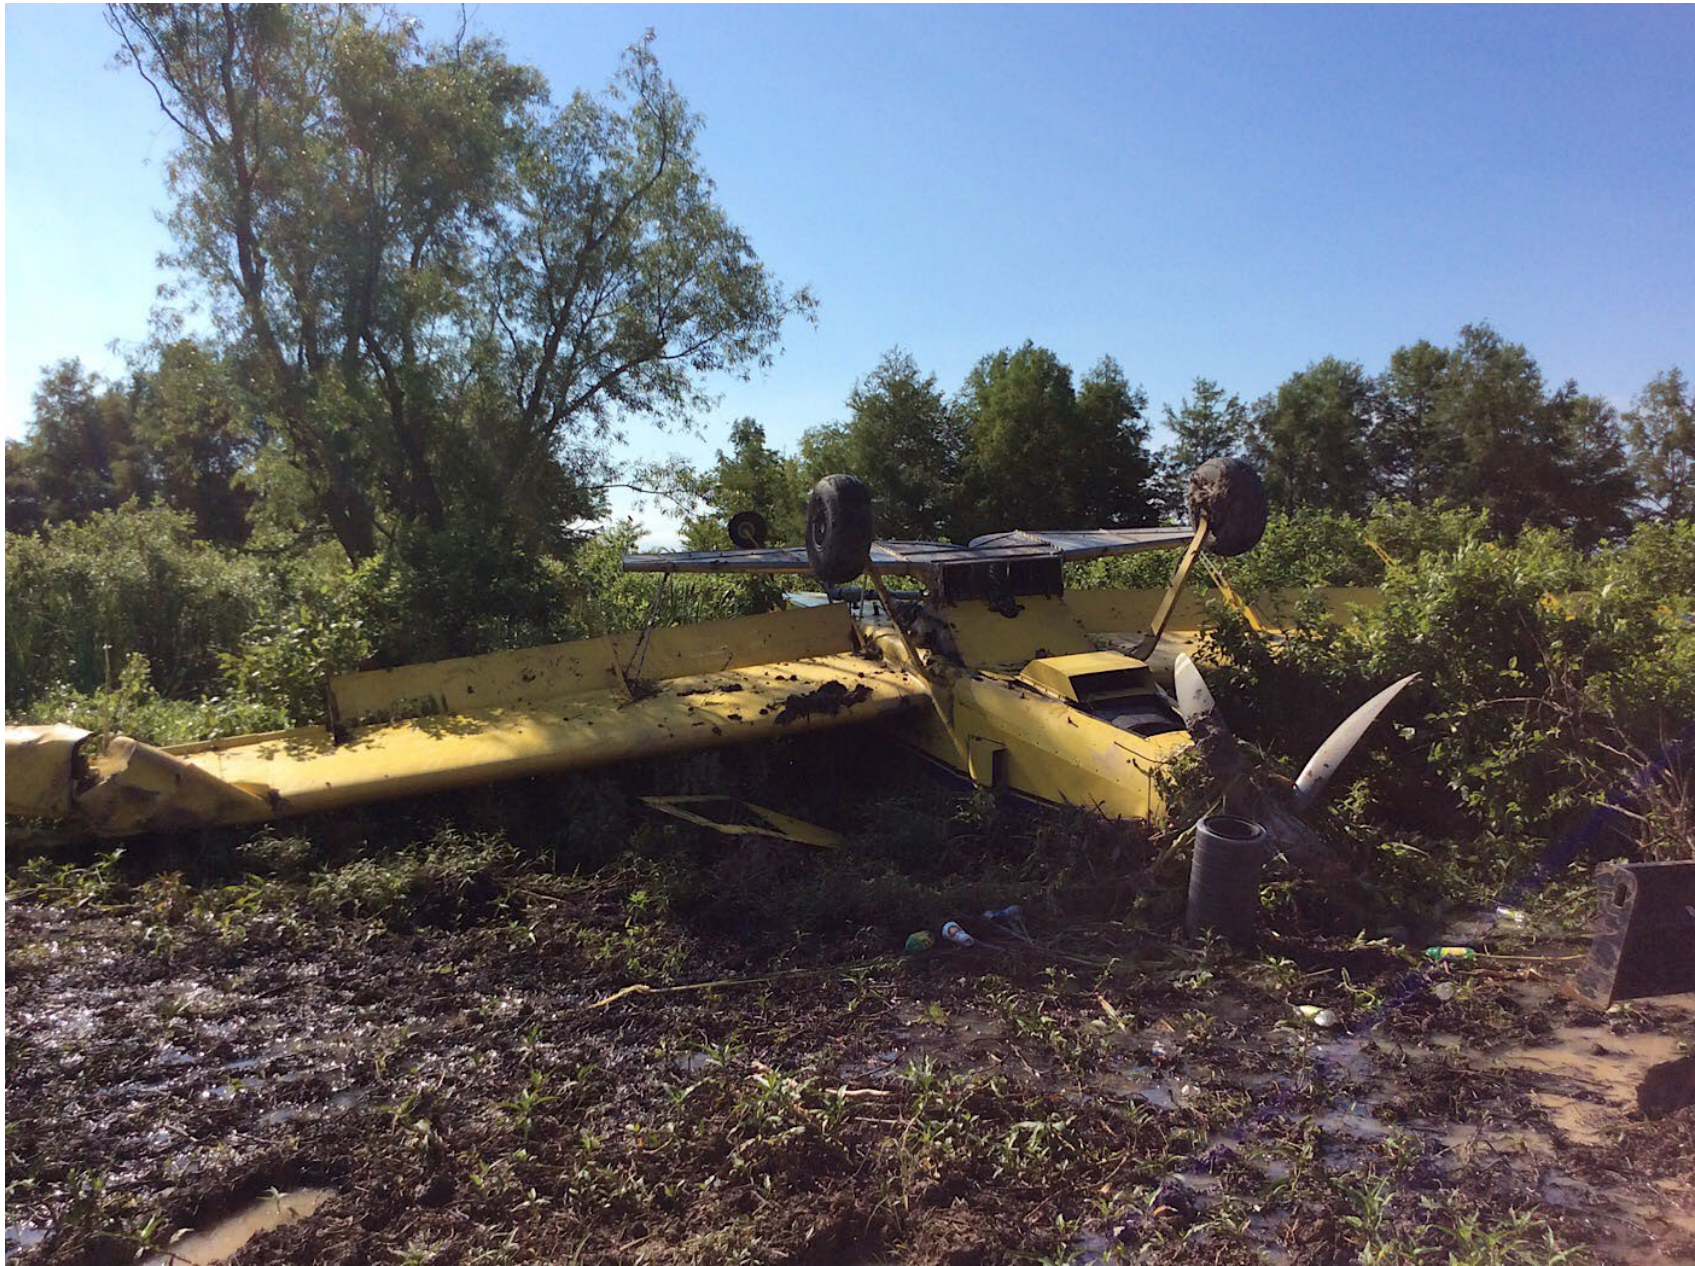
**Photo 1 – View of the front of the airplane at the accident site (courtesy of the Federal Aviation Administration).**

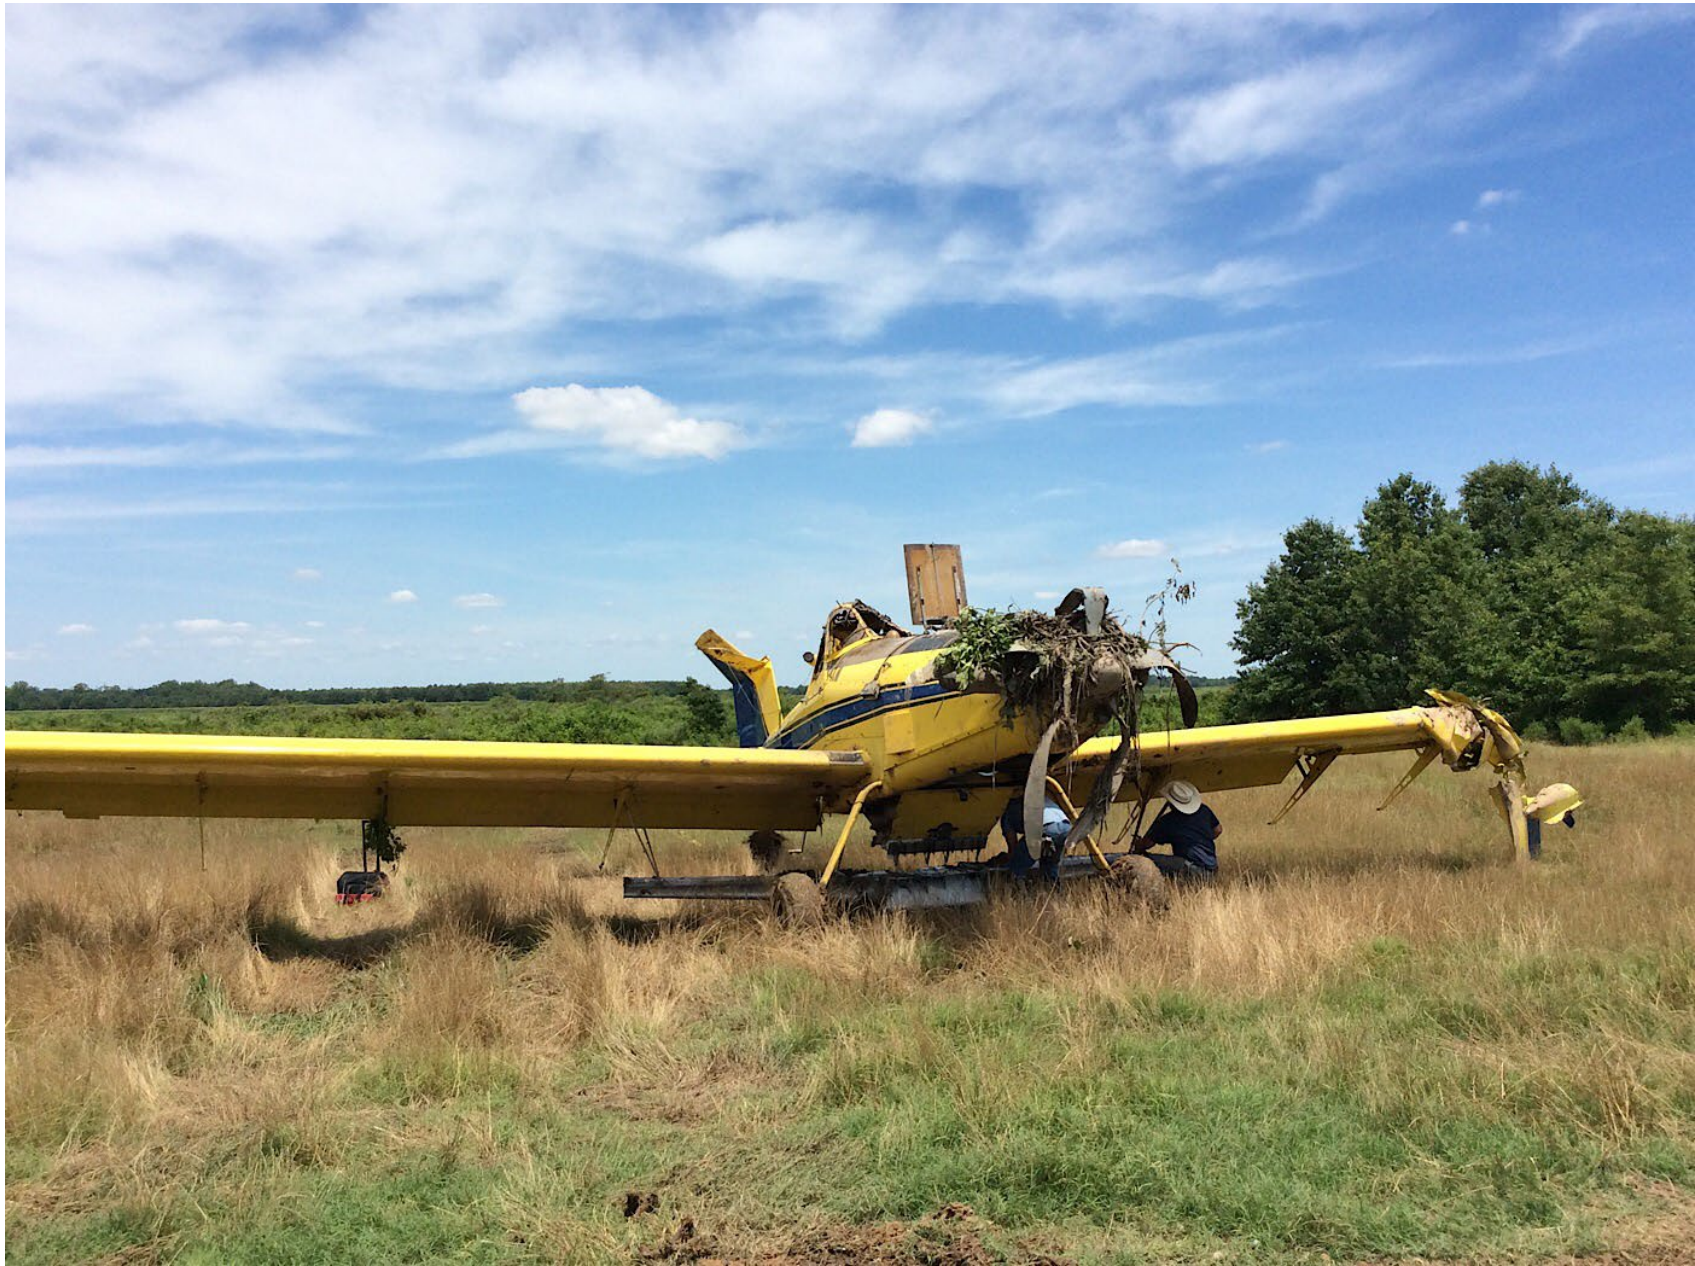
**Photo 2 – View of the front of the airplane at the accident site (courtesy of the Federal Aviation Administration).**

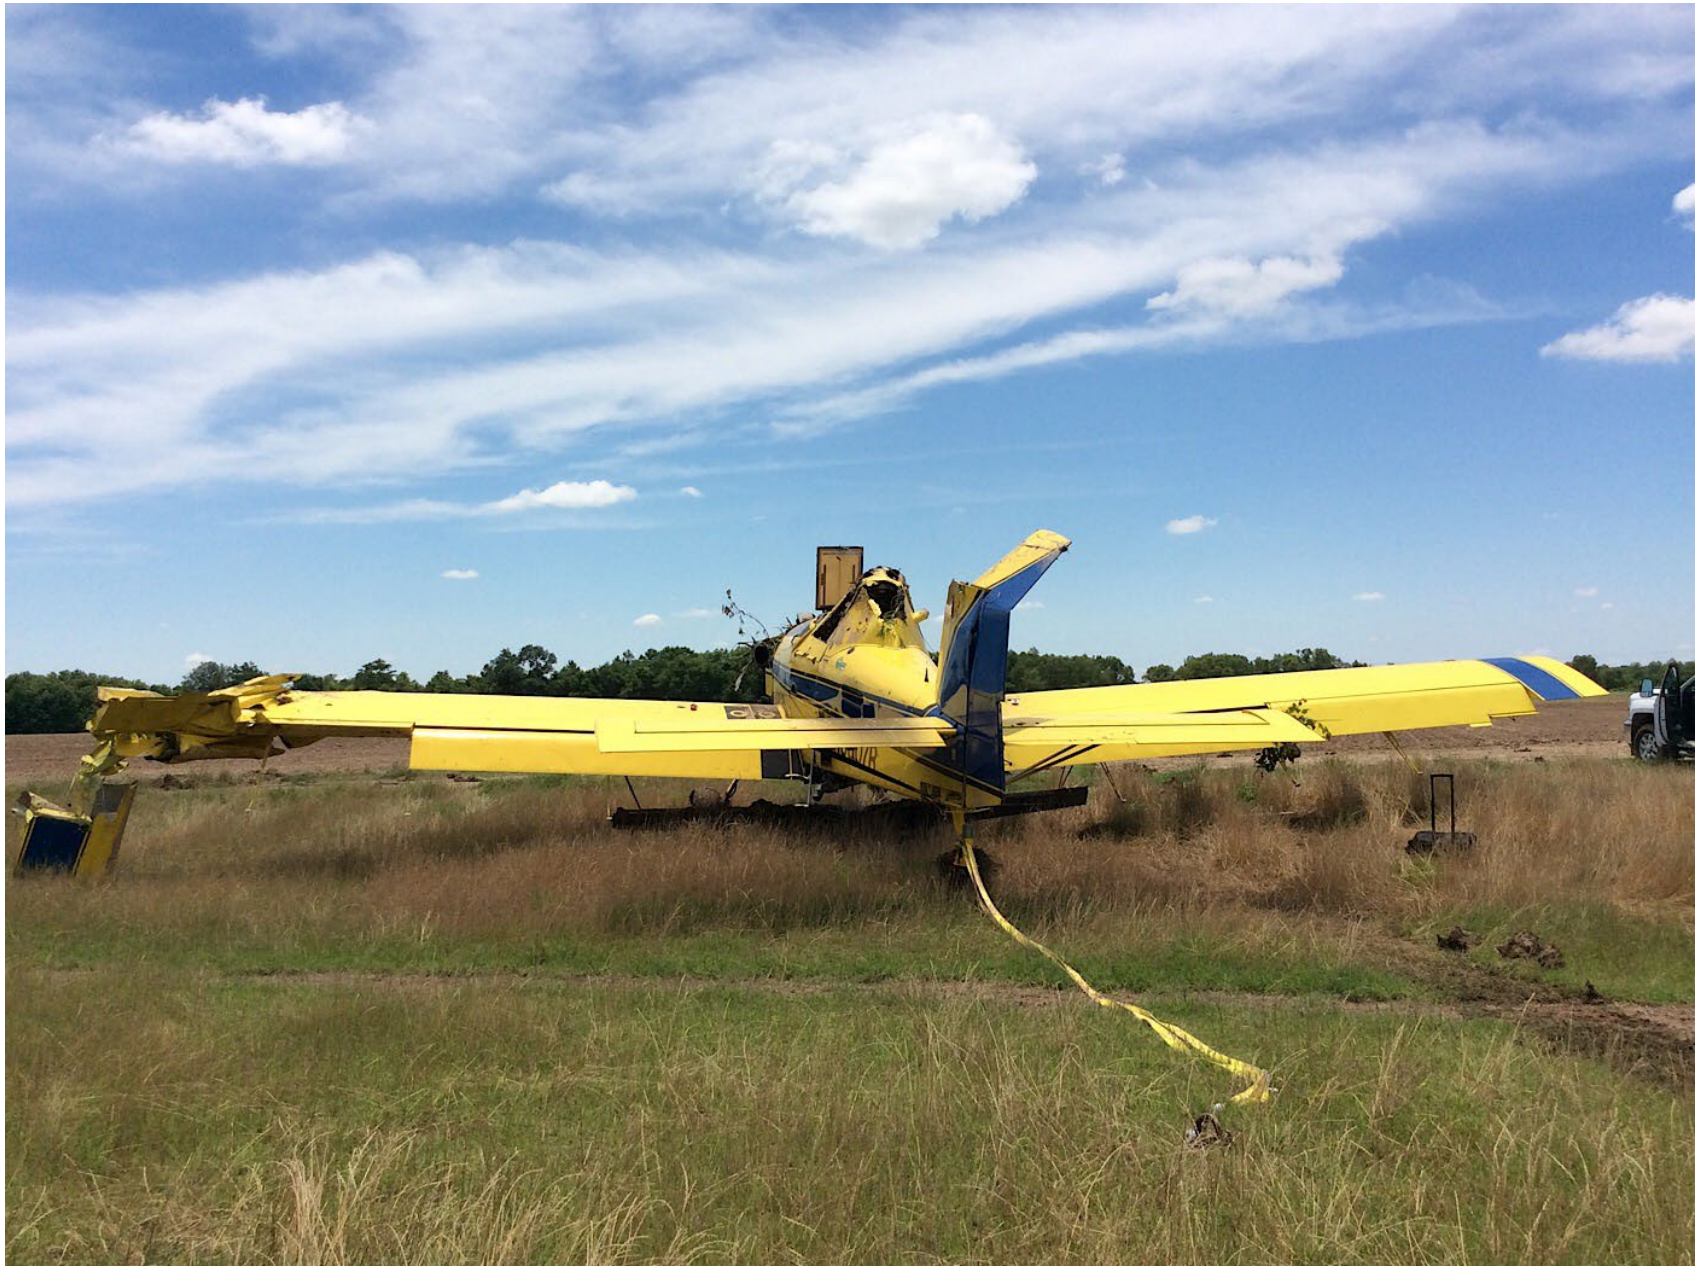
**Photo 3 – View of the rear of the airplane at the accident site (courtesy of the Federal Aviation Administration).**

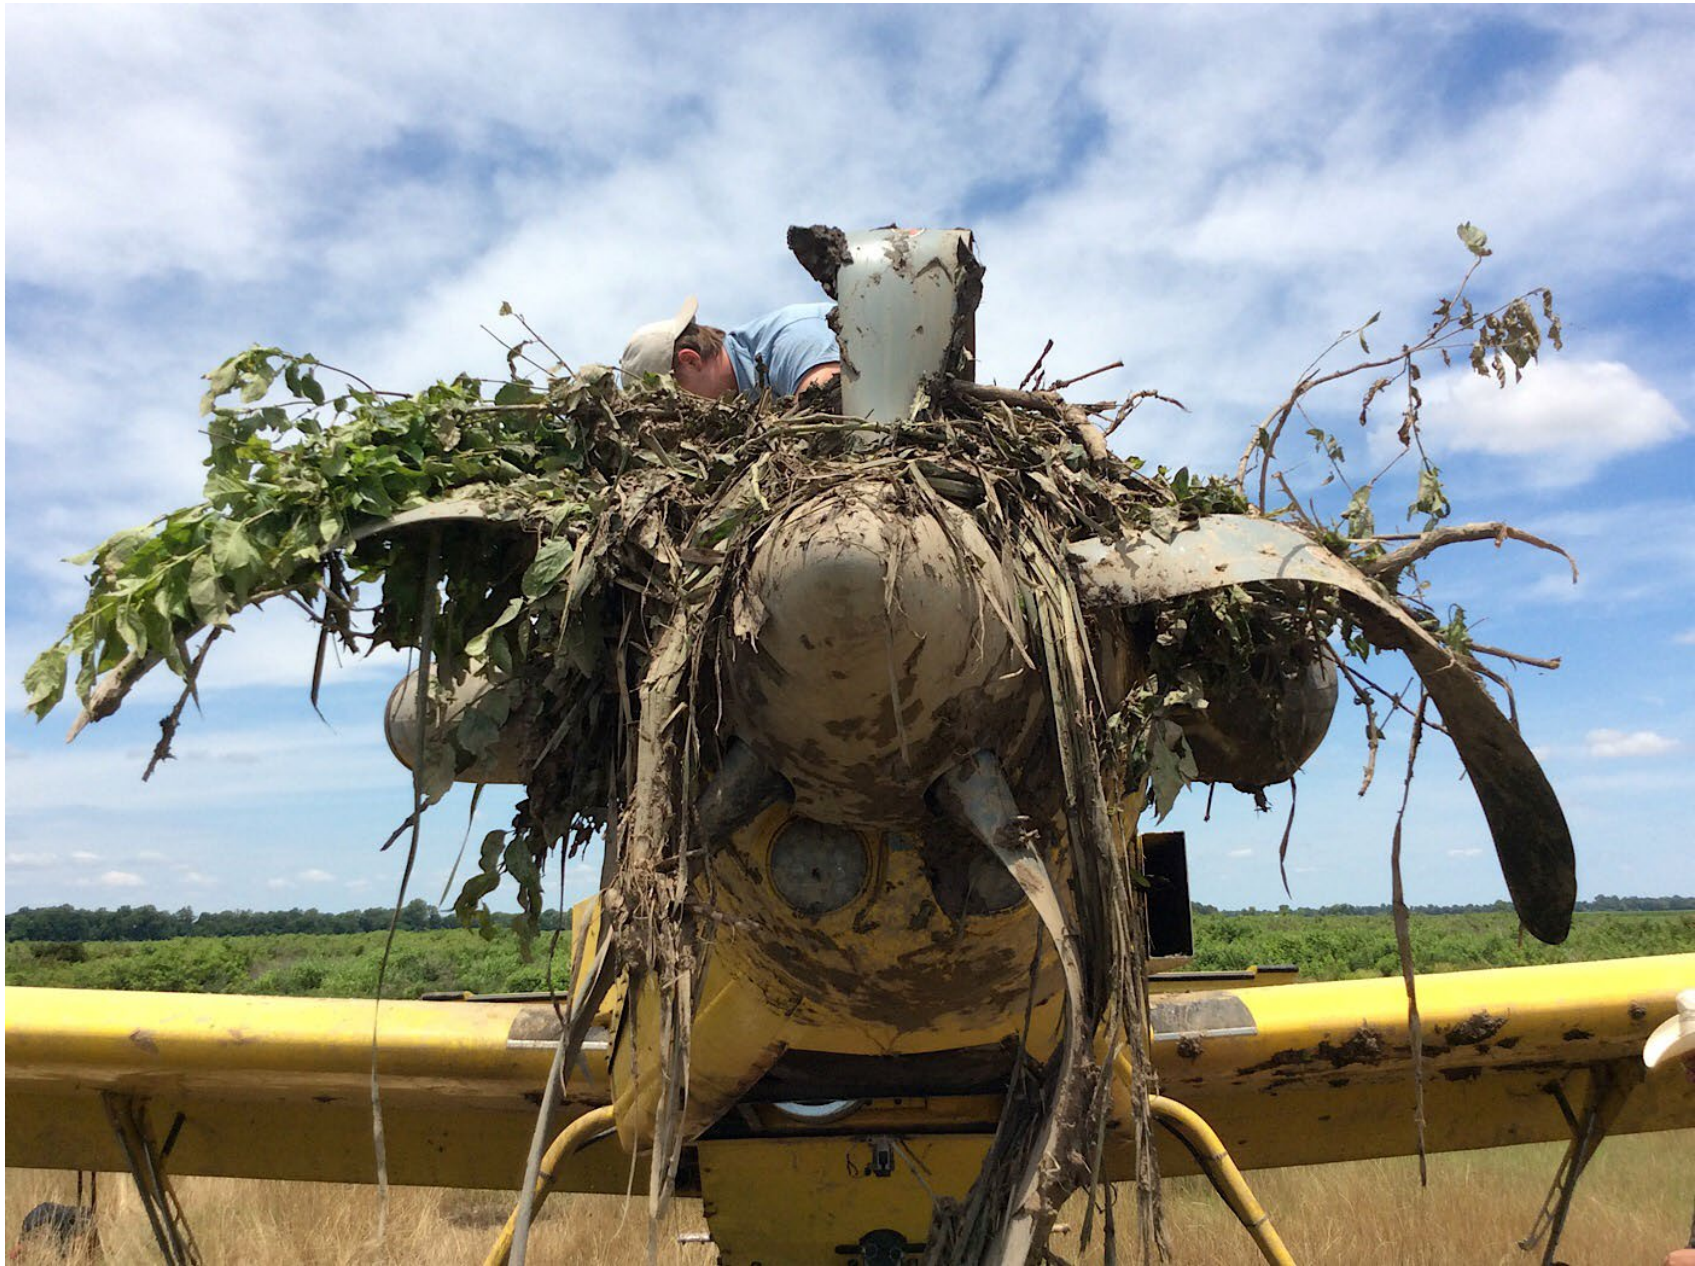
**Photo 4 – View of the propeller at the accident site (courtesy of the Federal Aviation Administration).**

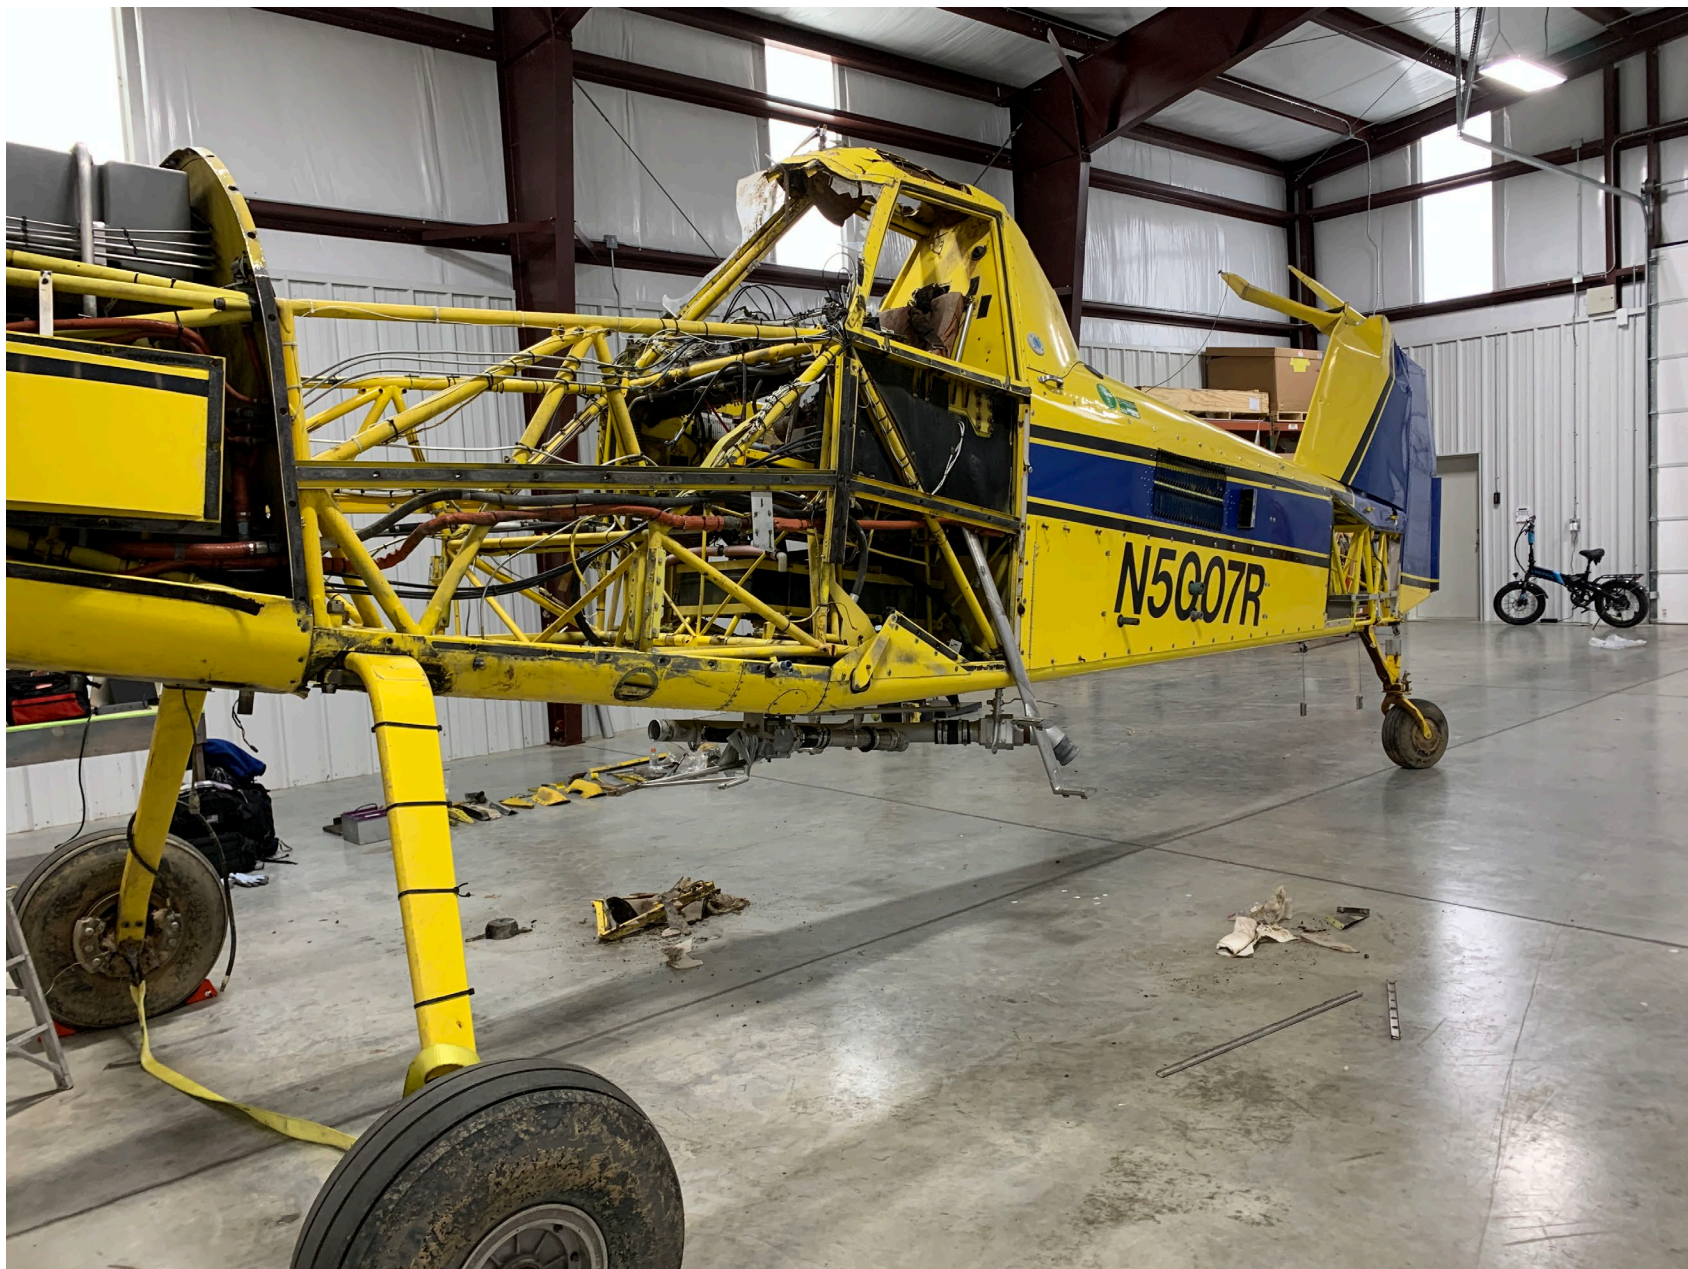
**Photo 5 – View of the left side of the airplane during the airframe examination.**

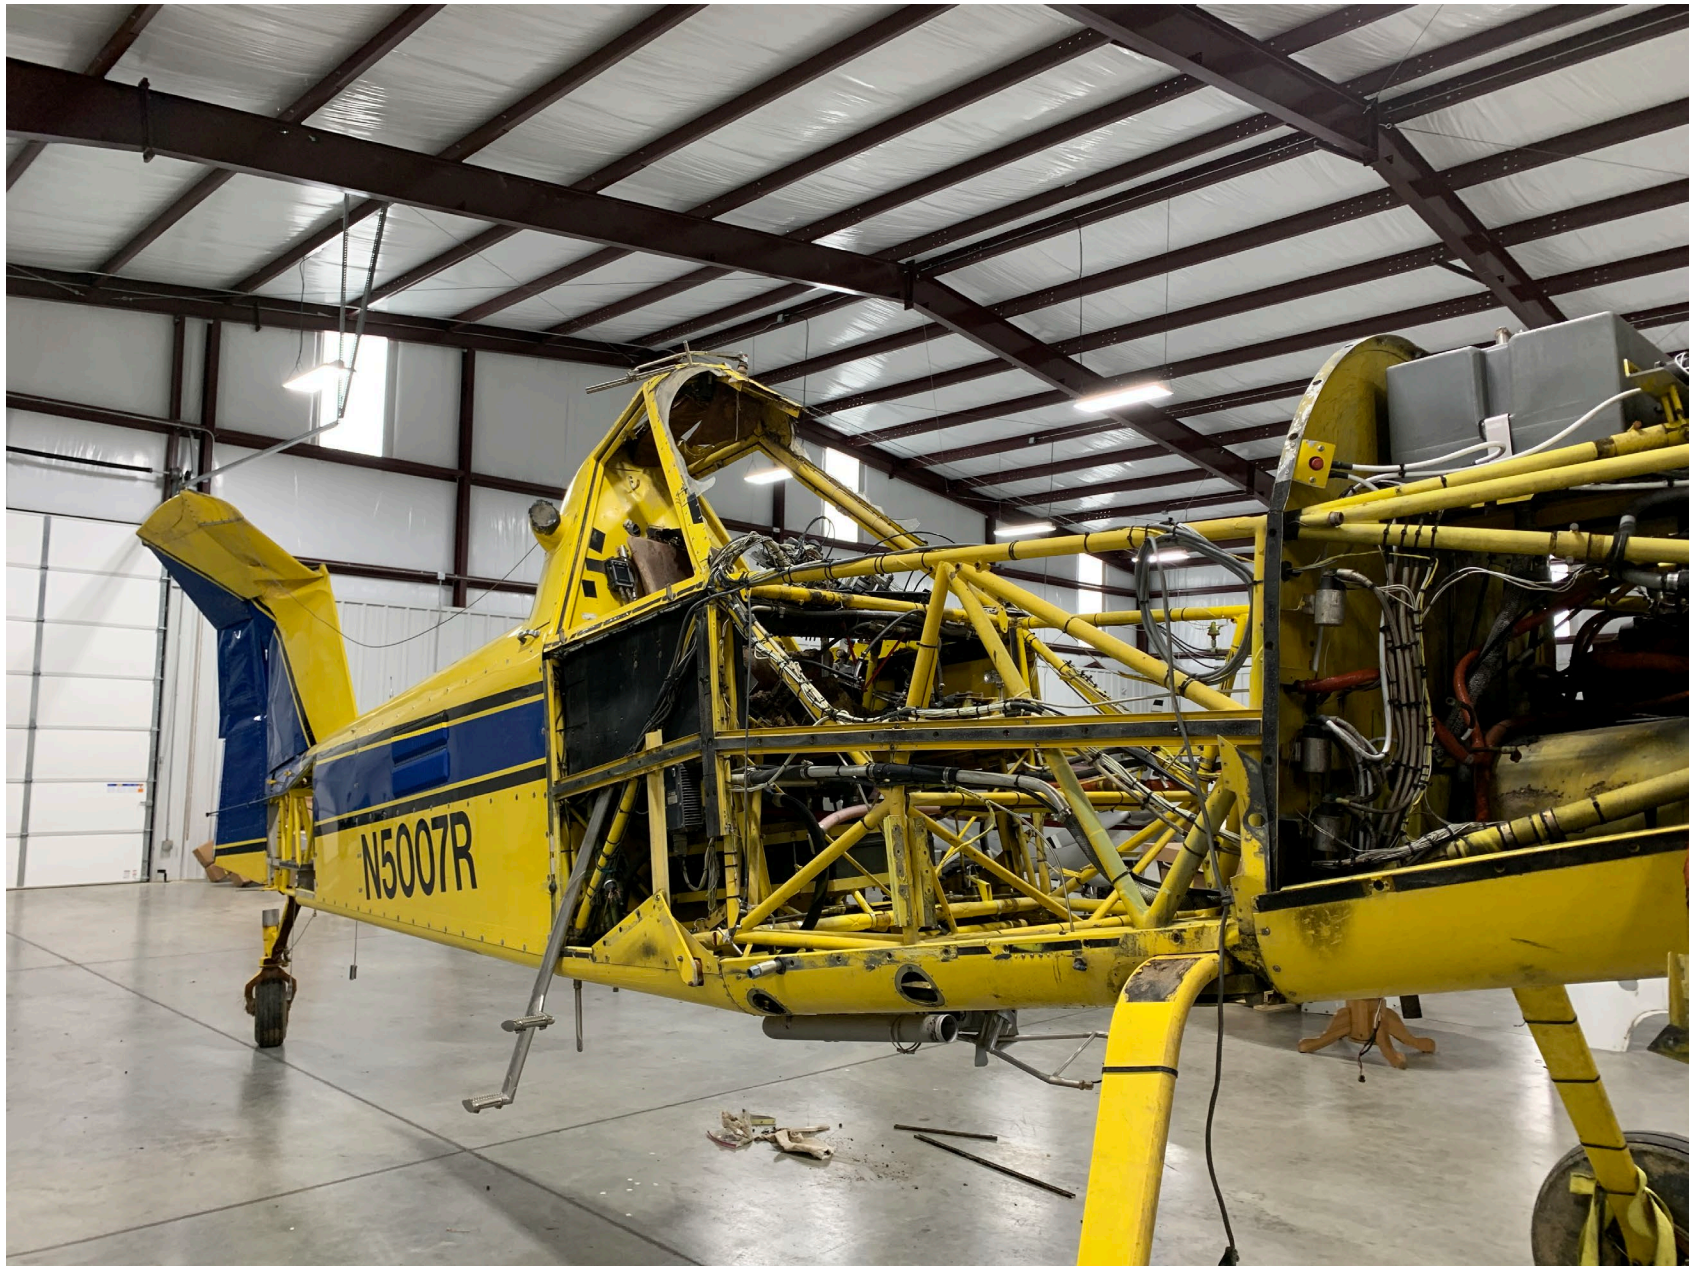
**Photo 6 – View of the right side of the airplane during the airframe examination.**

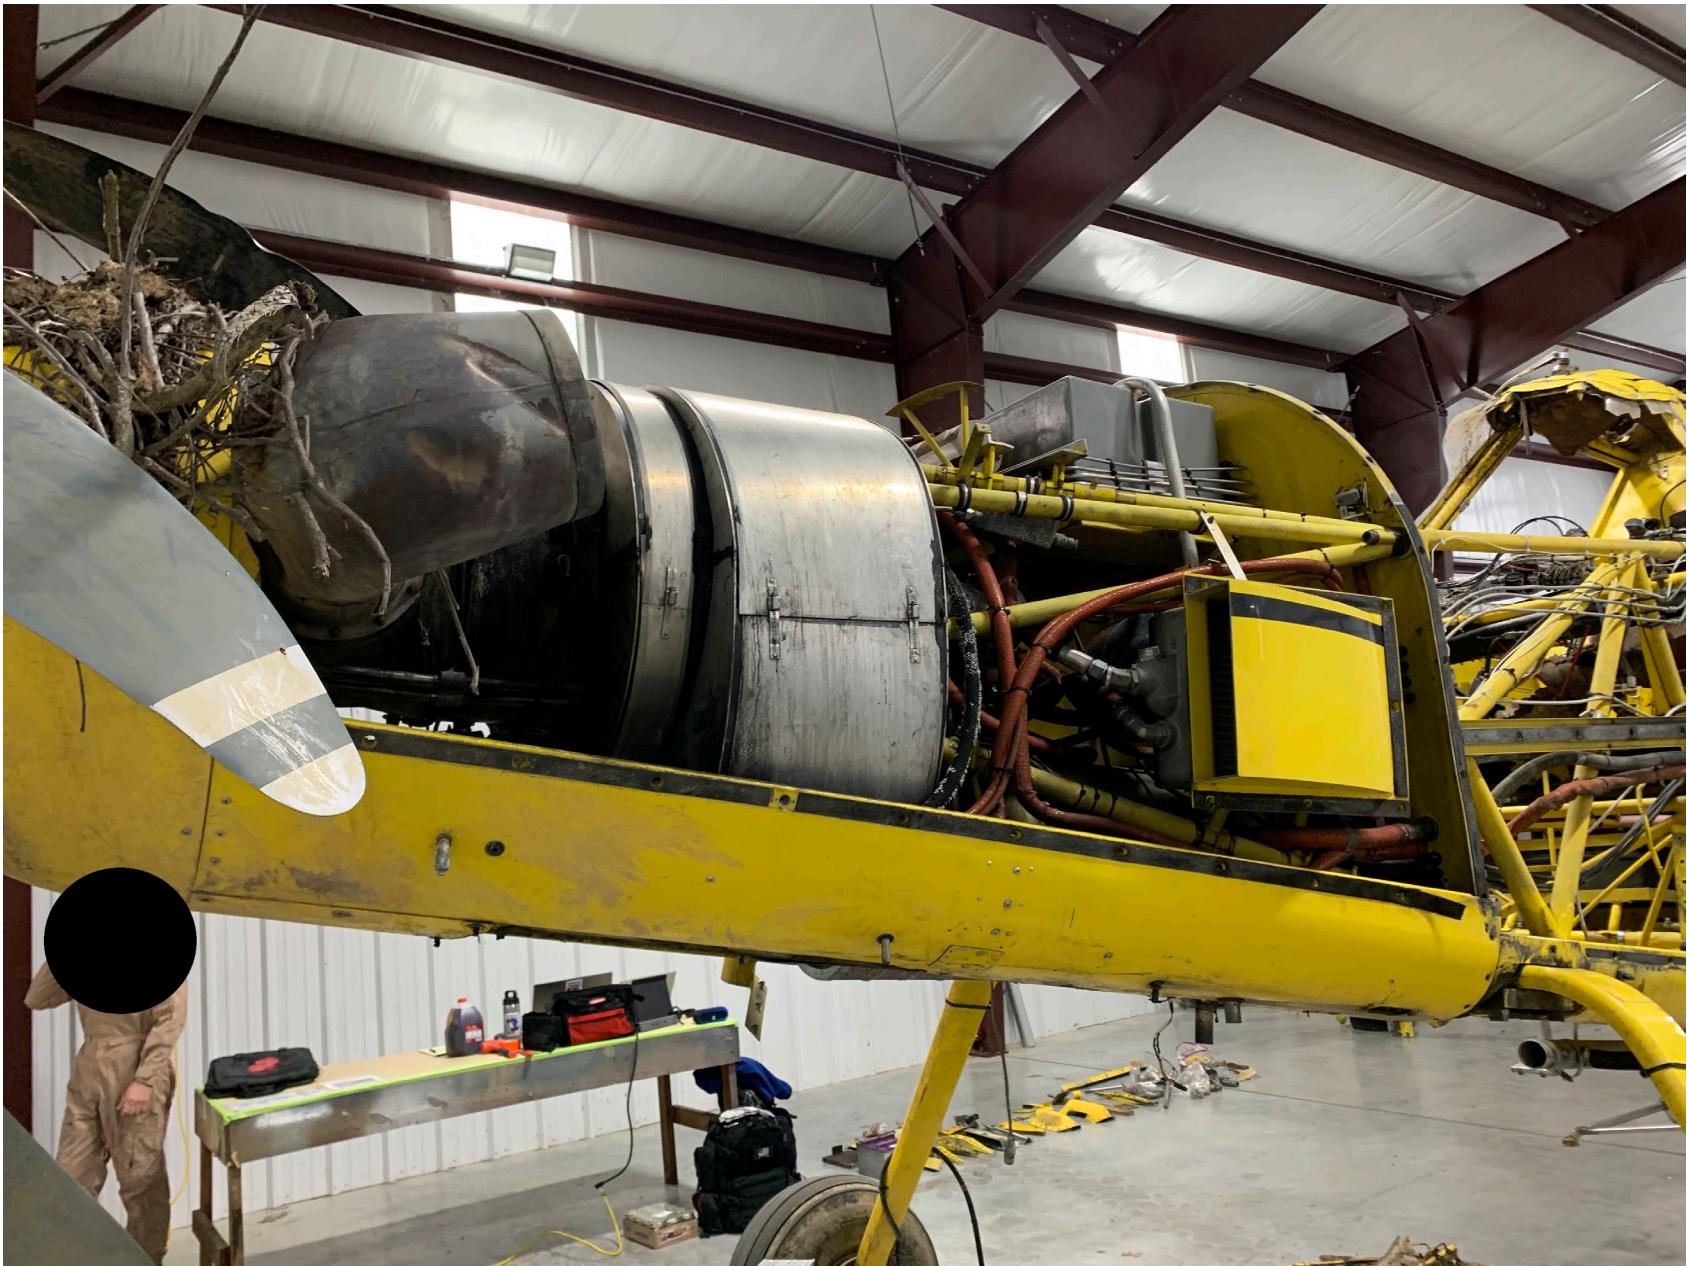
**Photo 7 – View of the left side of the engine during the airframe examination.**

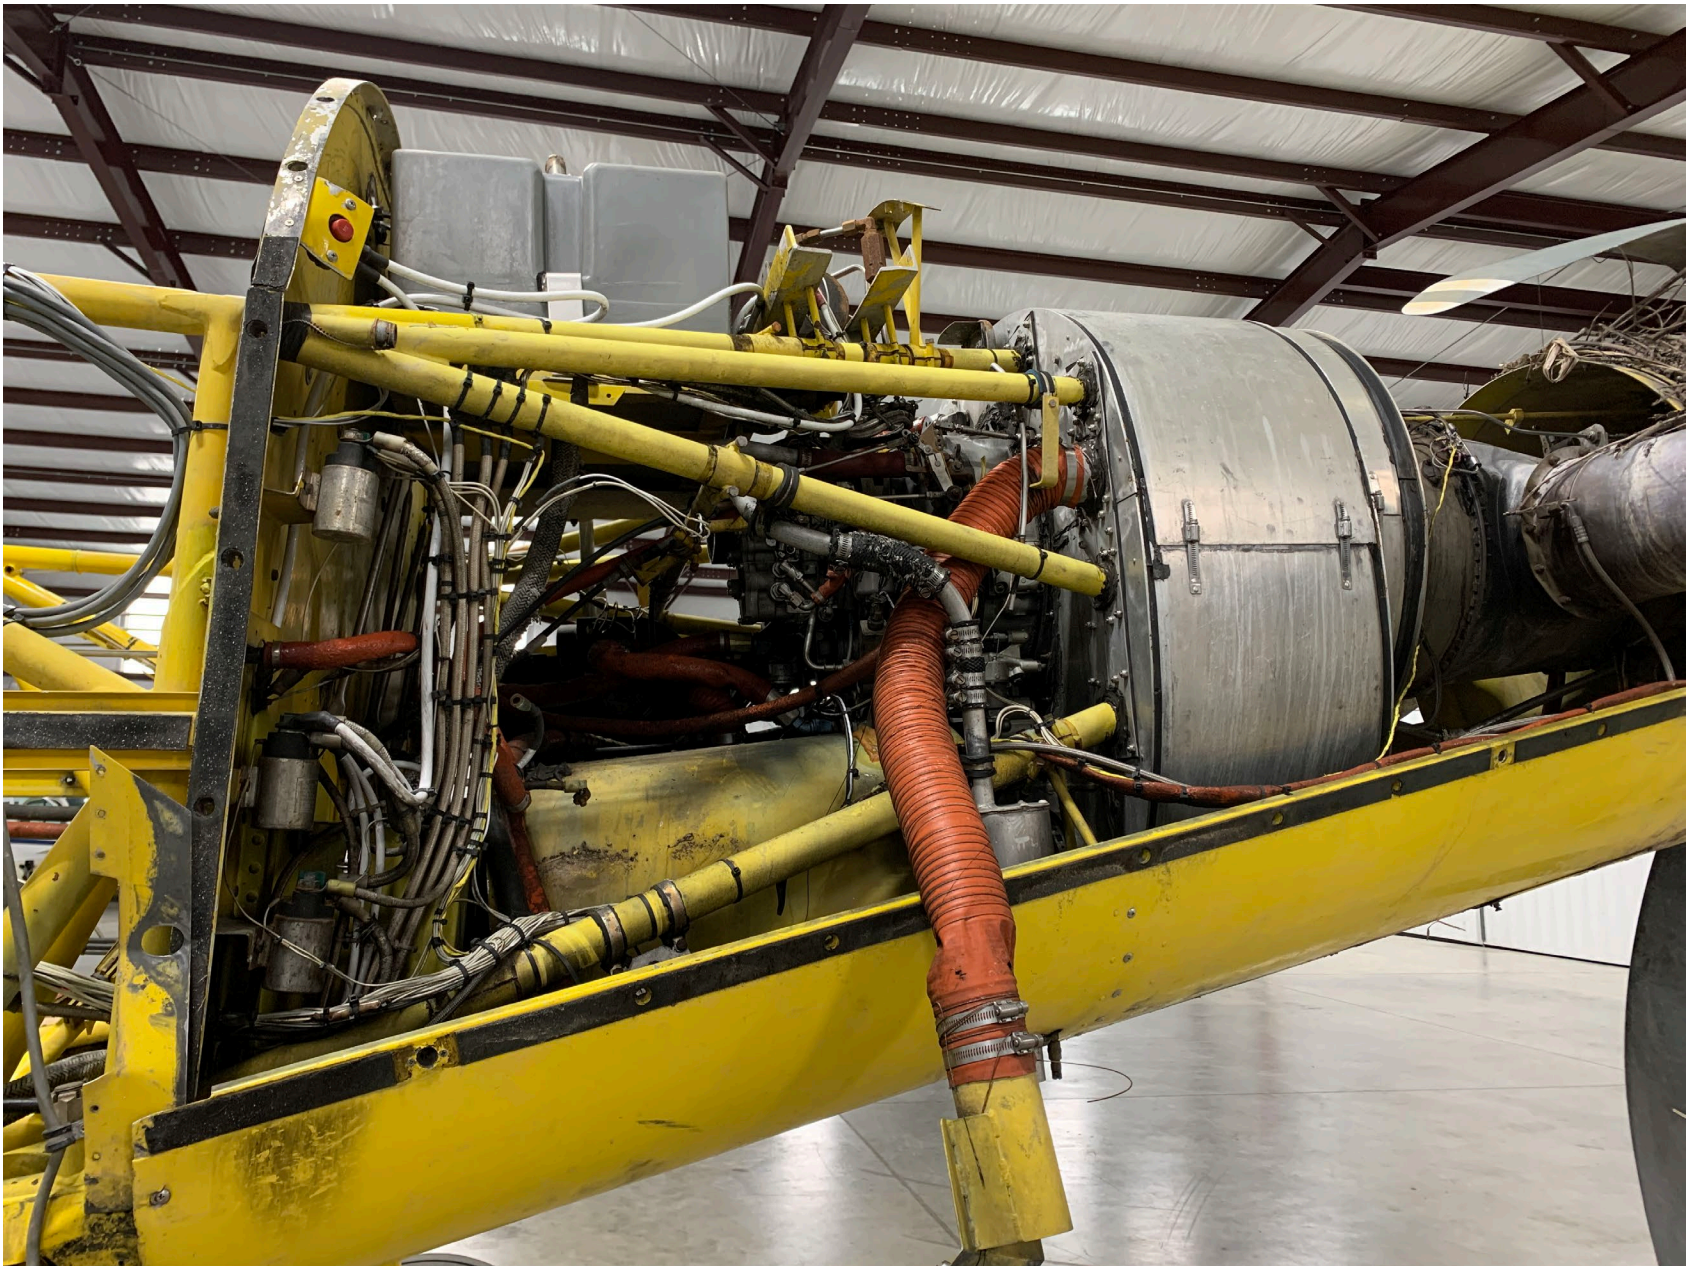
**Photo 8 – View of the right side of the engine during the airframe examination.**

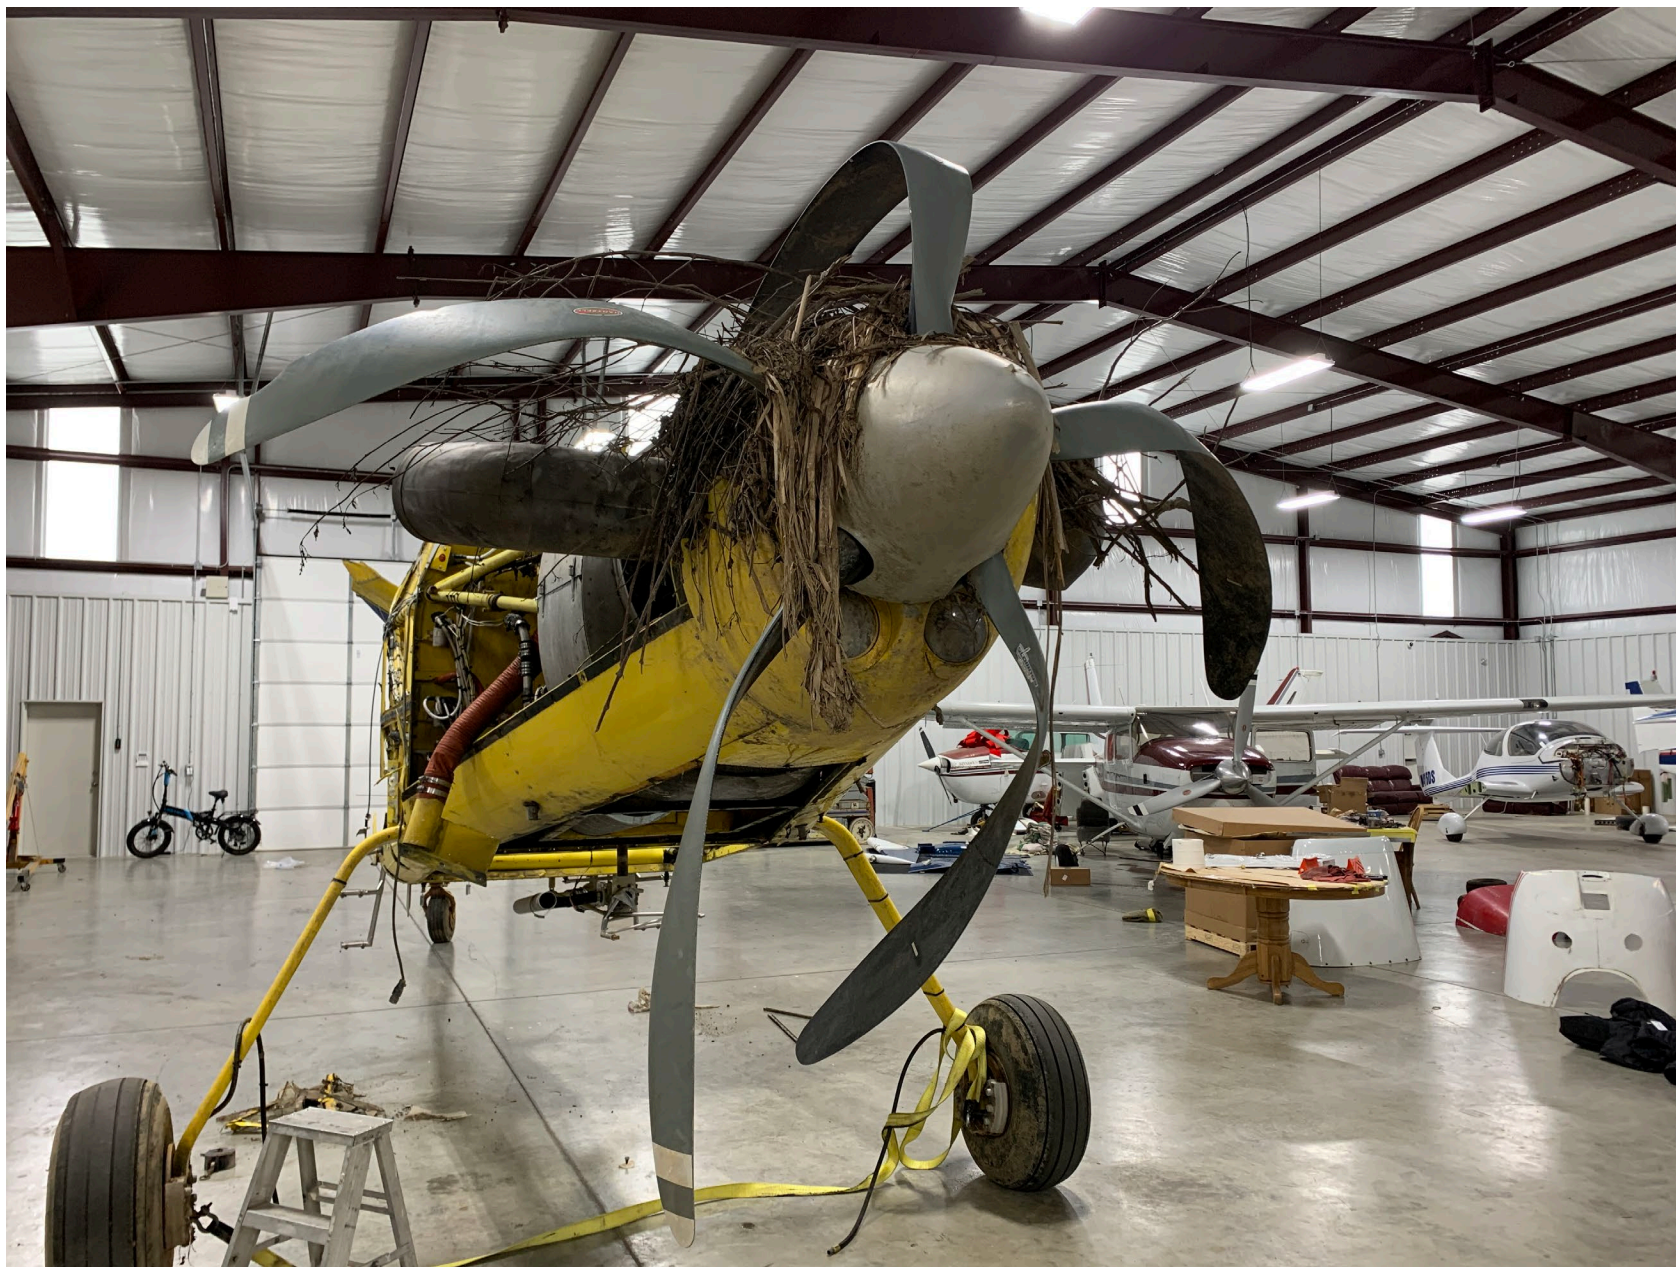
**Photo 9 – View of the propeller during the airframe examination.**

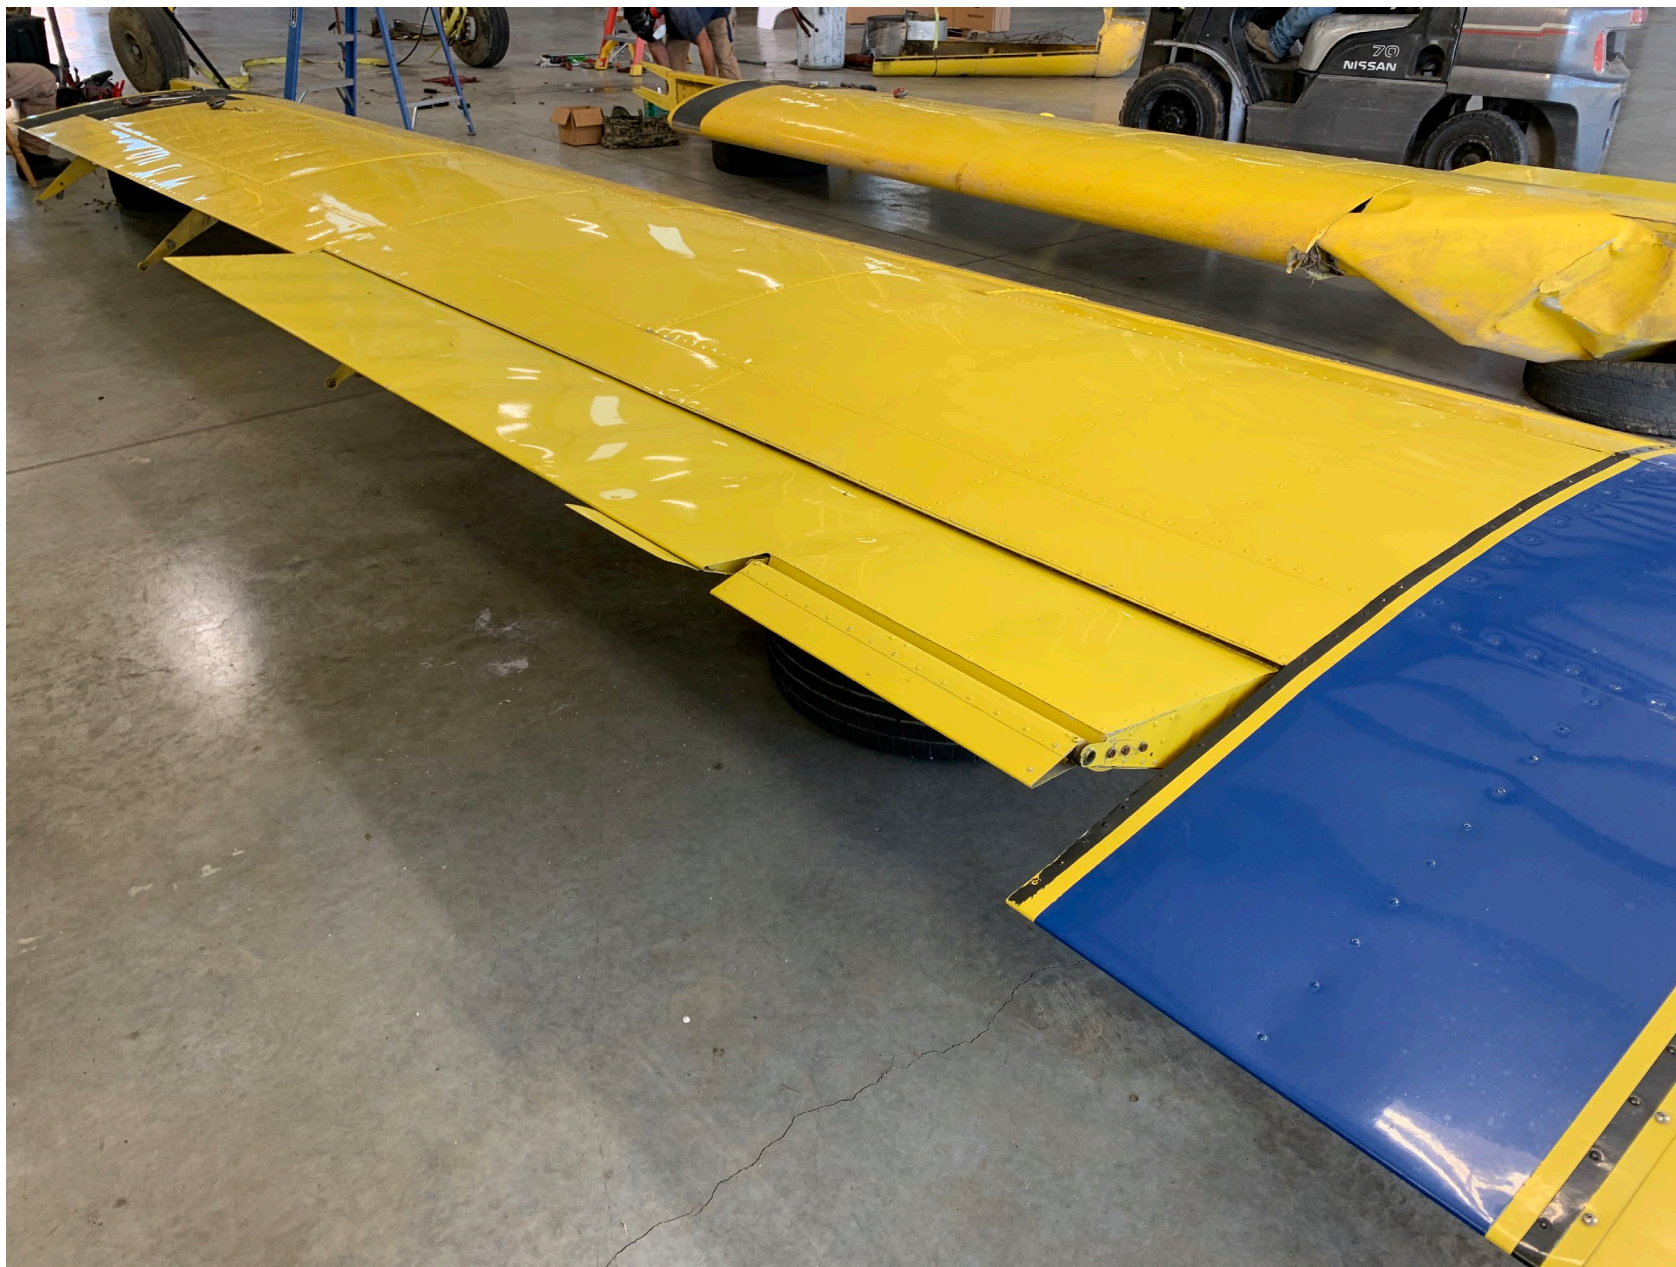
**Photo 10 – View of the wings during the airframe examination.**
