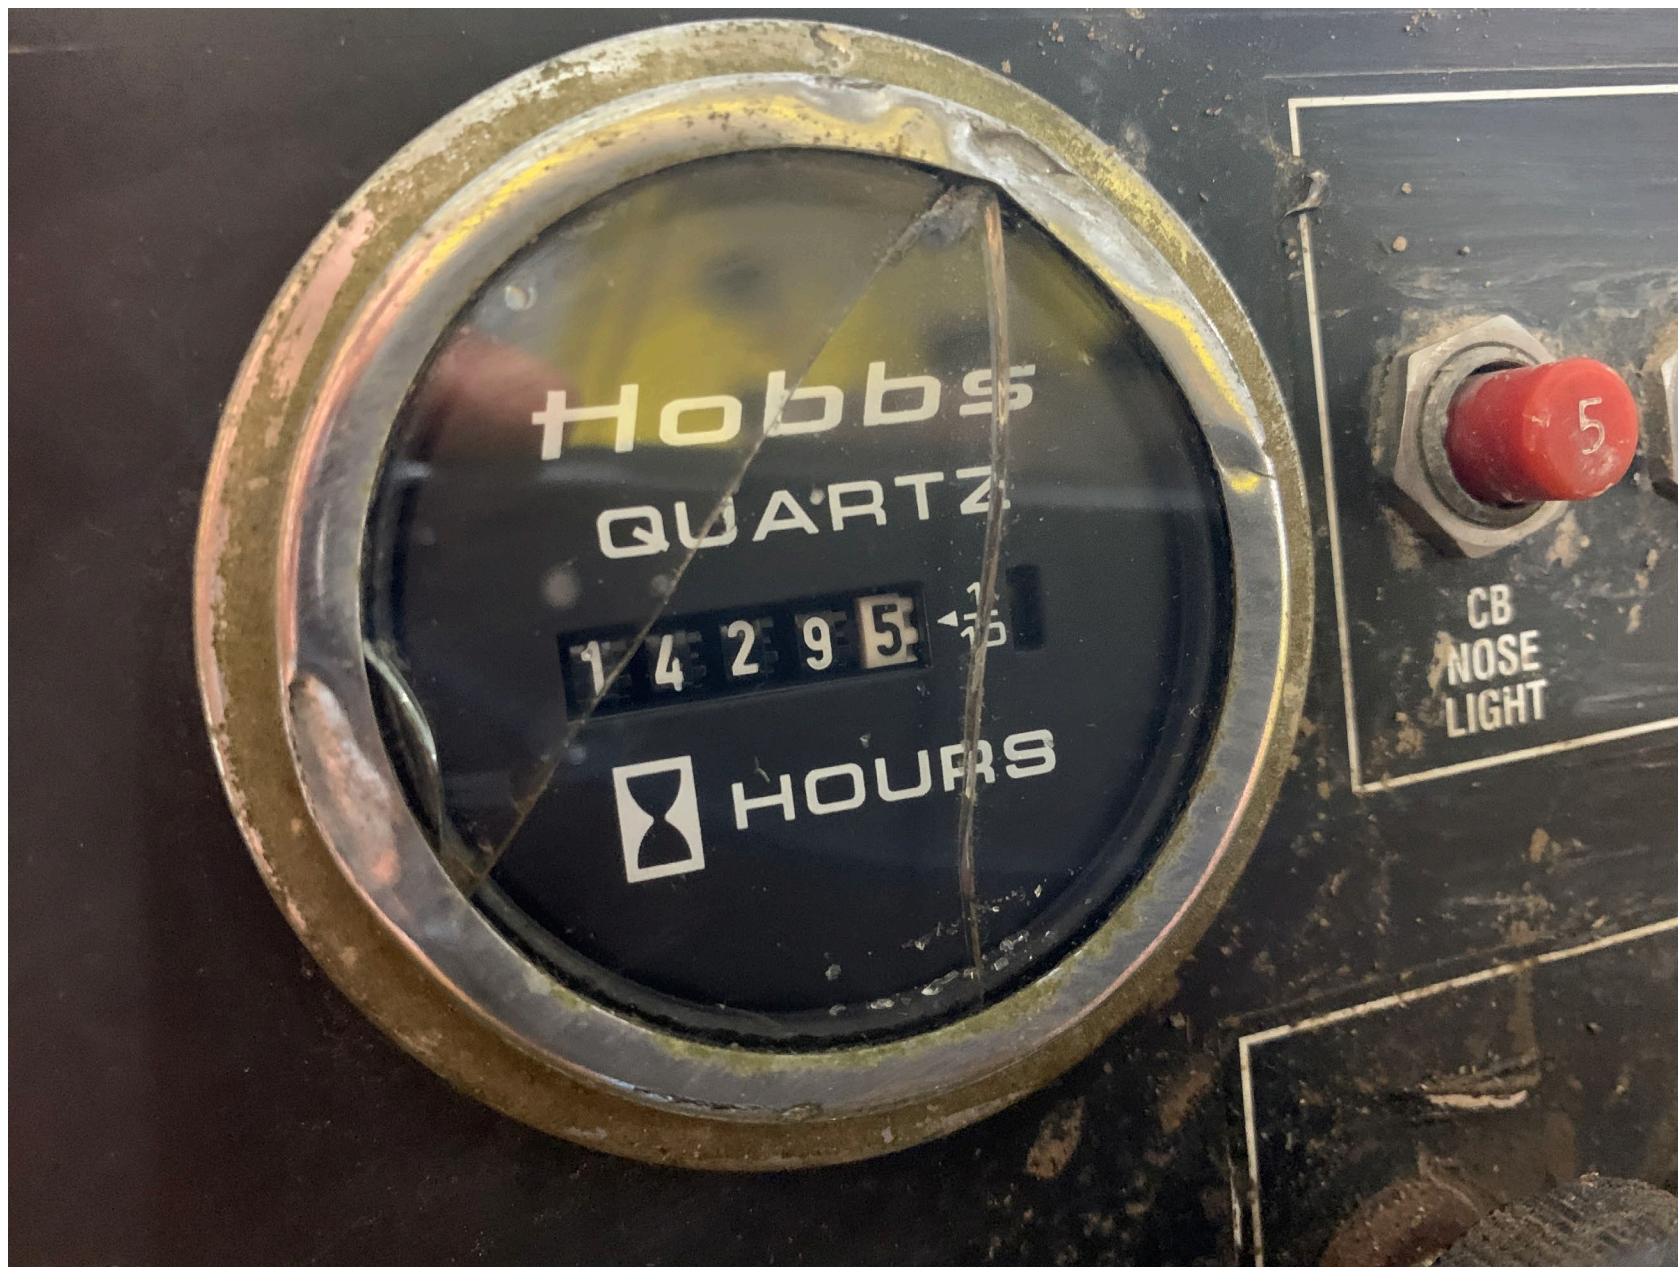
**Photo 11 – View of the Hobbs meter during the airframe examination.**

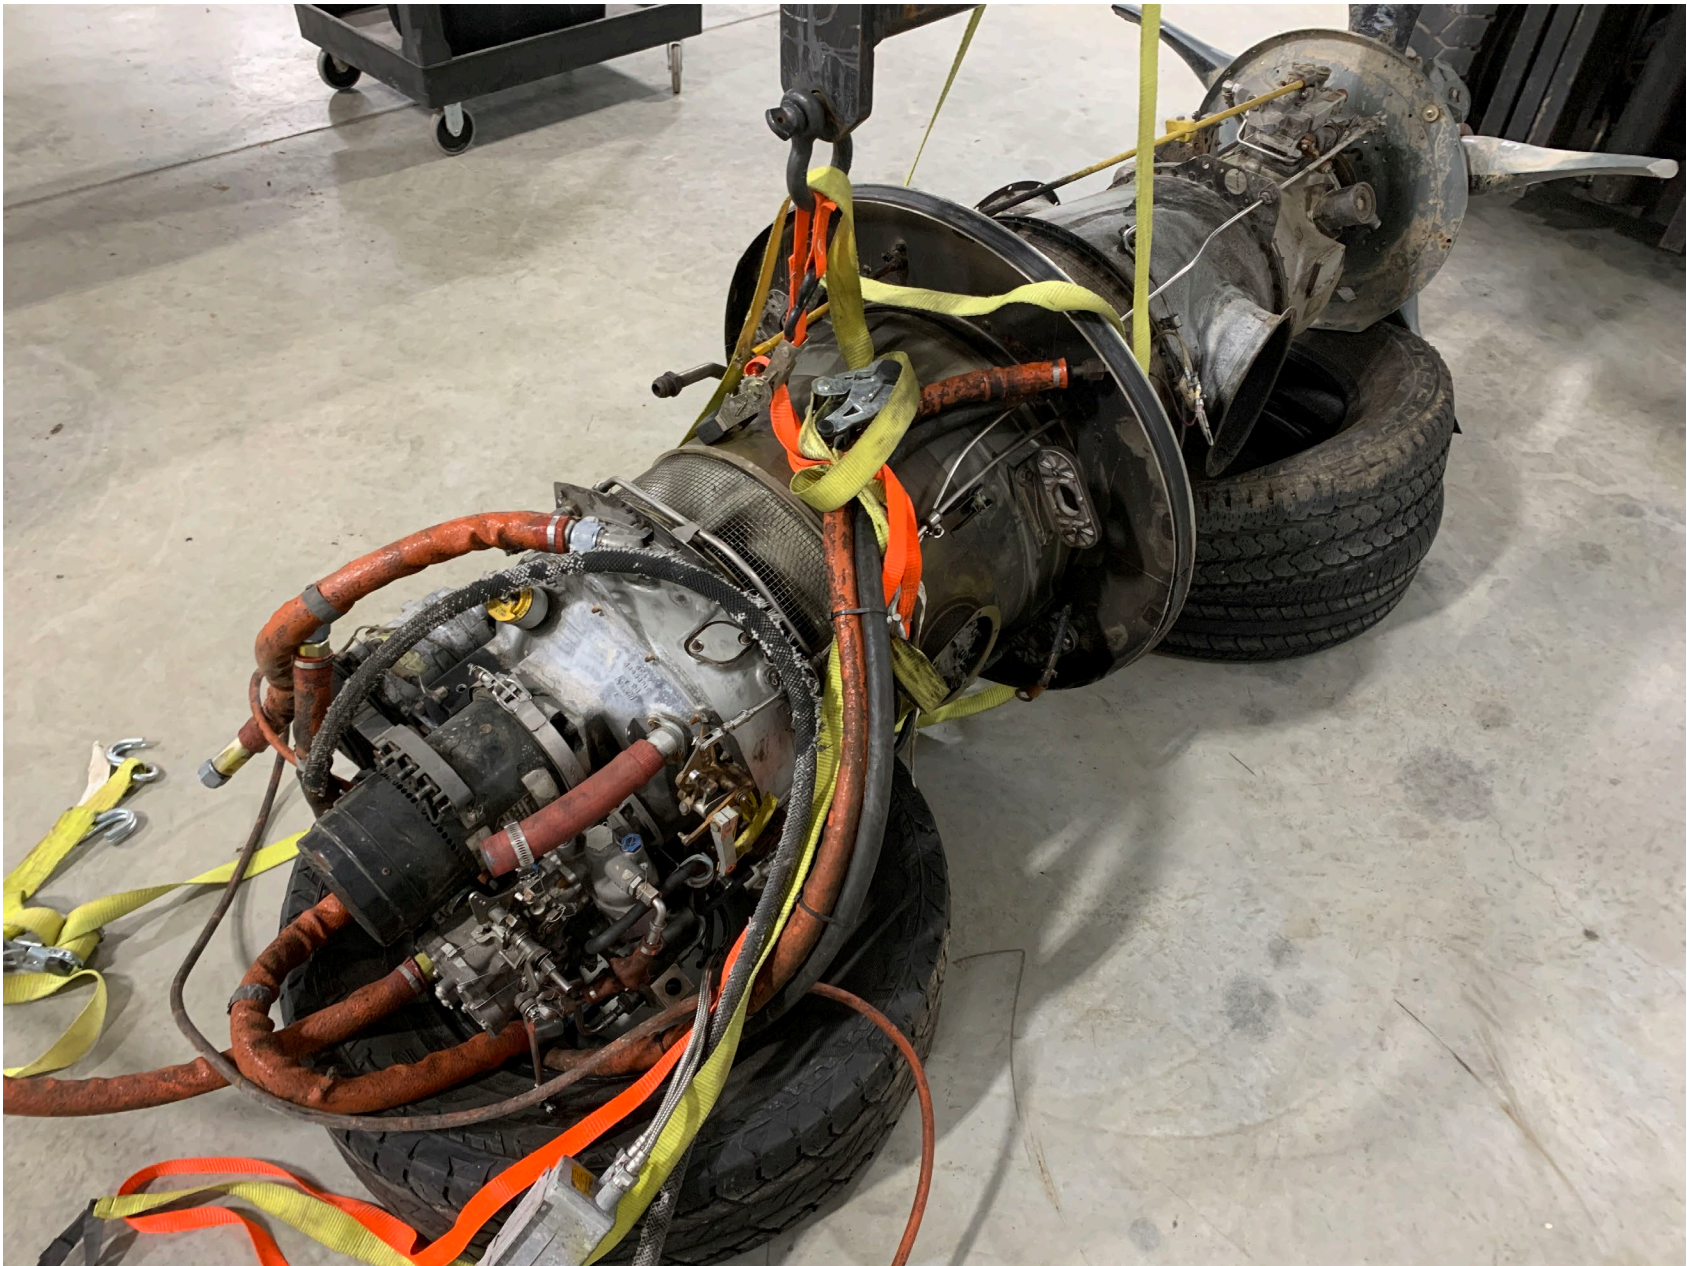
**Photo 12 – View of the engine removed during the airframe examination.**

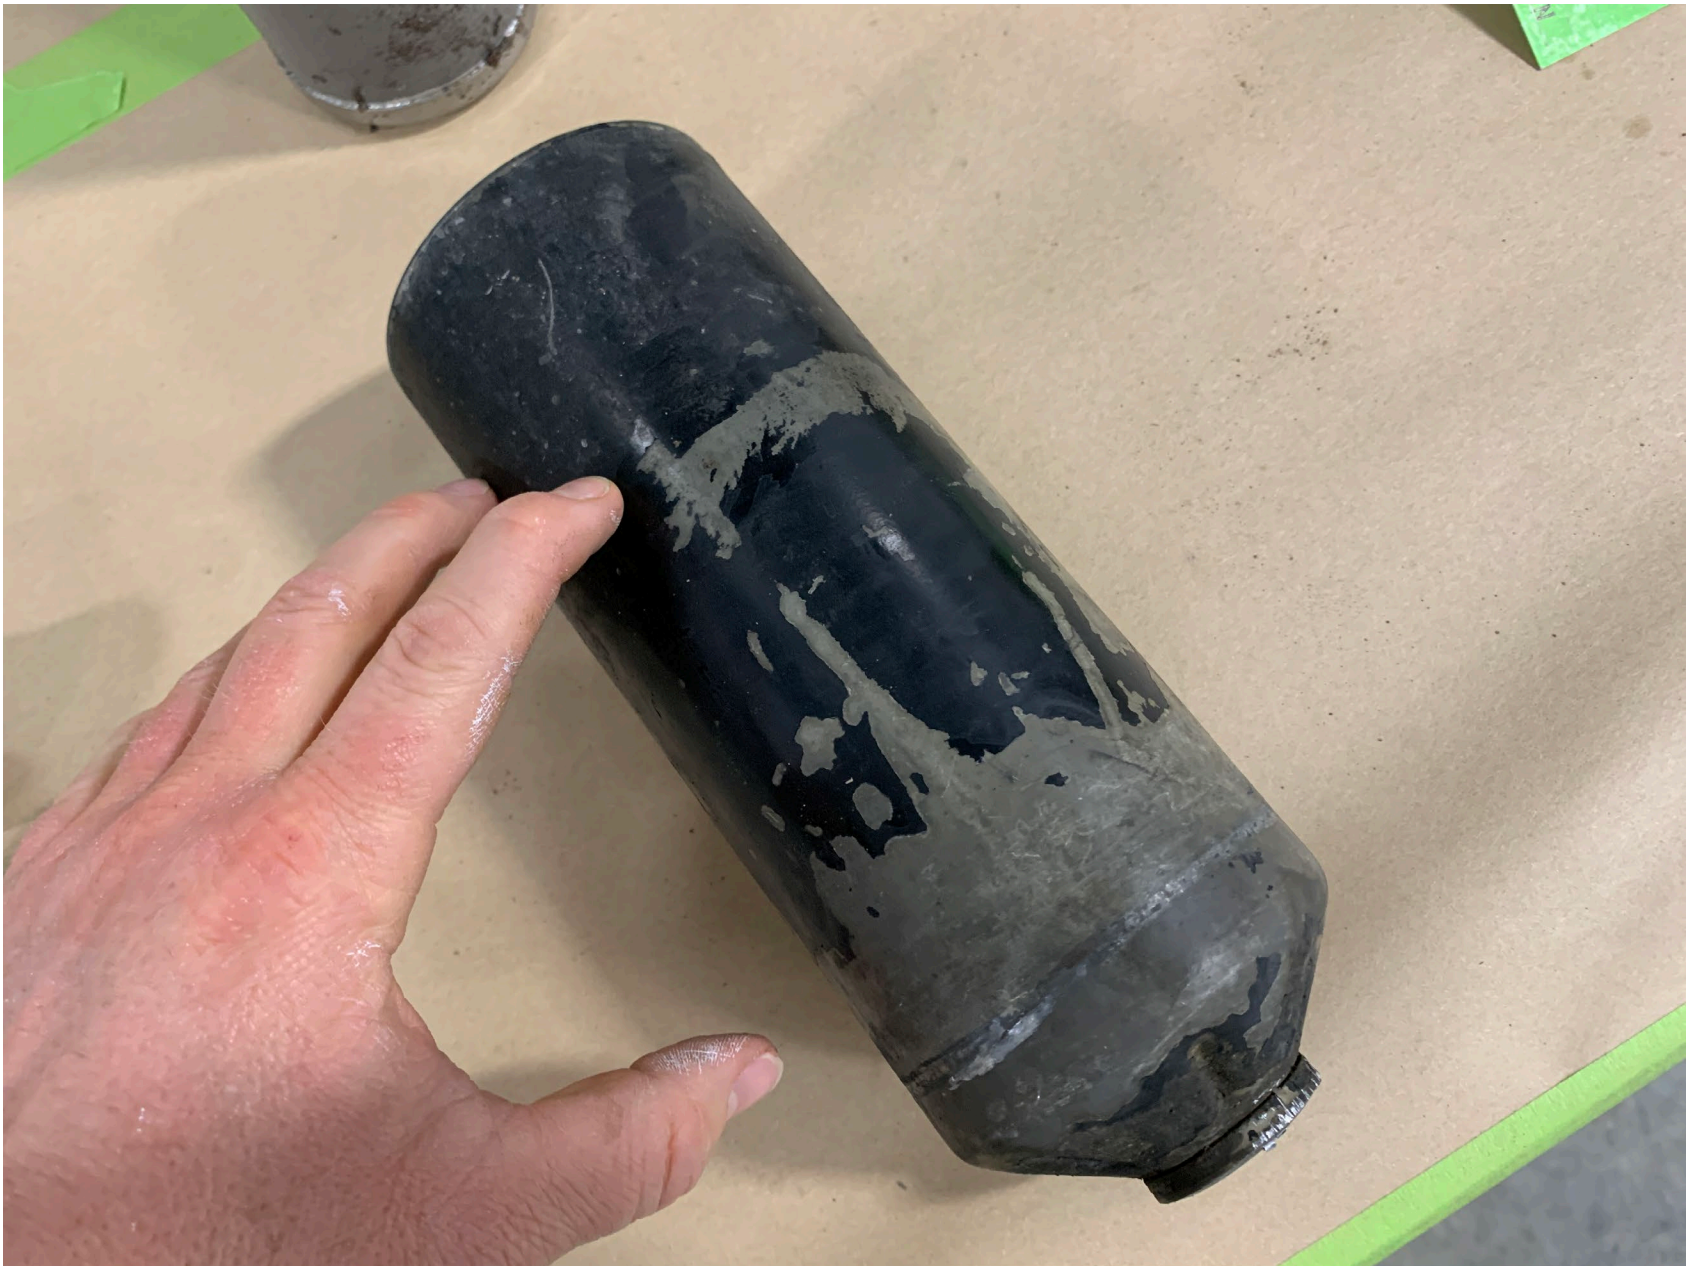
**Photo 13 – View of the firewall fuel filter bowl.**

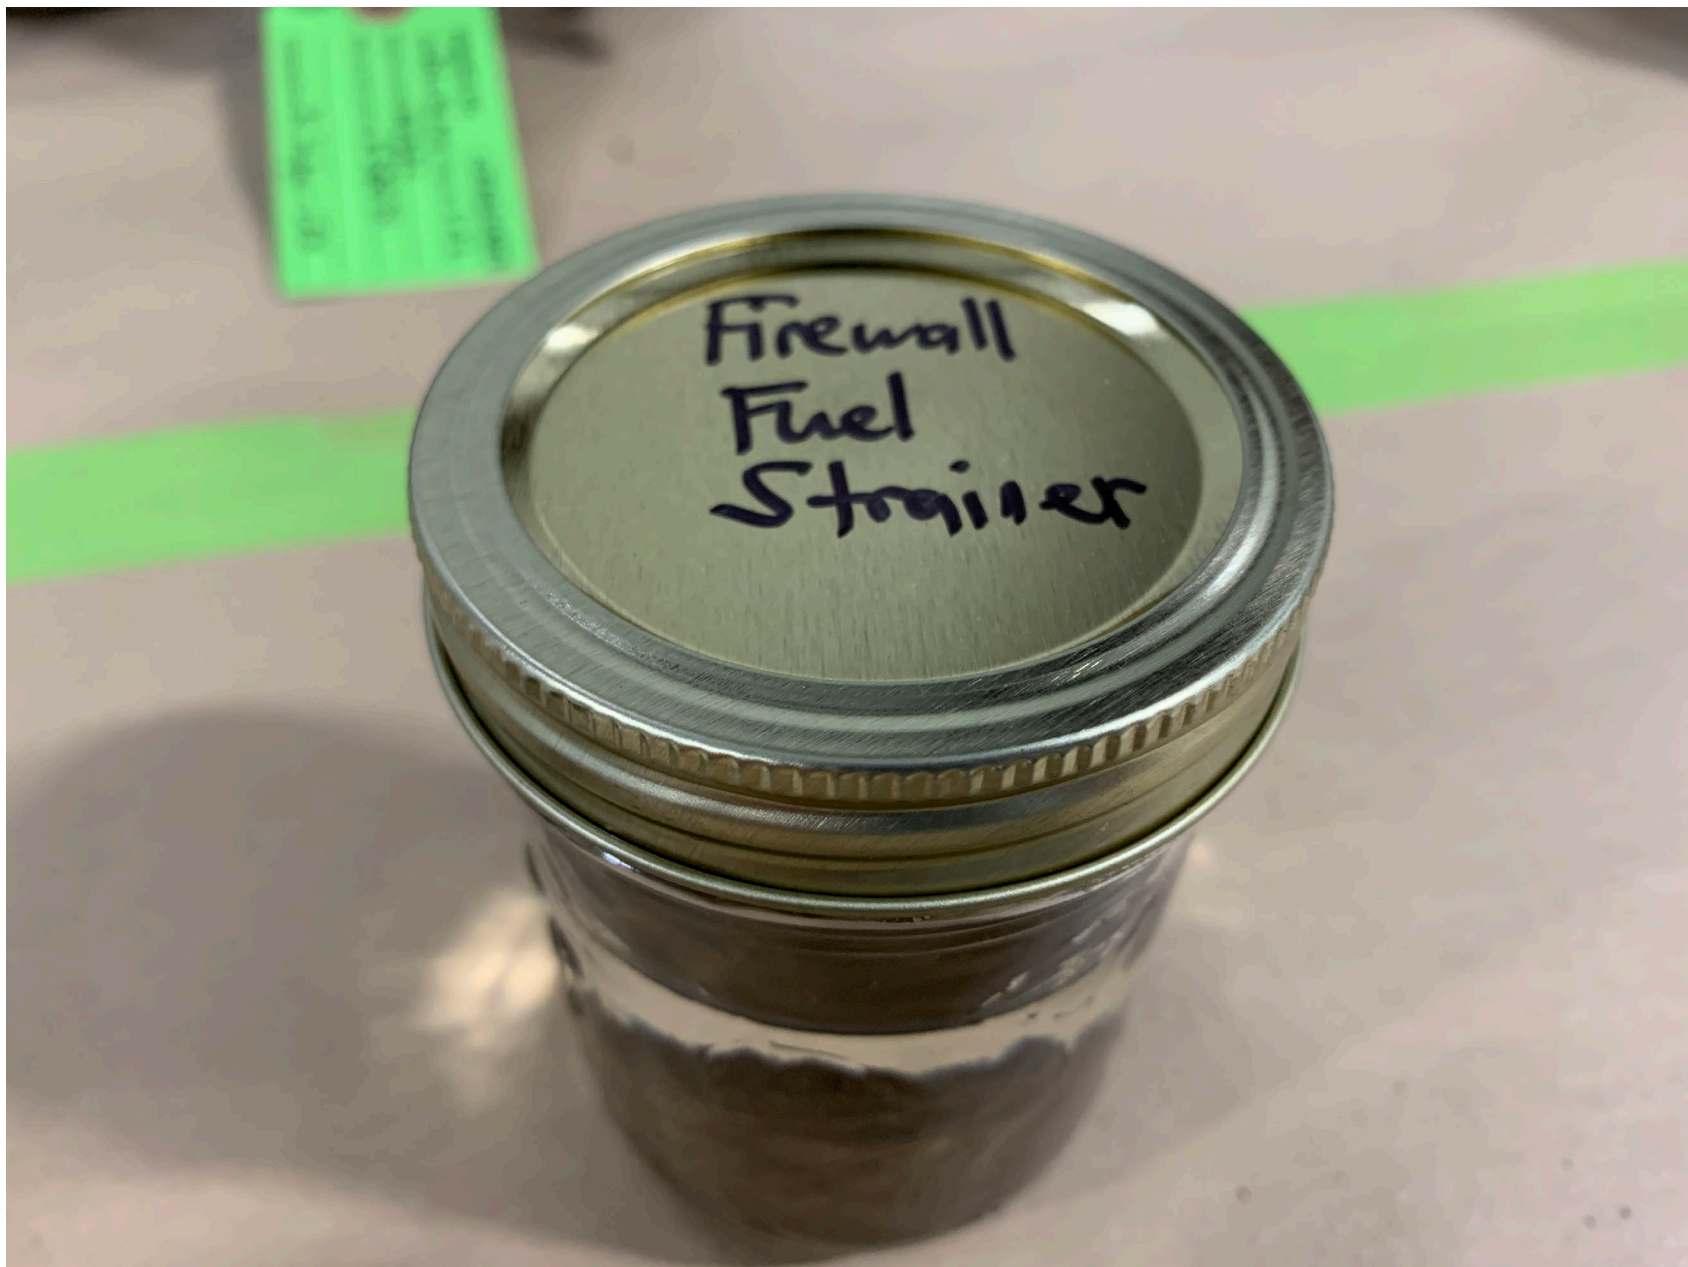
**Photo 14 – View of the fuel sample, with contamination, obtained from the firewall fuel filter bowl.**

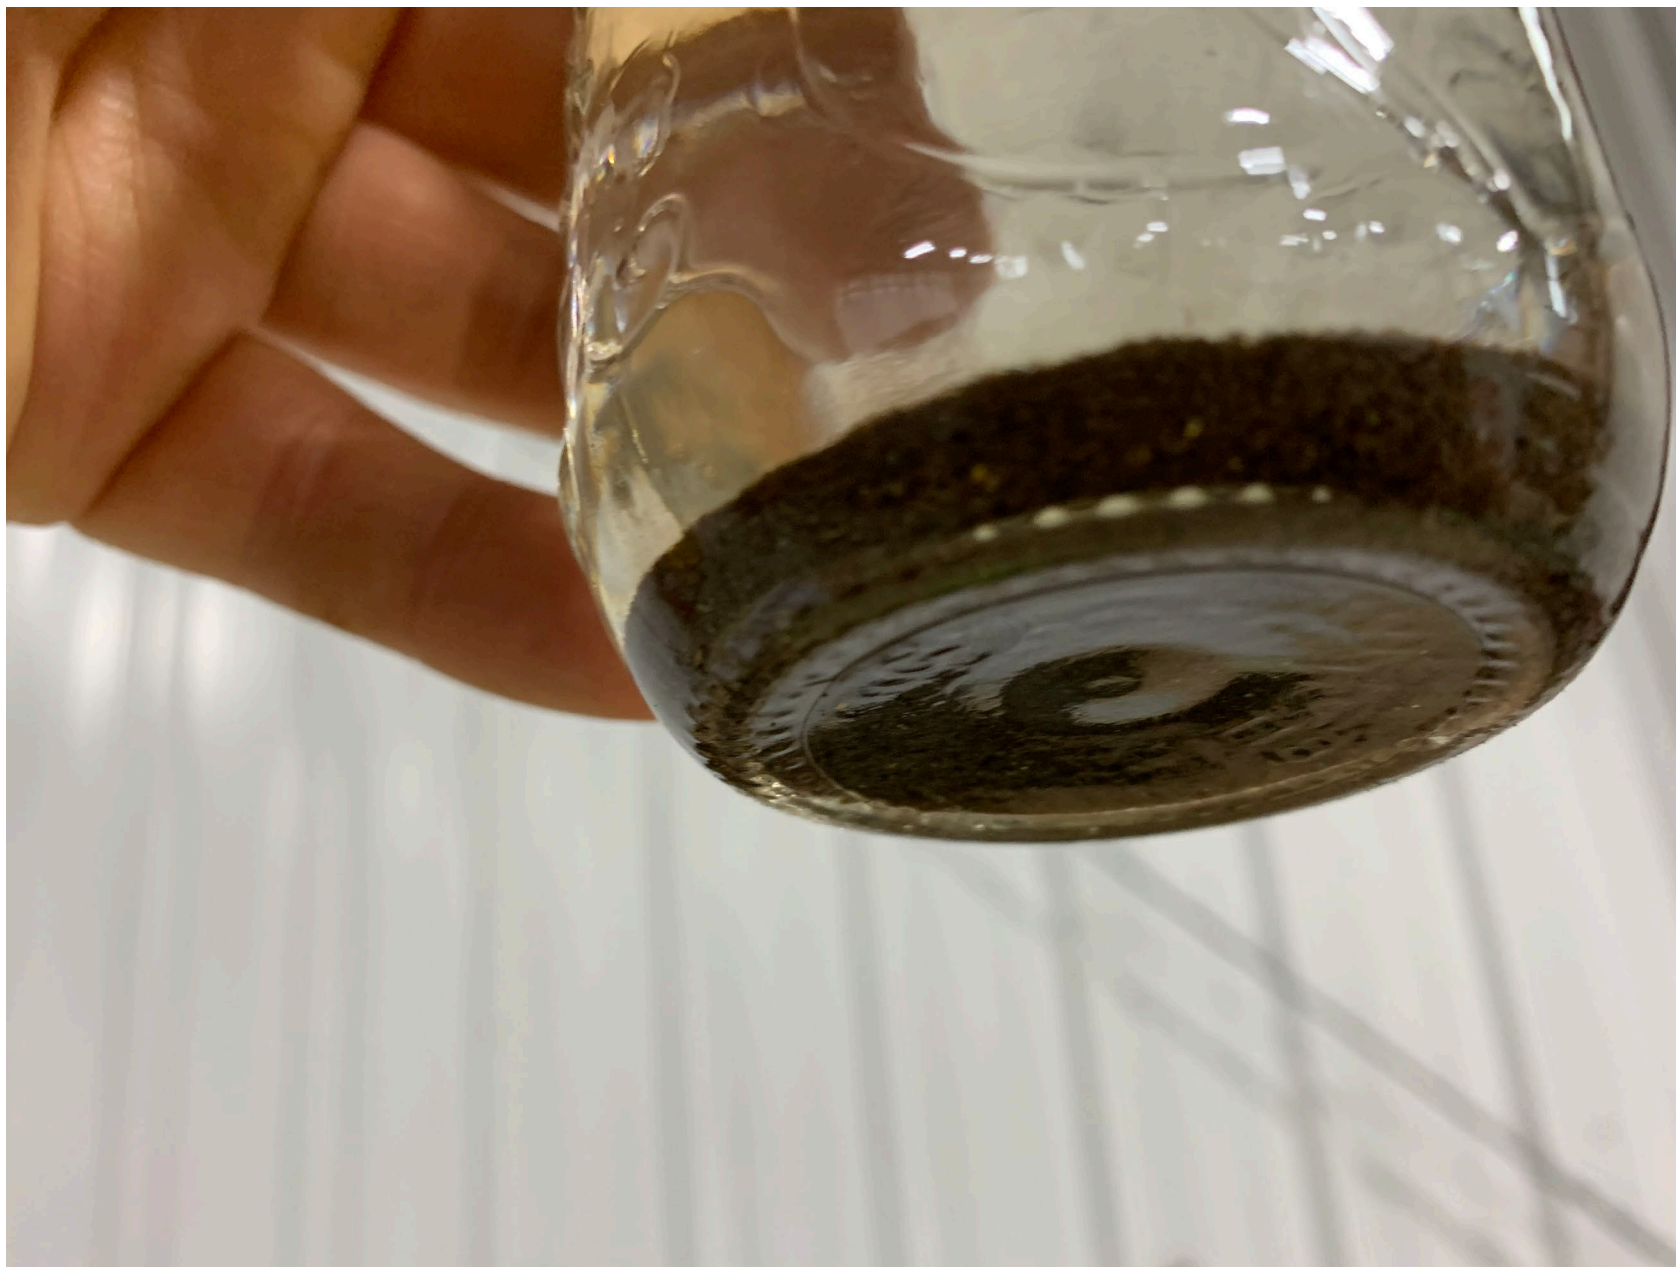
**Photo 15 – View of the fuel sample, with contamination, obtained from the firewall fuel filter bowl.**

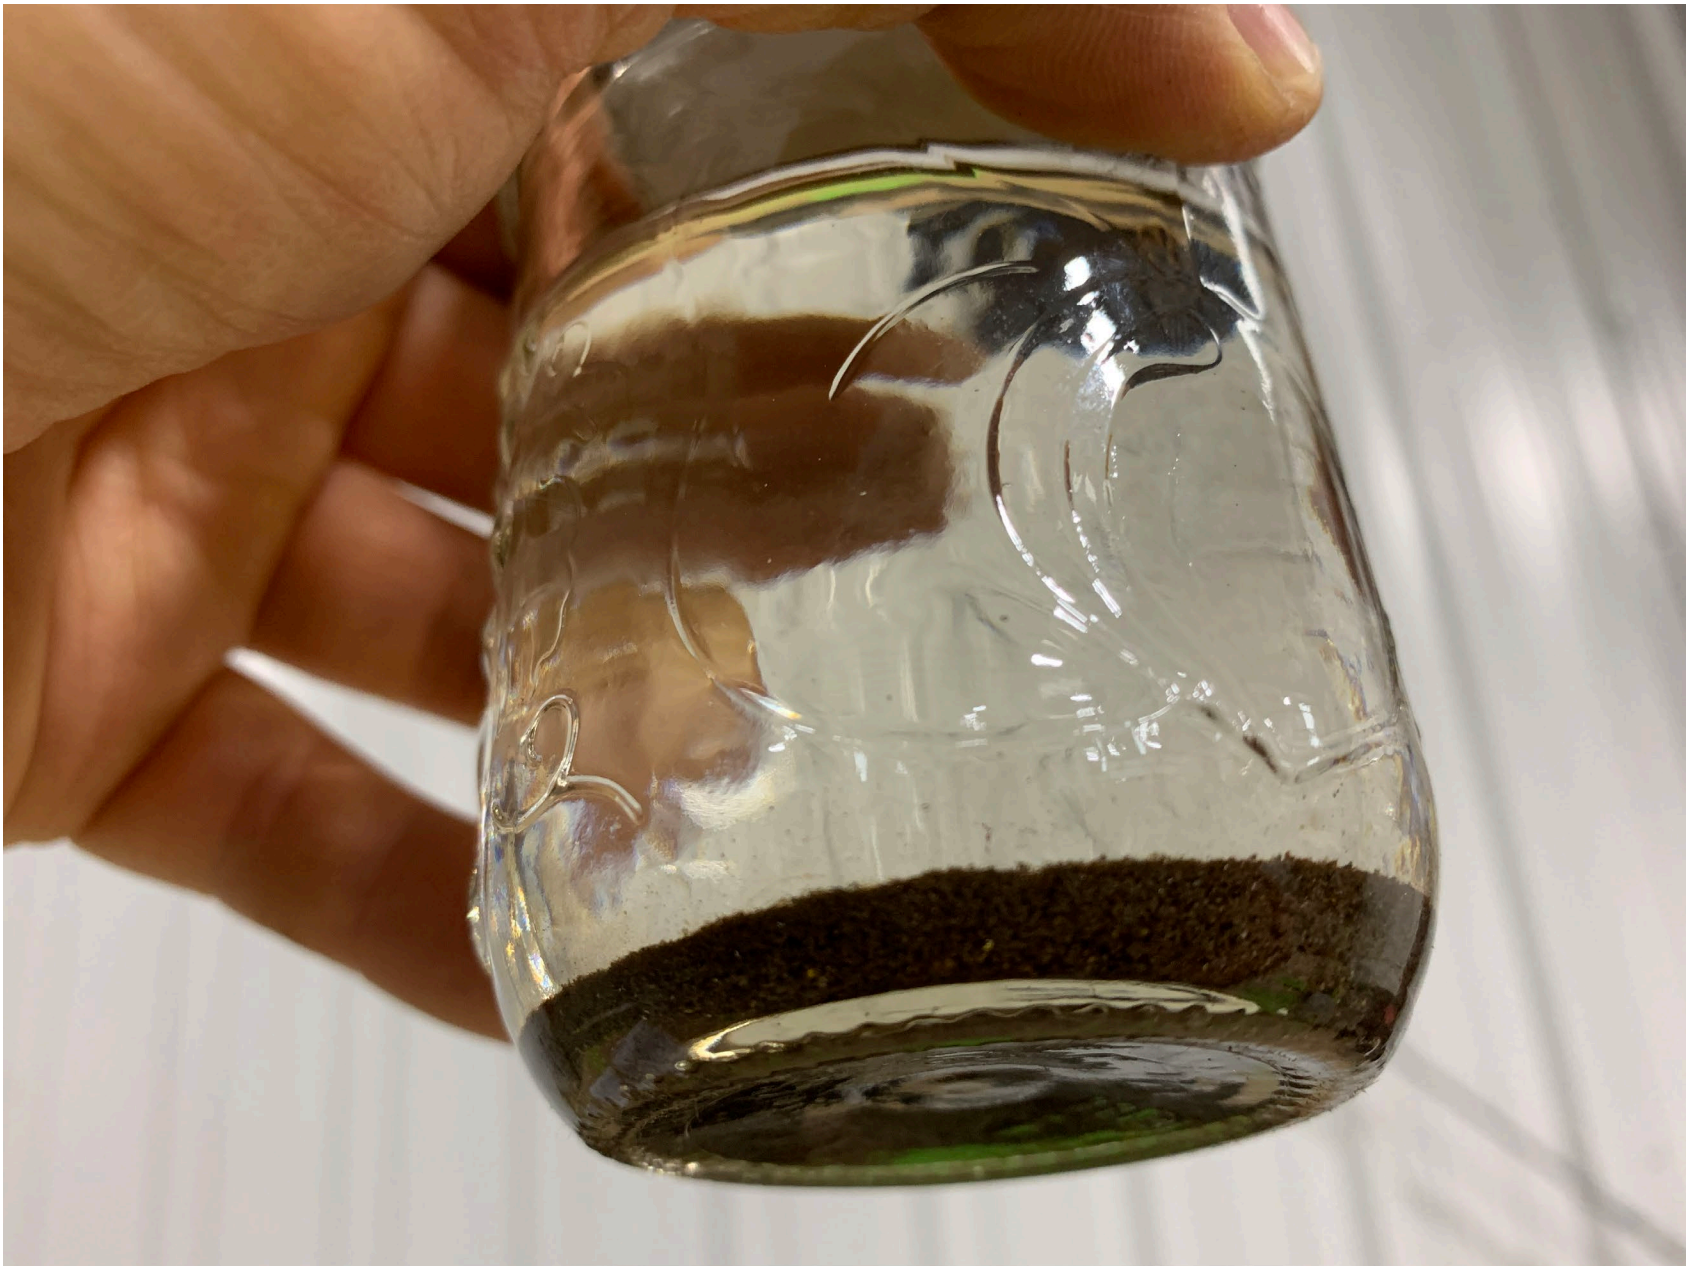
**Photo 16 – View of the fuel sample, with contamination, obtained from the firewall fuel filter bowl.**

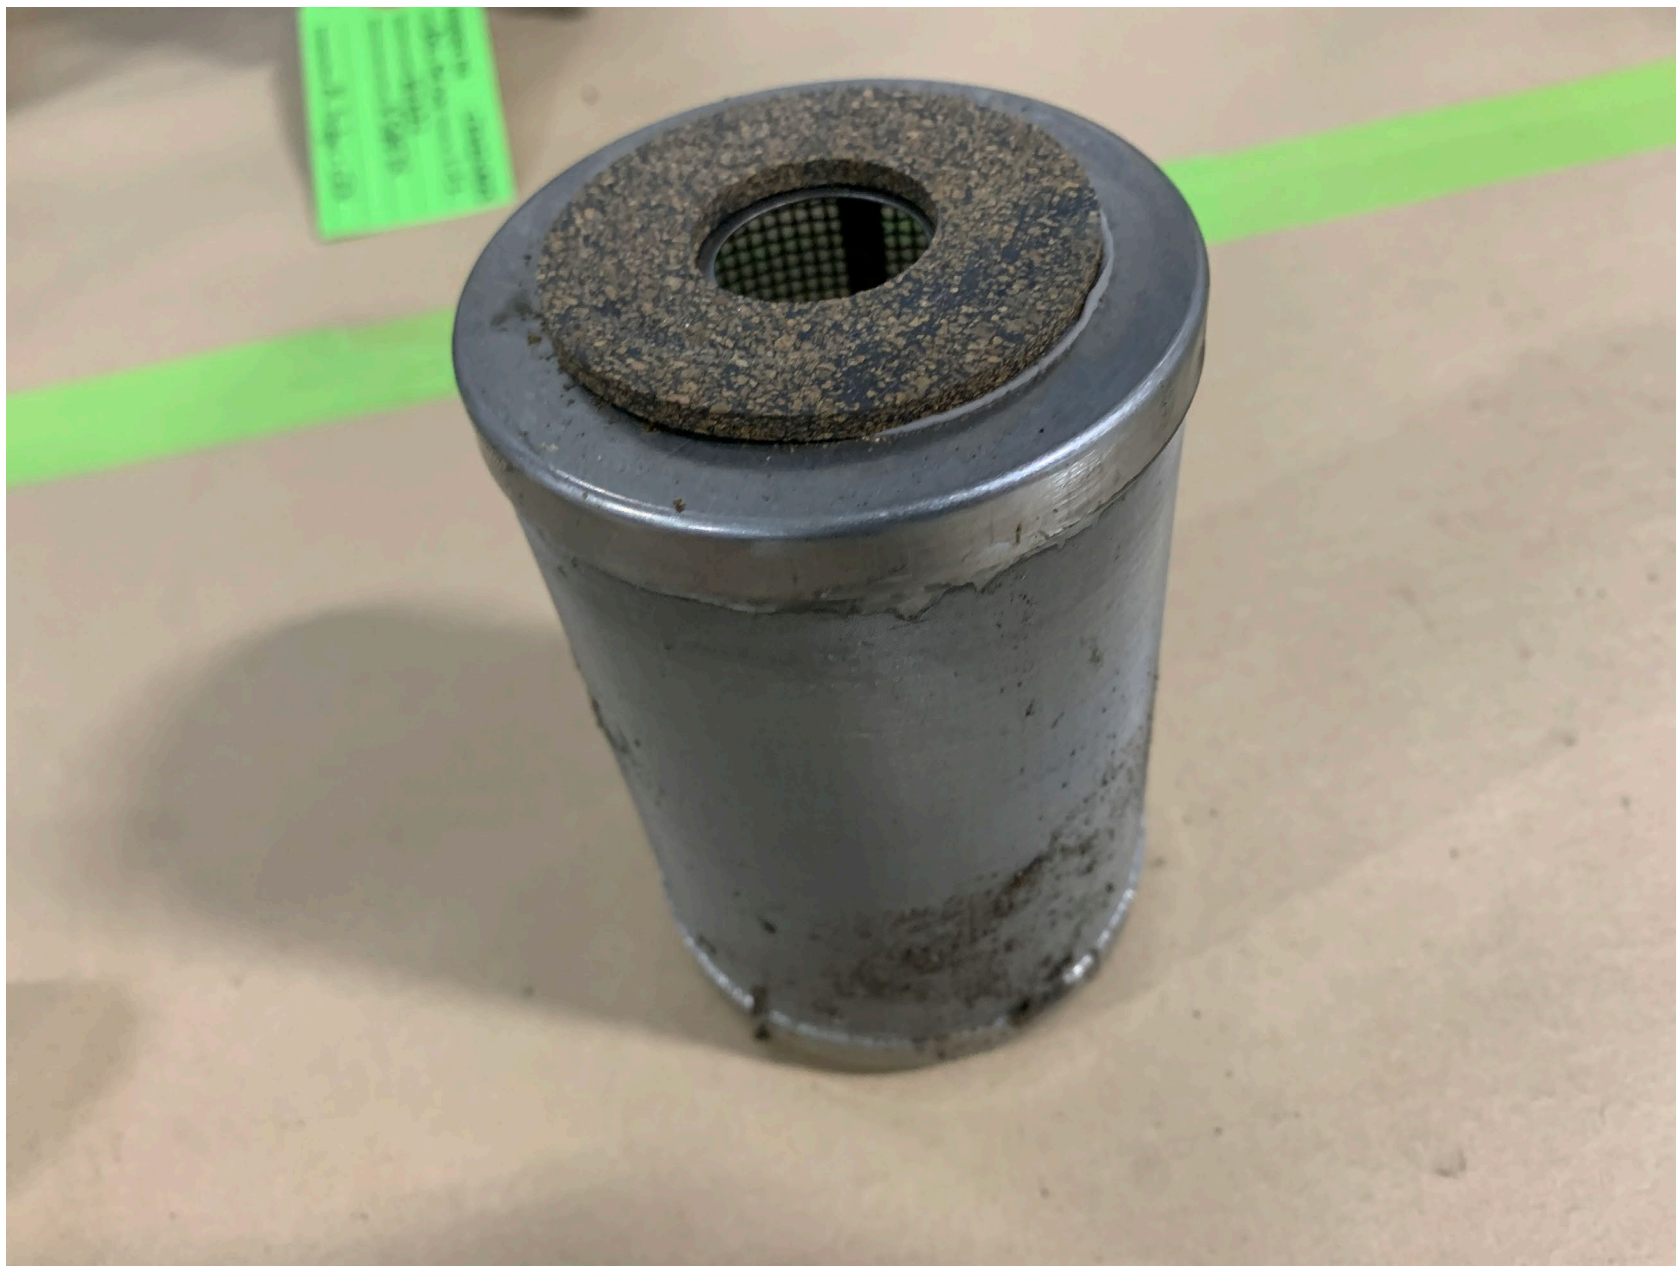
**Photo 17 – View of the firewall fuel filter, with contamination.**

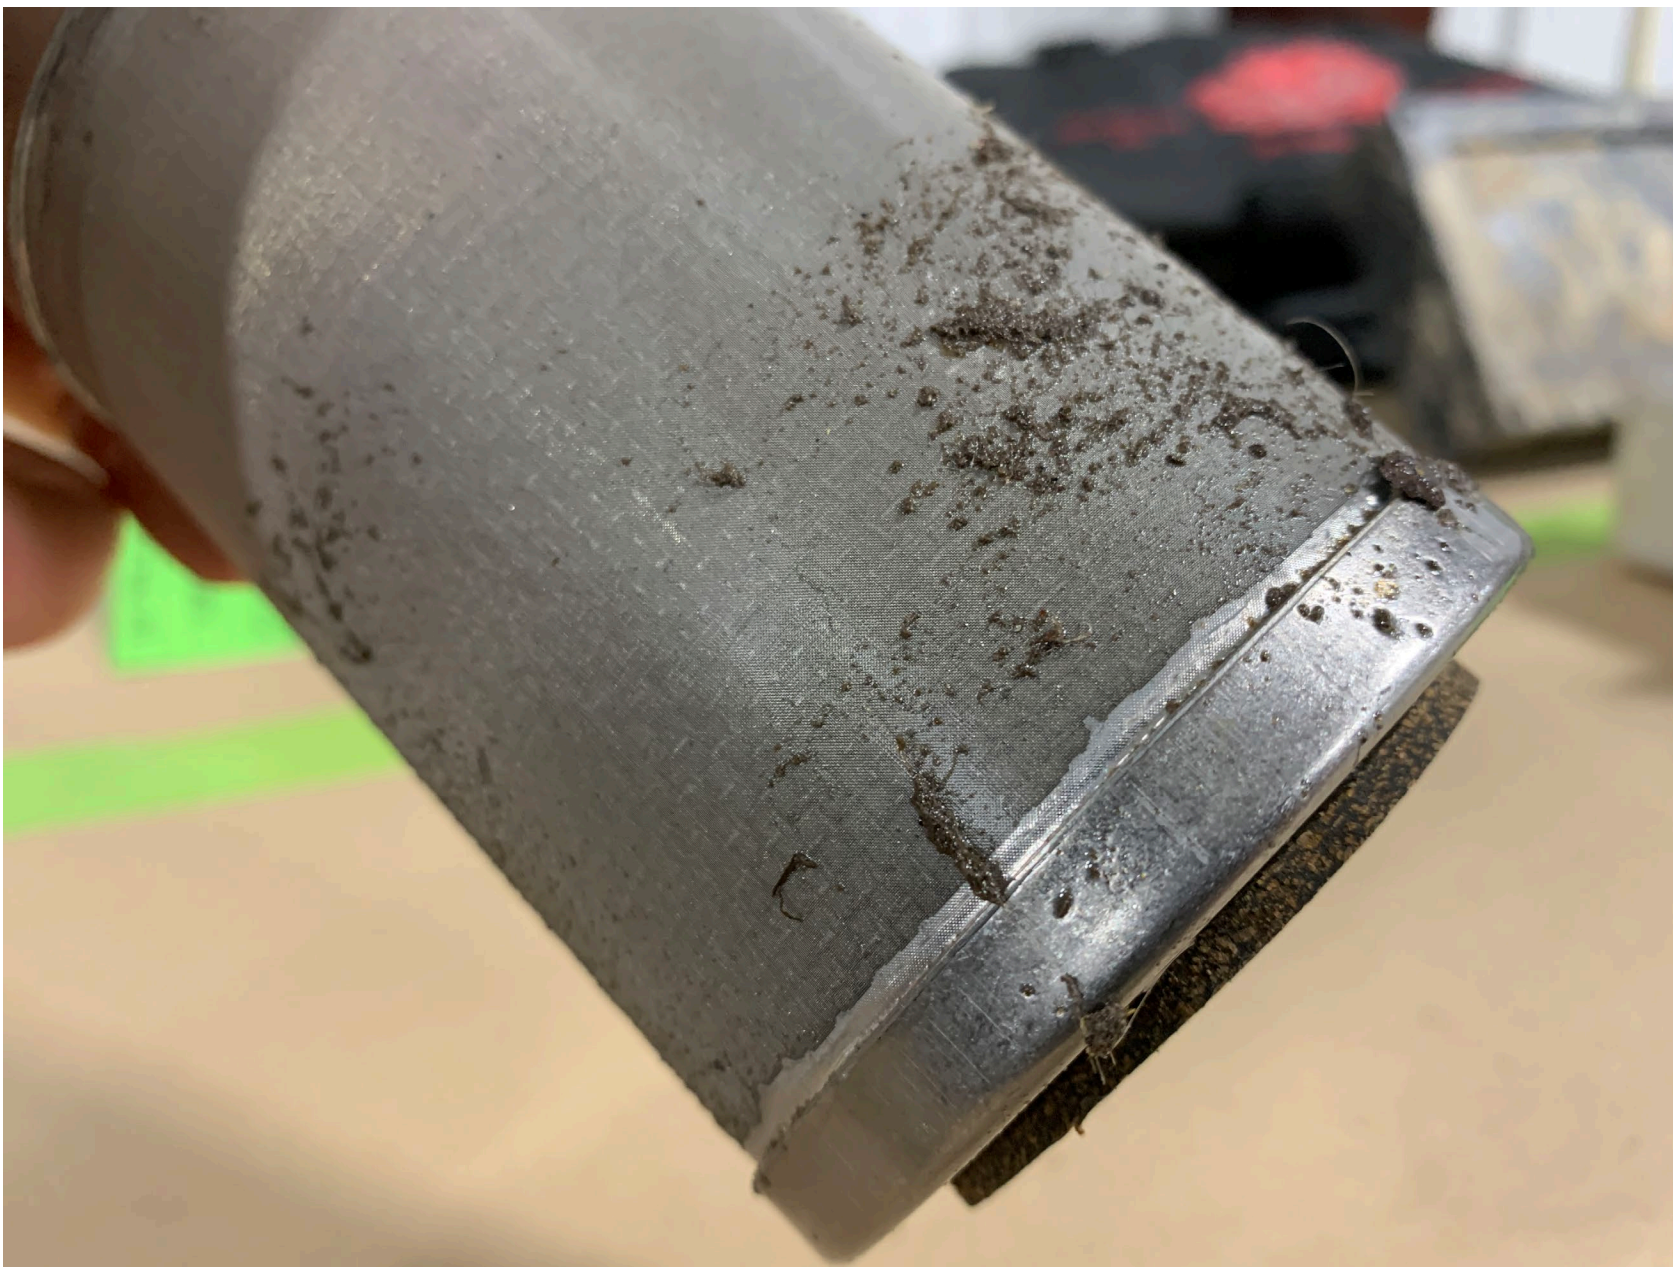
**Photo 18 – View of the firewall fuel filter, with contamination.**

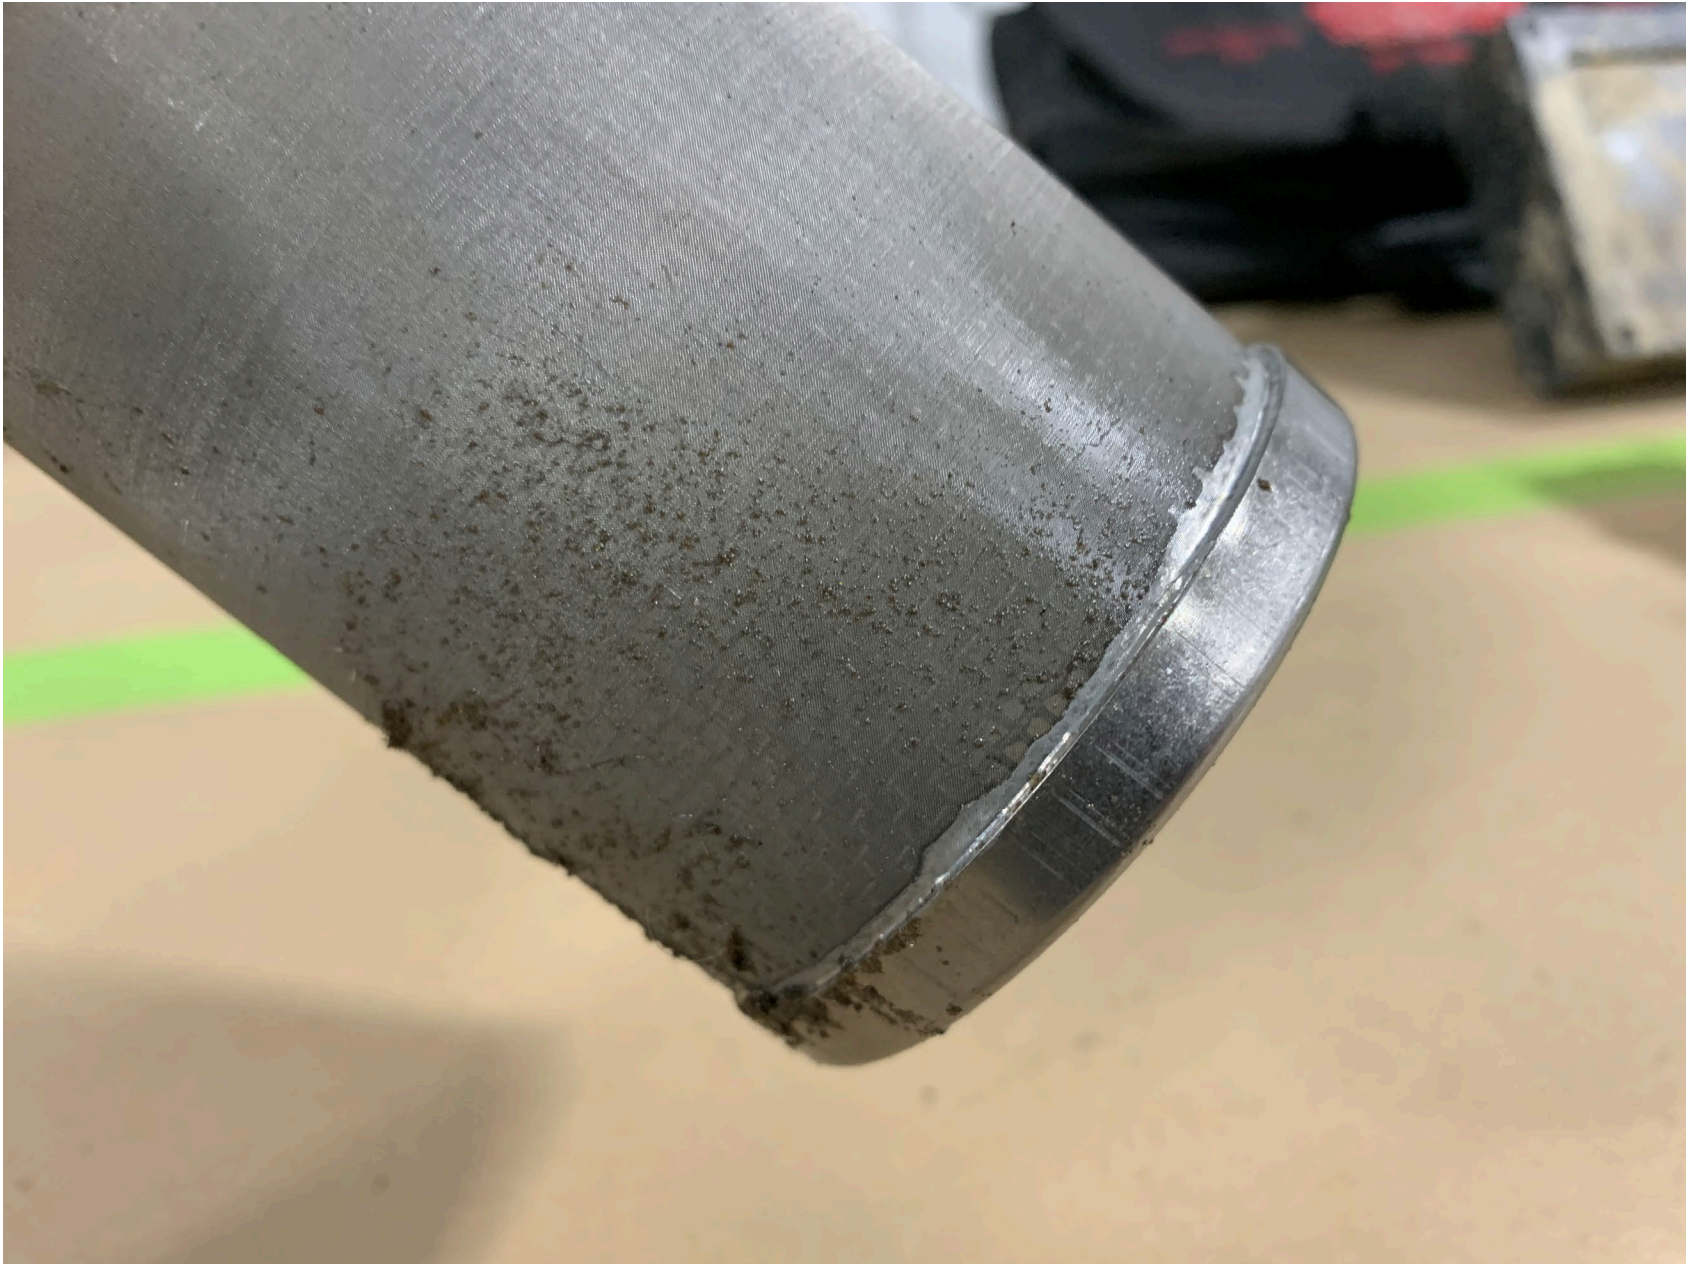
**Photo 19 – View of the firewall fuel filter, with contamination.**

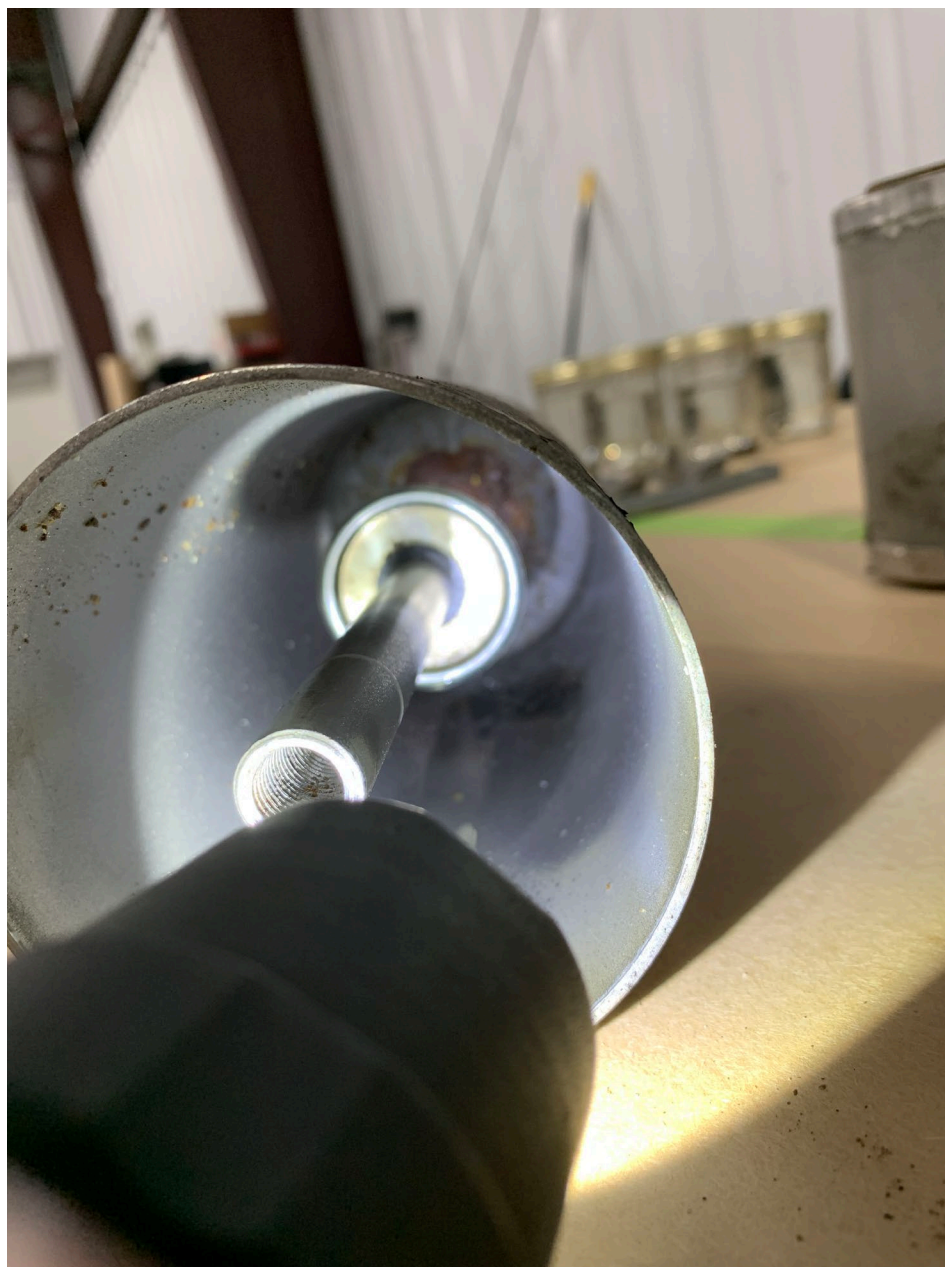
**Photo 20 – View of the inside of the firewall fuel filter bowl, with contamination.**
