**NTSB File No.:** CEN22LA228

**Aircraft:** Air Tractor AT-602

**Registration No.:** N5007R

**Written by:** Les Doud  
Air Safety Investigator – Hartzell Propeller Inc.

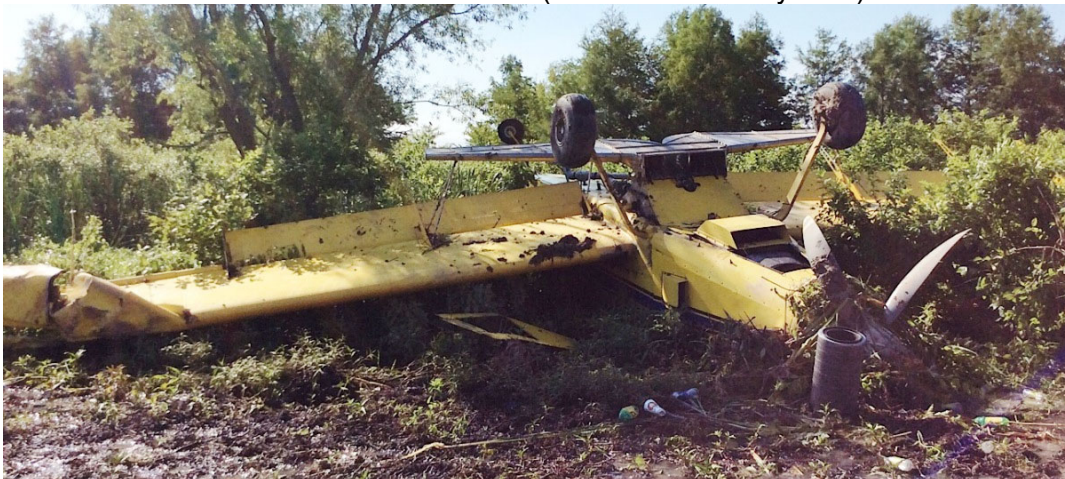
The accident propeller remained attached to the engine propeller shaft flange throughout the impact sequence with all five blades attached as shown in Photo #1. The aircraft wreckage was recovered to Dawson Aircraft Parts & Salvage in Clinton, AR as shown in Photo #2. The blades were cut approximately 12" outboard of the blade clamps (Photo #3) to facilitate shipping to the Pratt & Whitney Engine Services (PWC) in Bridgeport, WV. The propeller was removed from the engine shaft flange and disassembled at PWC to remove the piston, blade clamps and shanks. Measurements of impact marks on the cylinder surface and piston internal surface were recorded and analyzed to aid in blade angle determination. Blade damage was assessed to aid in determination of blade section impact angles and thus engine power state at initial impact.

Photo #1 - Aircraft in-situ (Photo Provided by FAA)

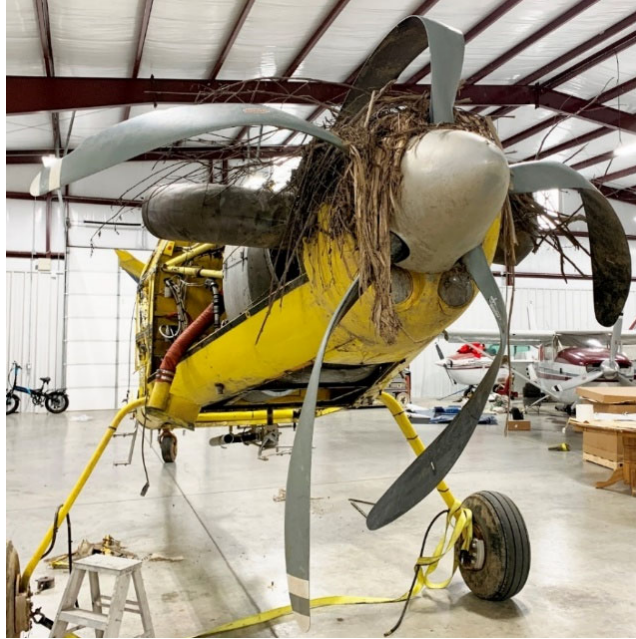
Photo #2 - Aircraft after recovery at Dawson's (photo provided by NTSB)

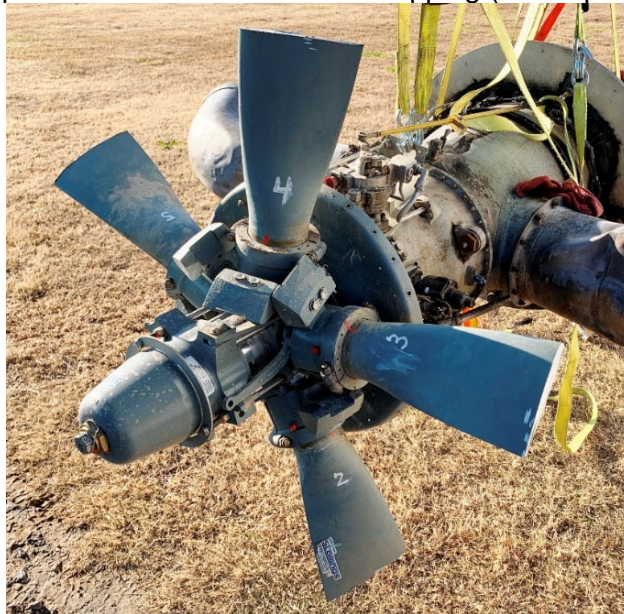
Photo #3 – Propeller blades cut to facilitate shipping (Photo provided by NTSB)

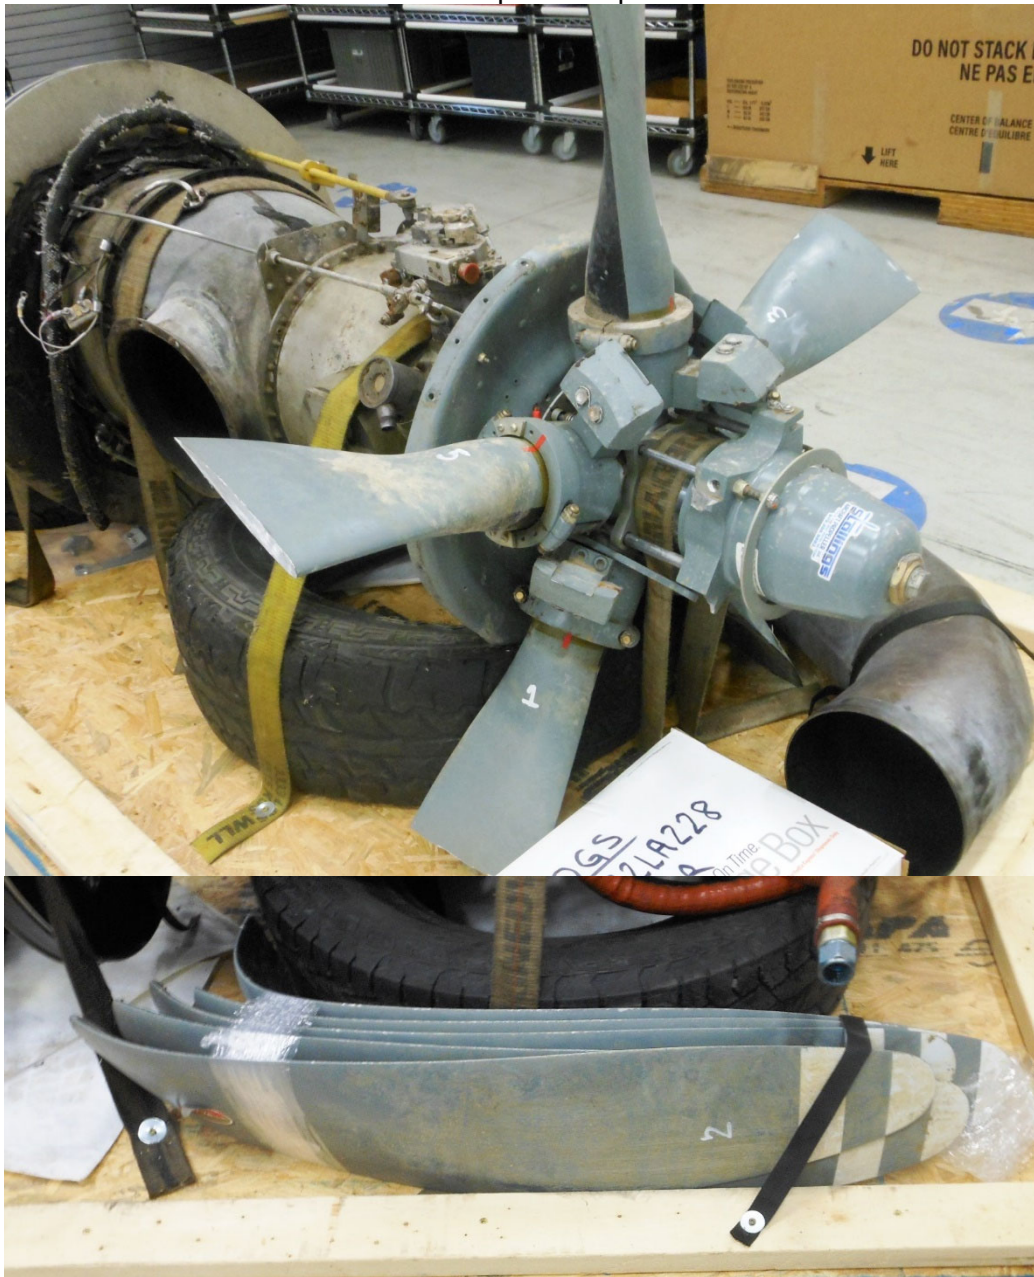
**“As Received” Condition:** The propeller remained attached to the engine propeller shaft flange throughout the impact sequence and is shown in-situ in Photo #1. The aircraft was recovered to Dawson Aircraft Parts & Salvage for examination and disassembly as shown in Photo #2. All blades were cut at approximately 12” from the blade clamp to facilitate shipment inside of the engine crate. The propeller was shipped to Pratt & Whitney Canada in Bridgeport, WV and arrived for examination as shown in Photo #4.

Photo #4 – Propeller as-presented

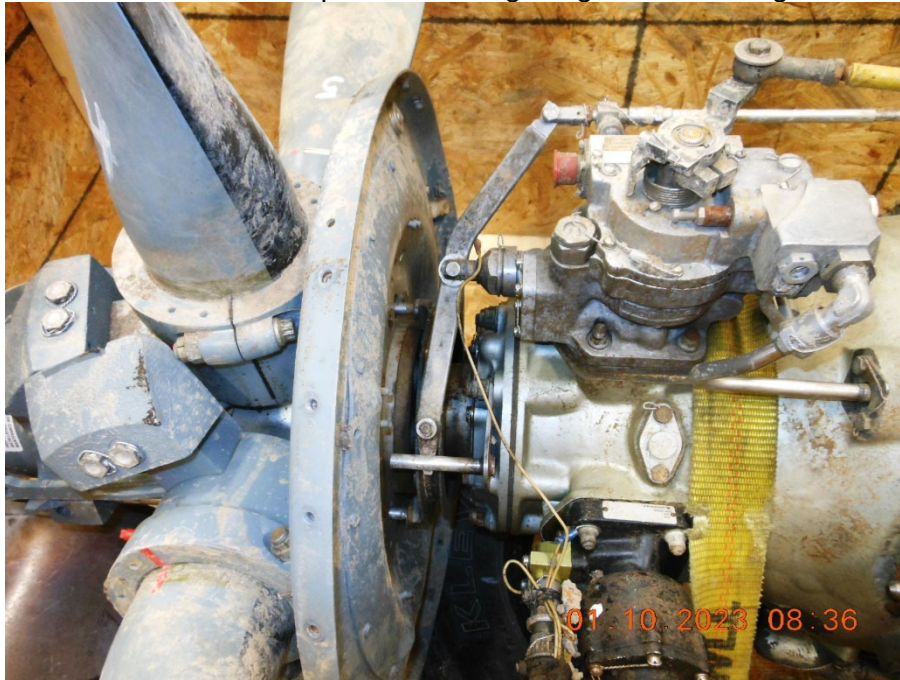
There appeared to be propeller control continuity via the propeller governor beta arm, carbon block and beta ring. All were intact and properly positioned under the retaining

pin (Photo #5). All eight propeller mounting bolts were secure and lockwired with no evidence of oil leaks from the propeller or propeller flange.

Photo #5 – Propeller mounting flange and beta ring

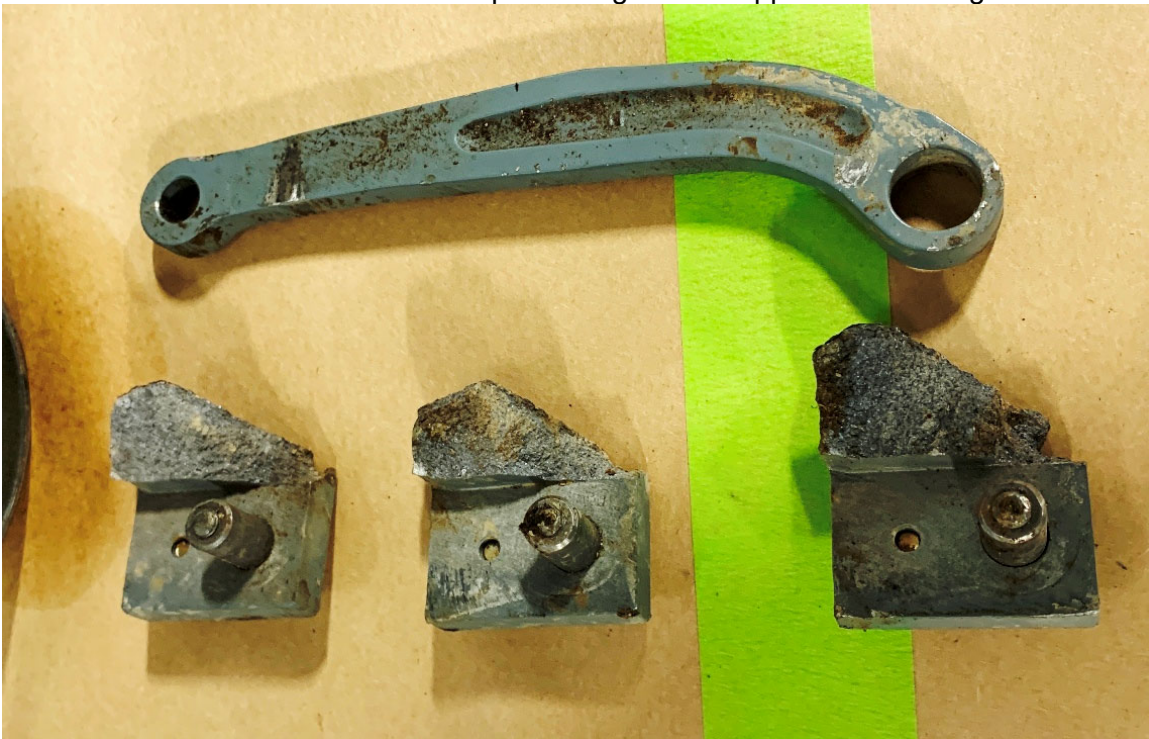
Three fragments of the piston at the link pin connections and the #5 link arm were recovered in the wreckage and shipped loose as shown in Photo #6. The slip indicators on all five blades showed no slippage/rotation of the blades within the clamps.

Photo #6 - Link arm and piston fragments shipped loose in bag

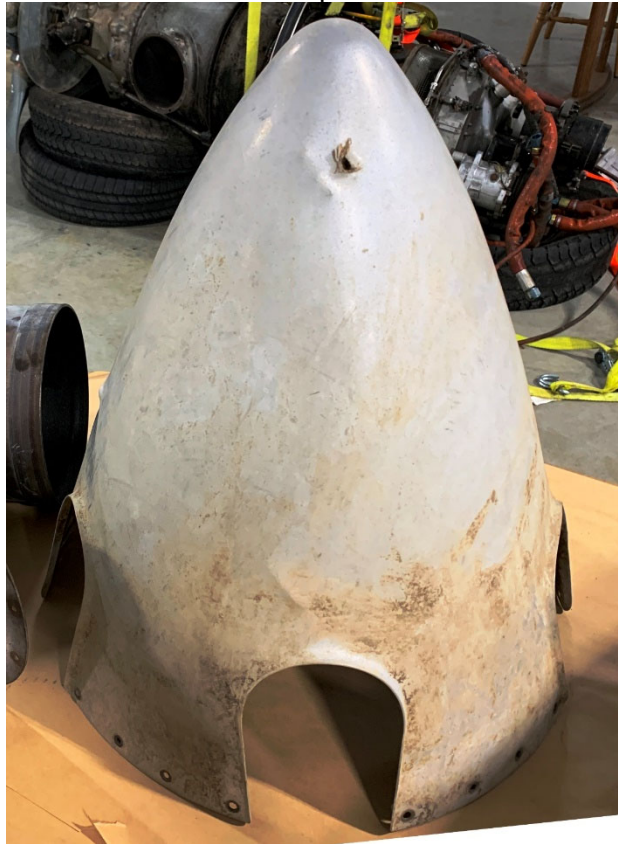
**Spinner Dome:** The spinner dome was intact with relatively little damage as shown in Photo #7. There was one, small puncture near the nose. There were no discernable counterweight impressions in the dome.

Photo #7 – Spinner dome

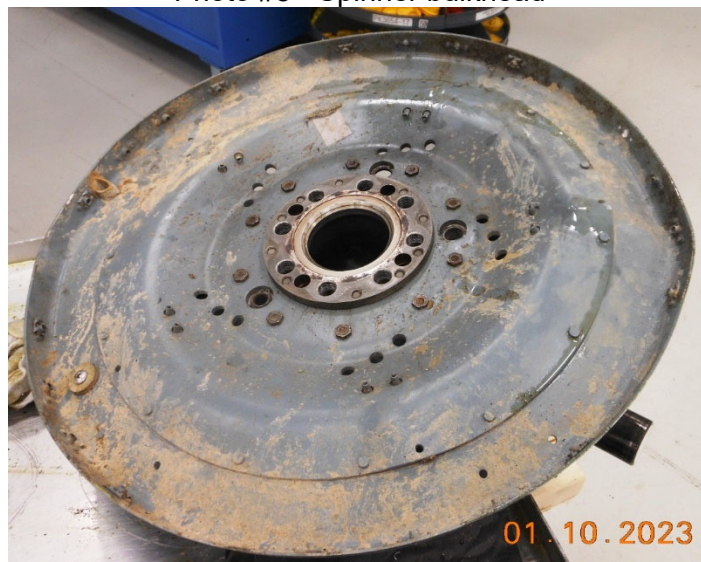
**Spinner Bulkhead:** The spinner bulkhead was intact and had some localized bending of the dome mounting flange (Photo #8). The bulkhead remained secure to the hub unit. There were three counterweight impact marks adjacent to the #1, #2 and #3 blade arms indicating over-rotation of those clams past the reverse stop sometime during the impact sequence.

Photo #8 - Spinner bulkhead

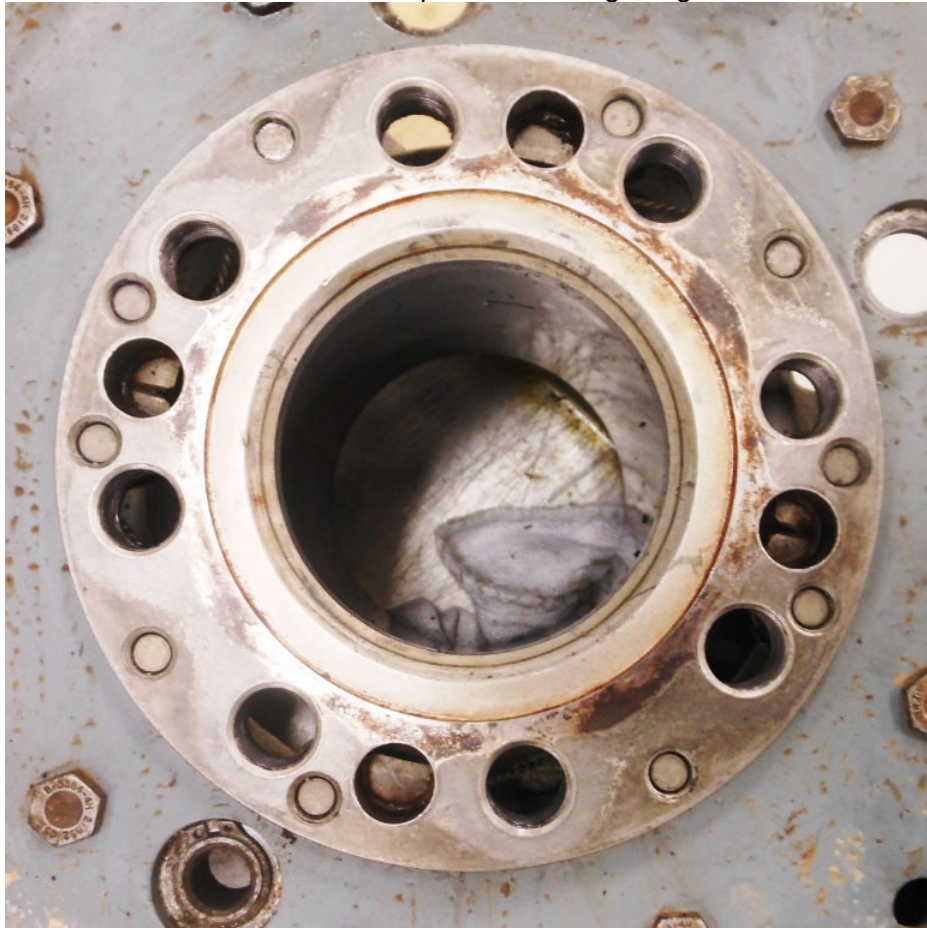
**Engine/Propeller Mounting:** The propeller mounting flange had all eight mounting bolts secure and lockwired. The flange appeared intact and undamaged with no remarkable dowel or mounting bolt hole deformation (Photo #9). All four dowel pins remained in the engine propeller shaft flange. There appeared to be some corrosion on the flange but there was no indication it affected sealing, mounting and torque.

Photo #9 - Propeller mounting flange

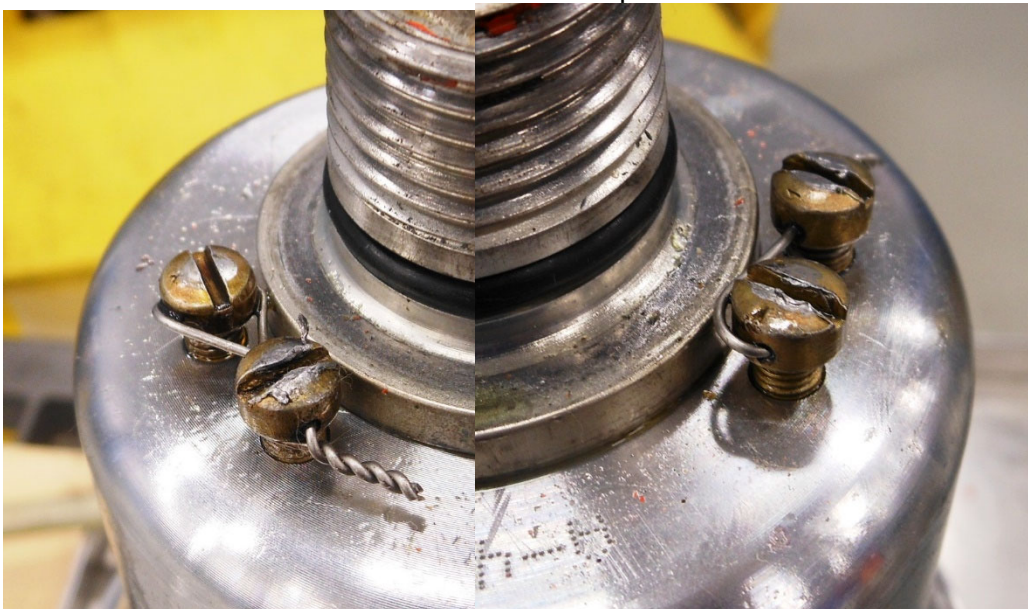
**Feather Stop Screws:** The feather stop screws appeared to have some lighter damage due to contact with the piston but not consistent with damage associated with being at/near the feather position at impact with terrain (see Photo #10).

Photo #10 – Feather stop screws

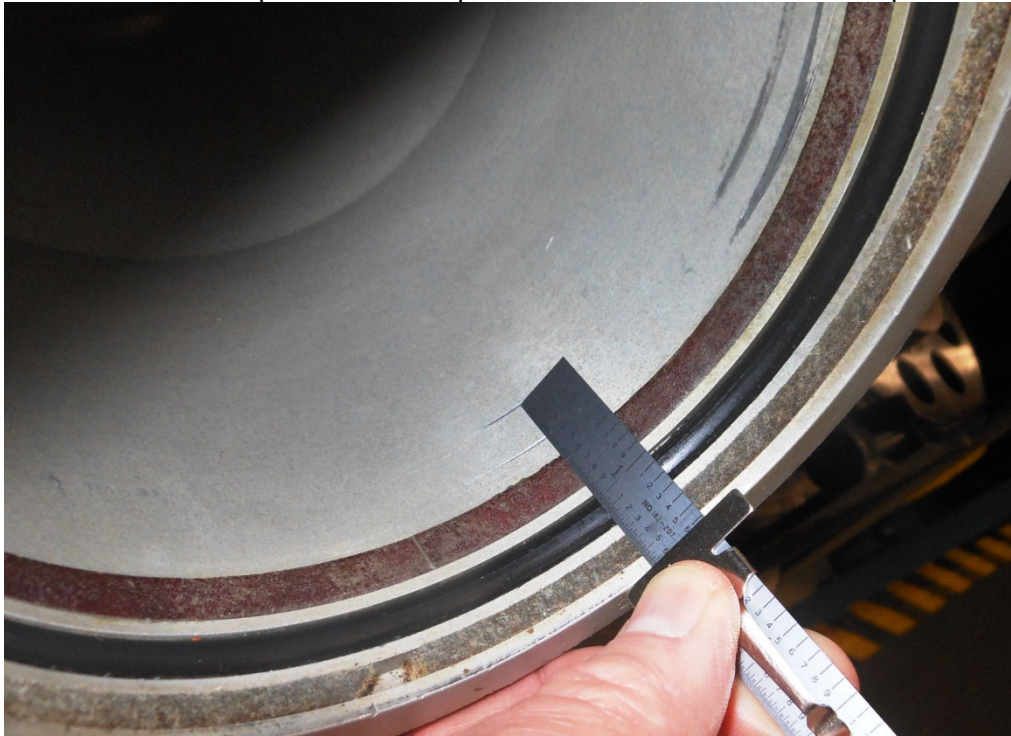
**Piston:** The piston remained securely attached to the pitch change rod with the nut intact and torque striped. The #1, #2, #3 and #5 link pin attachment points fractured from the piston; three pieces were recovered in the wreckage. The four, fractured areas and link pin holes indicated the link arm was rotated to low pitch and pulled down from the impact forces rotating the blade/clamp towards low pitch. When received the piston was jammed forward 2.55" from the beta guide collar by over-rotation of the #3 clamp binding against the #4 counterweight. The piston otherwise appeared intact and capable of holding oil pressure. There were several circumferential marks on the internal surface made by contact with the top corner of the cylinder during the impact sequence (see Photo #11). The marks measurements and interpretation are presented in the following Table #1.

| Marks from Bottom Piston Edge OR from Cylinder top corner | Approximate Equivalent Blade Angle | Pre-impact Confidence Level / Why? |
|---|---|---|
| 1.5 – 1.6" from bottom of piston.<br><br>There was a corresponding cylinder crease at ~1.6" from top corner. | < -11° | Low – Propeller would not have been near the reverse stop after takeoff. This is likely a result of the impact forces rotating blades and forcing the piston forward to the reverse mechanical stop. |
| Scuffs starting at approximately 2.35" from top corner of cylinder | Approx. 13° | High – blade angle at or near the expected running flight idle blade angle, consistent with a low power, underspeeding condition. |

Photo #11 – Representative impact marks on internal surface of piston

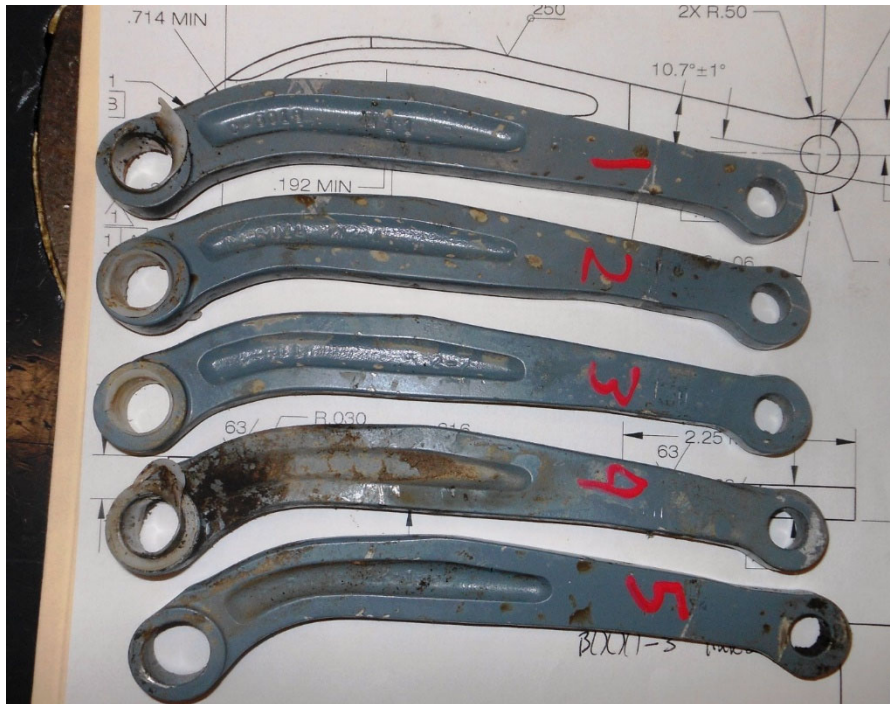
| Link Arm | Link Arm Condition |
|---|---|
| 1 | Attached at link screw, pulled from link pin. Appeared normal, no remarkable bending or twisting, link screw bushing torn. |
| 2 | Attached at link screw, pulled from link pin. Appeared normal, no remarkable bending or twisting, link screw bushing torn. |
| 3 | Attached at link screw, pulled from link pin. Appeared normal, no remarkable bending or twisting, link screw bushing torn. |
| 4 | Attached at both link screw and pin. Appeared normal, no remarkable bending or twisting, link screw bushing torn. |
| 5 | Separated from link screw and pin, found loose in wreckage. Link screw hole elongated, bushing pulled/missing |

Photo #12 - Link Arms

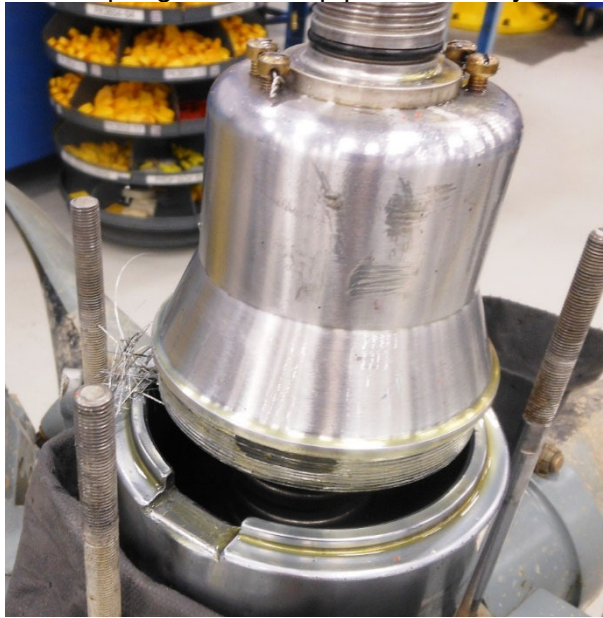
**Feathering Spring Assembly:** The feathering spring assembly had been forcefully pulled from the cylinder during the impact sequence and was sitting loose on top of the cylinder (Photo #13). The forward spring retainer threads were stripped with loose, remnant thread whiskers laying on the cylinder. The spring remained secure and loaded with both fore and aft spring retainer in-place (Photo #14). The spring was not removed from the assembly.

Photo #13 - Spring retainer cup pulled from cylinder mount

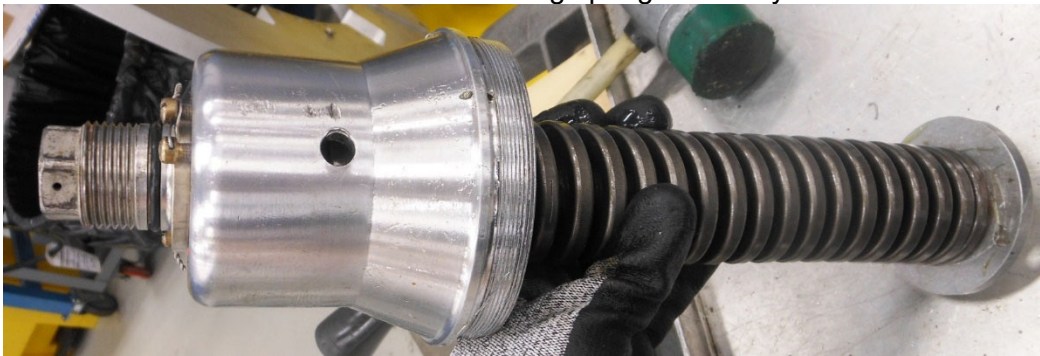
Photo #14 - Feathering spring assembly

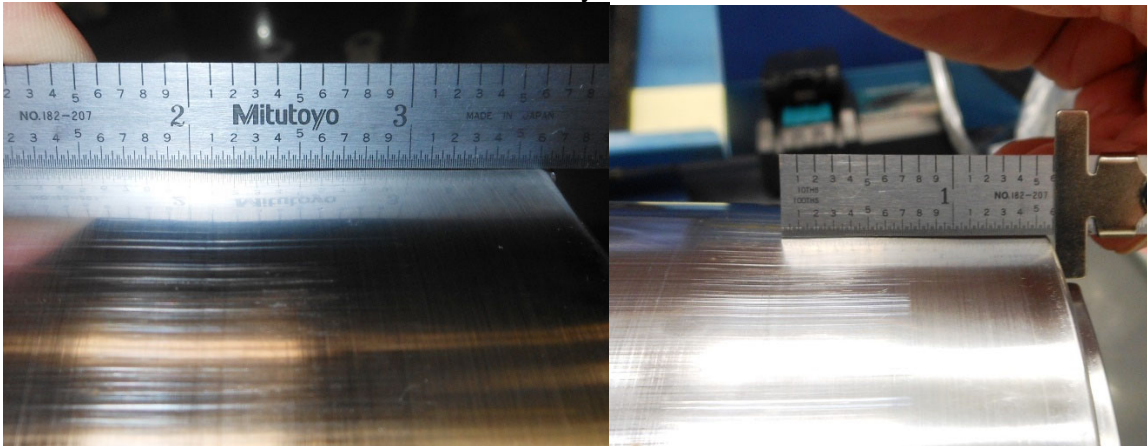
**Cylinder:** The cylinder was removed from the hub during the examination. There was a crease in the cylinder wall at approximately 1.6" from the top corner (Photo #15) which corresponded with one of the piston marks noted in Table #1. There was scuffing on the cylinder wall starting at approximately 2.35" from the top corner which corresponds to a running flight idle blade angle position. The cylinder remained threaded on the hub and was removed without difficulty.

Photo #15 – Cylinder crease

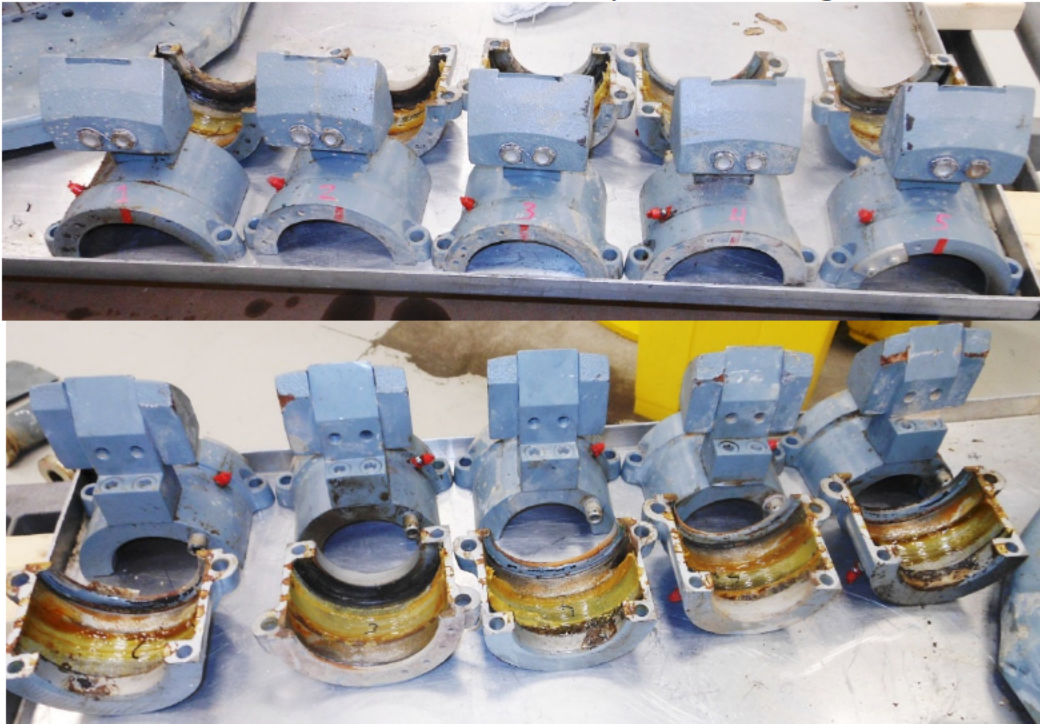
**Clamps and Counterweights:** See Photo #16. All clamp bolts were present and secure.

Photo #16 – Blade retention clamps & counterweights

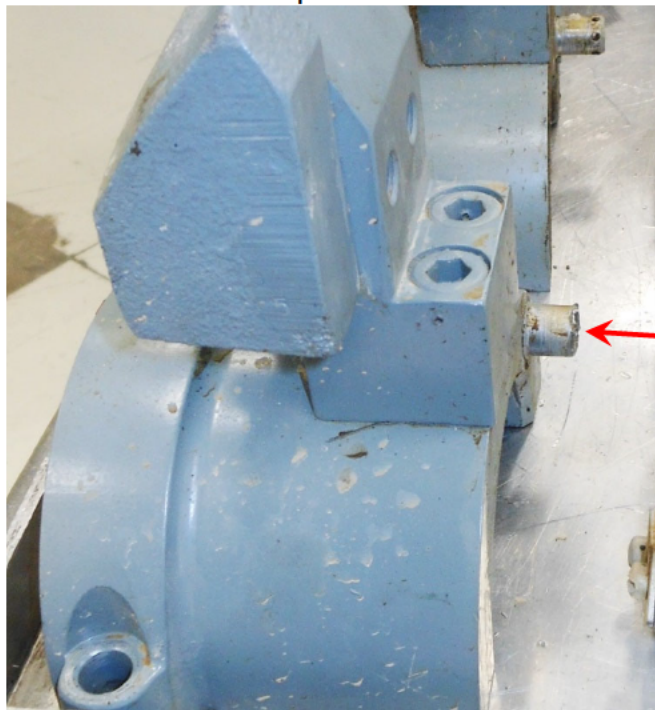
| Clamp Pos. | Clamp S/N | Clamp Condition | Counterweight Condition |
|---|---|---|---|
| 5 | F9833 | Link screw sheared at cotter pin hole plane (Photo #17) | Intact, random scratches |

Photo #17 - Clamp #5 sheared link screw

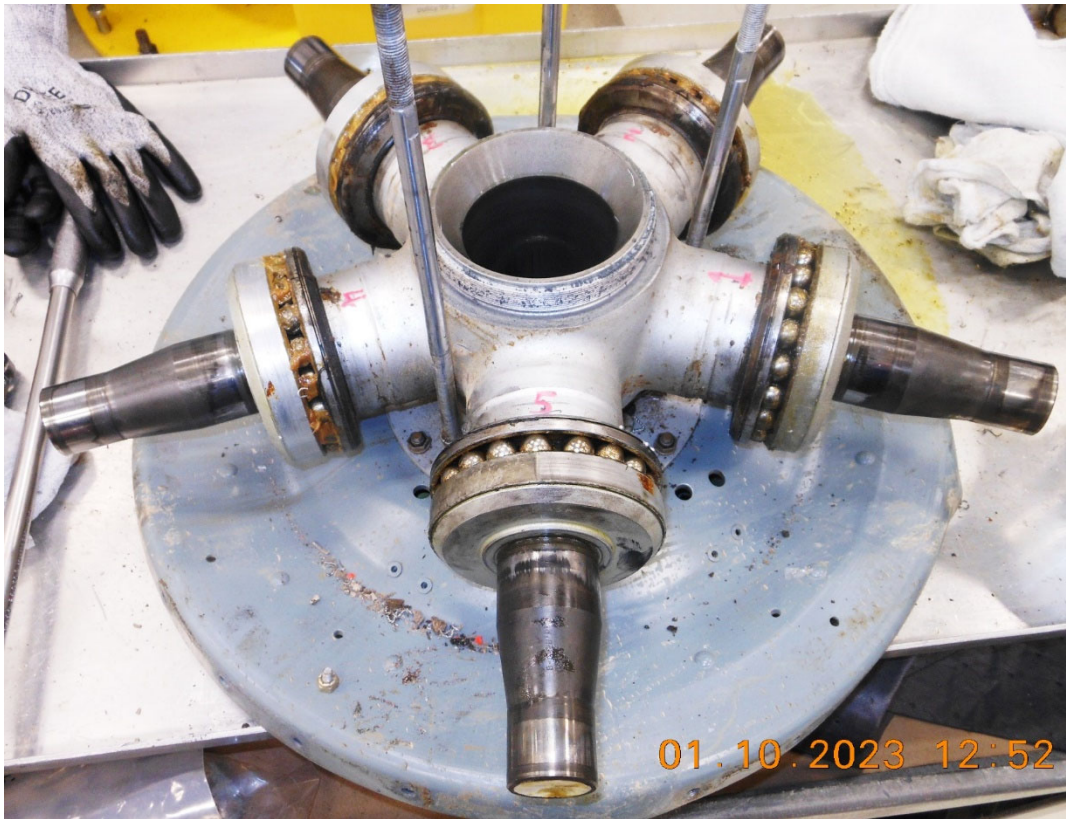
**Hub Unit:** The hub unit/spider was intact with no remarkable fractures or visible cracks (Photo #18). All four pilot tubes were intact and appeared undamaged. The blade shanks were removed without the need for a wedge. The cylinder attachment appeared undamaged. The blade retention bearings were intact with adequate grease except for blades #1 and #5 bearings appeared to be underserviced with grease. There were no discernable impression marks on a blade arm flange.

Photo #18 - Hub unit

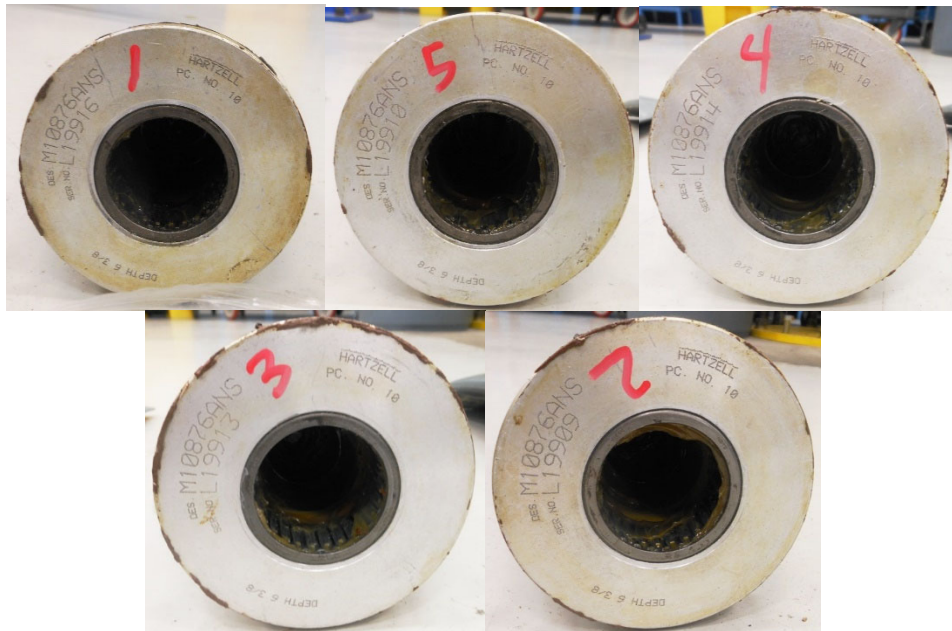
| Butt/shank impact marks | There was a shallow pilot tube bore shoulder impression around the blade bore |

Photo #19 - Blade butts

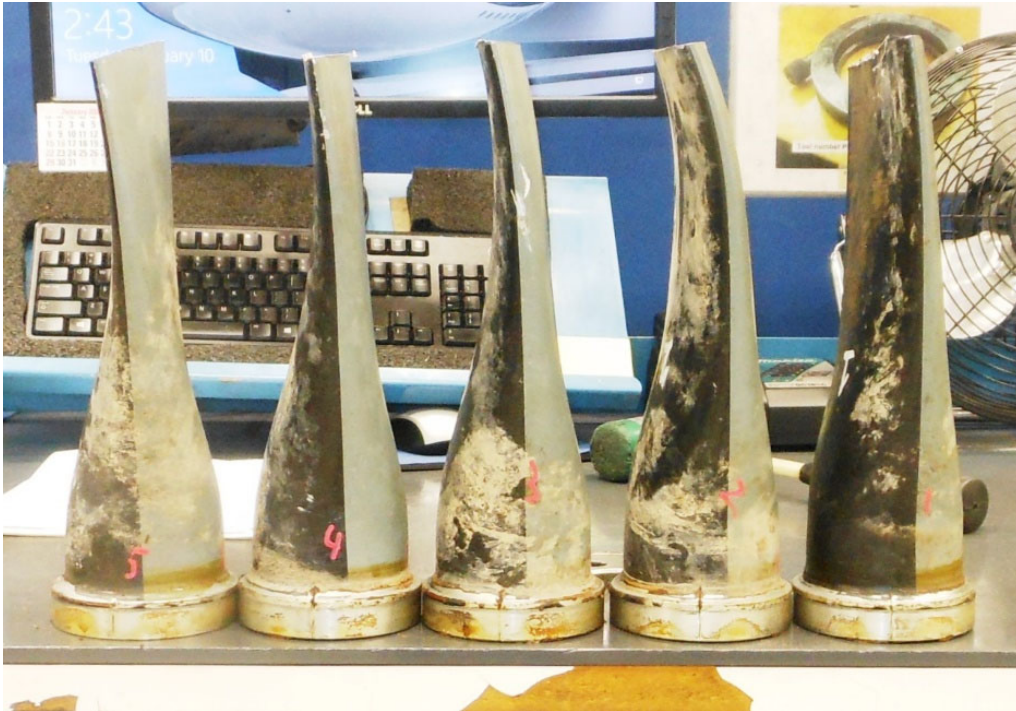
Photo #20 – Blade shanks

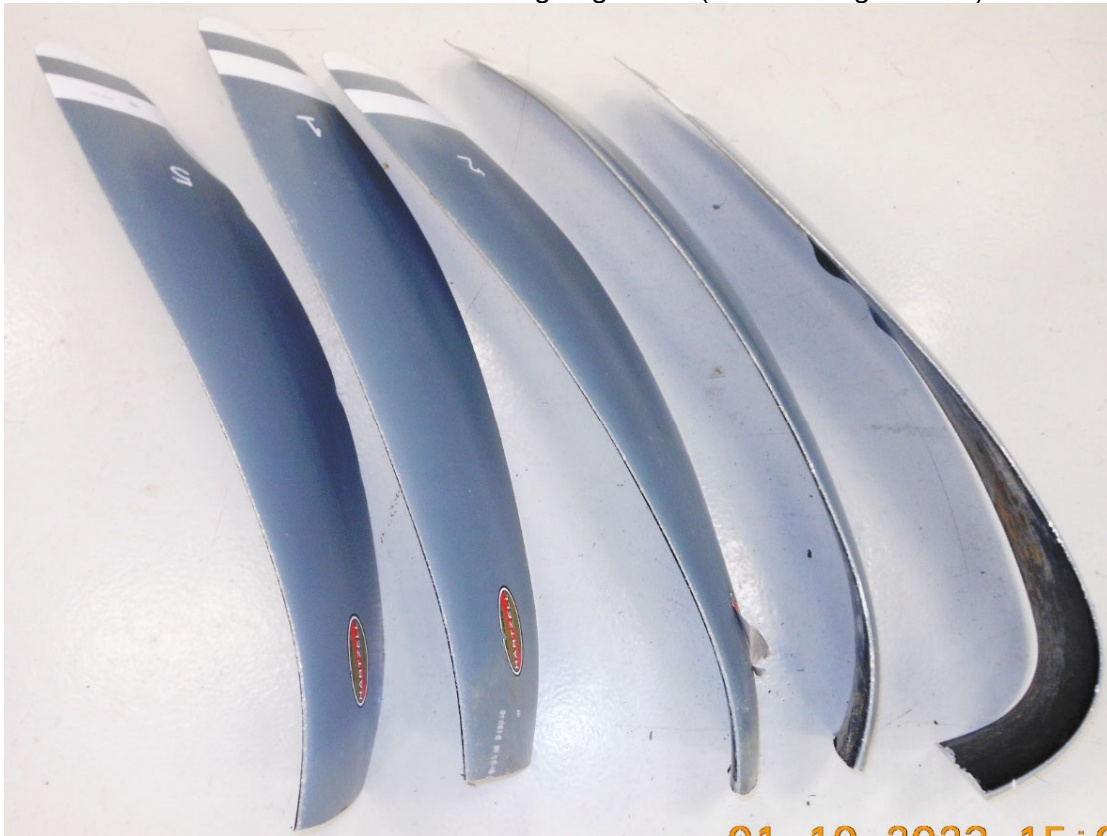
All five blades were subjected to impact forces that bent them aft (camber-to-face) in varying degrees. There was no remarkable chordwise/rotational scoring, leading edge gouging or blade fractures. The spinner dome sustained minimal impact damage and was found attached to the spinner bulkhead with no remarkable counterweight impressions noted. Blade #4 was in a low pitch position, two blades (#2 and #3) had rotated towards low pitch, beyond the reverse stop until contacting the spinner bulkhead, and two blades (#1 and #5) were in a high pitch/feather position.

Photo #21 – Blade bend leading edge view (4-3-2-1-5 right to left)

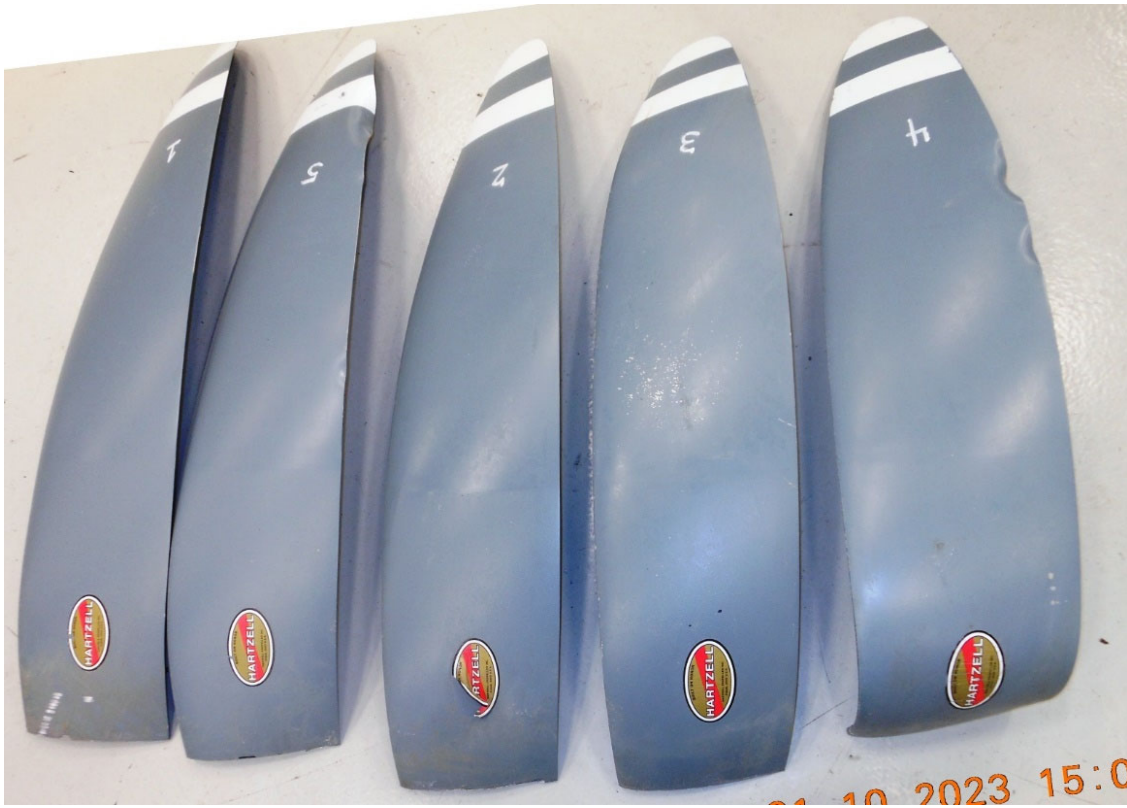
| Camber side | Some vegetation varnish streaking in the chordwise/rotation direction otherwise not remarkable |

Photo #22 – Blades camber side

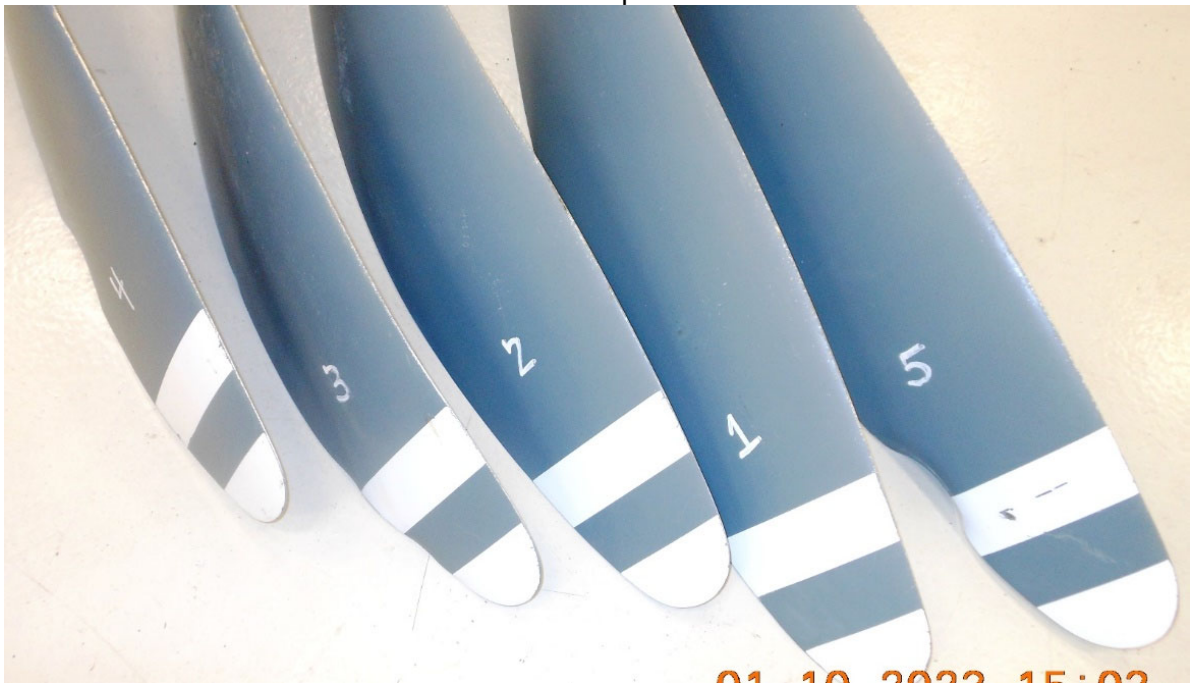
Photo #23 - Blades tip camber area

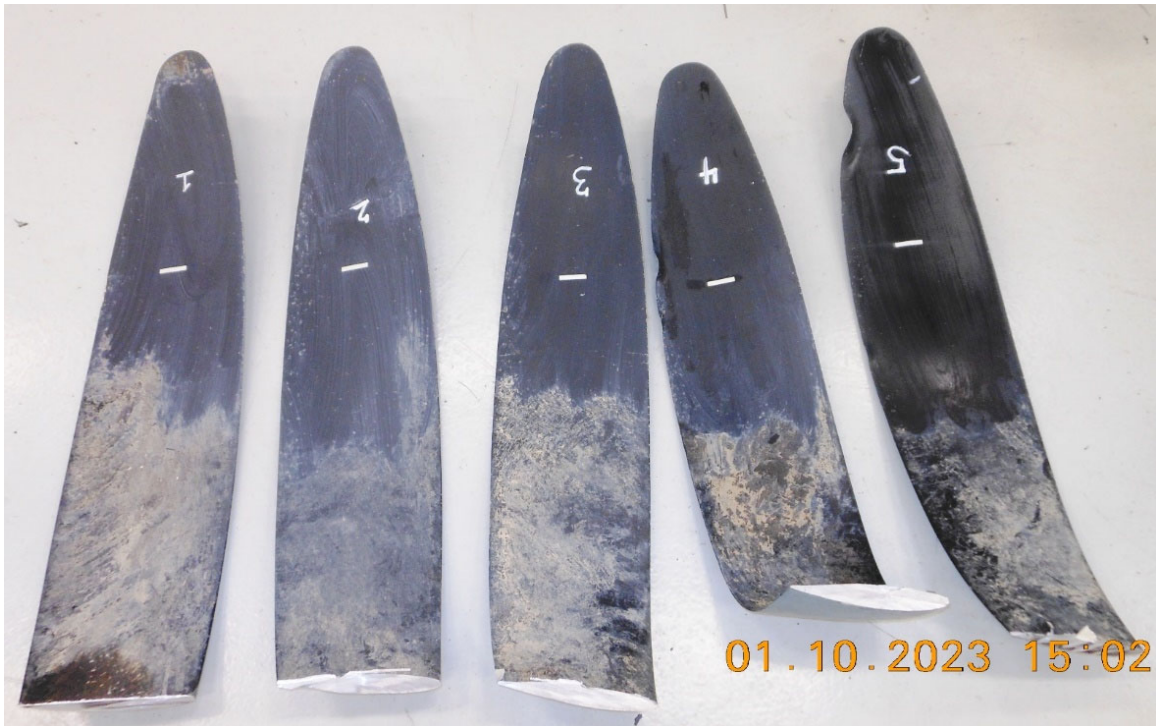
Photo #24 – Blades face side
