# National Transportation Safety Board

CEN22LA234

## EXAMINATION SUMMARY

Location: Henderson, Texas  
Date: 06/06/2022  
Time: 0950 CDT  
Aircraft: Robinson R44 N94WC

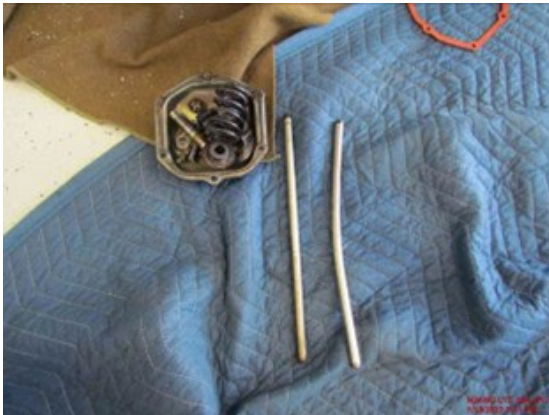
- The valve covers, and bottom sparkplugs were removed for the examination. The crankshaft was rotated by hand and thumb compression was obtained at all cylinders except number 2 cylinder. Examination of number 2 cylinder revealed that the exhaust push rod was bent, and the exhaust valve was found stuck. Borescope inspection of cylinder #2 showed that the exhaust valve had contacted the piston. The intake valve appeared to be recessed in the valve seat. See Photos 1-4.

Photo 1 Bent Push Rod  
(Courtesy of Lycoming)

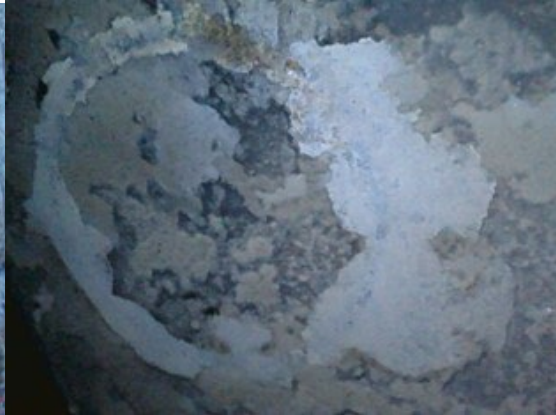
Photo 2 Valve Impression on Top of Piston  
(Courtesy of Lycoming)

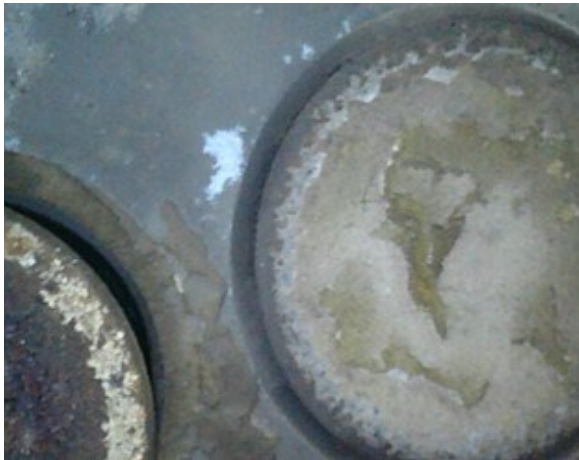
Photo 3 Recessed Intake Valve  
(Courtesy of Lycoming)

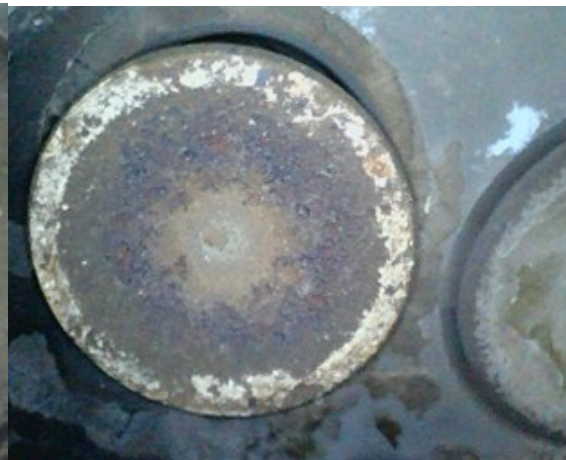
Photo 4 Impact Marks on Exhaust Valve  
(Courtesy of Lycoming)
