# National Transportation Safety Board

CEN22LA247

## **AIRCRAFT EXAMINATION NOTES**

Location: Olla, Louisiana  
Date: June 9, 2022  
Time: 1605 CDT  
2105 UTC  
Airplane: Piper PA-32R-301

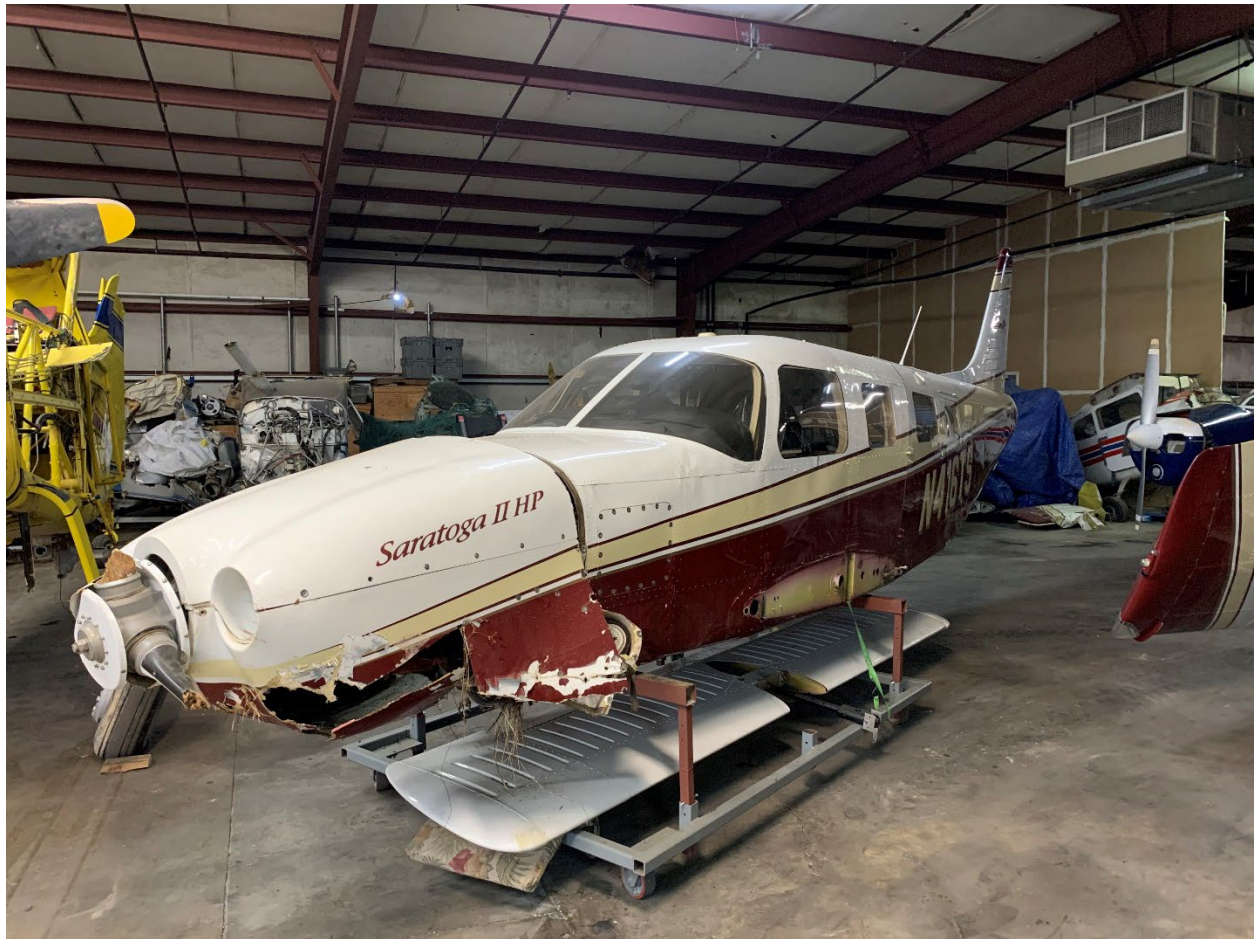
The airplane had been moved to an off-site facility for storage after the accident. The fuselage was resting on a wheeled cart and was predominately intact with damage to the forward fuselage evident. There were areas of fuselage skins that

had buckling of the skin. These areas included section forward and mid-fuselage skins.

Figure 1: Airplane fuselage during the examination.

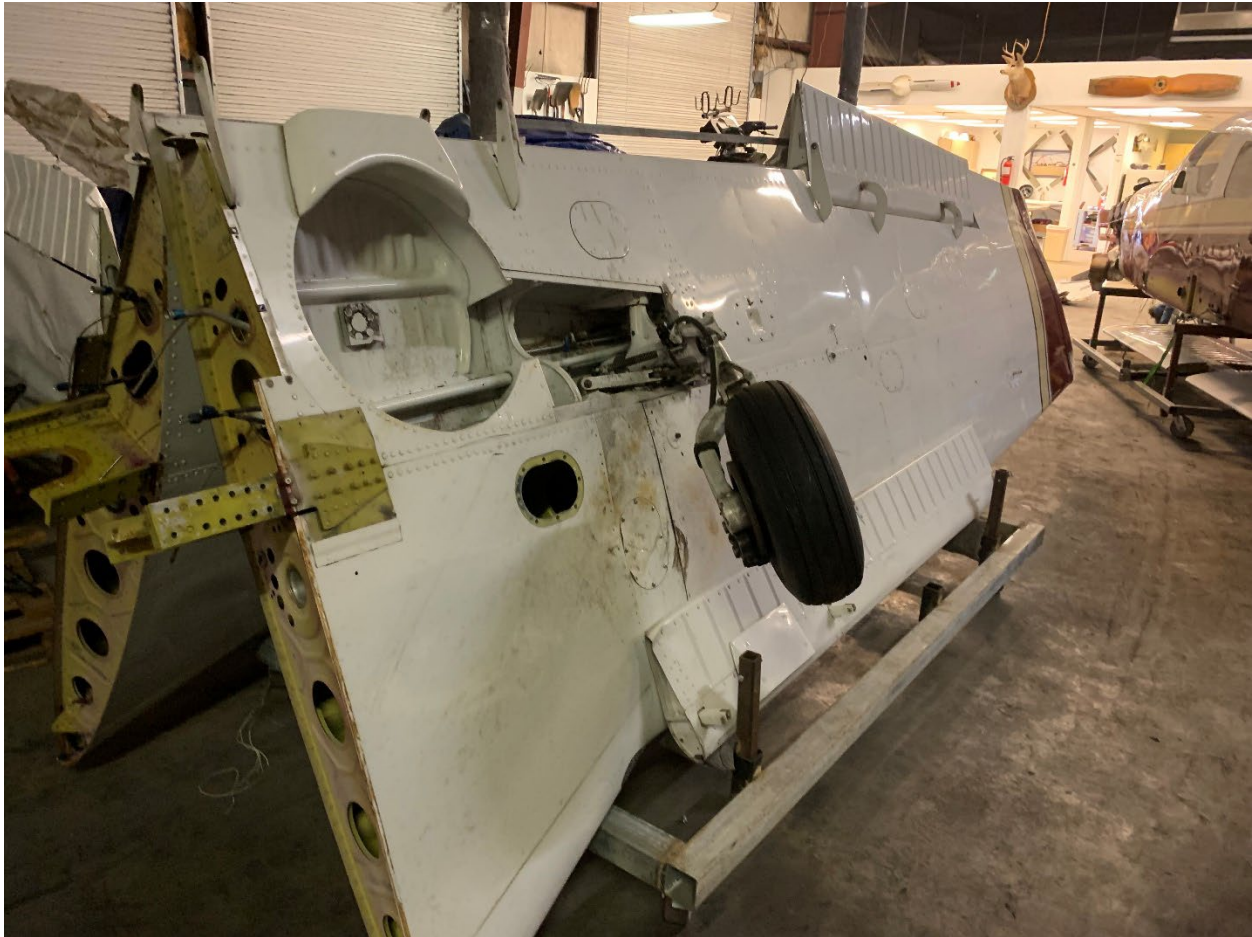
The wings had been removed from the airplane for transport and were on a stand. The right wing was predominately intact but had damage to the bottom surface in the area near the landing gear. The aileron remained attached and intact. The flap had been removed during recovery. The right landing gear was still attached to the wing. The landing gear strut tube was bent. The fuel cap was in place.

According to the recovery crew, 41 gallons of fuel were recovered from the right fuel tank.

Figure 2: Right wing of accident airplane.

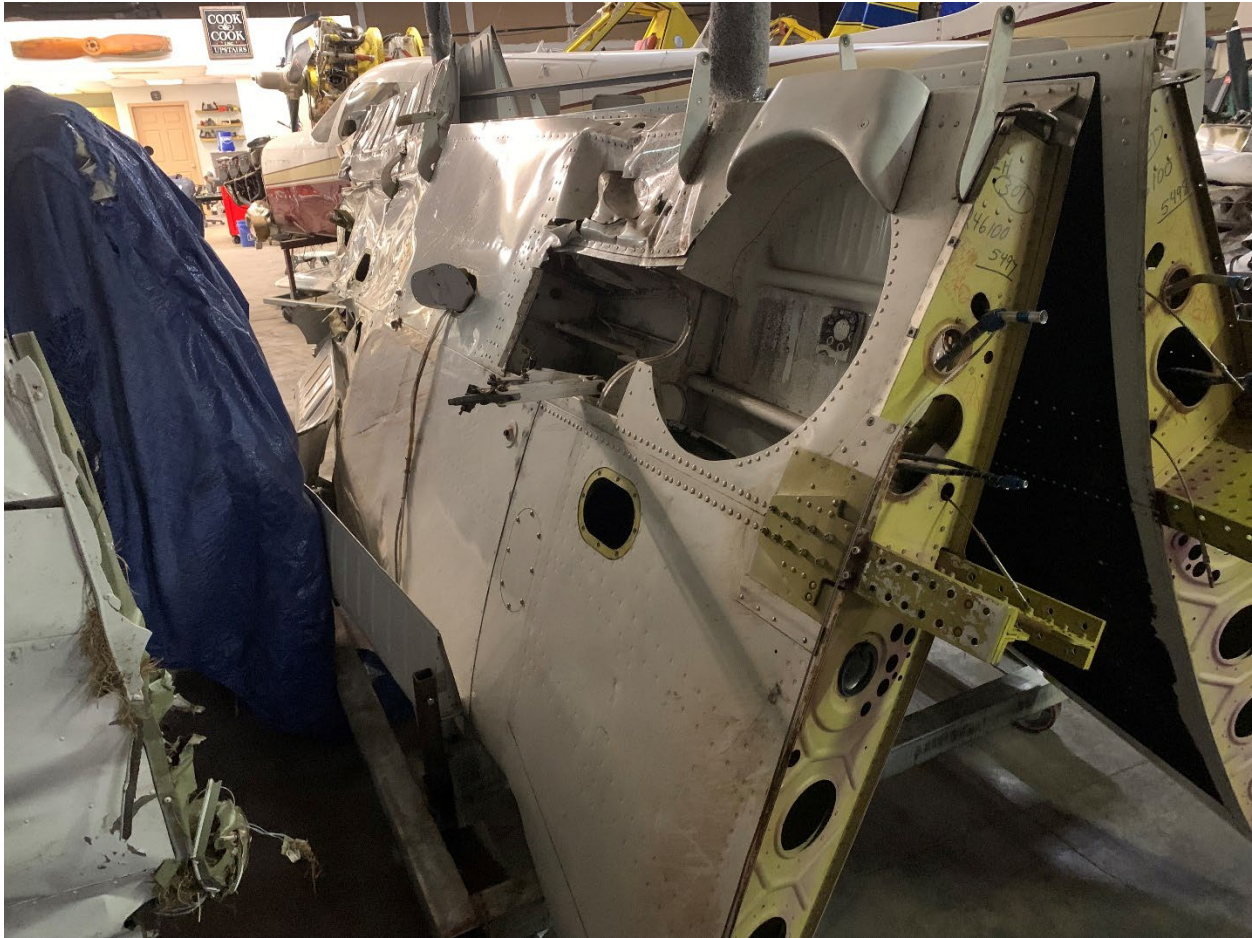
The left wing had significant damage. The outboard 5 feet of the wing structure and the outboard 1 foot of the aileron were separated from the inboard portion of the wing. The fuel bladder was exposed and ripped open. The aileron remained partially attached to the wing. The outboard aileron hinge had separated with the outboard portions of the wing and aileron. The flap was removed for transport and was bent, but all hinges attach points were intact. There was damage to the lower surface of the wing in the area near the landing gear. The left landing gear had separated from the wing. The fuel cap was in place.

Figure 3: Left wing of accident airplane.

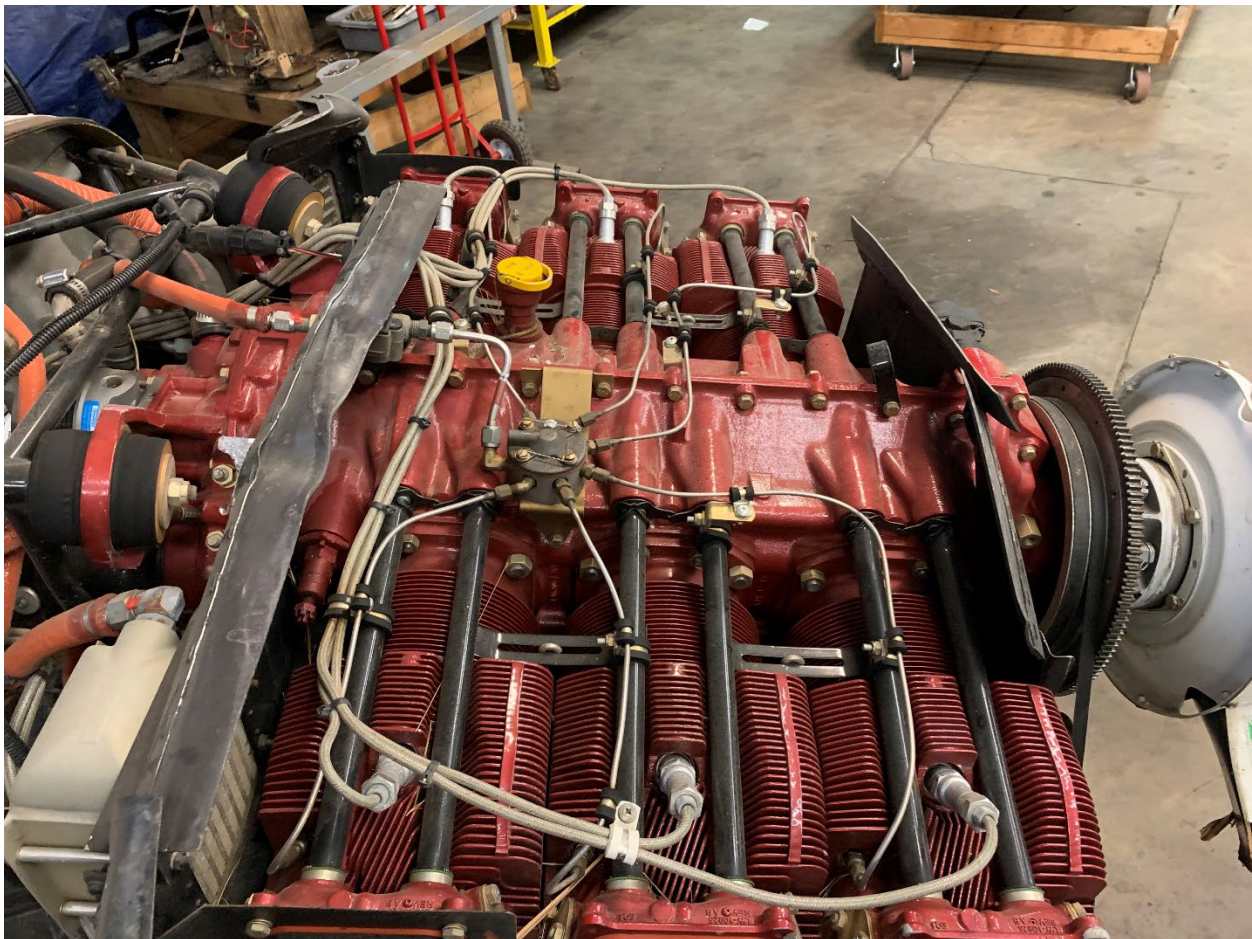
The engine cowling was removed to expose the engine. The top engine mount ears were fractured, and the engine was tilted downward slightly. Cockpit to engine controls were found secured. The engine crankshaft was free to rotate. The top set of spark plugs were removed, and suction and compression were verified on all

cylinders. The left magneto was equipped with an impulse coupling and all six leads produced spark when the engine was rotated by hand. The right magneto did not have an impulse coupling and would not produce spark when the engine was rotated by hand. The right magneto was removed from the airplane and an electric drill used to turn the input shaft at a faster RPM. When this was done, spark was observed from all 6 spark plug leads. The fuel injection distribution block on the top of the engine was opened and the diaphragm was intact. The plunger was free in the bore and there was a small amount of fuel within the distribution block. The engine driven fuel pump was tested by disconnecting the input and output hoses and placing the input hose into a bucket of fuel. When the engine was rotated, the fuel pump sucked fuel from the bucket and pumped it out of the output hose. The fuel injection throttle body was removed from the engine and the fuel screen removed. The fuel screen was clean and free of debris.

Oil and fuel lines were found connected and secured. Examination of the engine oil cooler and associated oil lines did not reveal any evidence of oil leakage. Oil was present in the oil lines, engine oil sump, and oil pump. The oil pump turned freely with no binding.

Figure 4: The engine of the accident airplane.

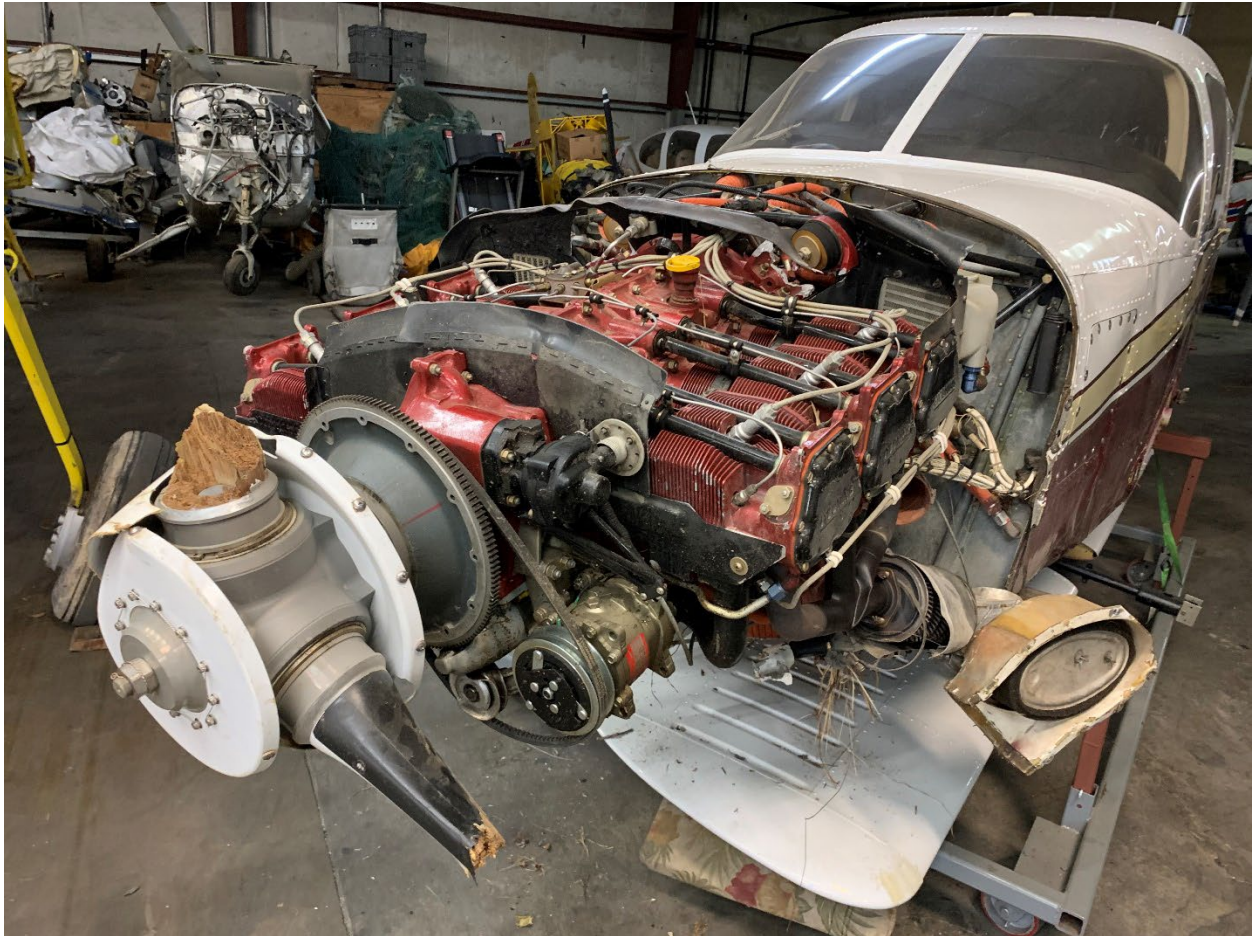
The 3-blade propeller had all 3 wood core blades broken off at the root. The blade roots remained in the propeller hub. The propeller hub remained attached to the engine crankshaft.

Figure 5: Front of accident airplane showing the engine and propeller.
