**Hartzell Propeller Air Safety Investigator Field Report**

Occurrence Date: June 8, 2022  
Location: Evansville, IN  
Aircraft: Beechcraft Baron 58  
Aircraft Registration: N78KL  
Aircraft Hobbs: 2969.6  
Propeller TSN/TSO: 2353.5 / 1199.6

**Propeller Examination**

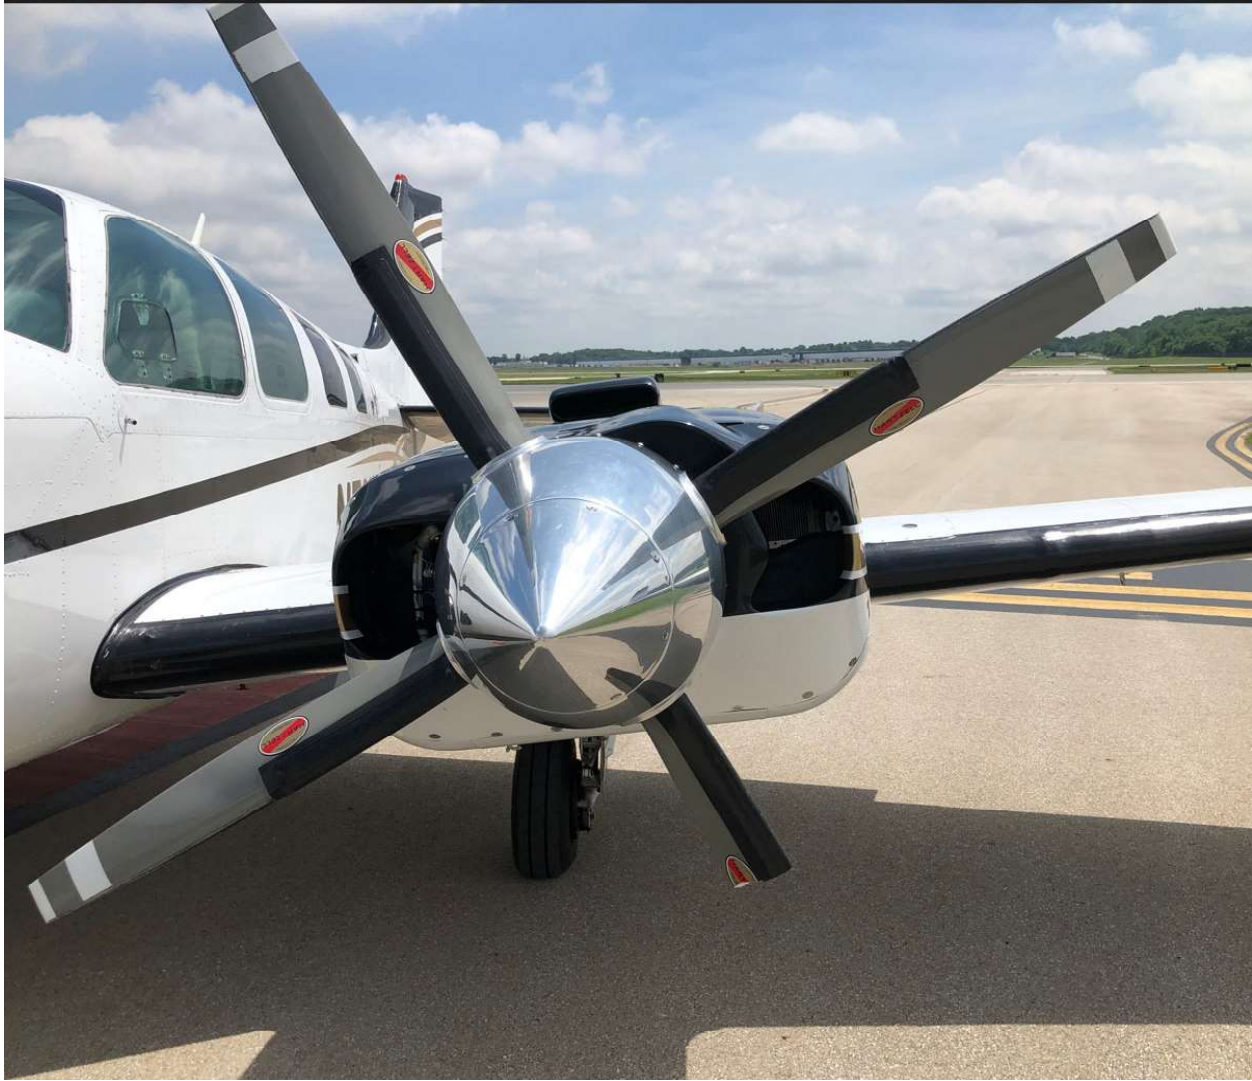
While enroute from Paragould, AR (KPGR) to Dayton, OH (KDAY) at 9000 ft., a portion of one blade from the left propeller separated from the aircraft. They pilot diverted to Evansville, IN and landed safely. Photo #1 shows the propeller after landing.

Photo #1 – Left propeller with one blade fractured

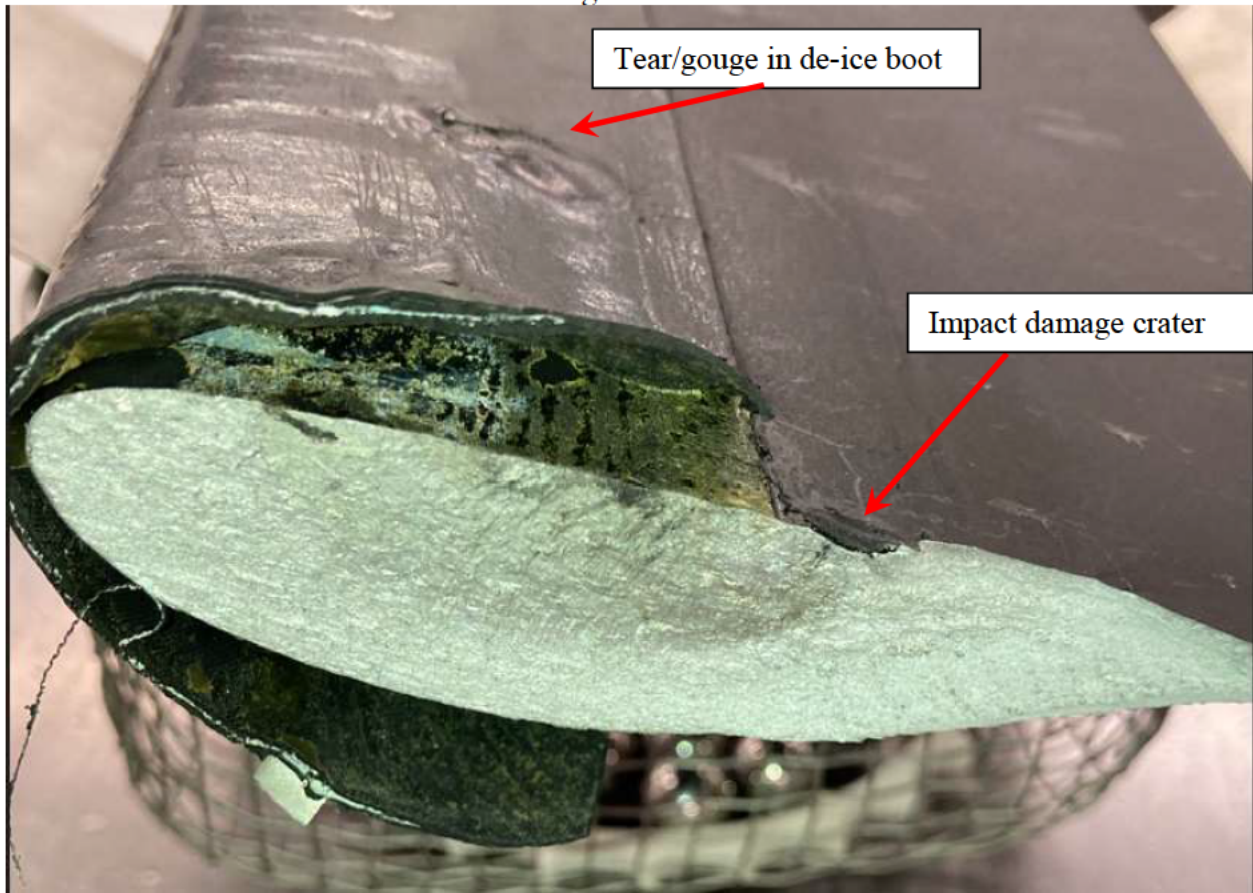
The fractured blade Design No. is FC7063Q, S/N is J51843 manufactured on September 6, 2000. The blade is a “Q-tip” design normally measuring 34.81” from blade butt-to-tip. The subject blade fractured approximately 16.5” from the blade butt. There was a small impact crater measuring approximately 0.25” long and 0.15” wide at approximately 45% chord on the face side of the fracture surface. There was also a tear/gouge in the de-ice boot inboard of the fracture and at approximately 30% chord (Photo #2). Photo #3 shows the damage crater from the face side with a small lip protruding outboard of the fracture surface. The de-ice boot severed at the fracture and was partially de-bonded on both camber and face sides.

Photo #2 – Overall damage to face side of fractured blade

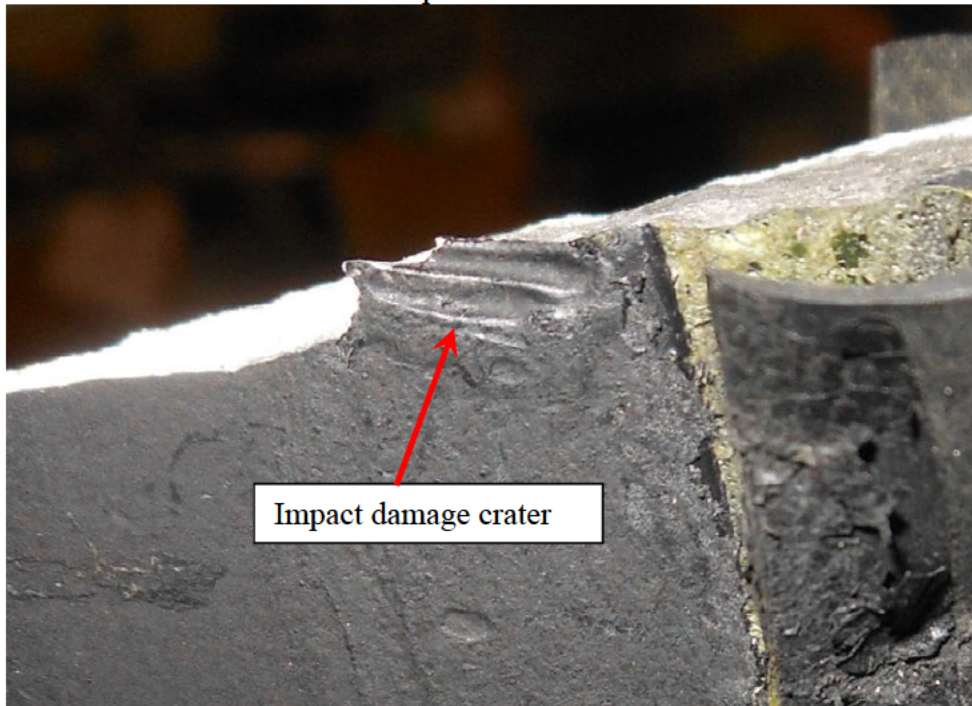
Photo #3 – Impact crater from face side

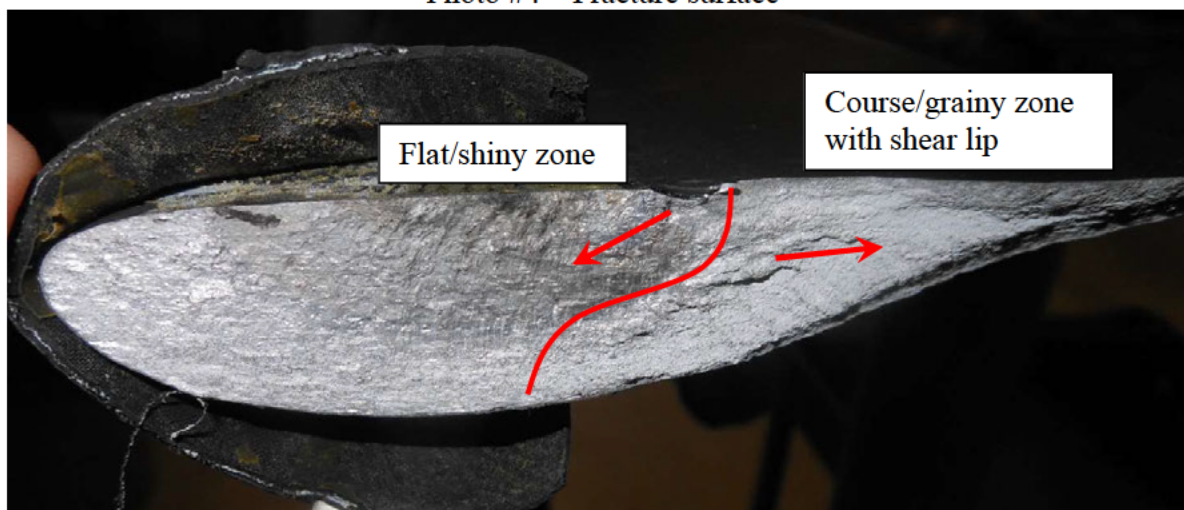
The fracture surface exhibited a shiny fatigue area with characteristic “beach marks” emanating from the impact crater at 45% chord and progressing mostly forward, toward the leading edge. The shiny fatigue surface covered approximately 50-60% of the section area. A course and grainy surface starting at approximately 50% chord and progressed to the trailing edge suggesting a rupture/overload zone (Photo #4). There also appeared to be either blade paint or primer over the impact crater, and some appeared to have penetrated into the blade fracture surface at various locations, but it could not be confirmed with the optical instruments available.

Photo #4 – Fracture surface
