CEN22LA251

## INVESTIGATION PHOTOGRAPHS

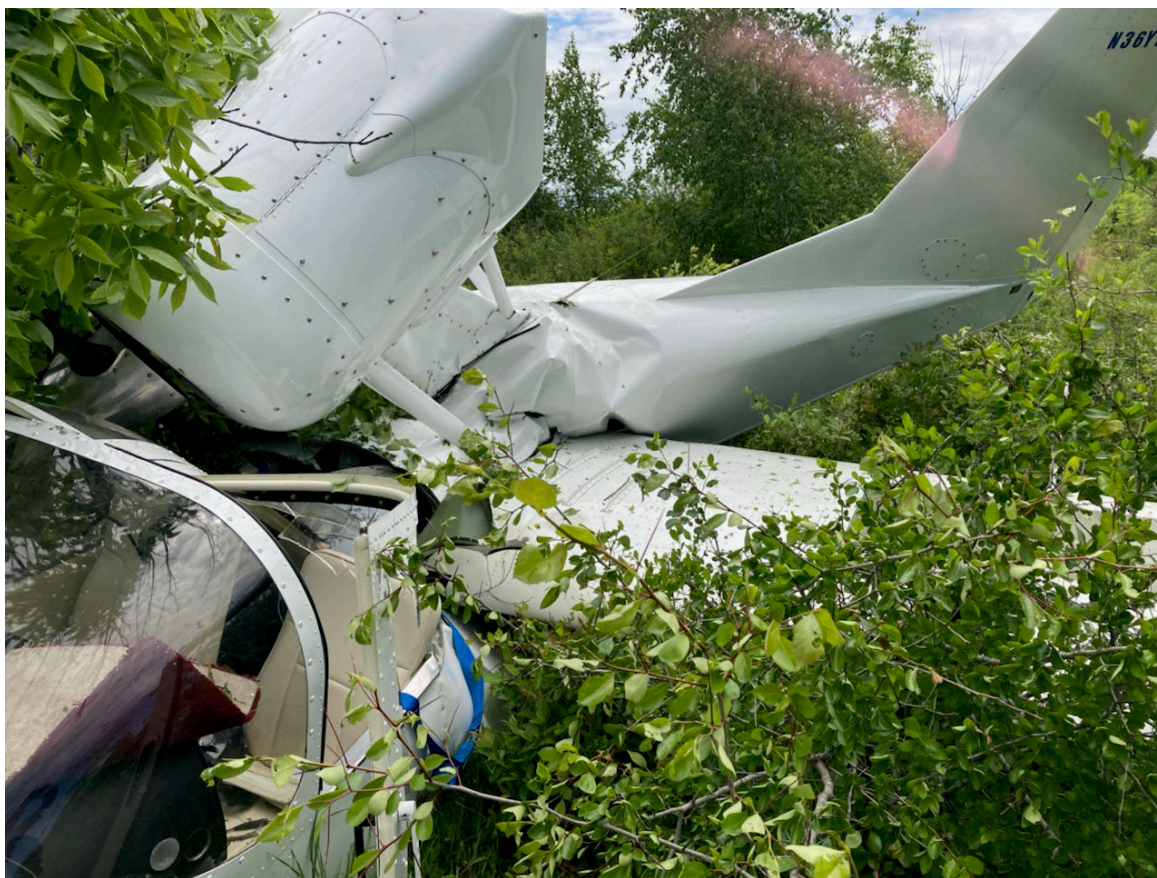
**Photograph 1 - Damage Overview (Courtesy of Pilot)**

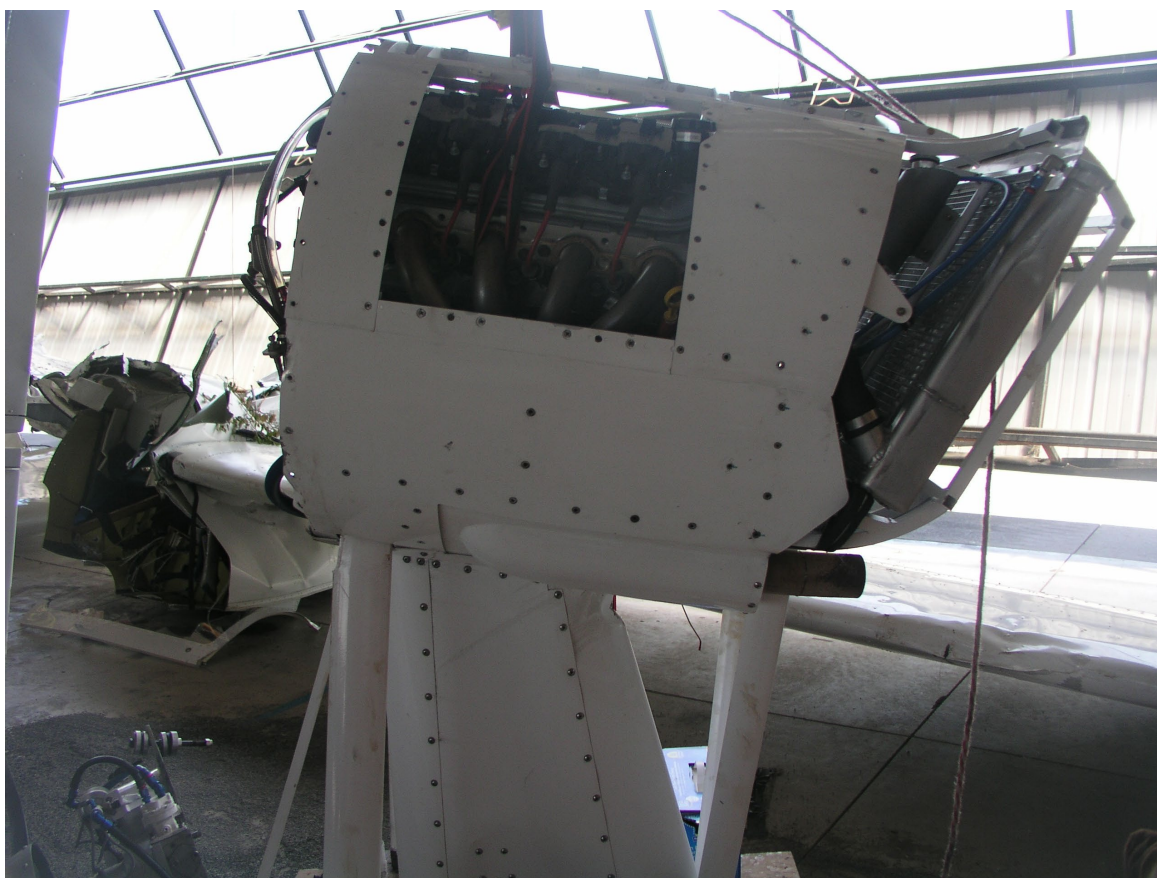
**Photograph 2 - Left Side of Engine (Courtesy of Pilot)**
