## **Examination Summary**

NTSB ACCIDENT NUMBER: CEN22LA255

AIRCRAFT REGISTRATION/AIRCRAFT TYPE: N5895Q, Mooney M20E

**Post-Accident Examination Summary**

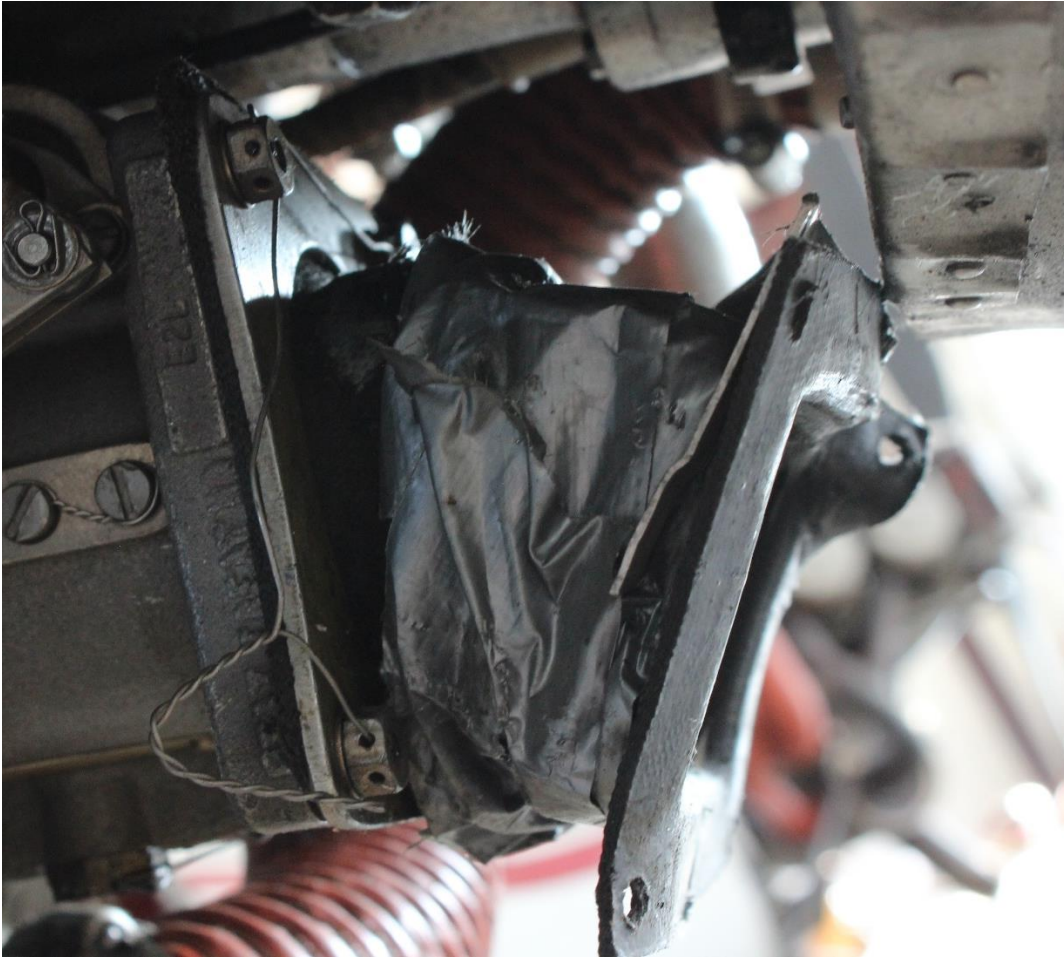
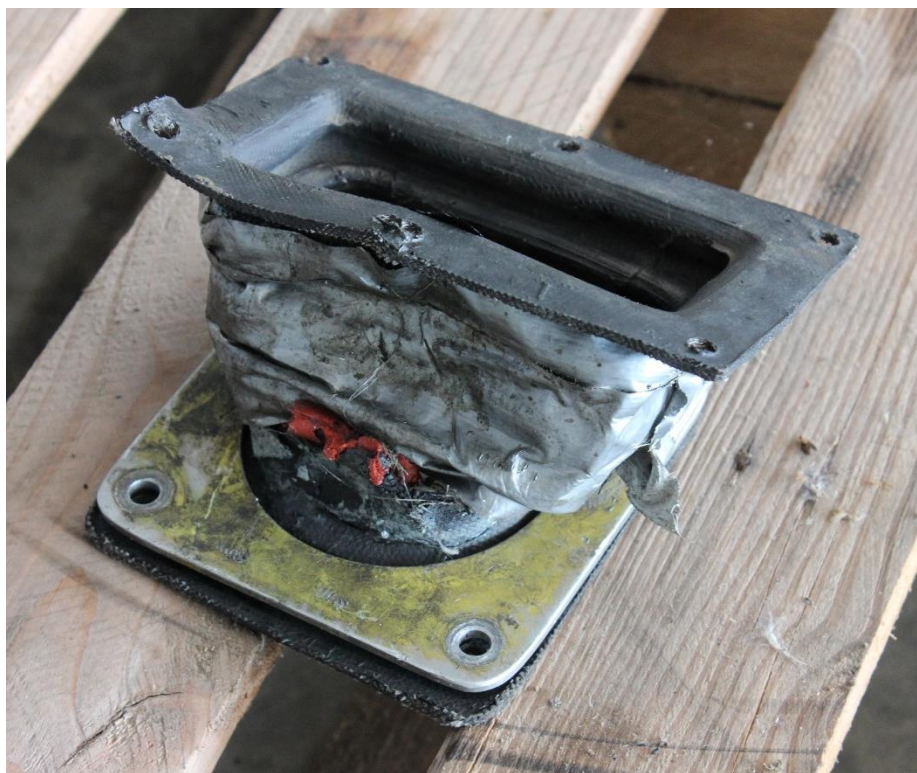
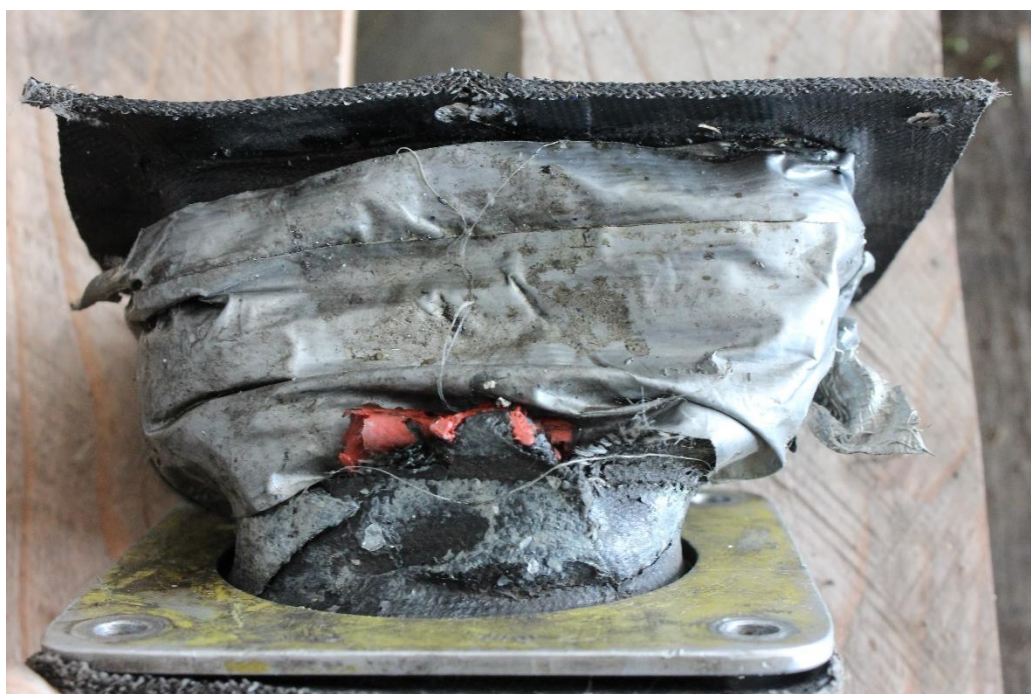
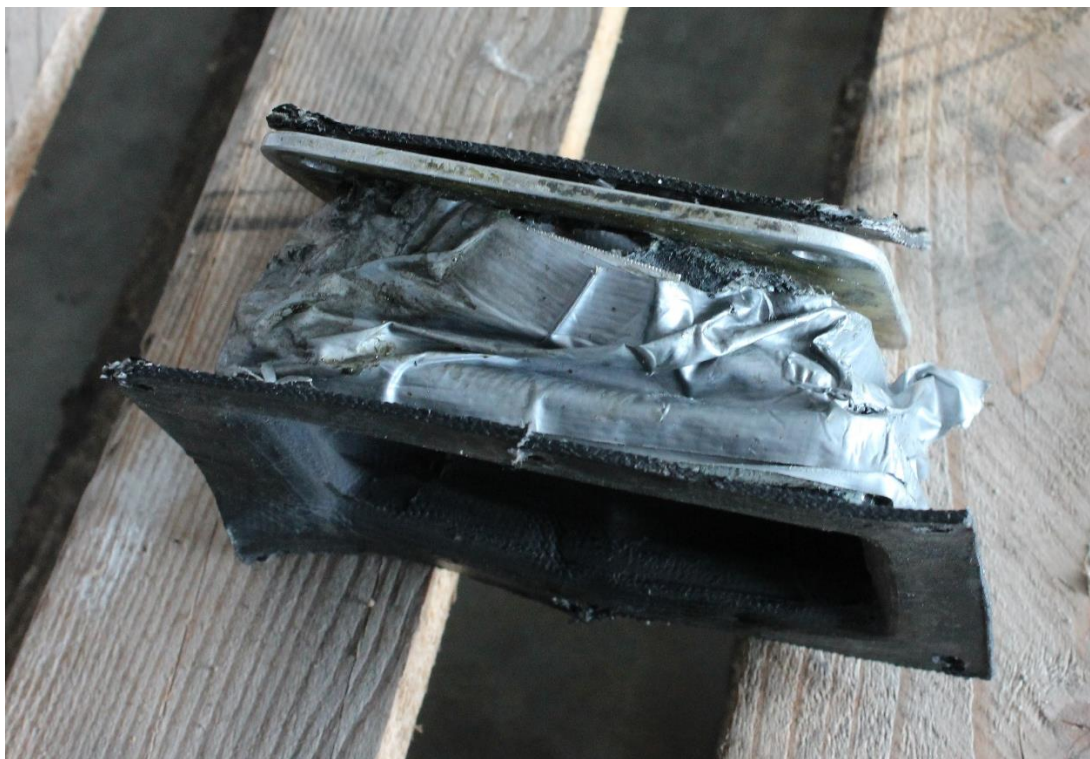
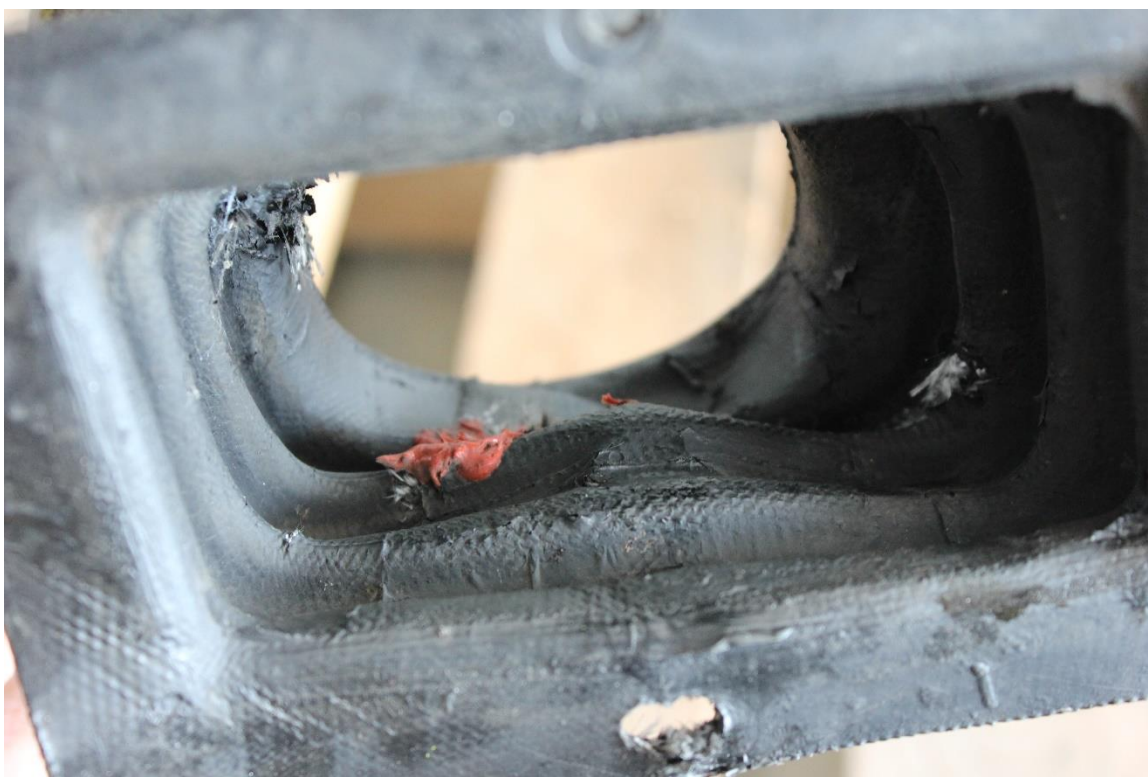
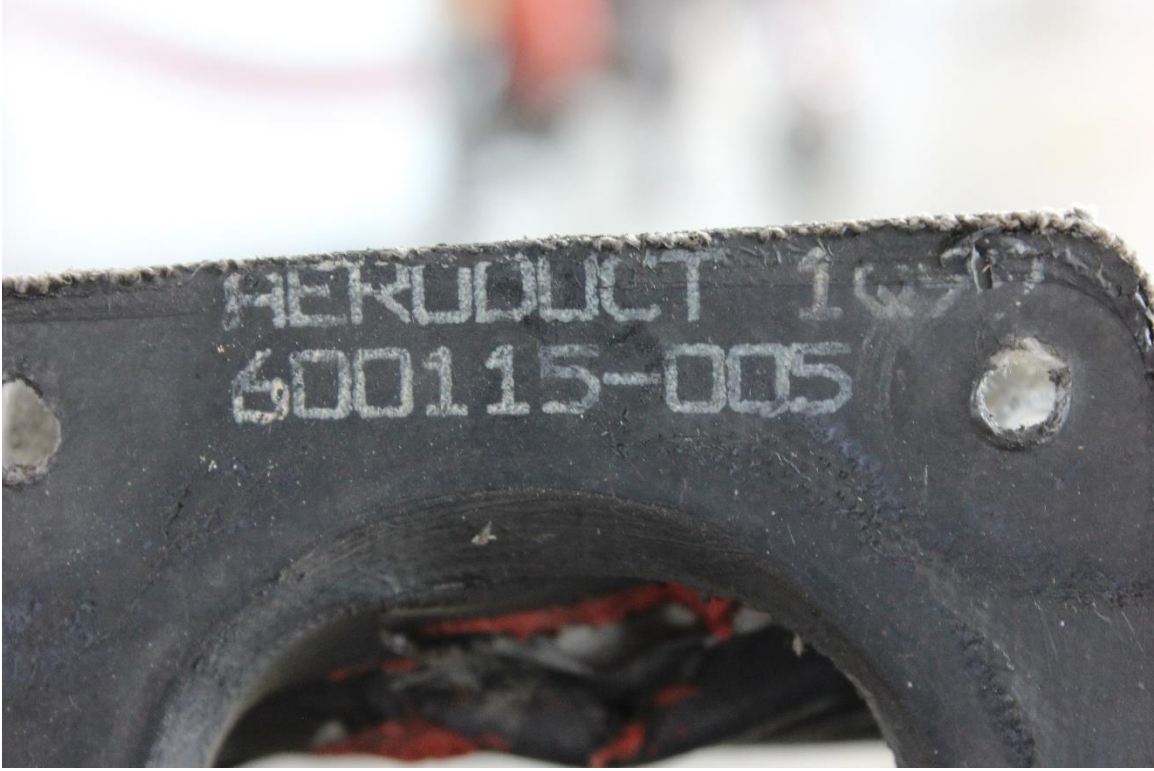
The fuselage was relatively free of impact damage. It was separated along rivet lines during recovery. When the engine cowling was removed, the air induction coupling (Mooney Part No. 600115-3) was found to be wrapped in grey tape.

*Photo 1: Induction Coupling*

*Photo 2: Induction Coupling*

*Photo 3: Induction Coupling*

*Photo 4: Induction Coupling*

*Photo 5: Induction Coupling*

*Photo 6: Induction Coupling*

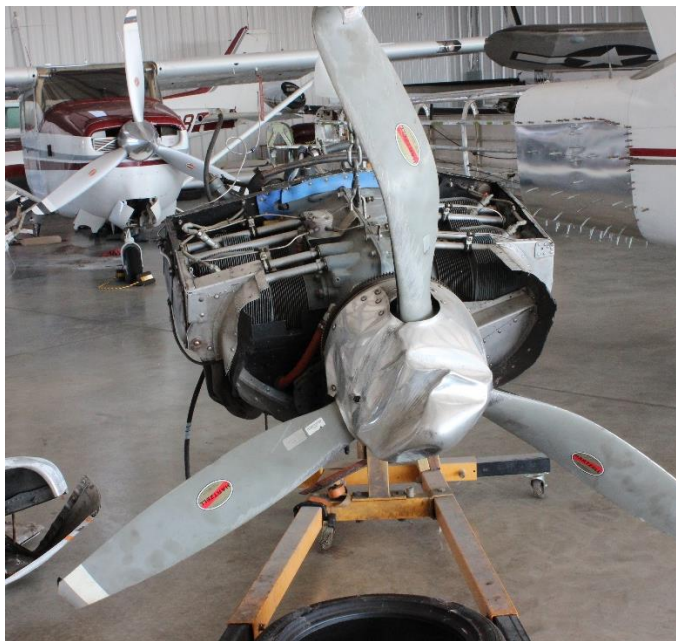
The engine was removed from the airframe during recovery with all engine controls documented prior to removal. The engine was relatively free of impact damage. Of the 3 propeller blades, the top blade tip was curled forward and the remaining two were slightly curled aft at the tip.

*Photo 7: Engine and Propeller*
