# National Transportation Safety Board

CEN22LA256

## **MATERIALS LABORATORY**

Factual Report 22-095

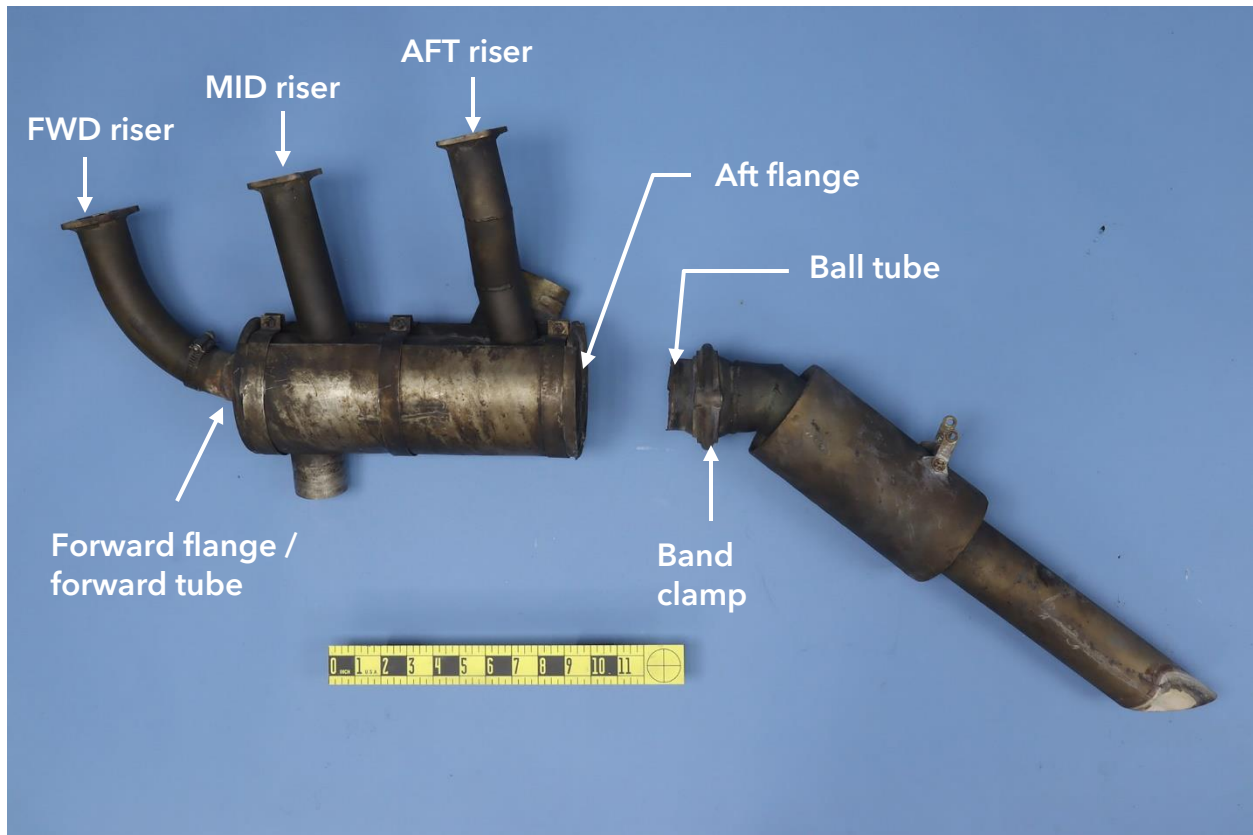
The right-side muffler and tailpipe assemblies from a Bellanca 17-30A were submitted to the NTSB Materials Laboratory for examination as shown in figure 1. The muffler assembly consisted of a cylindrical shell with flanges welded to the forward and aft ends, and mid and aft risers welded to the shell along the top. The cylindrical shell was covered by a shroud that was part of a heat exchanger system. The forward and aft flanges each had an opening in the center, as seen for the aft flange in figures 2 and 3. The opening was formed in such a way as to construct a sleeve (figure 3) into which the forward tube or aft ball tube, respectively, was inserted. The flange sleeve and tube ends were aligned and then fusion welded to form an edge joint. The aft ball tube was connected to the tailpipe by a spherical joint backed by a compression ring and secured with a V-band clamp, as seen in figure 2a.

**Figure 1.** Image of the as received muffler and tailpipe assemblies. The ball tube at the outlet of the muffler had separated from the aft flange and was attached to the tailpipe by a band clamp.

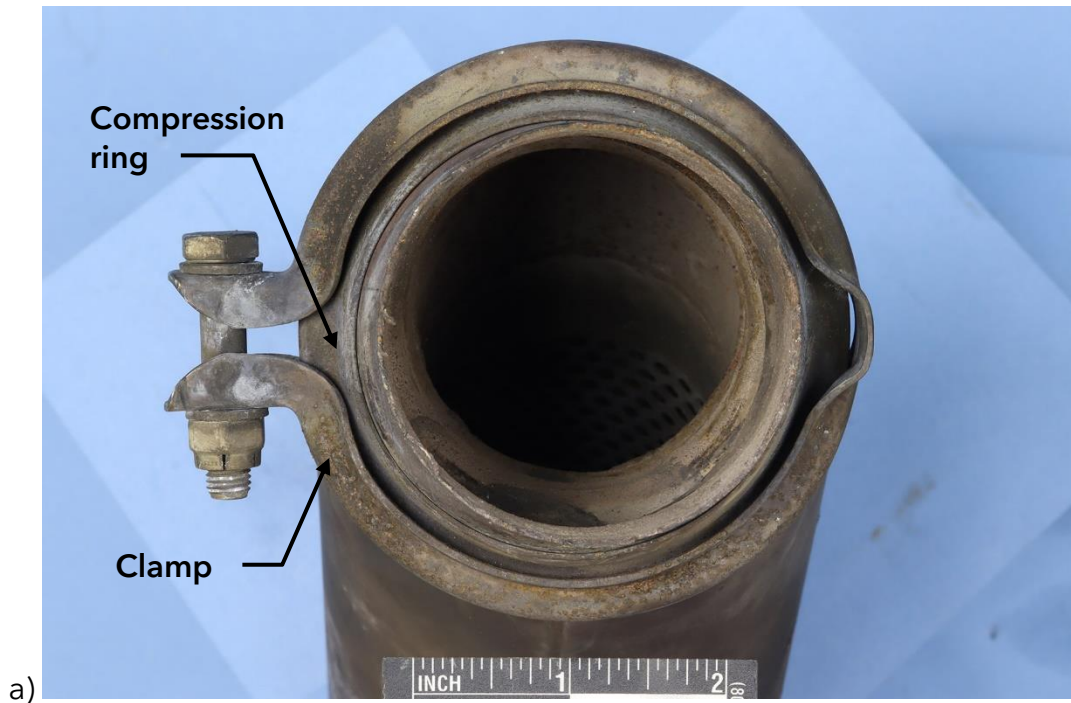
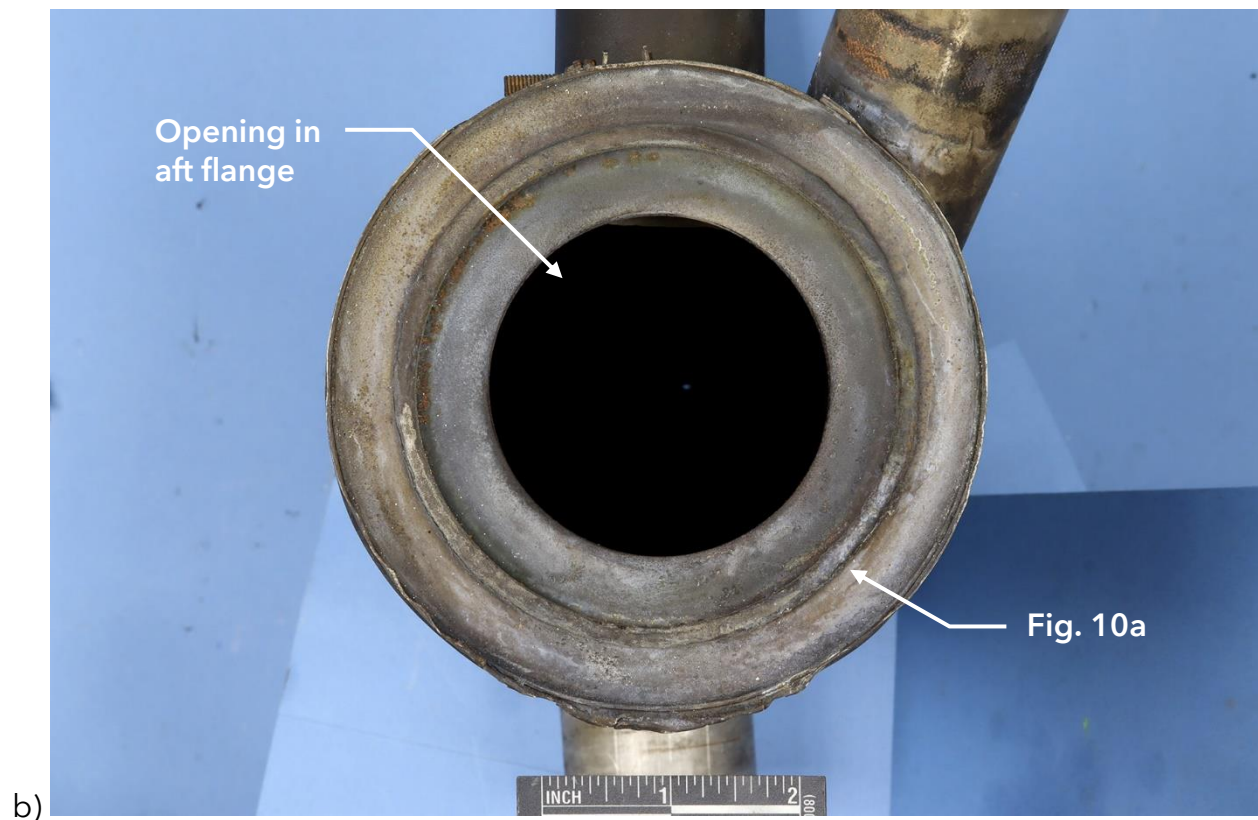
**Figure 2.** a) Image showing the insertion end of the ball tube and the band clamp and b) image of the aft muffler flange showing the opening into which the ball tube is inserted.

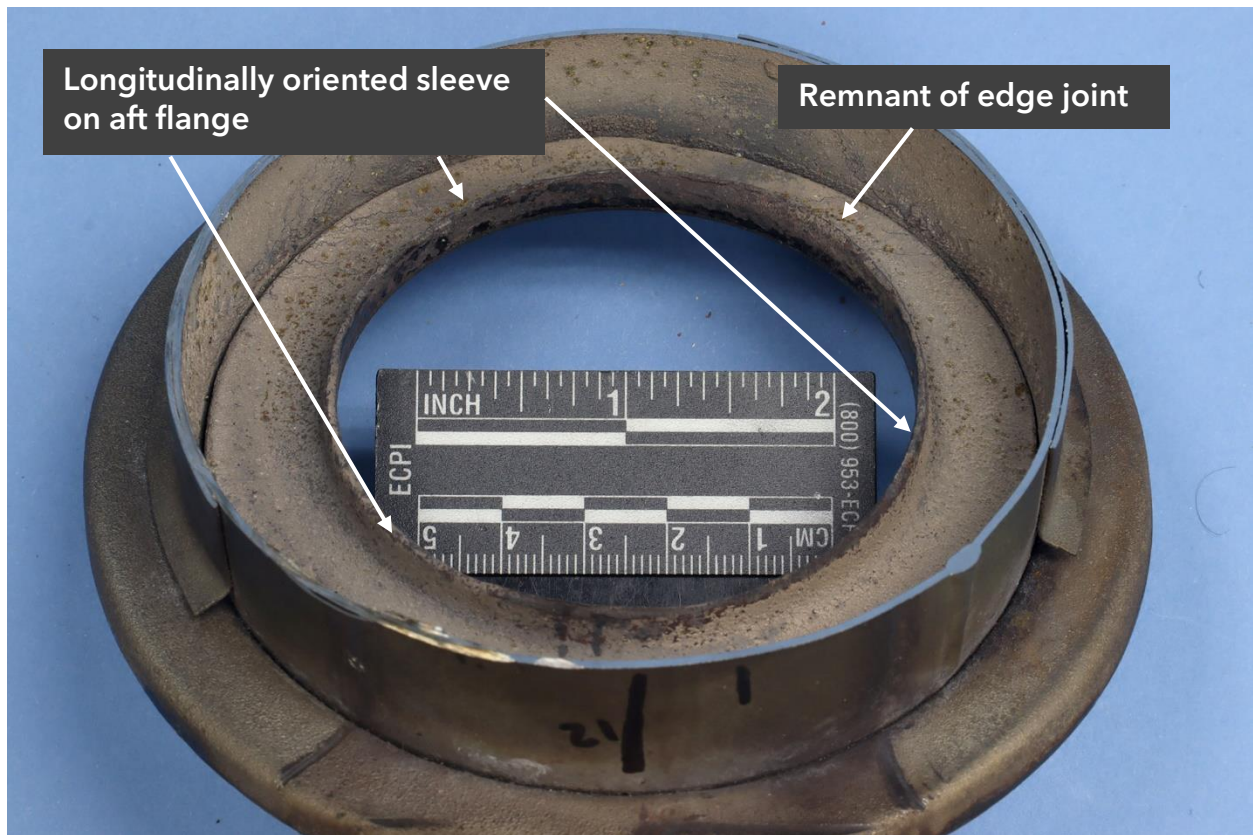
**Figure 3.** Image of the muffler aft flange inner surface after cutting the flange from the muffler body. The flange contained a longitudinally oriented sleeve that surrounded the opening and to which the tube was edge welded.

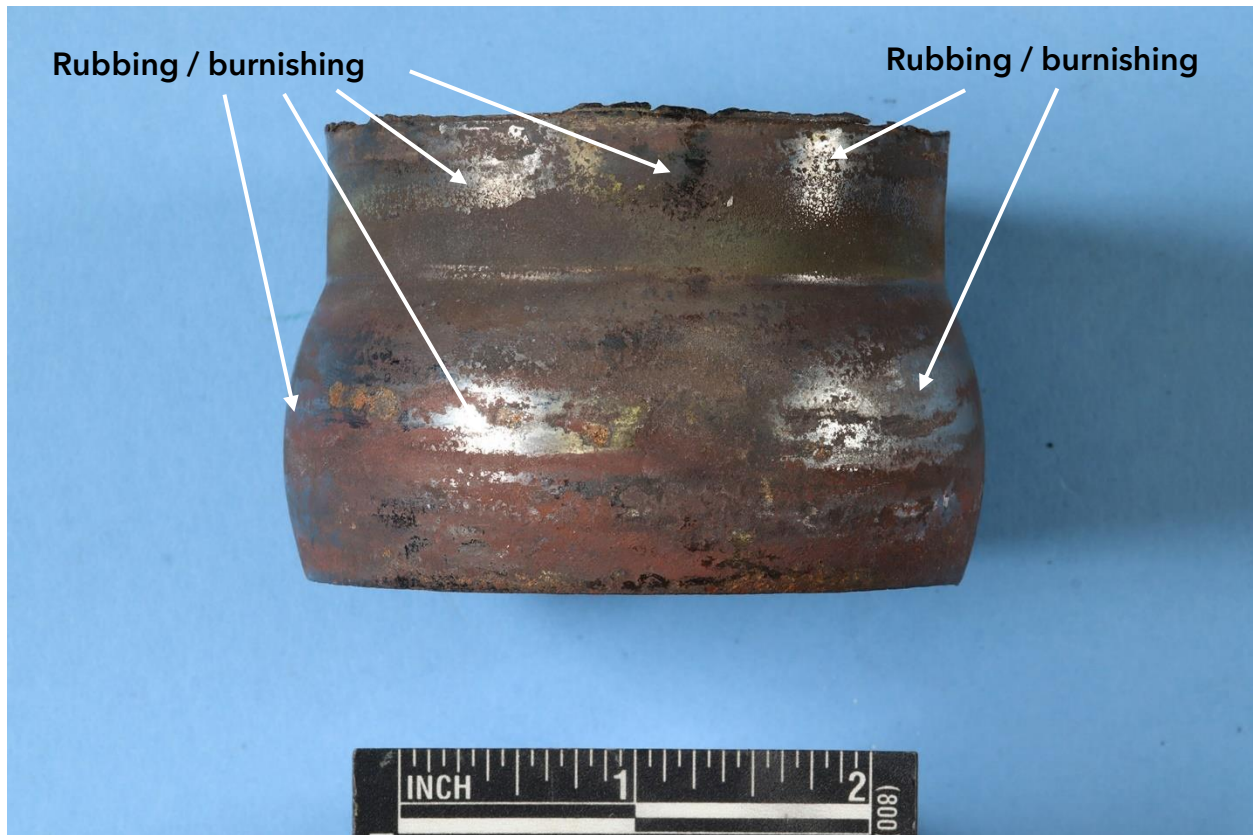
The bolt that secured the band clamp could be turned by hand and the nut had impinged upon the thread runout section of the bolt. The bolt and clamp were removed in the lab, separating the ball tube from the tailpipe. The compression ring was then removed leaving just the ball tube, which is shown in figures 4 and 5. The outside of the tube exhibited a rubbed and burnished appearance in the regions where it lapped the aft flange and at the connection to the tailpipe, as seen in figure 4.<sup>1</sup> The perimeter of the tube was assigned clock positions as if viewed from upstream looking downstream with 12 o'clock at top dead center. Between the 6 o'clock and 9 o'clock positions, the forward end of the tube had been cut back, as

**Figure 4.** Image of ball tube showing rubbing / burnishing marks near the muffler aft flange sleeve and near the connection to the tailpipe. The marks were present around the entire perimeter of the tube.

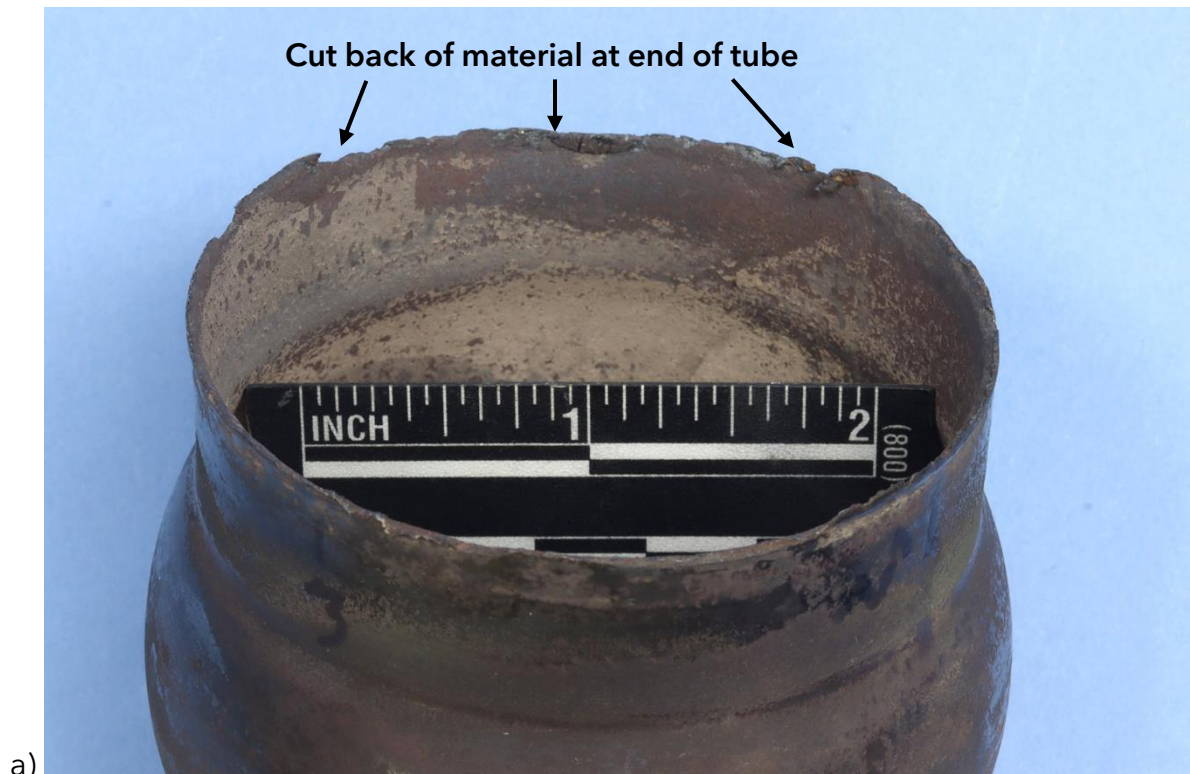
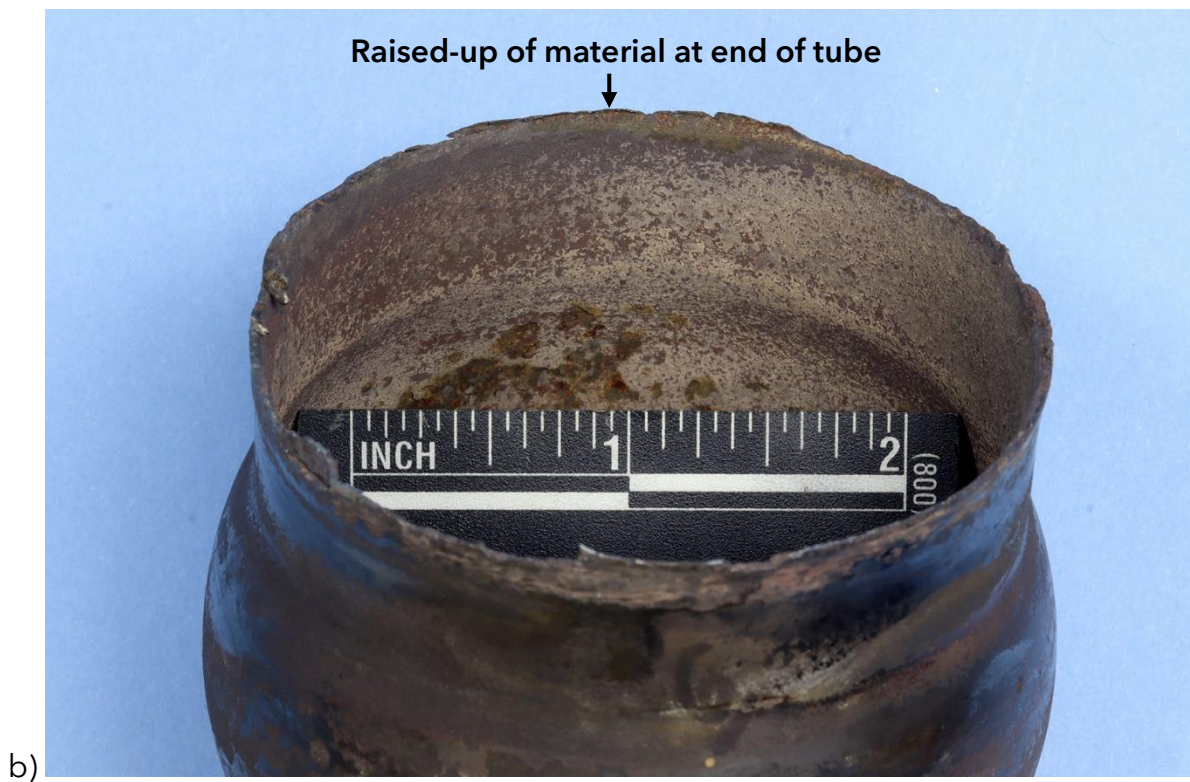
seen in figure 5a. By contrast, near the 12 o'clock position, there was a region of raised up material at the forward end of the tube.

**Figure 5.** Images of the forward end of the ball tube, which is inserted into and welded to the muffler aft flange; a) region where material had been cut back from the end of the tube and b) region where material had been raised up at the end of the tube.

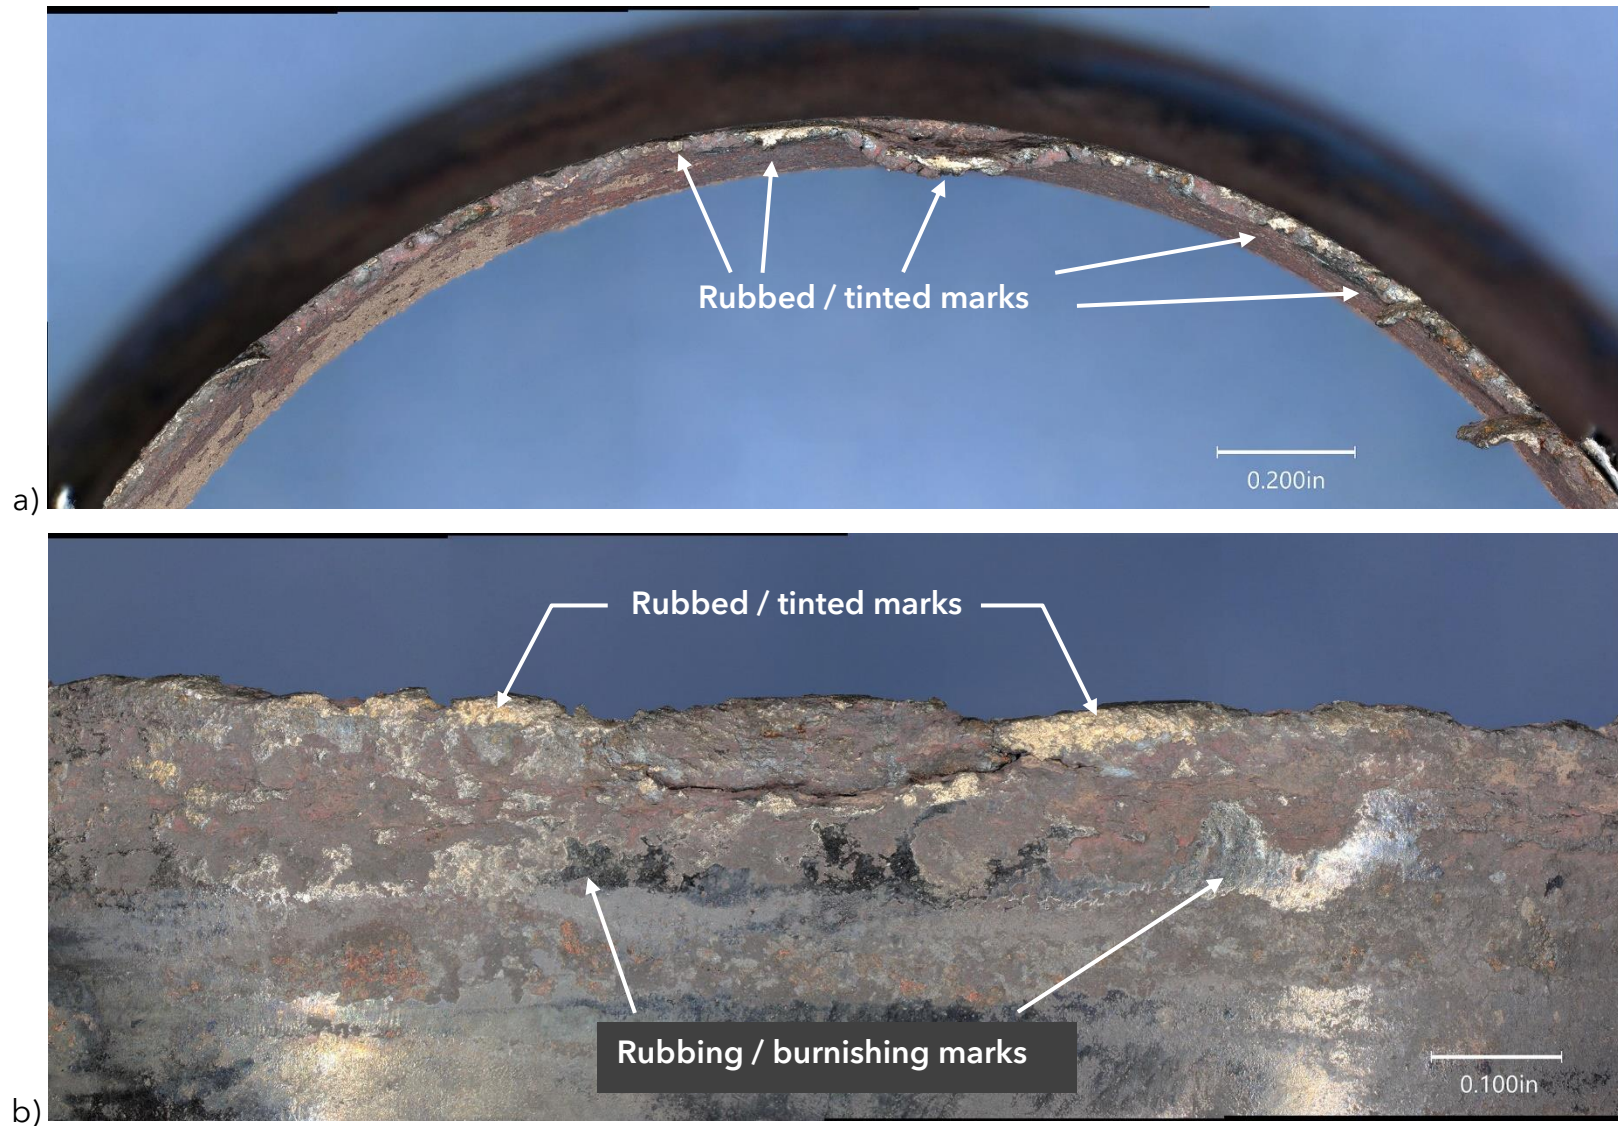
The cut back region of the ball tube is shown in greater detail in figures 6 and 7. As indicated in figures 6a and 6b, the end face and outer diameter of the tube exhibited multiple locations where the surface exhibited a rubbed and gold-tinted appearance. Rubbing/burnishing along the outer diameter, as previously described, is also indicated in figure 6b. The inner diameter surface along the cut back edge is shown in figure 7a - c. After removal of a layer of lead deposits, much of the surface had an intermingled and rough red and gray appearance, consistent with oxide scale. However, there were also regions along the edge that exhibited a silver mottled appearance that was consistent with material that had either been at the incipient point of melting or had partially melted before resolidifying, several regions of which are indicated in figure 7b. Near the ends of the cut back region (near 6 o'clock and 9 o'clock) there were pieces of metal that appeared to be fused to the adjoining metal, as indicated in figures 7a and 7c. Finally, near the 9 o'clock position, a piece of metal that was unfused or partially fused to the adjoining metal was observed and is indicated in figure 7c. The sleeve on the aft flange, shown in figure 8, was examined in this area for indications of fused material. No fused material was observed, however lead deposits on the face of the sleeve were.

**Figure 6.** Images of the tube end where the material had been cut back; a) end view indicated rubbing and tinting on the end face and b) image of the outer diameter surface indicating rubbing, burnishing, and tinting.

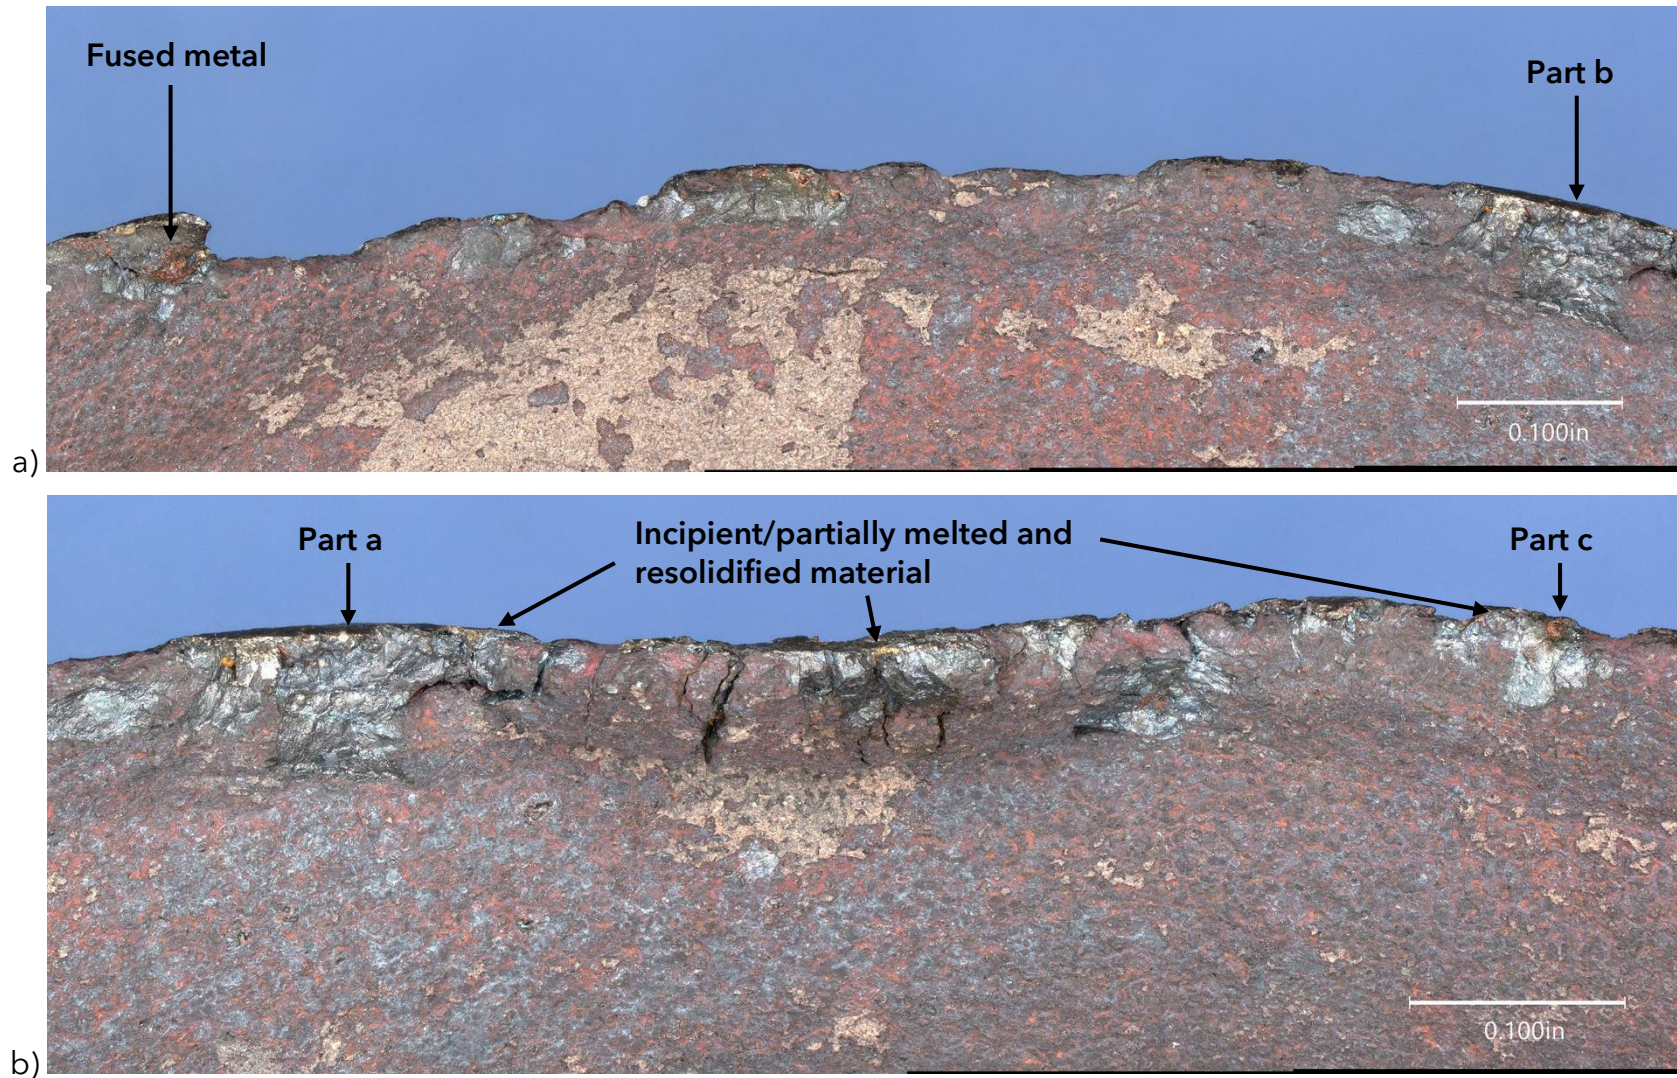
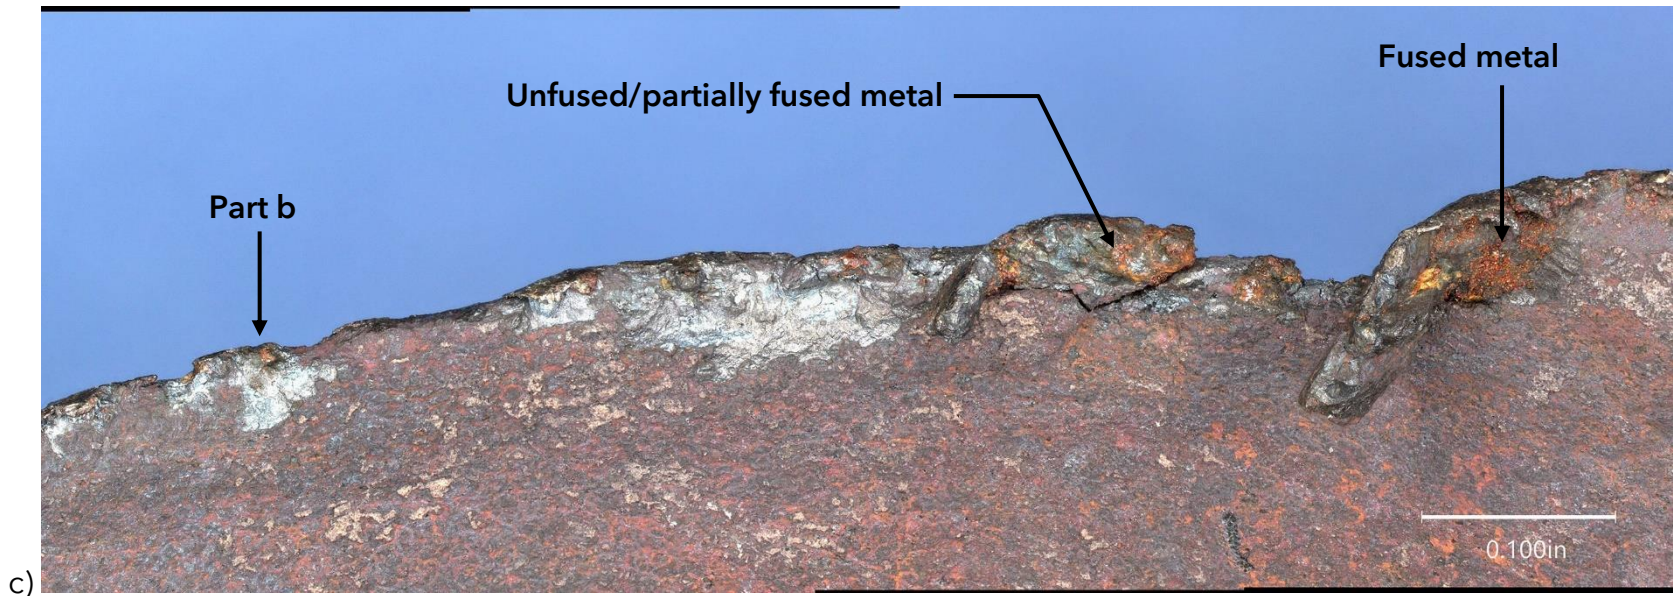
**Figure 7.** a) - c) Images of the inner diameter surface along the cut back edge. Regions of fused metal, molten and resolidified metal, and unfused metal were observed.

**Figure 7 (cont.).** a) - c) Images of the inner diameter surface along the cut back edge. Regions of fused metal, molten and resolidified metal, and unfused metal were observed.

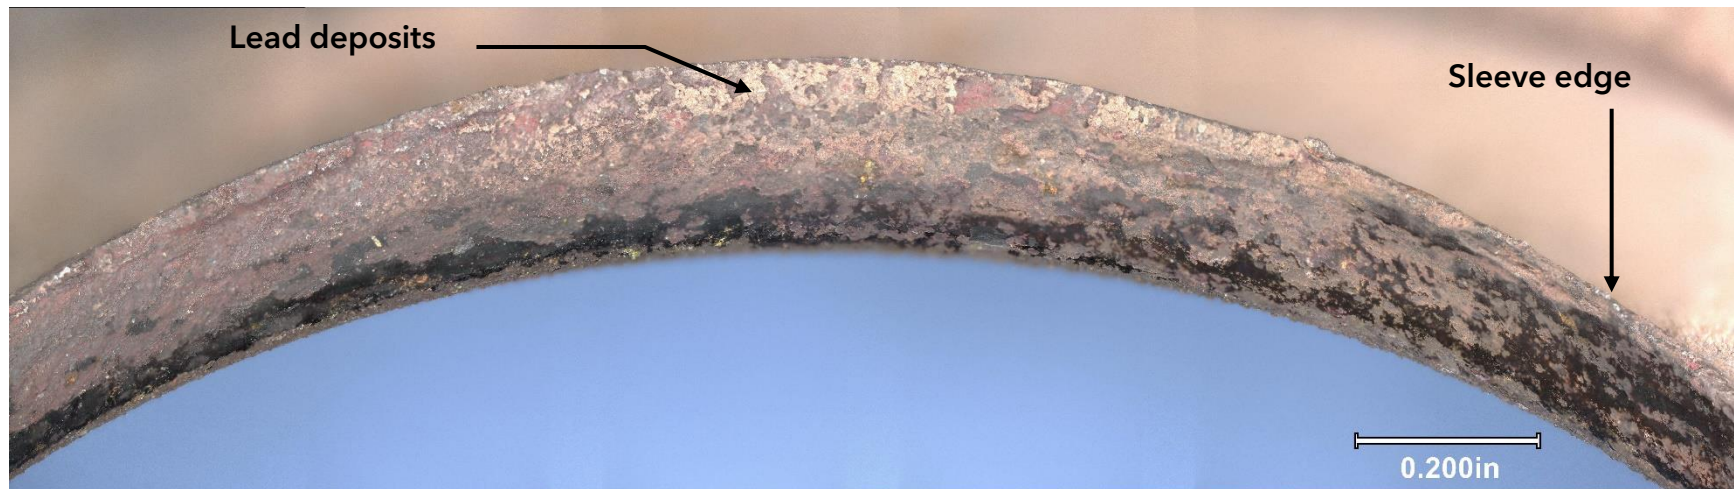
**Figure 8.** Image of the aft flange sleeve between the 6 o'clock and 9 o'clock positions.

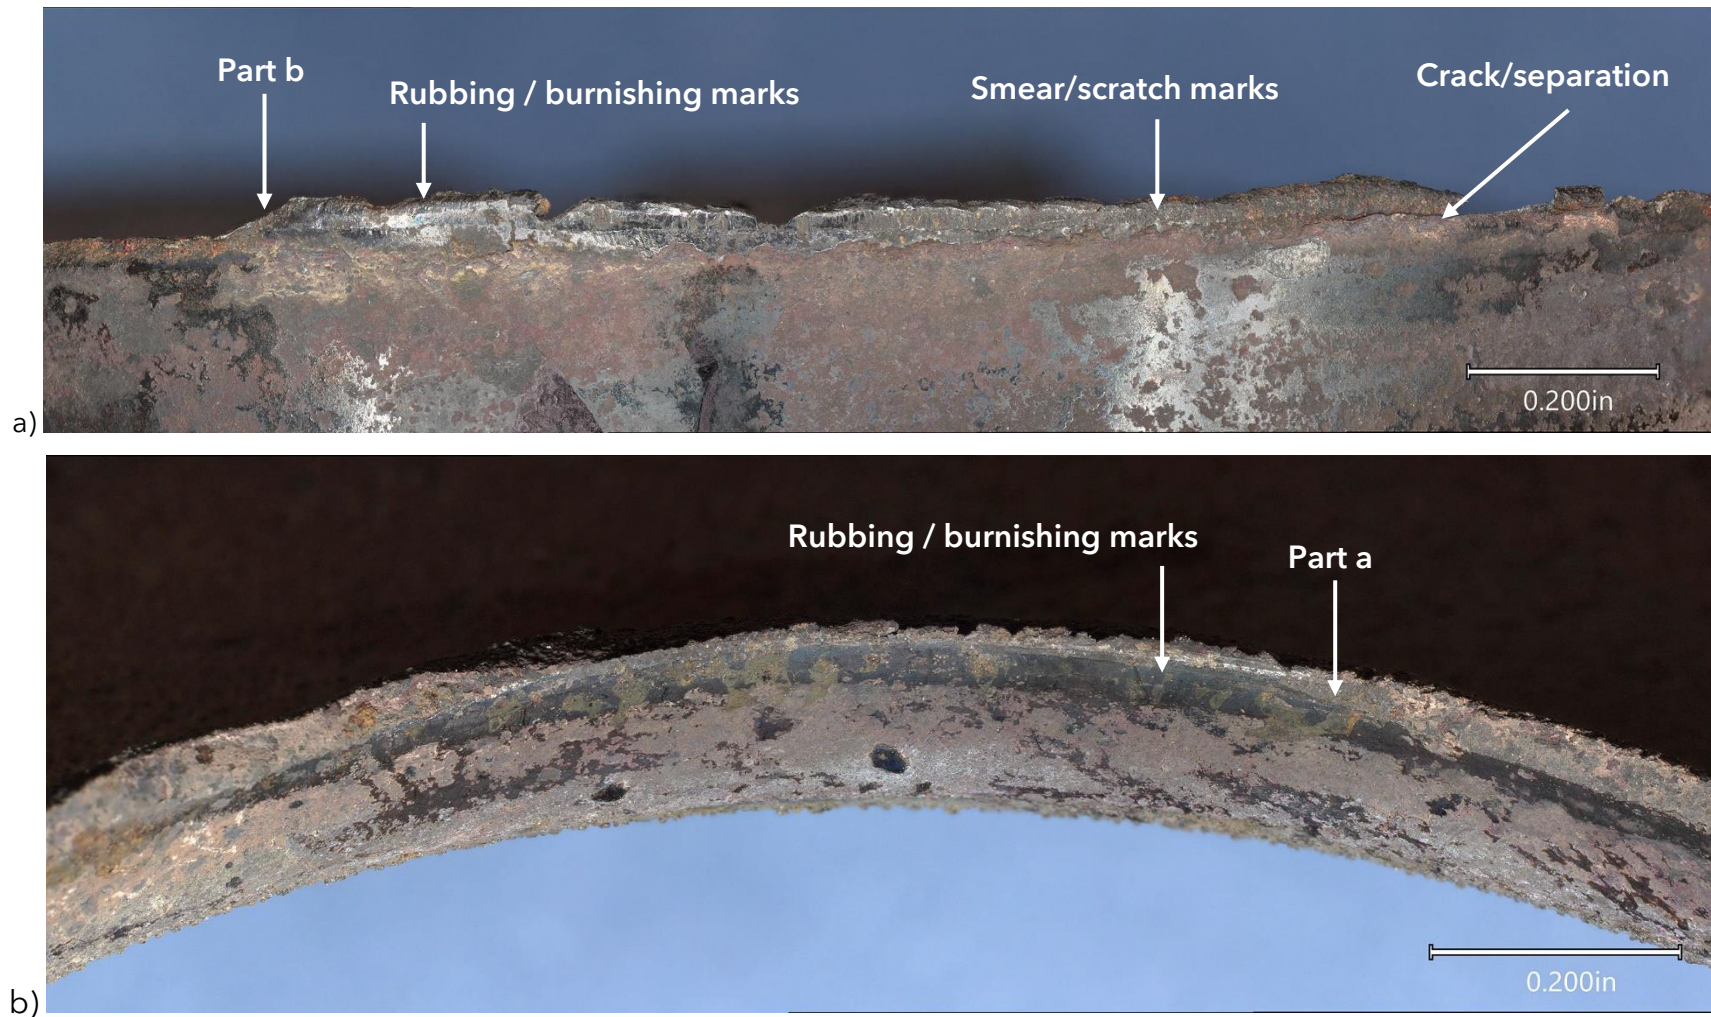
The raised-up region on the tube around the 12 o'clock position and associated aft flange sleeve are shown in greater detail in figures 9a and 9b, respectively. The raised-up material appeared to be fused to the end of the tube. On the outer diameter surface, the material exhibited a rubbed/burnished appearance between the 12 o'clock and 1 o'clock positions (left side of figure 9a) and a smeared/scratched appearance toward the 11 o'clock position (right side of figure 9a). At the end of the smeared/scratched region, there was a crack/separation between the raised-up material and adjoining tube material, as indicated in the figure. The sleeve on the aft flange, shown in figure 9b, exhibited a rubbed/burnished appearance in the same region.

**Figure 9.** a) Image of the tube outer diameter surface at the location with raised up material with rubbing and burnishing marks indicated and b) image of the aft flange sleeve's inner diameter surface with burnishing mark indicated.

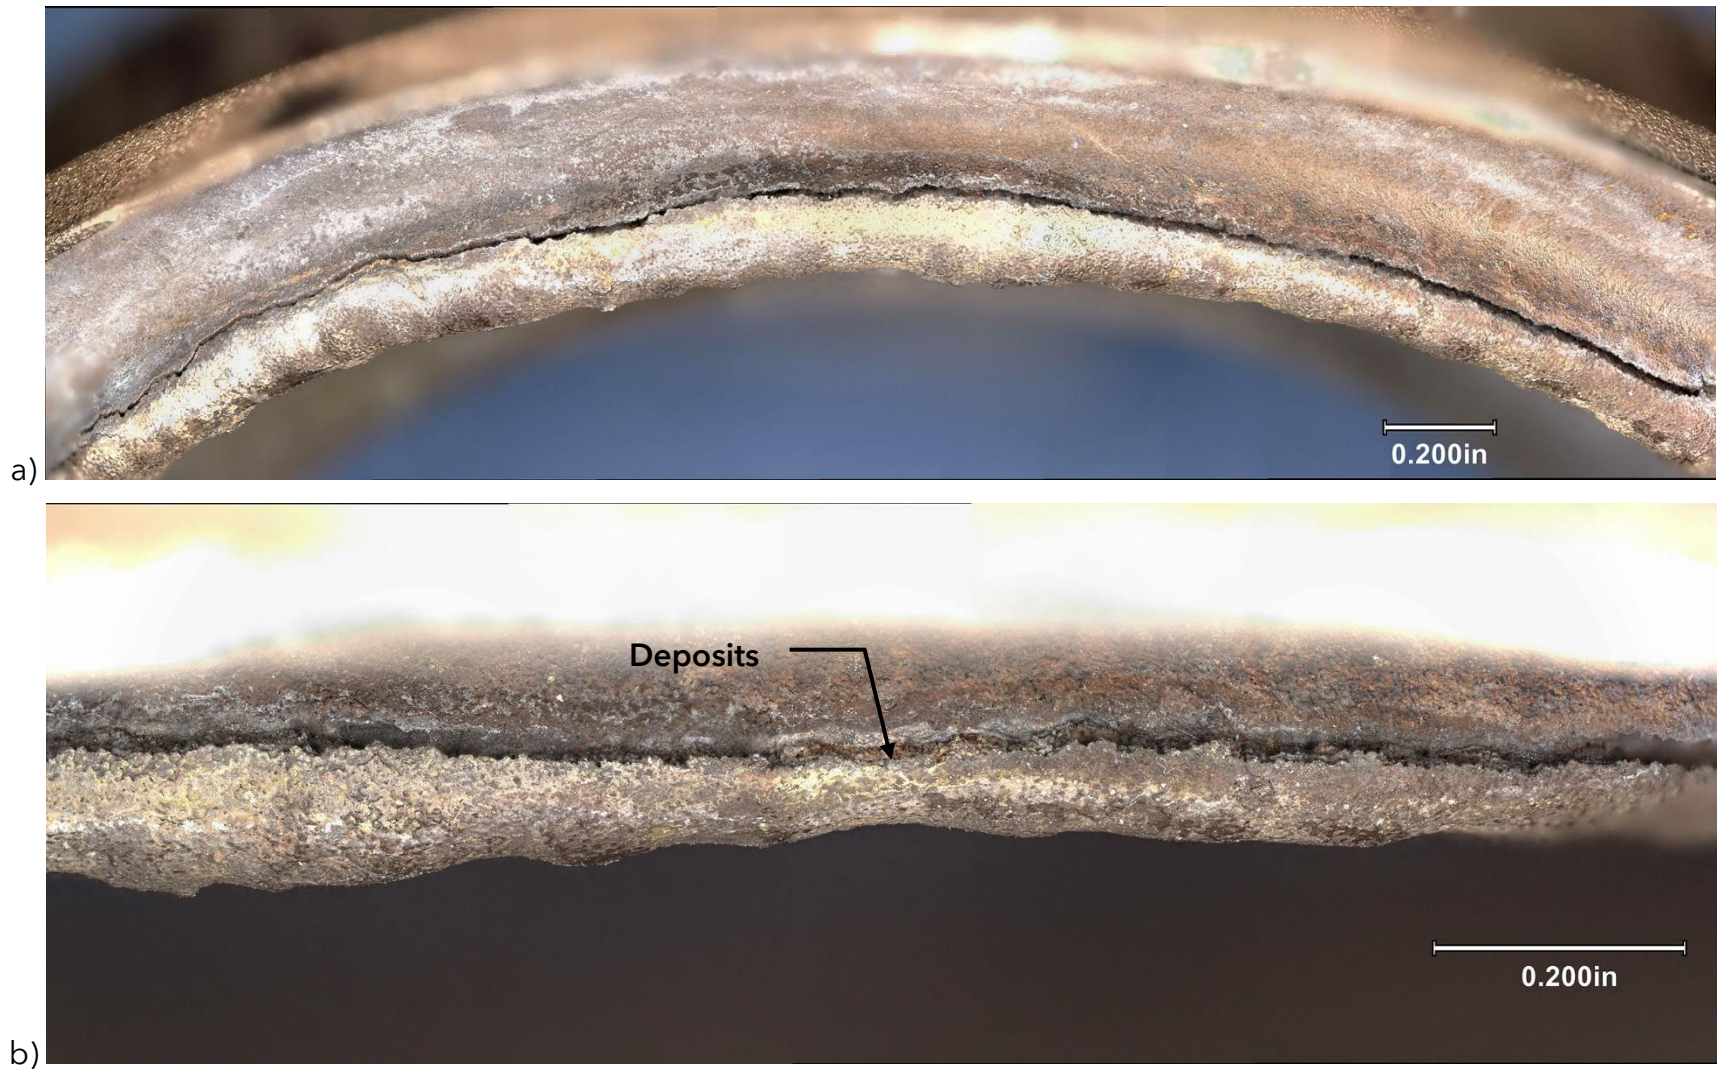
A crack was observed on the outward face of the aft flange between 3 o'clock and 6 o'clock as indicated in figure 2 and shown in figures 10a and b. The crack ran along the toe of a weld that joined the aft flange to the cylindrical body of the muffler. Examination of the crack with the aid of a binocular microscope indicated that the crack surfaces appeared oxidized and in at least one region, deposits were present on the fracture, as indicated in figure 10b.

**Figure 10.** a) Image of a crack observed on the outer face of the muffler aft flange between the 3 o'clock and 6 o'clock positions and b) higher magnification image showing deposits in the crack.
