| SUBJECT<br>Aircraft Accident at Mesquite Metro Airport. | | | |

**NTSB Case Number: CEN22LA259**

- For the accident airplane, N9475Y (Beechcraft 35-A33 equipped with a Continental Motors IO-470-J reciprocating engine), the only way the main landing gear (MLG) will make it back into the wheel well is when the landing gear handle has been positioned to the up position with the electrical power applied to the airplane. This will command the landing gear actuator/motor to retract the MLG, but first it will mechanically open the MLG inboard doors, then mechanically pull the gear into the wheel well, and then it will mechanically close the inboard gear doors after the gear is in the wheel well.

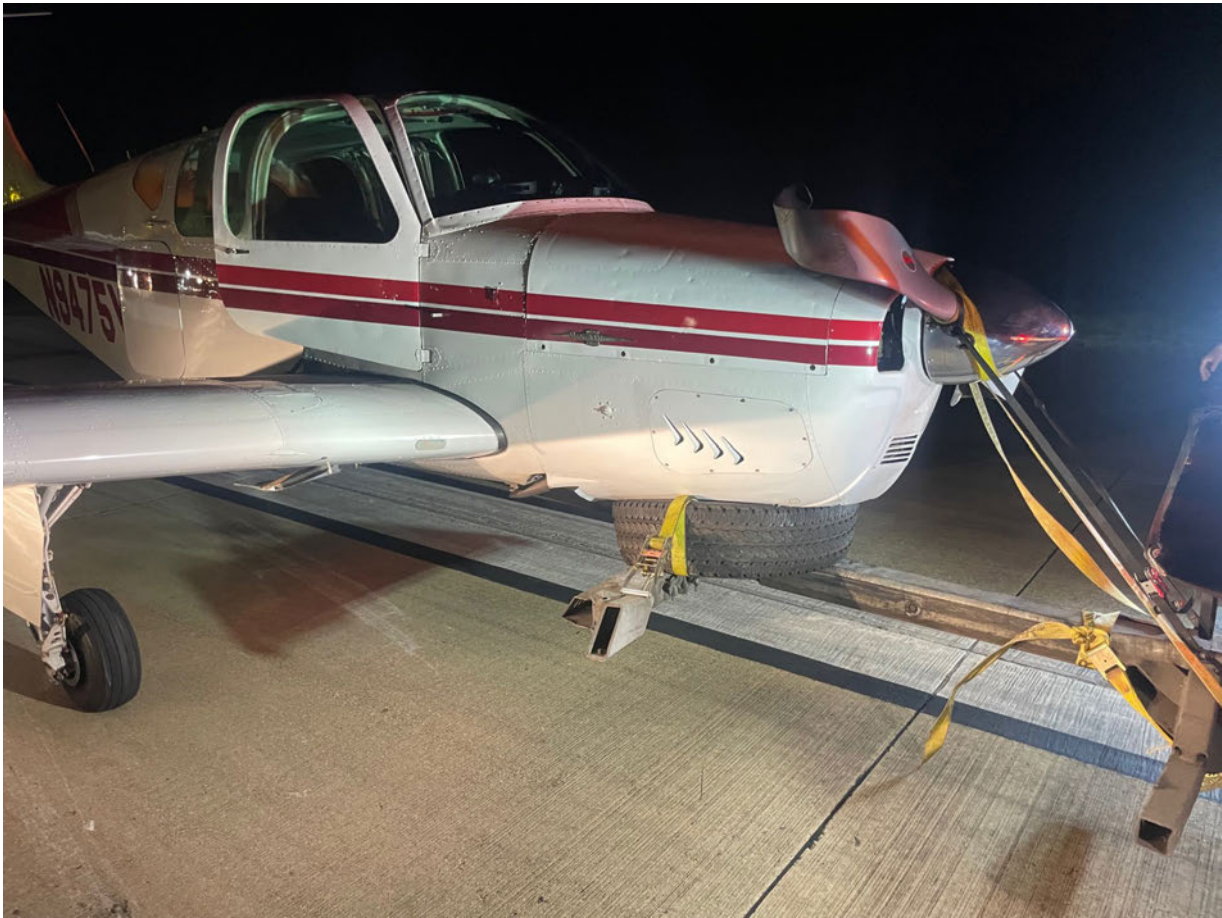
Sorry,  
After lifting the plane with the air bags, both main gears were folded due to the broken and bent roads  
So we were able to extend them down again manually and secure them with the straps  
And tow the plane with tow truck by lifting the front  
Since the nose gear stuck in up position we placed a tire under the engine compartment so the tow truck won't damage the front side sheet metal  
We move it slowly till we were able to put it inside the hanger.

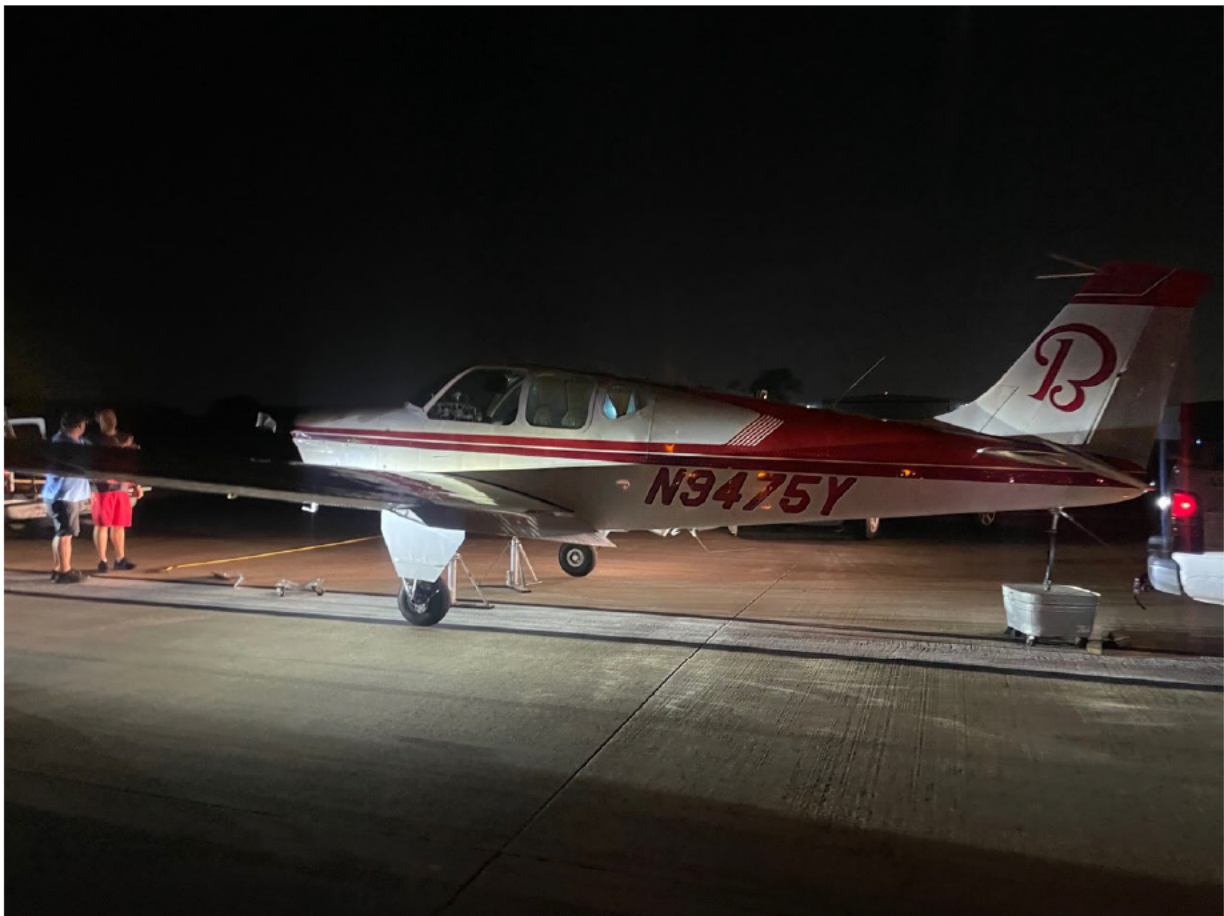
Hi Mike,  
Yes we used air bags  
And we were able to put the main gears on the up position because the rods were bent and one broke  
And then we towed the plane to the hanger.

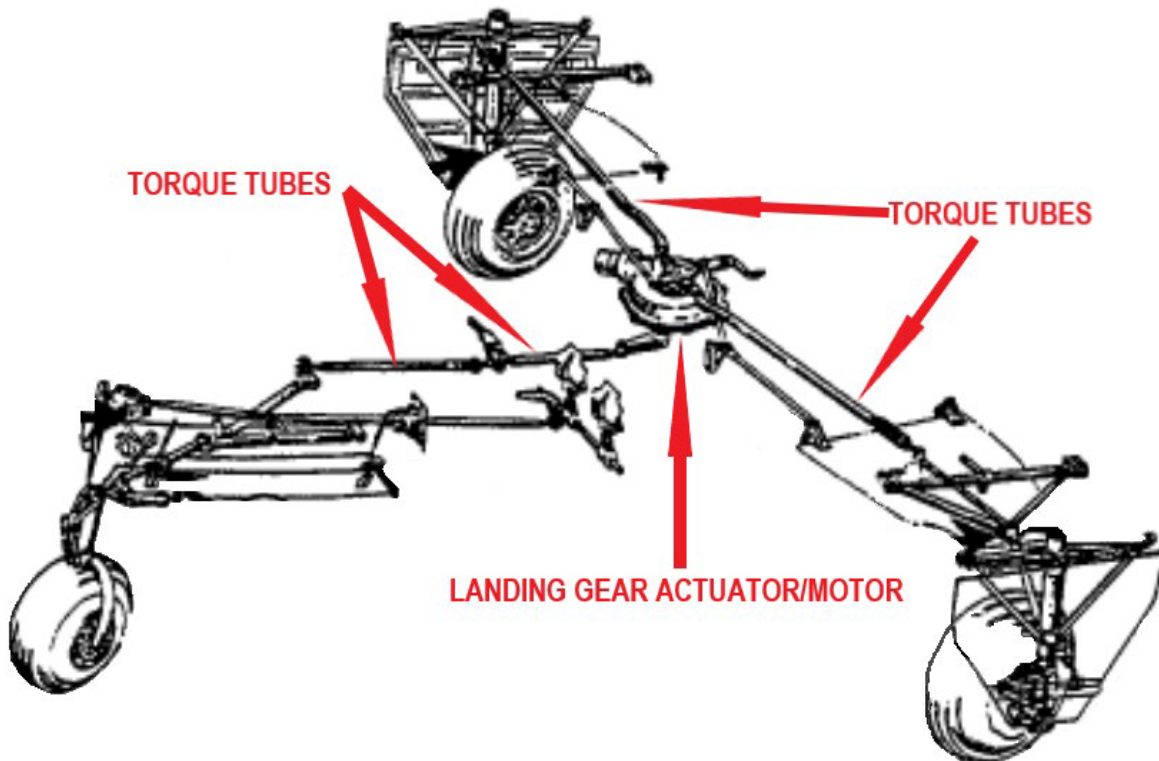
Landing Gear System

- All three push/pull torque tubes would have some issue (example: corrosion, mis-rig, loose, damaged) to allow all three gears to collapse at the same time, or
- If installed, the optional landing gear safety system, the safety switch is in the OFF position or is faulty or mis-rigged, and the landing gear switch is placed in the UP position, the landing gear will retract, or
- The landing gear safety system not installed; the landing gear switch is placed in the UP position commanding the landing gear actuator/motor to retract the landing gear. The landing gear is a mechanical system with torque tubes from the landing gear actuator/motor to each landing gear.
