## Carburetor Icing Probability Graph – CEN22LA283

Airplane: Amateur-built Osprey II

Accident Date: 6/24/2022

Accident Location: Bulverde, TX

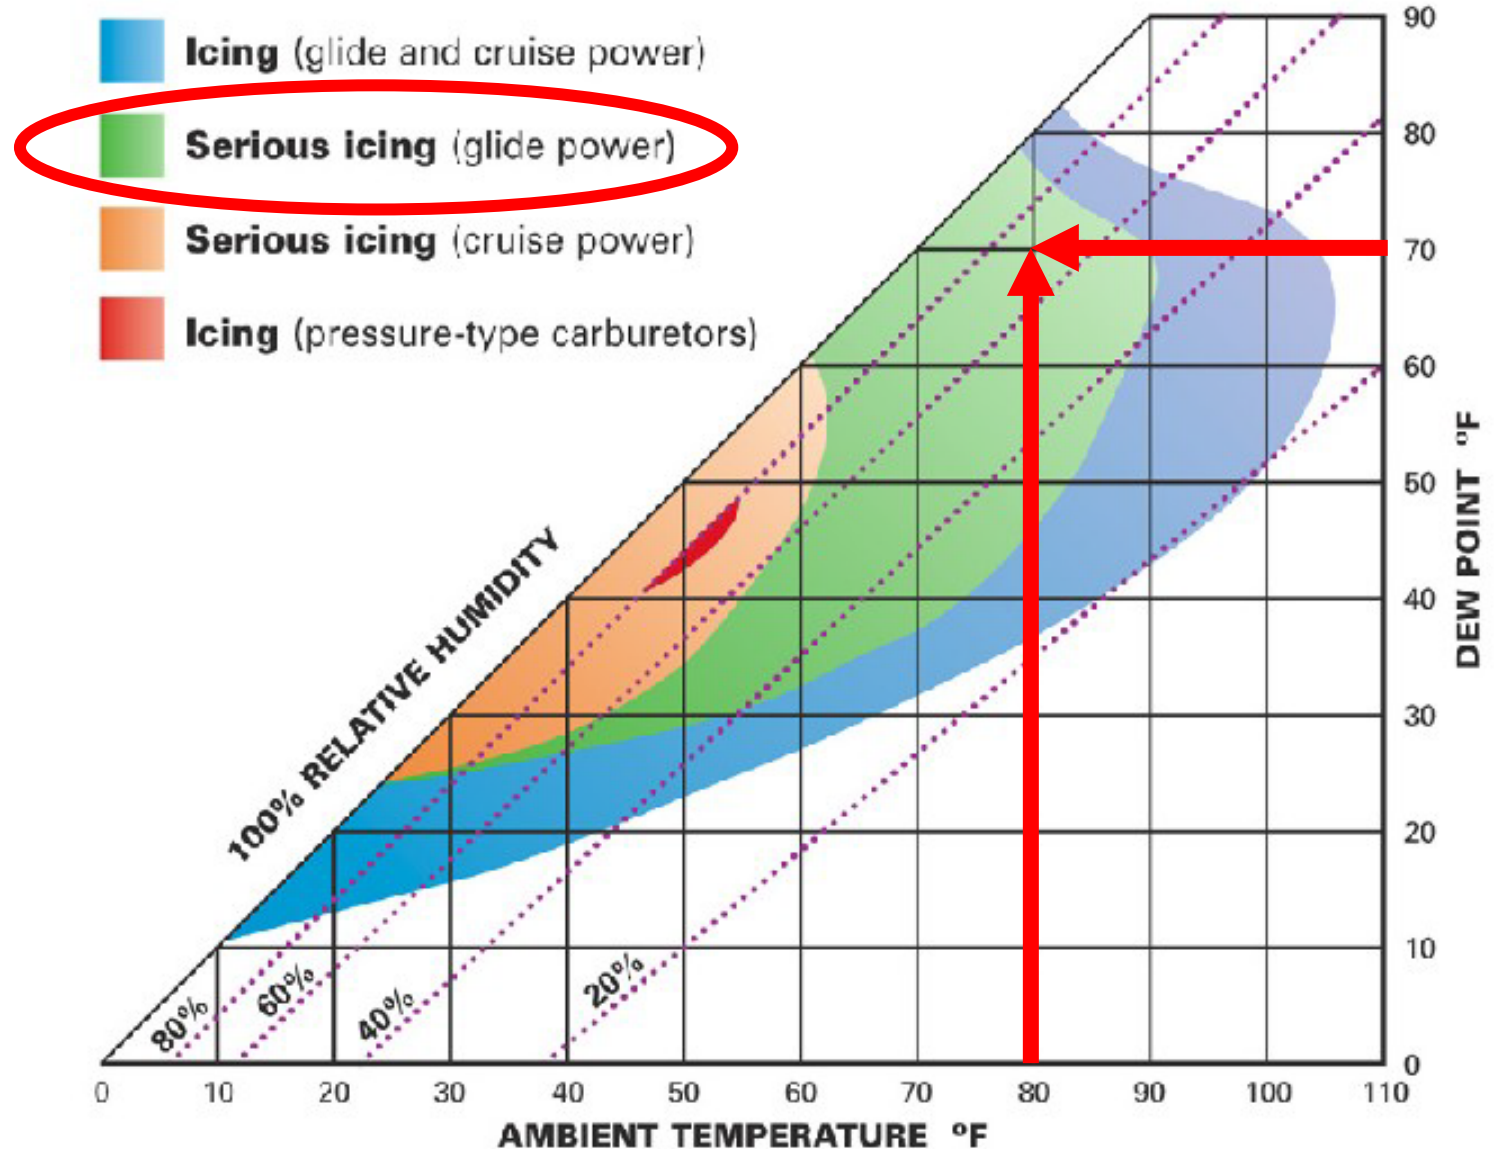
Weather: METAR KSAT 241351Z 22007KT 10SM FEW100  
FEW250 27/21 A2999 RMK AO2 SLP135 T02720211=

Temperature, 27° C = 80° F

Dew Point, 21° C = 70° F
