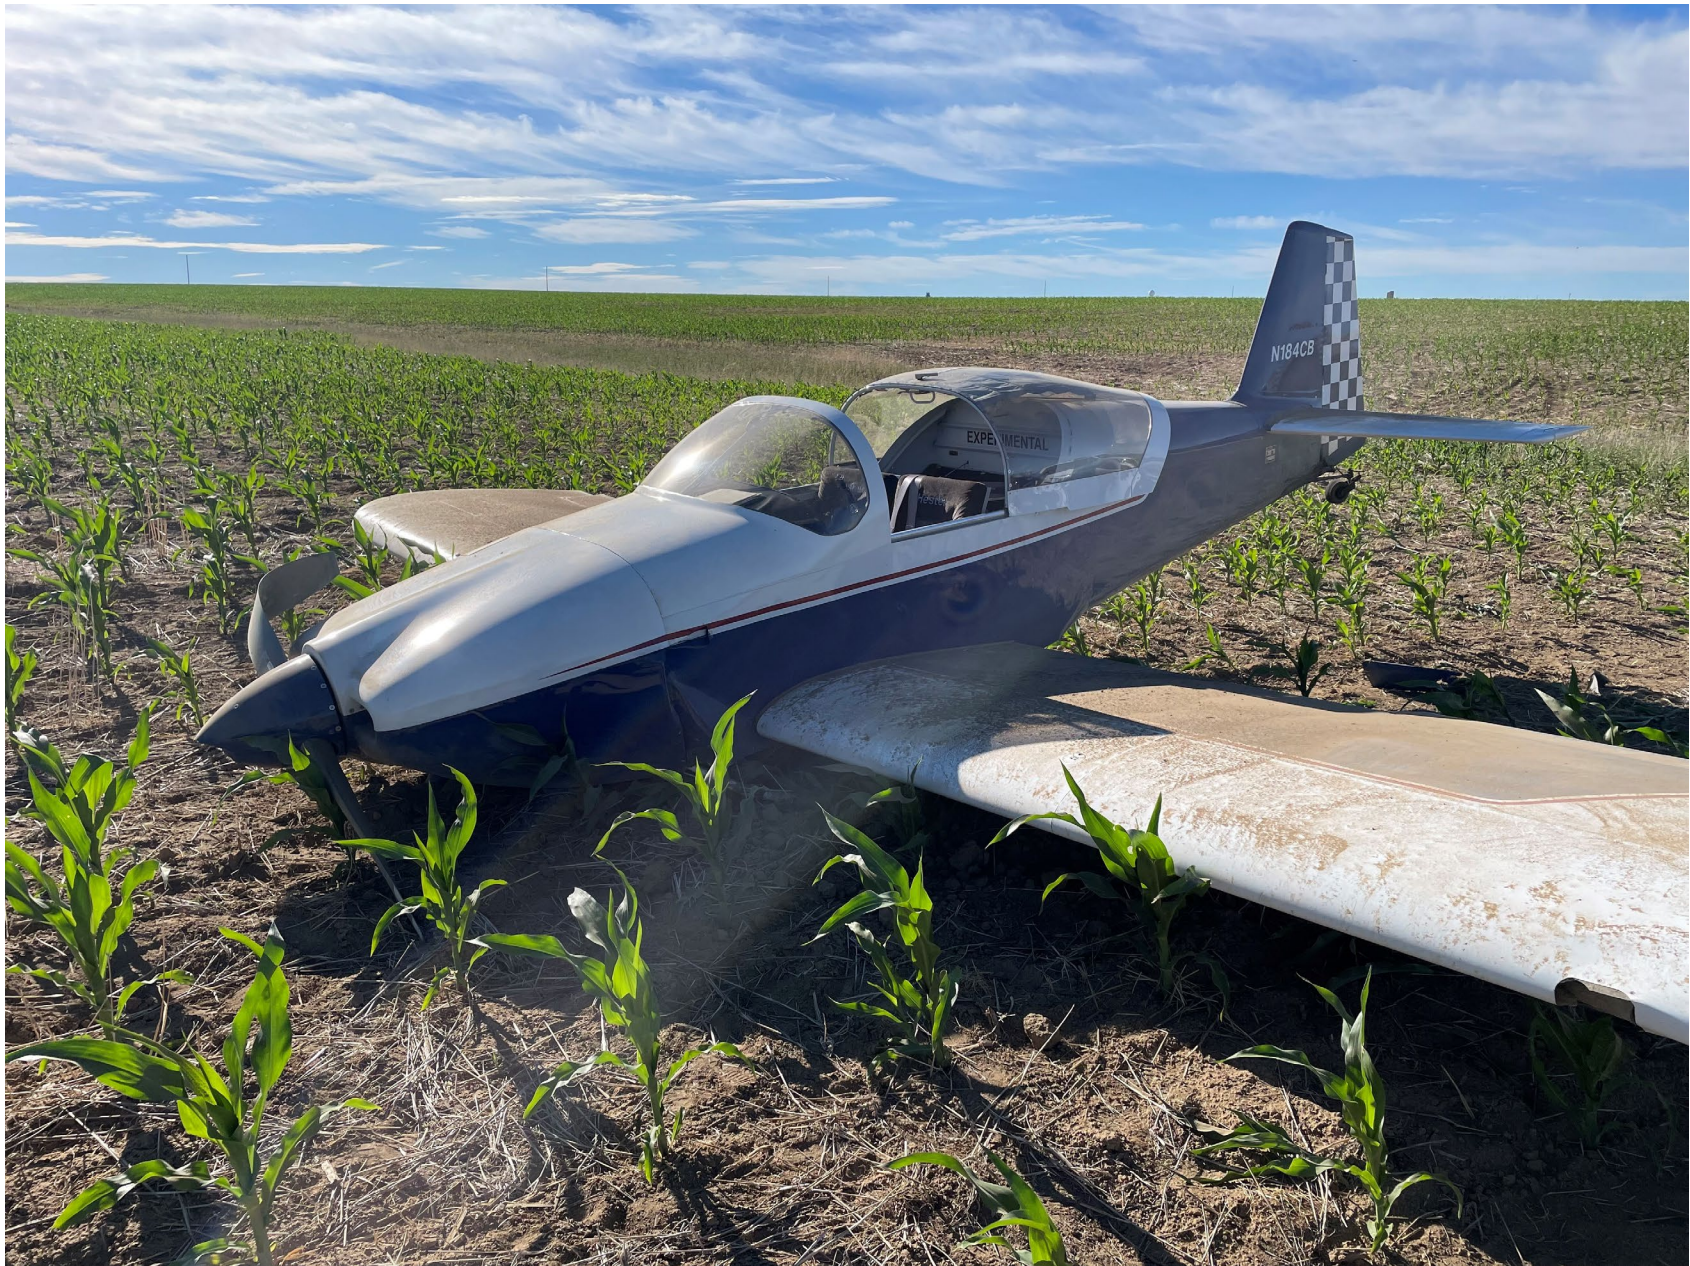
**Photo 1 – Left side view of the airplane in the field (courtesy of the pilot).**

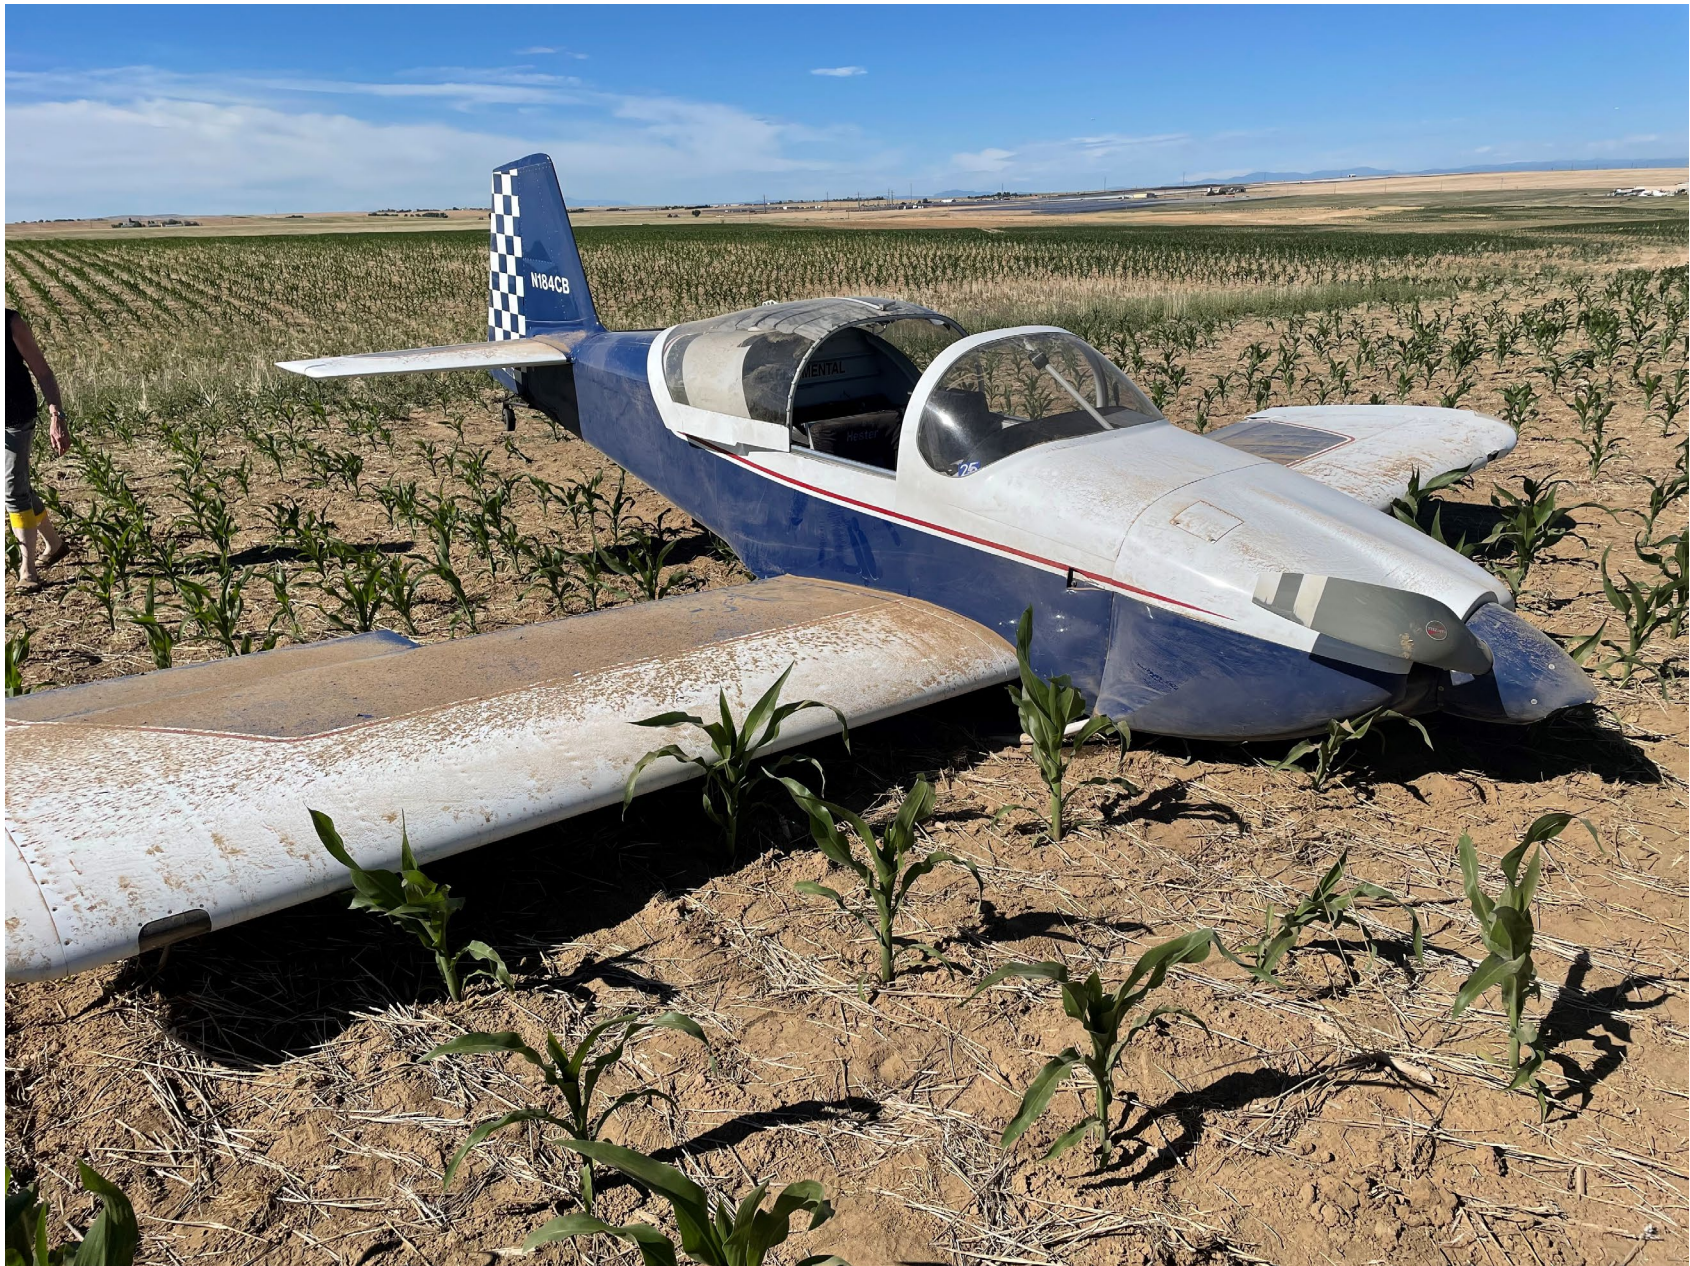
**Photo 2 – Right side view of the airplane in the field (courtesy of the pilot).**

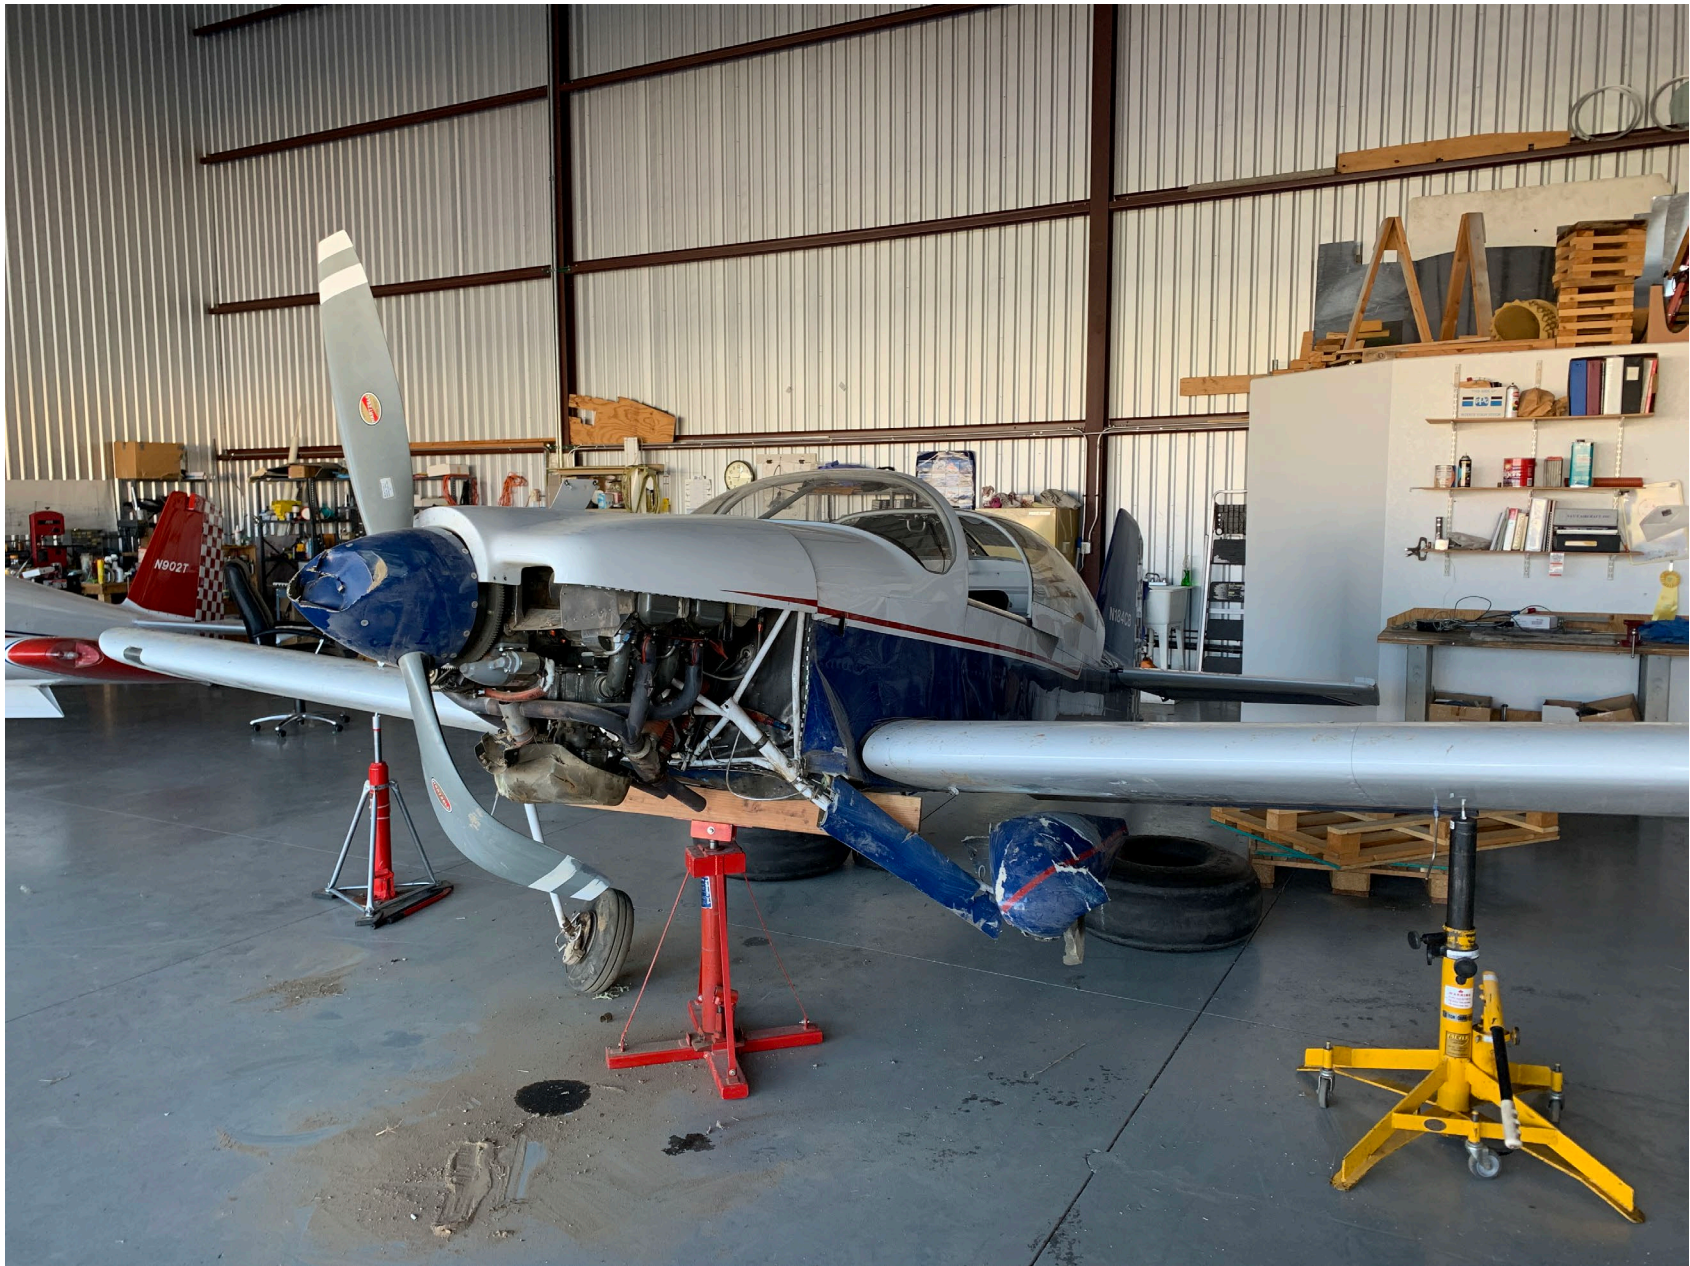
**Photo 3 – View of the airplane in the hangar after it was recovered from the field.**

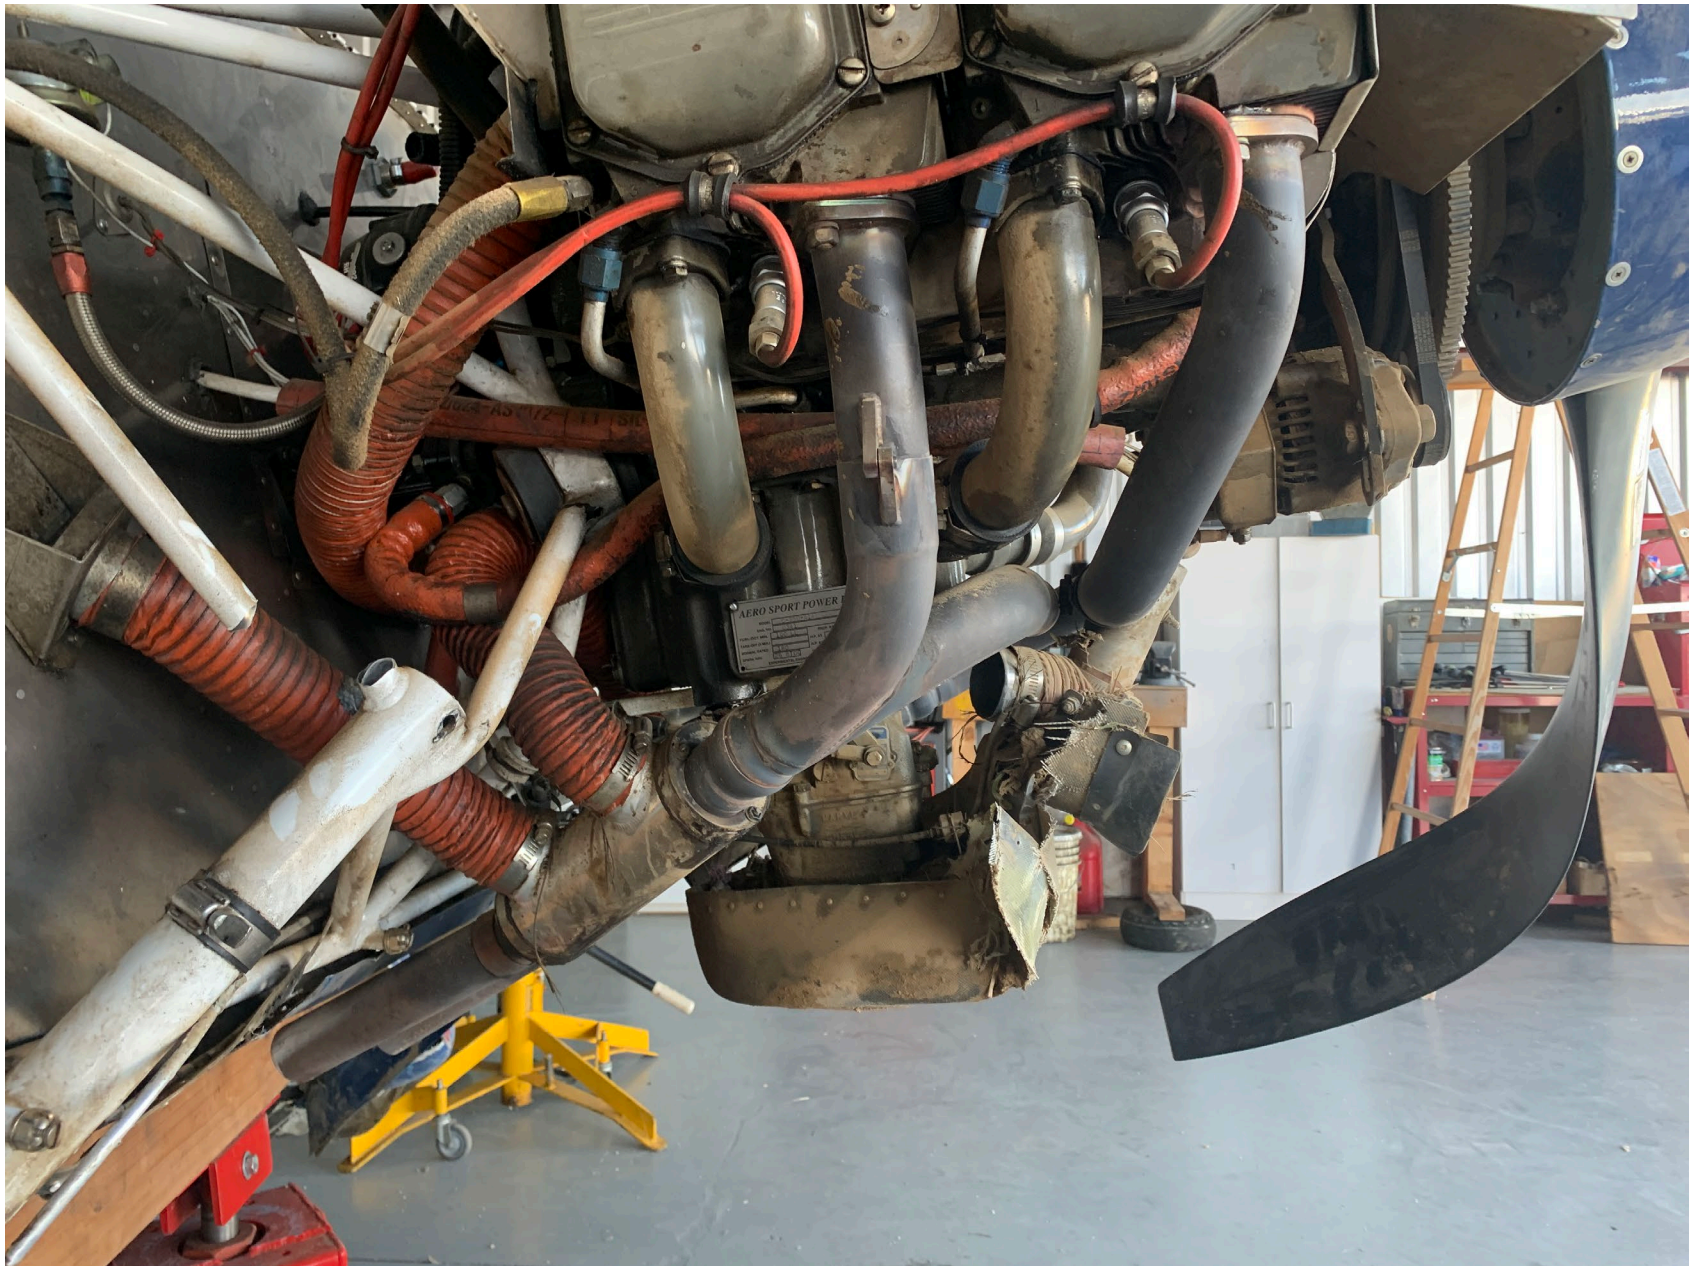
**Photo 4 – View of the substantial damage sustained to the right side engine mount.**

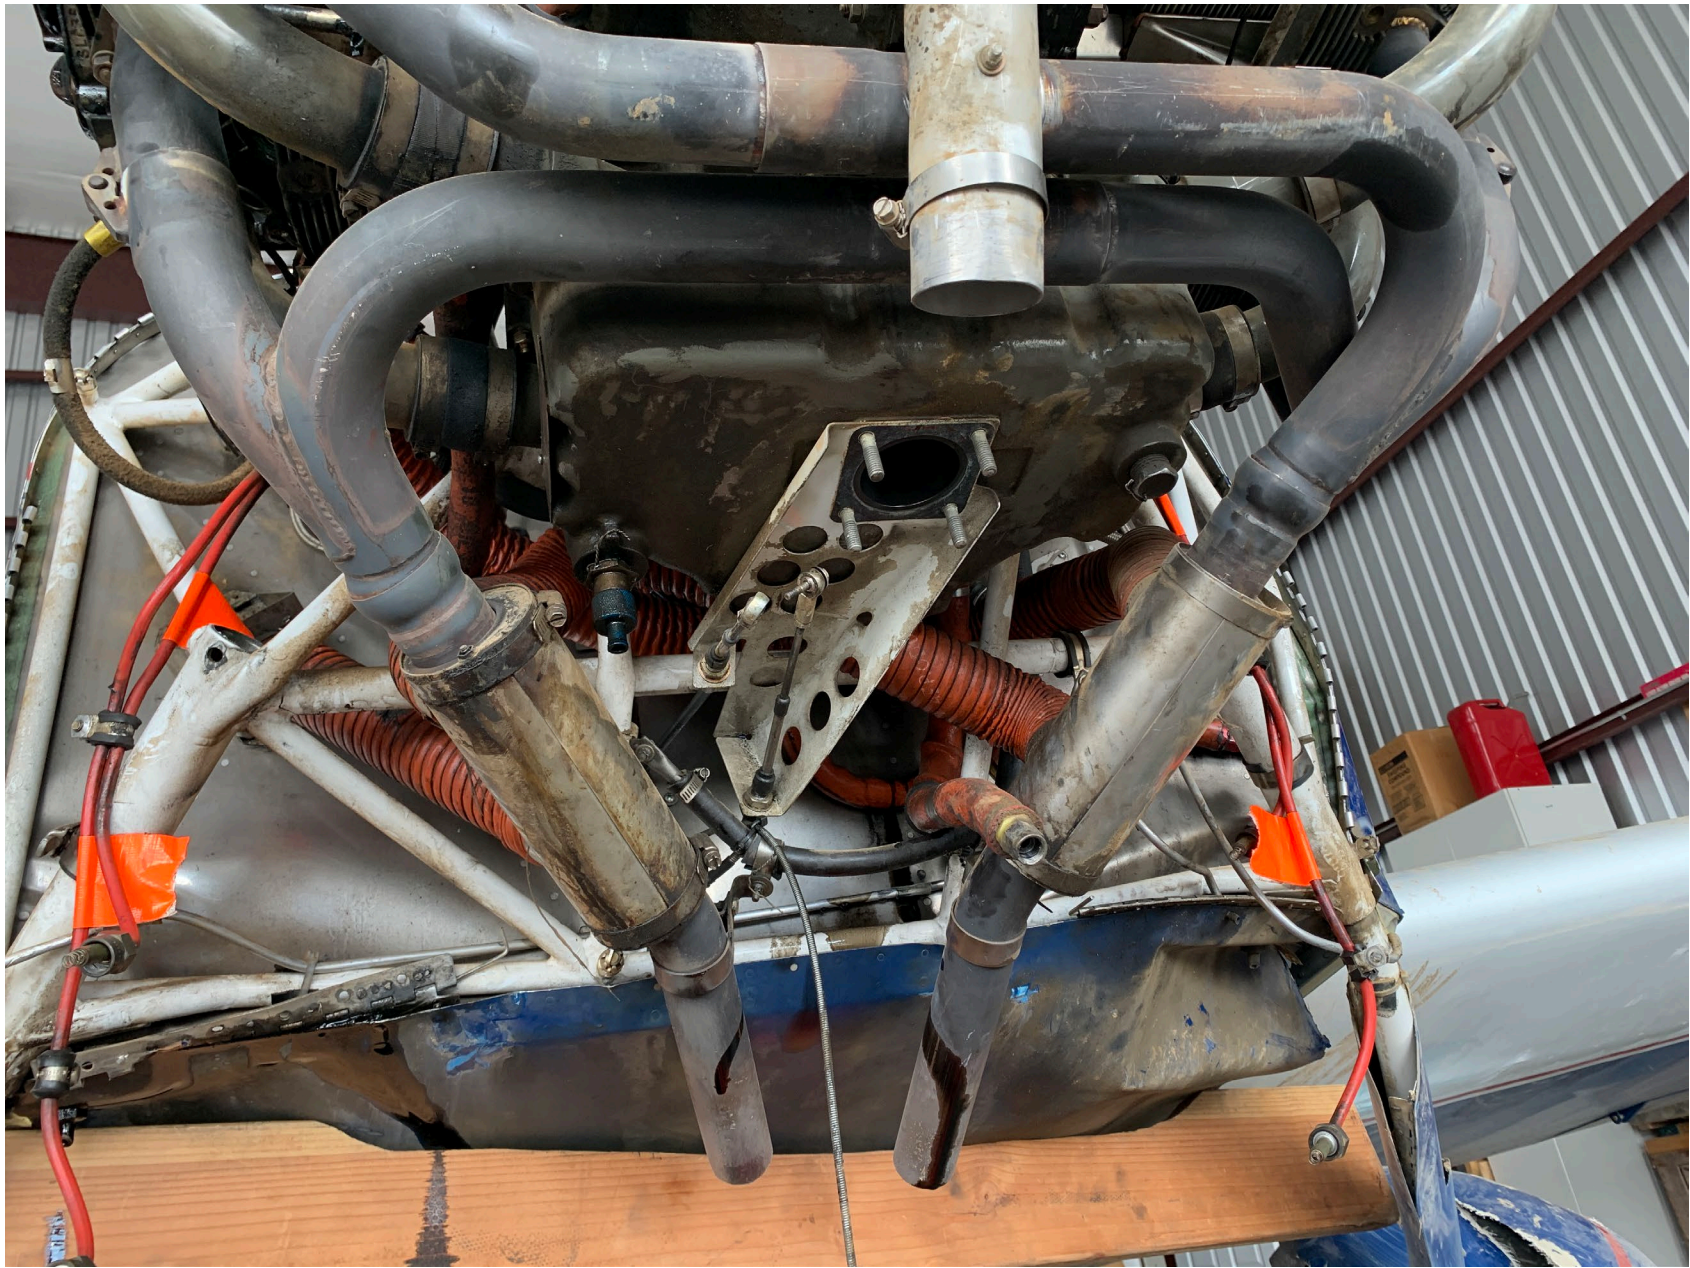
**Photo 5 – View of the substantial damage sustained to the area behind the firewall and to the lower fuselage.**

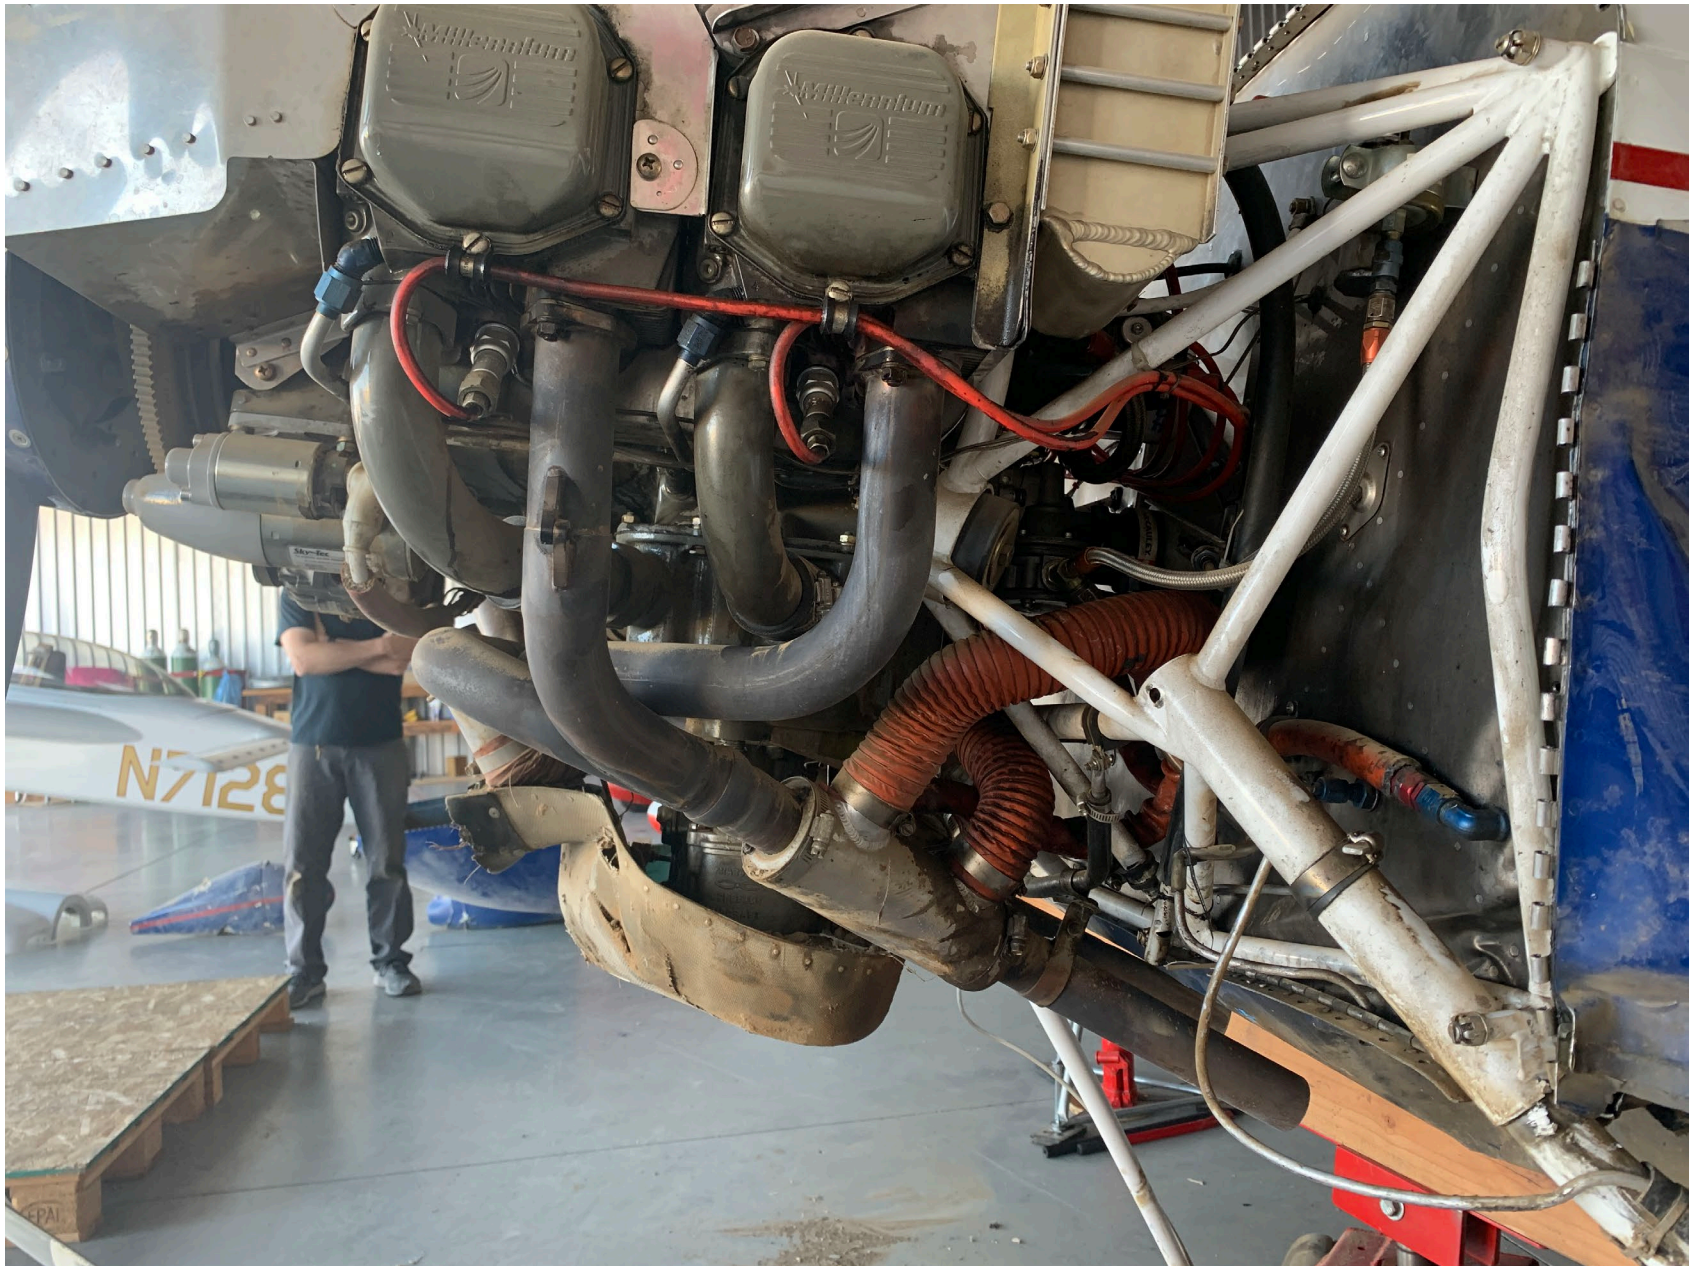
**Photo 6 – View of the substantial damage sustained to the left side engine mount.**

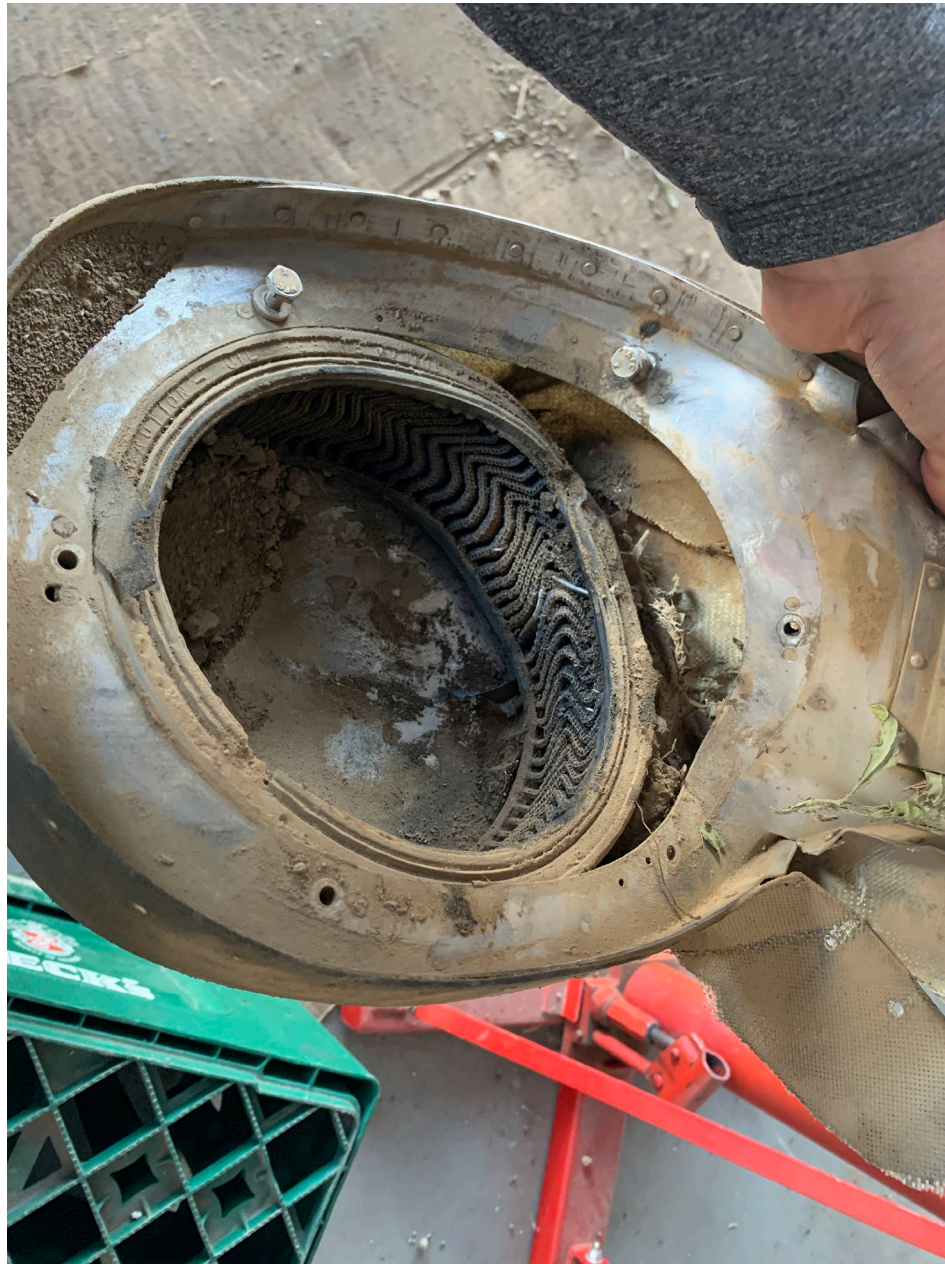
**Photo 7 – View of the air box removed from the engine.**

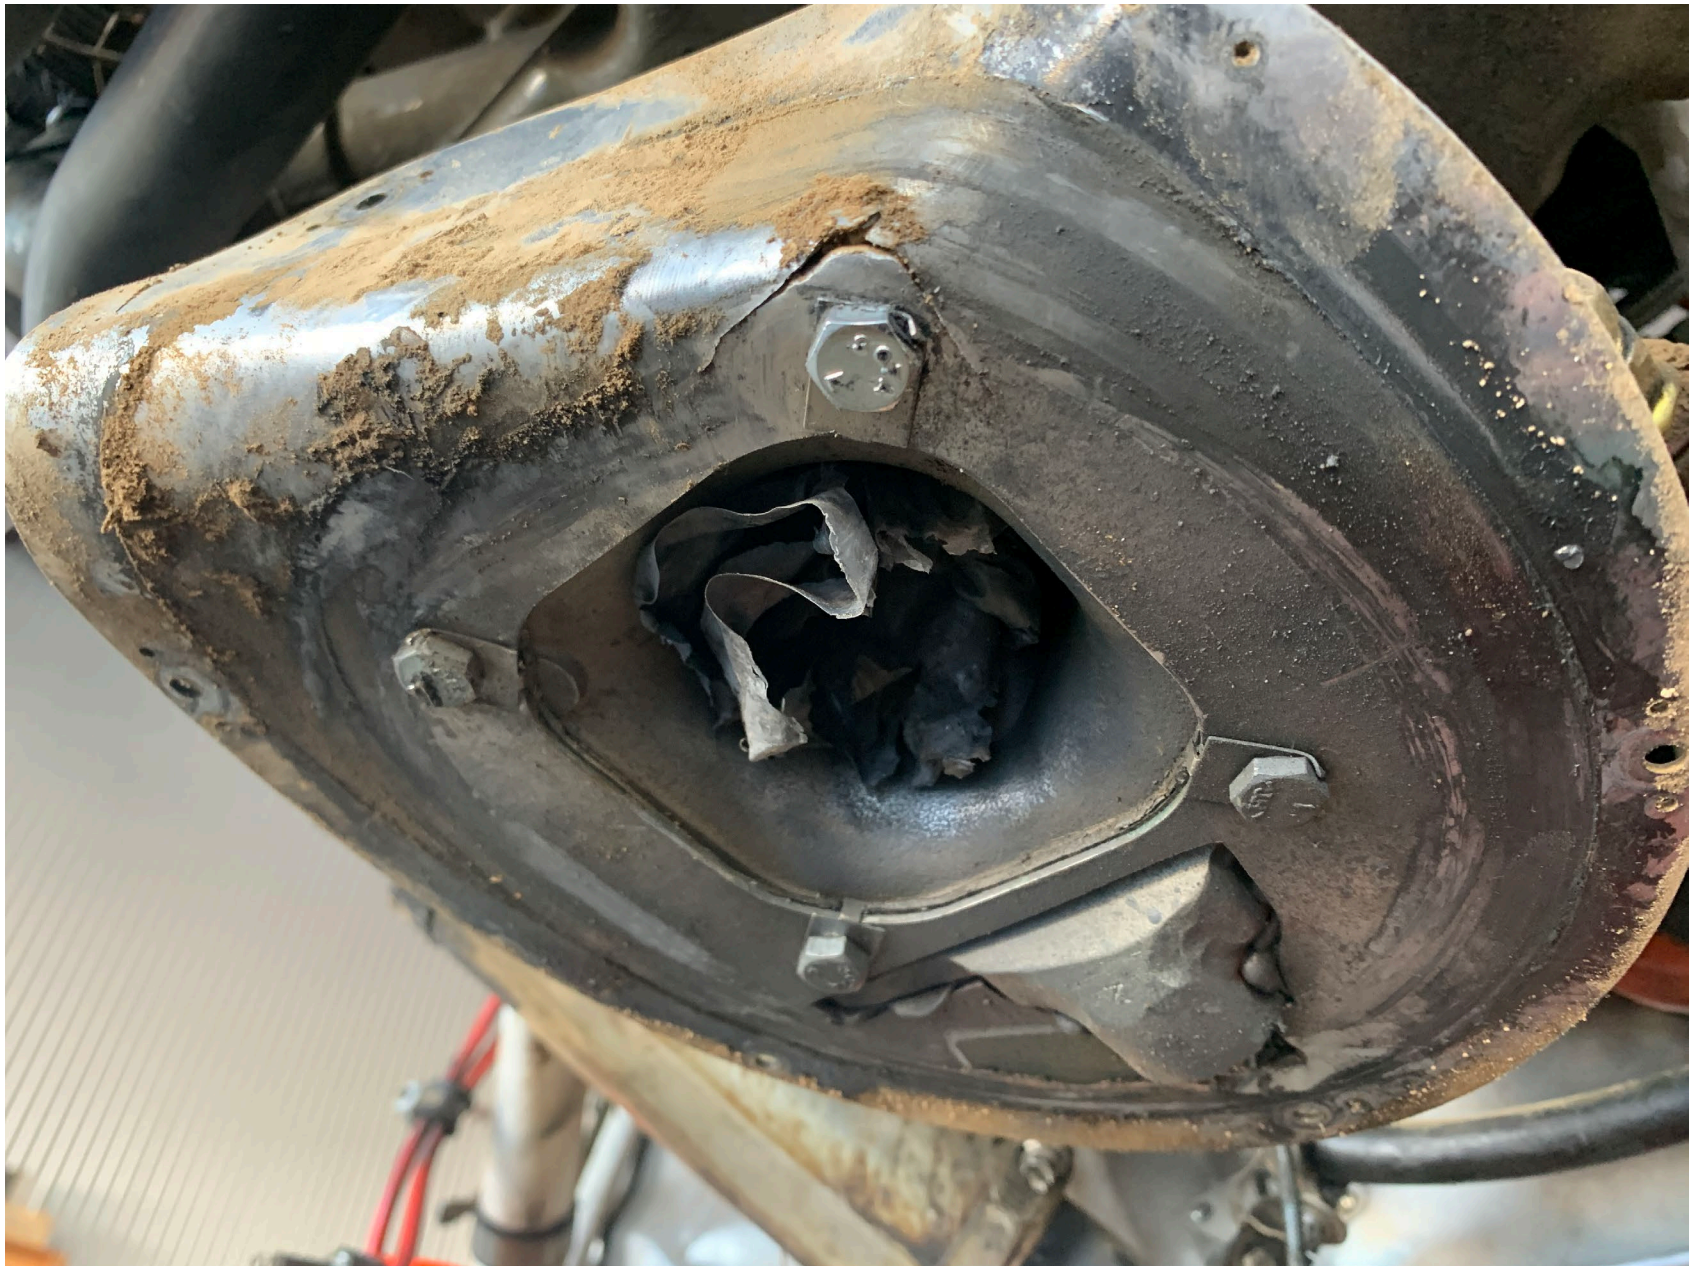
**Photo 8 – View of the throttle body with the air box removed, showing foreign object debris lodged in the throttle body.**

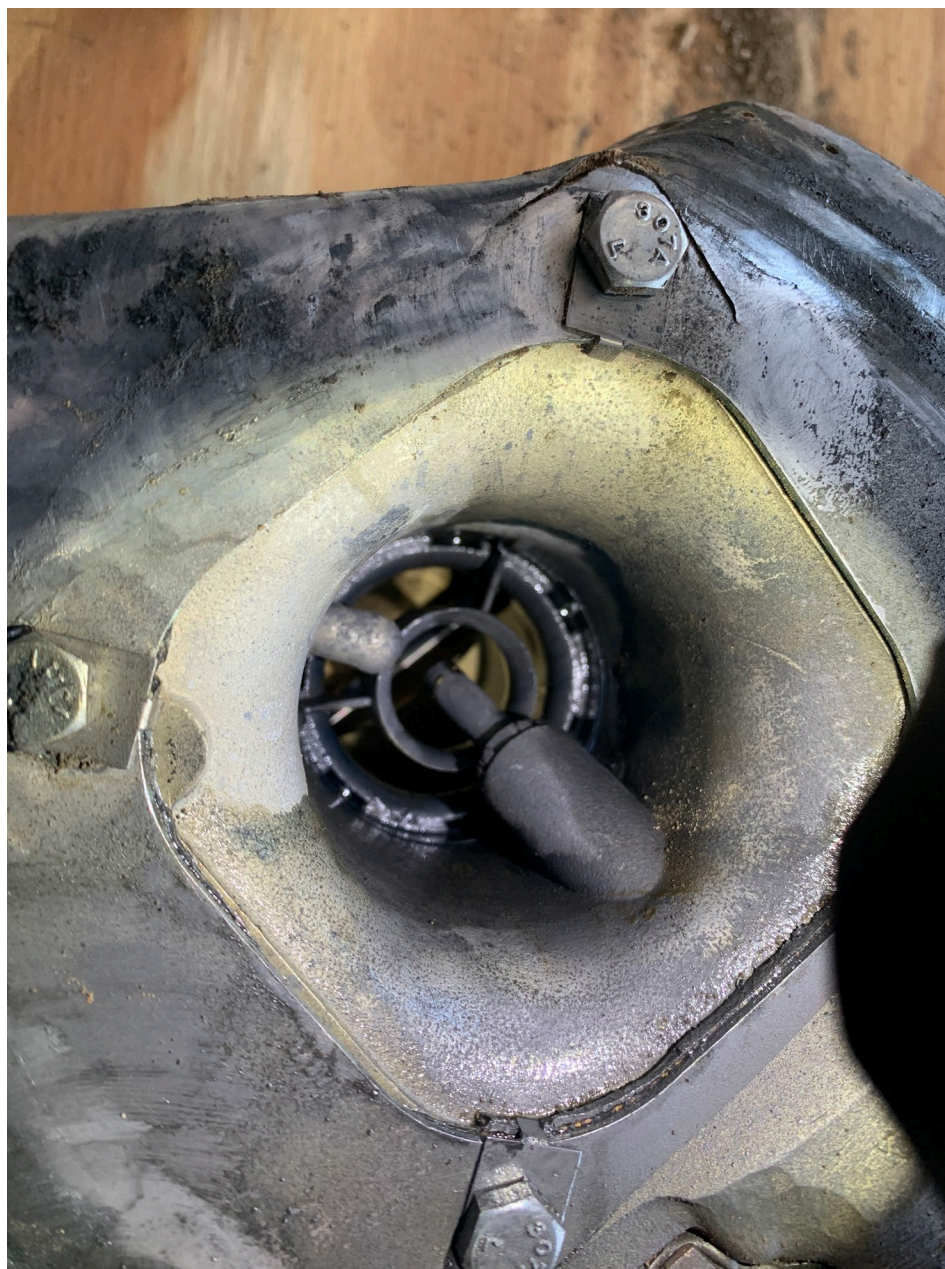
**Photo 9 – View of the throttle body once the foreign object debris was removed.**

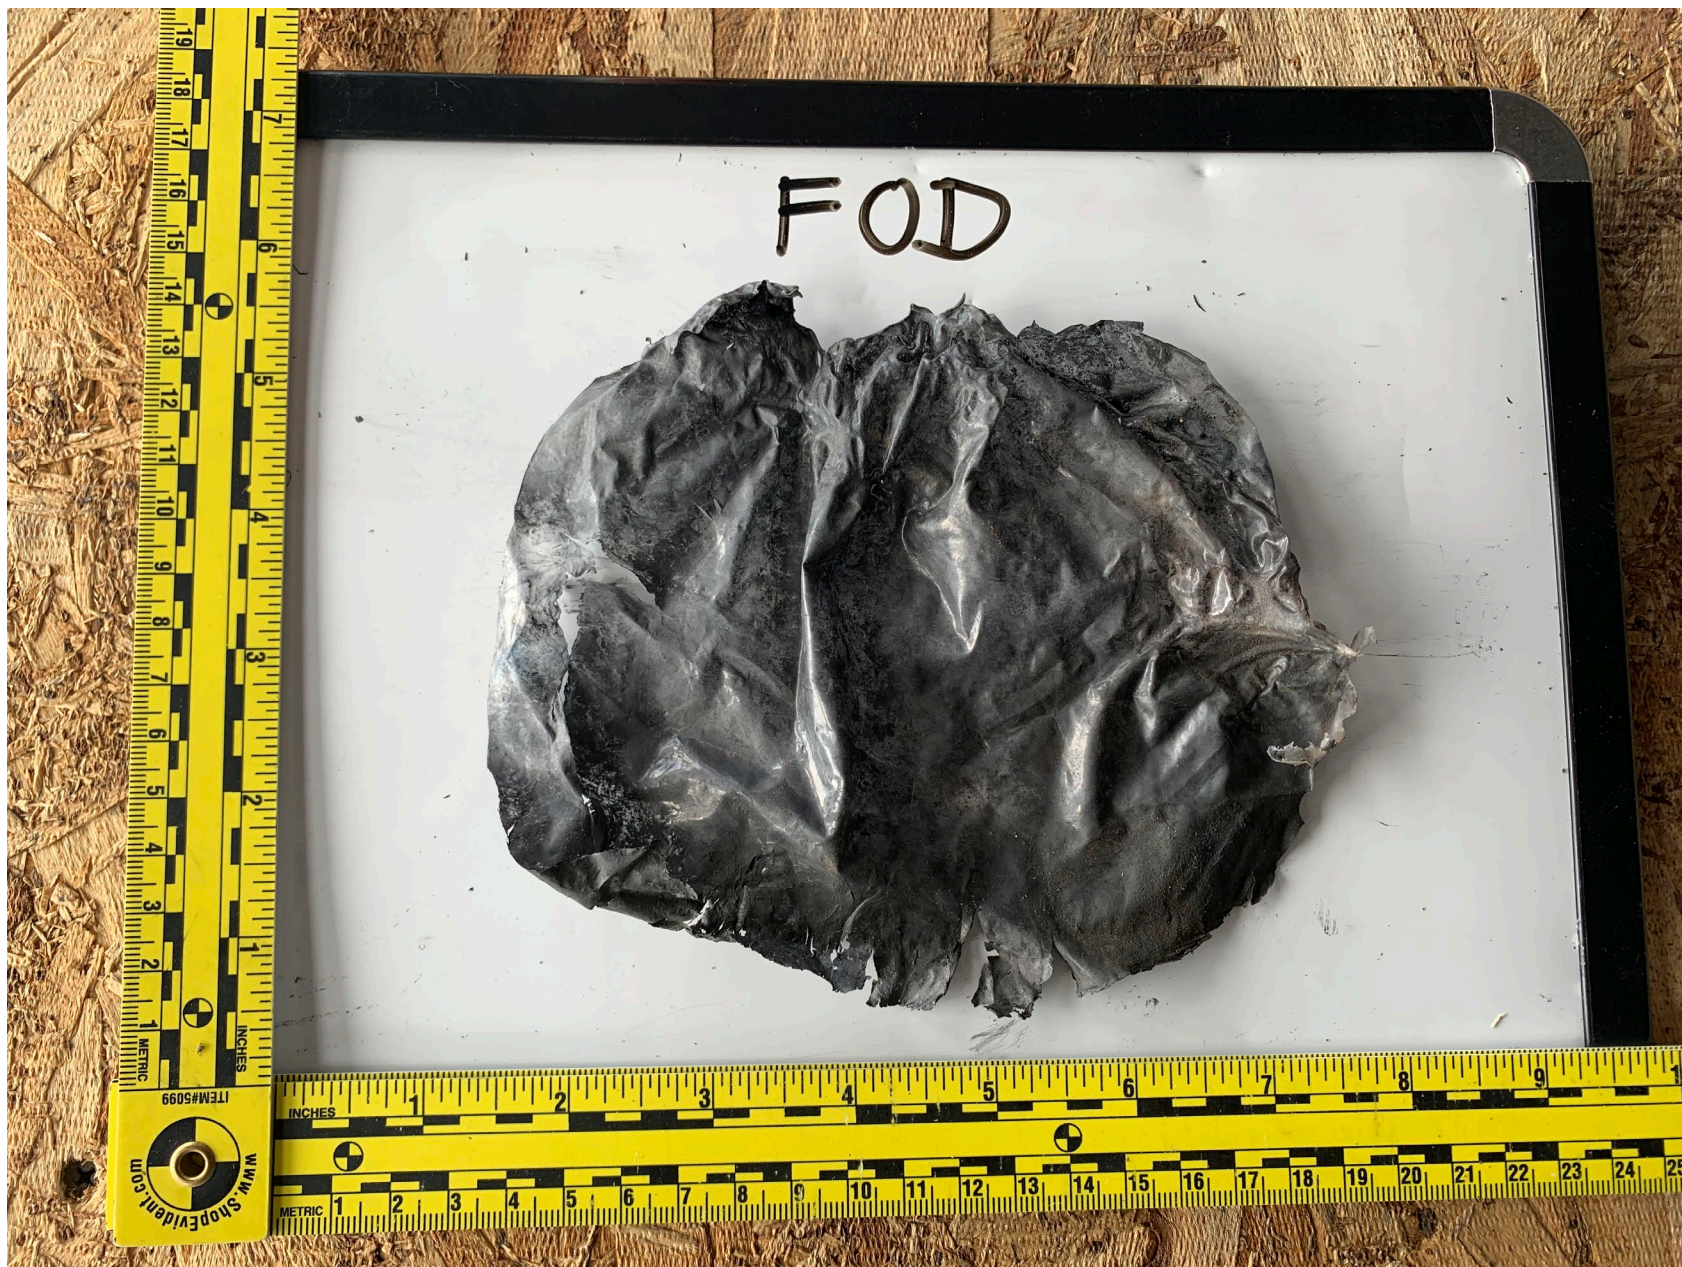
**Photo 10 – View of the foreign object debris removed from the throttle body.**
