# National Transportation Safety Board

CEN22LA312

## **POWERPLANTS**

Group Chair's Factual Report

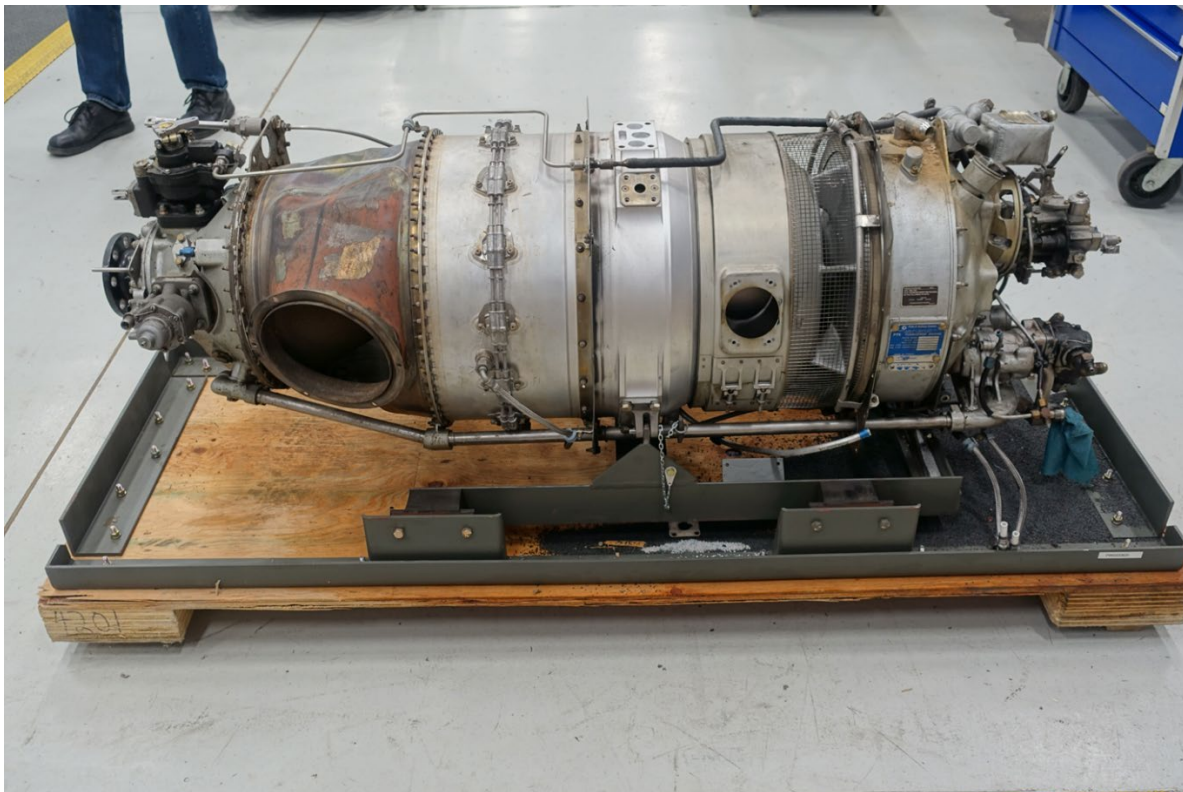
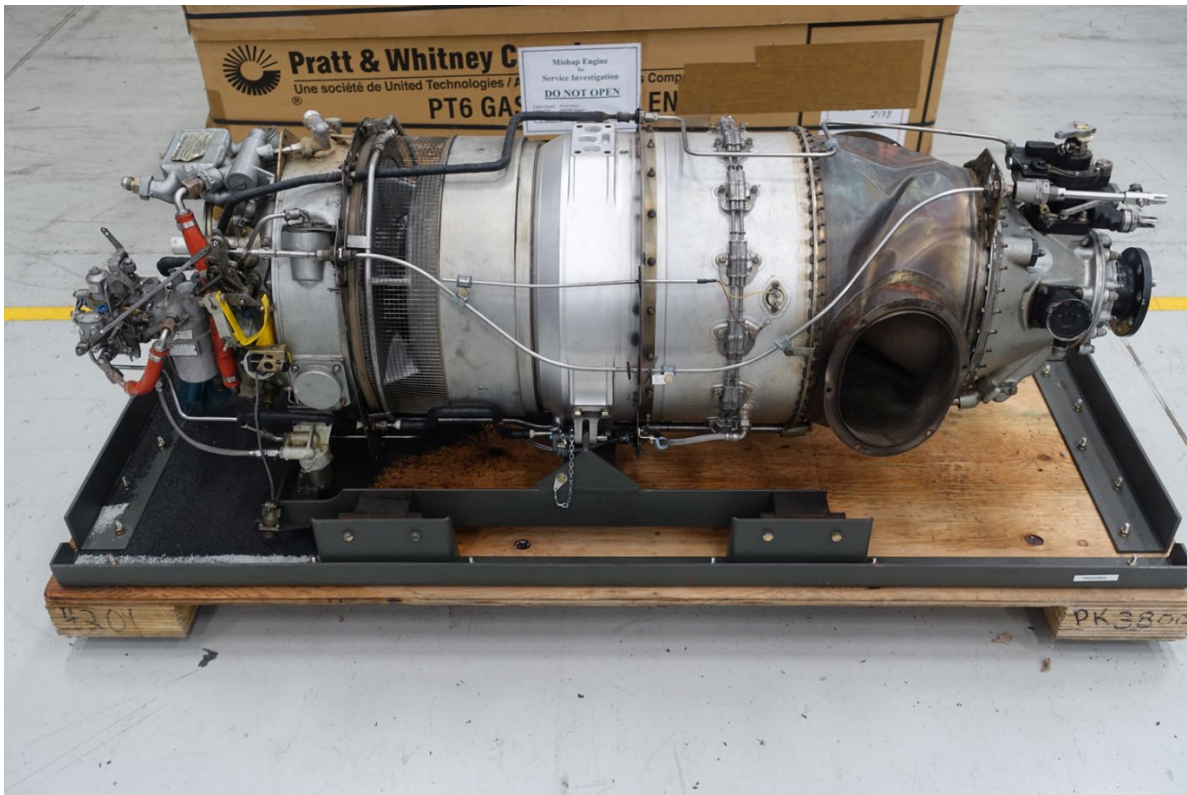
The engine was secured in a banded cardboard shipping container when the investigation team arrived at PWC-Bridgeport, West Virginia (**Photo 3**). There was no evidence of engine fire damage or radial uncontainment (**Photos 4, 5, and 6**). The exhaust case had deformation around the engine circumference. Loose metal fragments were collected in the exhaust duct at the 6 o'clock position aft of the PT blades (**Photo 7**). All PT rotor blades were broken at varying spanwise locations.

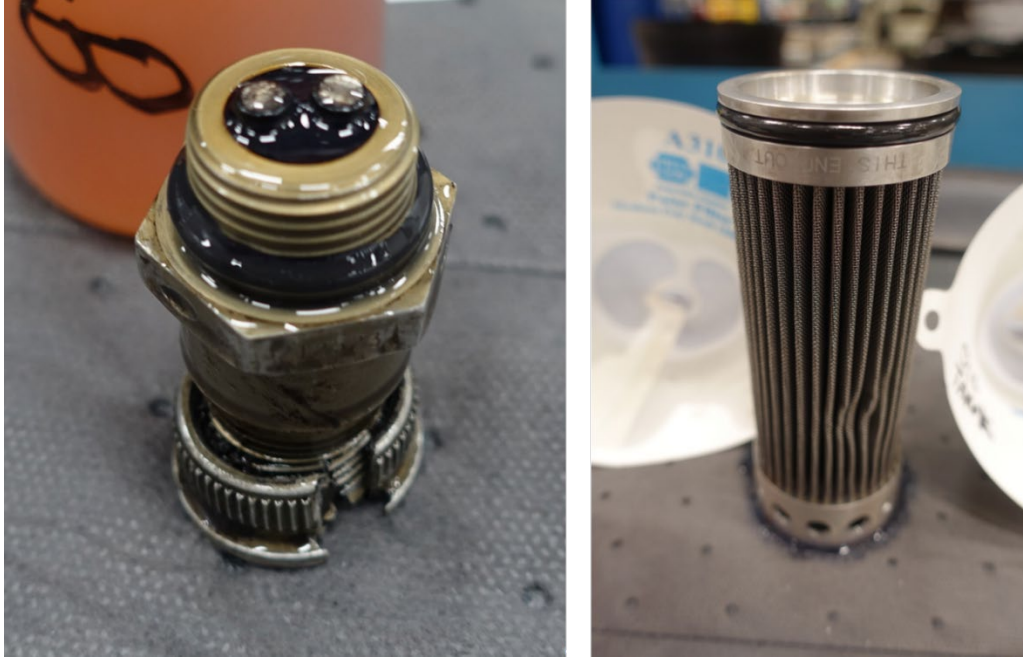
**Photo 8- (L) Magnetic Chip Detector, (R) Oil Filter**

The Ng<sup>4</sup> spool was seized and could not be rotated through the accessory gearbox (AGB). The PT was also seized and could not be rotated by hand. The AGB magnetic chip detector was free of debris accumulation. There was no debris in the oil filter and the residual oil in the filter pleats smelled normal (**Photo 8**). The oil drained from the AGB, reduction gearbox (RGB), and oil tank were filtered and a small amount of fine debris was observed.

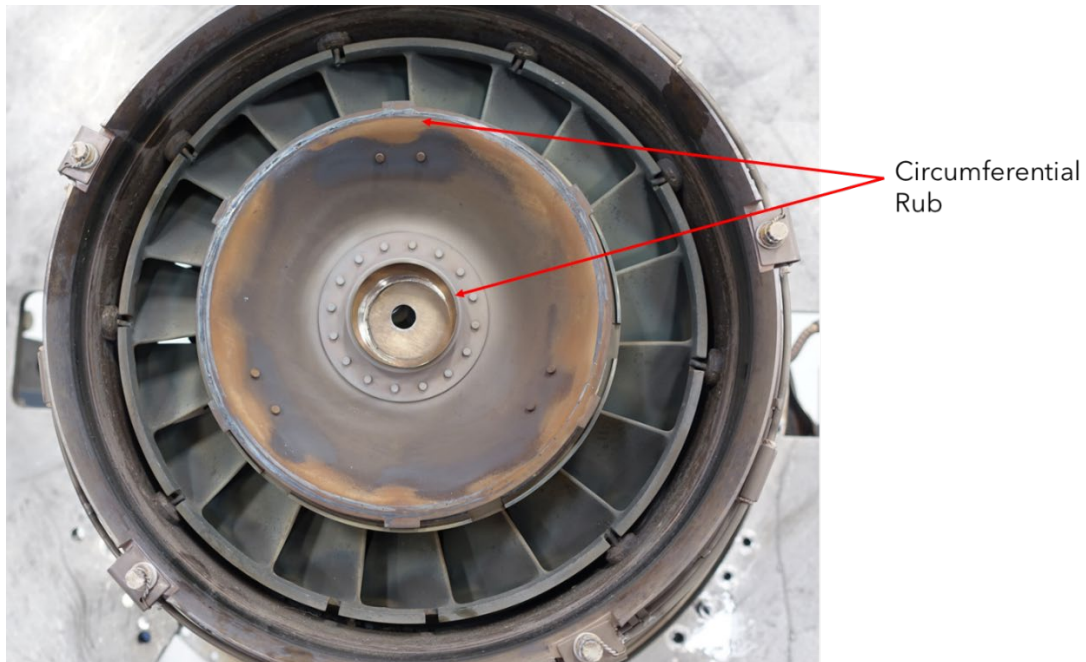
**Photo 9- PT Vane Ring, Pressure Side with Circumferential Rub Indications**

The PT vane ring baffle had circumferential rub around the outer diameter, center bore lip, and on the center bore of the vane ring (**Photo 9**). Coincidental rubs were present on the aft side of the CT rotor disk. As noted during the visual inspection, all PT rotor blades were broken at varying spanwise locations. When the PT vane ring was separated there was circumferential rub and impact damage between the suction side of the PT vane and the forward face of the PT rotor disk (**Photo 10**).

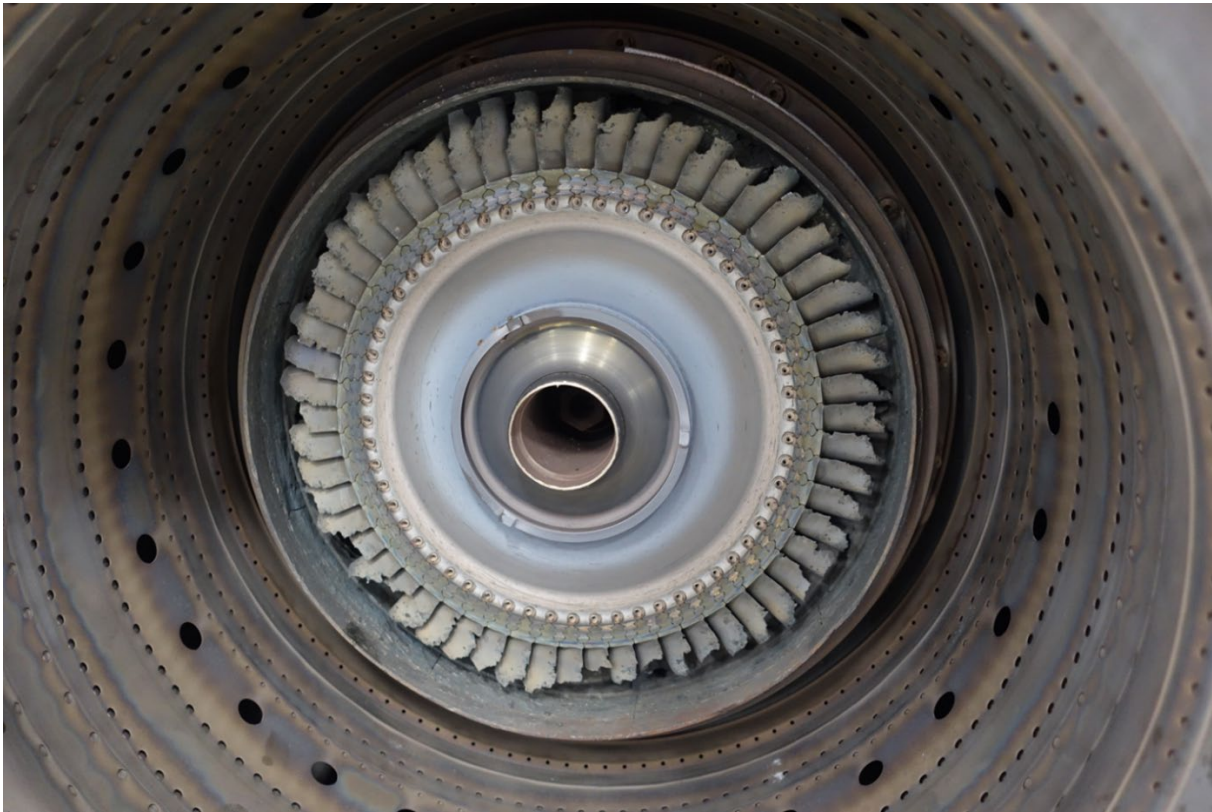
**Photo 11- CT Rotor, Trailing Edge, and Combustion Liner**

The CT rotor blades were all fractured at varying spanwise locations. The remaining CT blade stubs exhibited impact damage and were discolored/gray (**Photos 11 and 12**). A shim check was performed in accordance with the engine overhaul manual<sup>5</sup> to measure the gap between the blade platforms in the disk (**Figure 2**). The CT blade shroud had 360 degree impact damage and gouging.

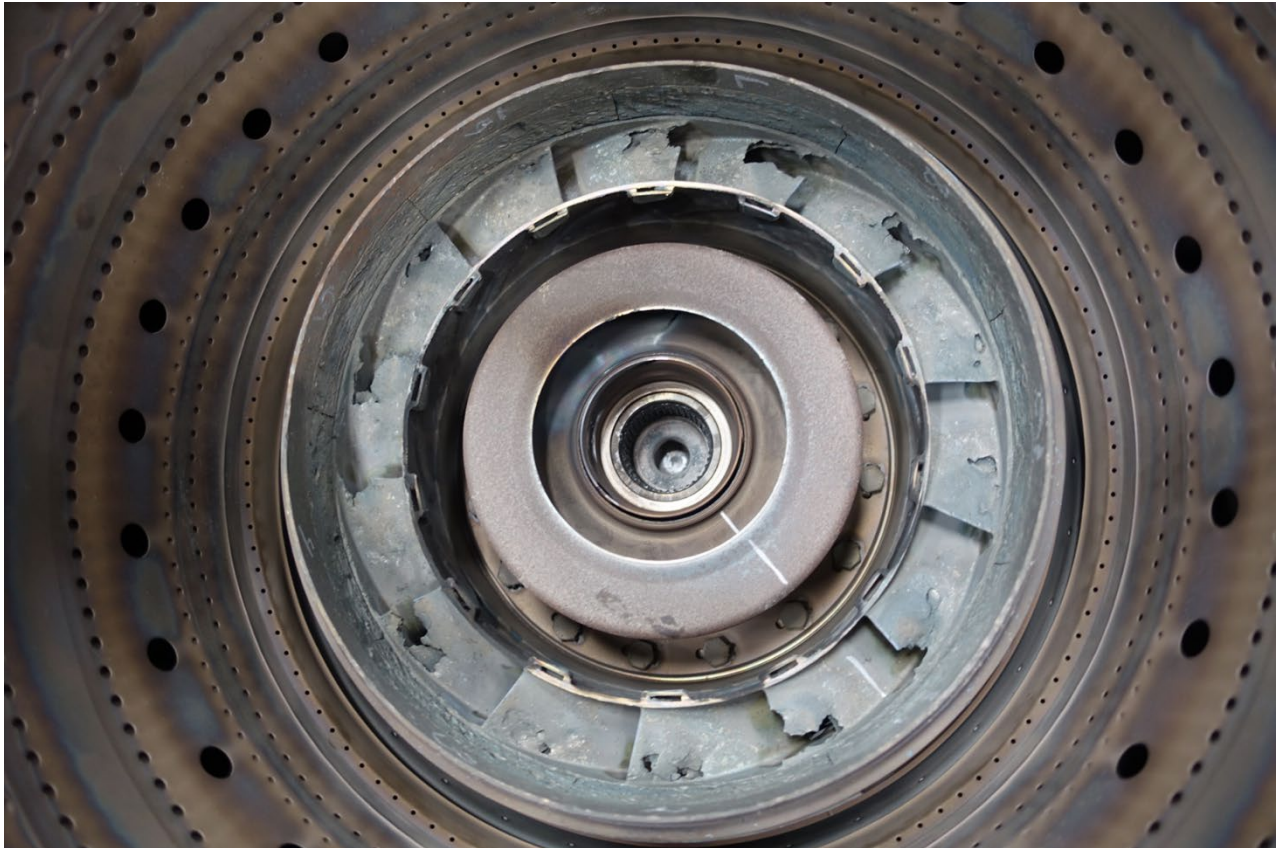
**Photo 13- CT Vane Ring, Suction Side**

The CT vane ring airfoils were all impact damaged and missing material, most concentrated along the trailing edge outer diameter (**Photo 13**). The remaining vane airfoils exhibited minor thermal discoloration. The CT vane lugs on

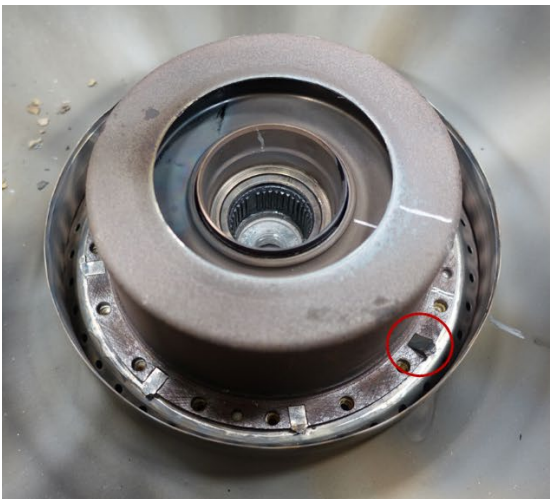
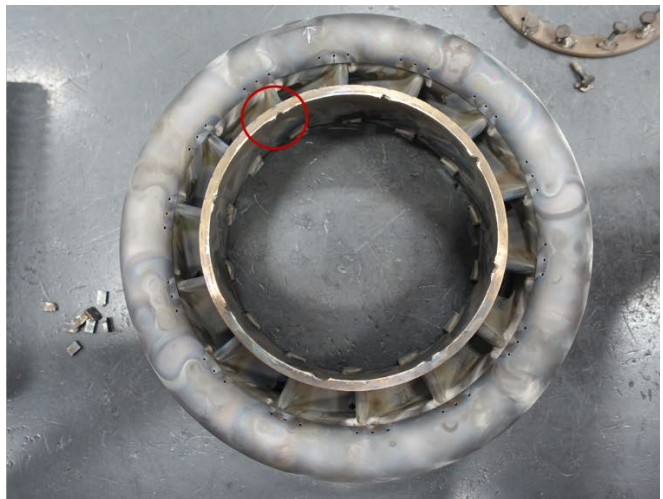
**Photo 14- (L) No. 2 Bearing Cover CT Vane Lug Fractures, (R) Impact Marks**

the No. 2 bearing cover plate were all fractured and coincidental impact marks were observed on the inner diameter of the CT vane assembly on the pressure/forward side (**Photo 14**).

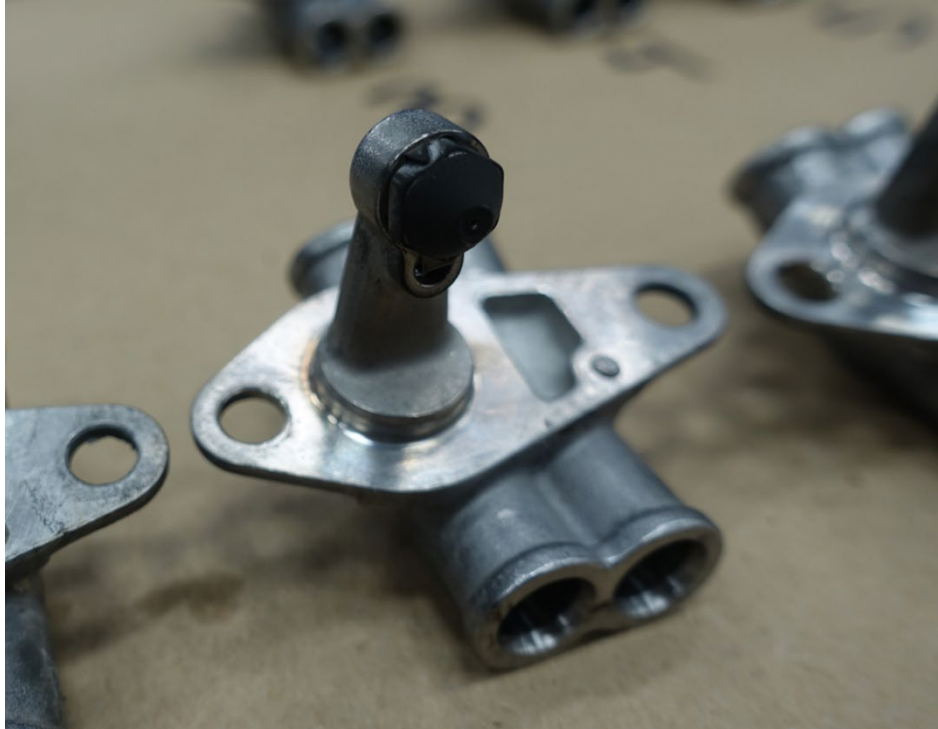
**Photo 15- Fuel Nozzle No. 13**

The combustion liner was intact and unremarkable. There was no evidence of fuel nozzle streaking or uneven wear. Fuel nozzles Nos.11-14, positioned between the 9 and 11 o'clock positions in the engine, had more carbon buildup than the other nozzles but the nozzle orifices were unobstructed (**Photo 15**).

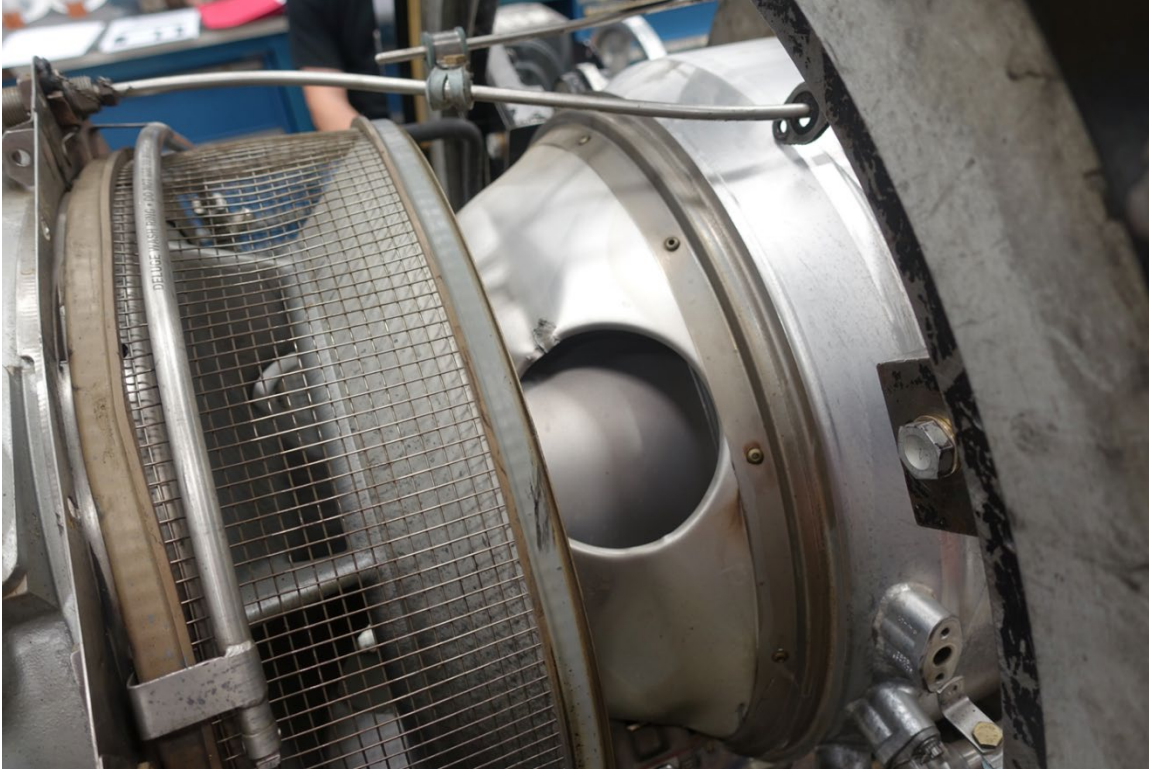
**Photo 16- Compressor Case Deformation**

There was visible case deformation as viewed through the compressor case compartment (**Photo 16**). According to PWC, compressor case buckling is common during CT rotor blade separation events.

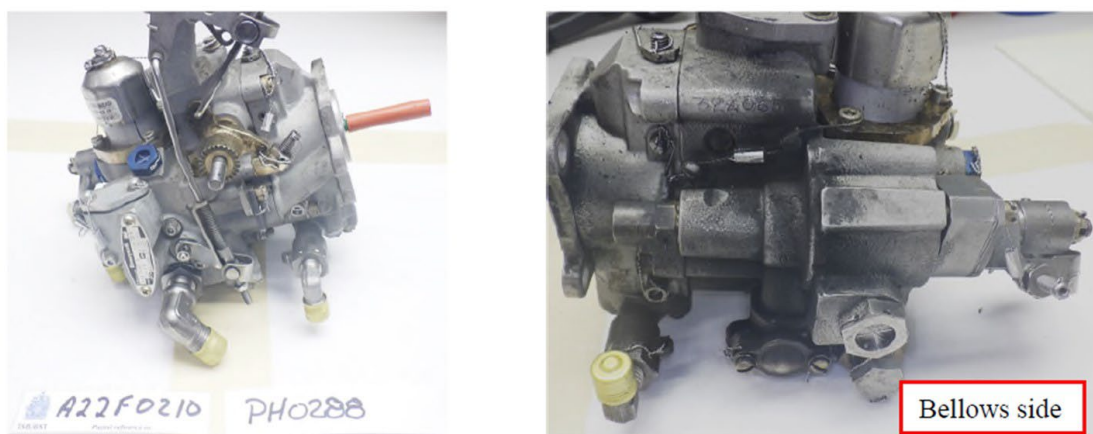
**Photo 17- FCU, as Received at PWC, Saint-Hubert Facility (Photos Courtesy of PWC)**

The FCU external surfaces were observed to be dirty and discolored during the as received visual inspection (**Photo 17**). The idle speed adjustment lockwire was a different size than the other lockwire present on the FCU, consistent with a permissible field adjustment at some point in the service history. The identification plate revealed that the FCU was overhauled at International Governor Services (IGS) in Broomfield, Colorado on December 2, 2020. IGS was contacted and provided a copy of the post-overhaul test run sheets to assist with the investigation.

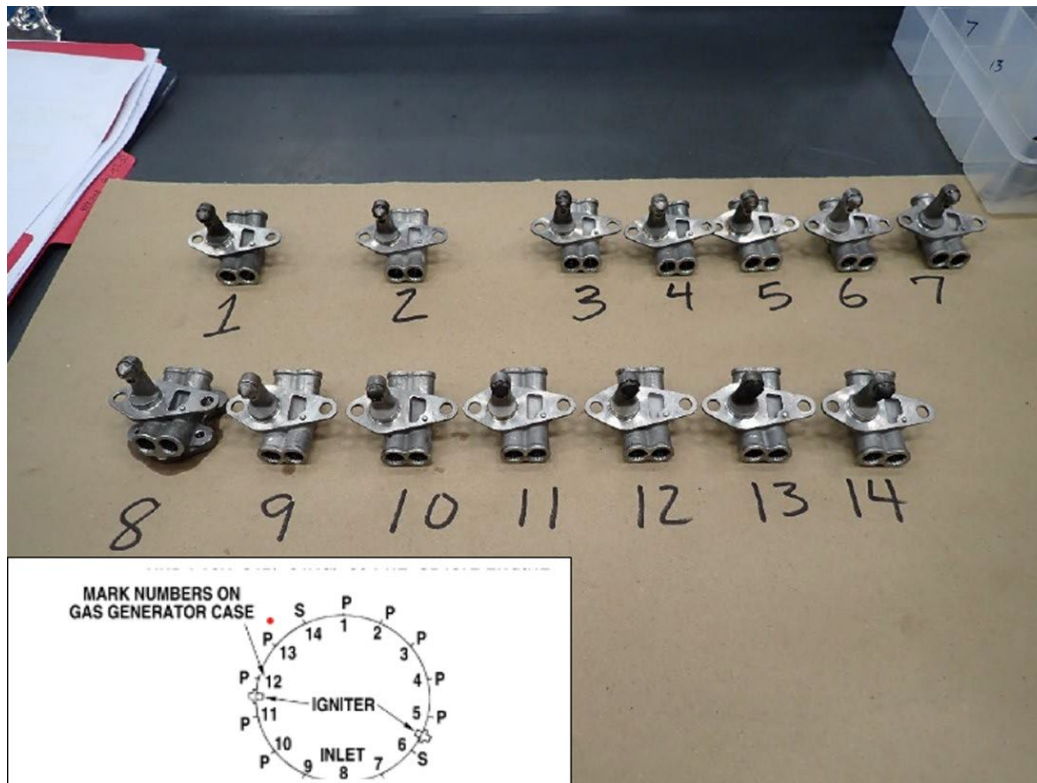
**Photo 18- Fuel Nozzle Set, Nozzle Position Identification Diagram (Photo Courtesy of PWC)**

The as received visual inspection of the set of 14 fuel nozzles identified a light film of black discoloration on the fuel nozzle tips from position Nos. 10 to 14 (**Photo 18**). The fuel locking tab washers were not installed in accordance with the CMM at position Nos. 3, 8, and 13. The fuel nozzles were flow tested and minor spray quality issues were noted including streaks and voids on several nozzles

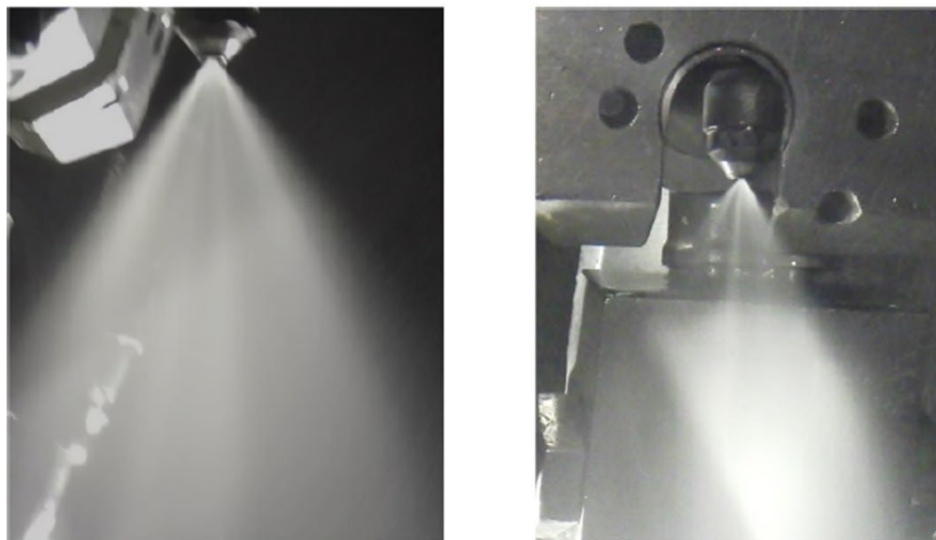
**Photo 19- Fuel Nozzle Spray Pattern During Test**

that were typical of nozzles with similar run time (**Photo 19**). The fuel nozzles pressure test was satisfactory. There were no fuel nozzle anomalies identified that would have precluded normal operation.

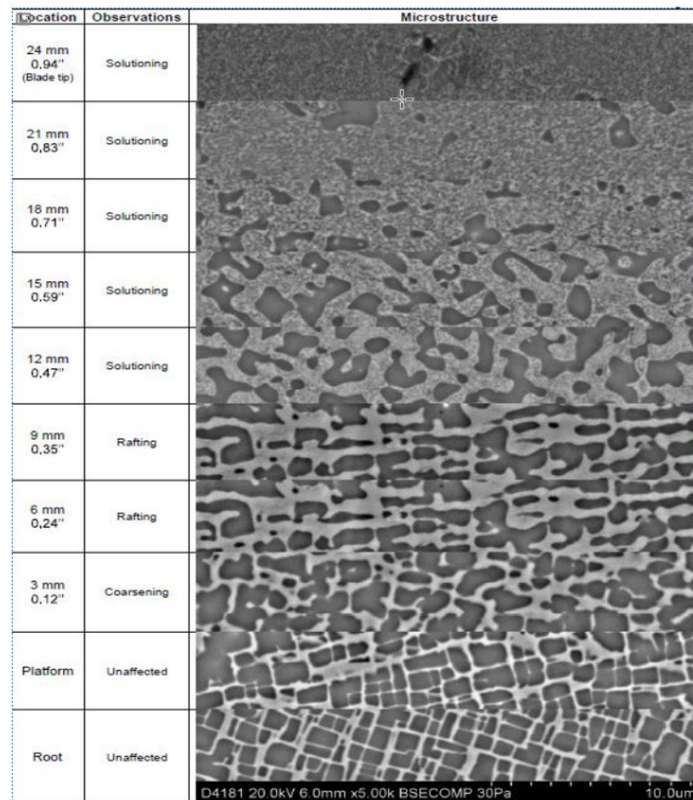
The complete set of 58 CT rotor blades were shipped to the PWC Materials Laboratory in Montreal, Québec, Canada for failure analysis (**Photo 20**). Blades No. 1 and No. 20 were sectioned to evaluate microstructure. Both blades exhibited solutioning of the gamma prime<sup>6</sup> (**Photo 21**). The PWC Materials Laboratory was unable to determine maximum temperature exposure or duration but stated that the solutioning observed in the microstructure occurs at temperatures above the published operating limits. A cross section of Blade No. 20 was examined 0.25 inches from the trailing edge with a scanning electron microscope. Micro-voids were observed perpendicular to the airfoil axis at the material grain boundaries (**Photo 22**). Micro-voids along the grain boundaries suggest creep<sup>7</sup>. Similar voids along the material grain boundary were observed when a cross section of blade No. 39 was viewed under the scanning electron microscope (SEM).

**Photo 21- CT Blade No. 1 Microstructure Analysis (Photos Courtesy of PWC)**

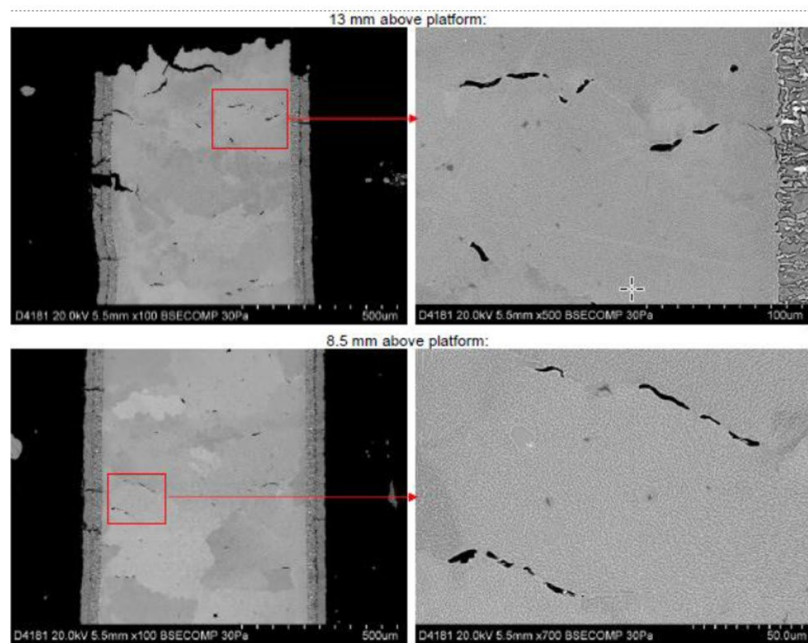
**Photo 22- CT Blade No. 39, Micro-voids Perpendicular to the Airfoil Axis Along Grain Boundaries (Photos Courtesy of PWC)**

On July 30, 2015, PWC released service bulletin (SB) PT6A-72-1767 with recommended compliance category 5 or 6<sup>8</sup>. The most recent revision 5, was released on July 16, 2020. The summary section of the SB states: *"There can be blade creep at the Compressor Turbine (CT) area when the engine is operated at higher temperatures and power than the Pilot Operating Handbook (POH) recommended power settings. To prevent creep-related events, introduce a new Compressor Turbine Disk Balancing Assembly which incorporates redesigned turbine blades made from a different material and increased gap at the blade inter and under platform. Also to increase vibratory stress margin, a new blade platform seal was added."* The new CT blade design features single crystal material which is comprised of a continuous crystal lattice that eliminates grain boundaries. The SB was not mandated by Transport Canada or the Federal Aviation Administration, so SB compliance is at the discretion of the owner/operator.
