CEN22LA312

PWC Service Investigation Accident/Incident Report No.: 23ECN00007, Engine  
Accessories Investigation

Engine Controls Accessories Technical Support  
Accessories Investigation

Adams aerial solutions LLC  
Air tractor AT502B, N5850R  
USA  
Event Date 11 July 2022  
PT6A-34AG, Serial No. PH0288

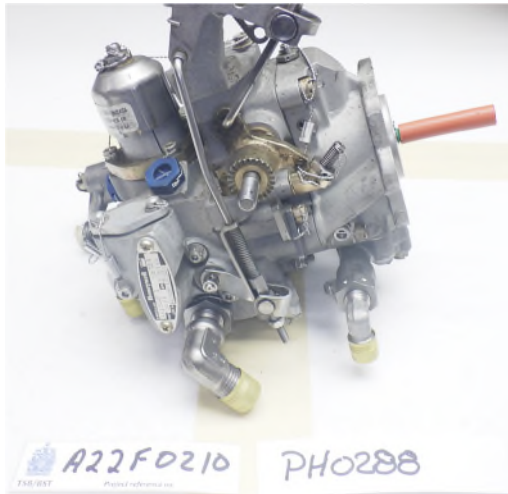
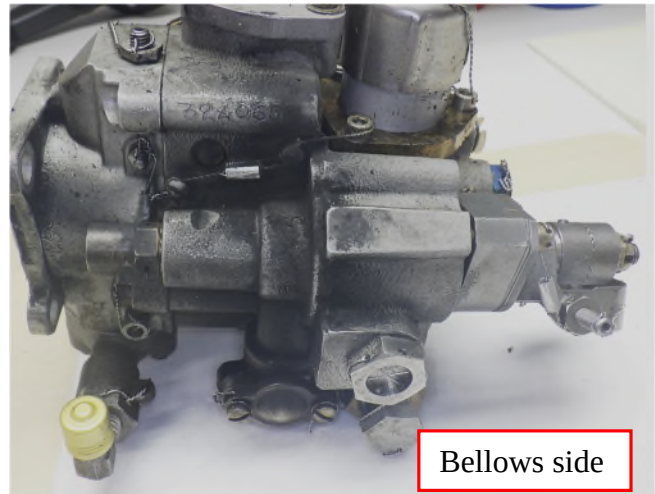
Figure 1

The as received condition showed dirty external surfaces mainly on the bellows side, which was exposed to the starter generator, a thicker layer of black deposit was observed (Figure 1). The identification (ID) plate revealed that the unit was overhauled by [REDACTED] on 12-02-20. There was an [REDACTED] Federal Aviation Administration (FAA) repair station [REDACTED], EASA Part-145 Approval, service label on the acceleration adjustment cup. The indexing mark on the acceleration adjustment cup was in line with the datum on the bypass valve housing. The part power trim was in the stowed position (normal). There was a rubber assembly label present on the flow body housing marked 02/2020 indicating that the rubbers, O-rings, and diaphragm, were replaced in February 2020, corresponding to the overhaul date on the ID plate. All levers were moving by hand on their full travel. The driveshaft was rotating by hand with the typical resistance. No signs of bearing wash out were visible on the drive shaft bearing retaining plate. The maximum Ng stop adjustment screw was measured to 0.235", indicating that it was adjusted to increase the maximum Ng governing speed (permissible field adjustment). The idle speed adjustment lockwire was of a different size compared to the other ones suggesting that the idle speed was adjusted (permissible field adjustment). The air inlet adaptor P3 port was clean. The Py port showed some debris in the threads (Figure 2), though the Py port bottom cavity was clean.

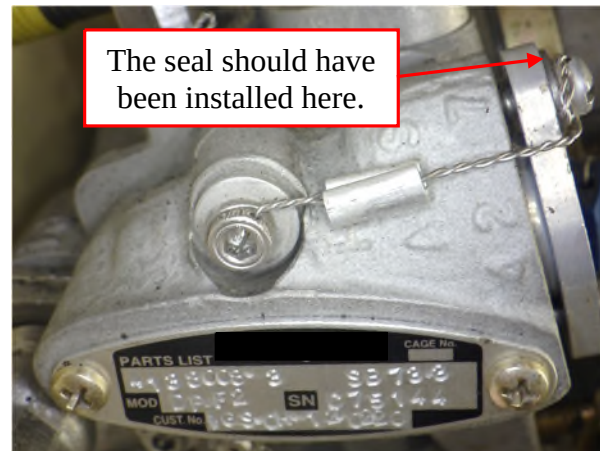
Figure 3

The lockwire seals were installed at the right locations per the [REDACTED] (CMM) 73-20-64 Rev. 02; however, they were not installed correctly. The seals were installed between the two attaching points instead of being fitted after the last attaching point (Figure 3).

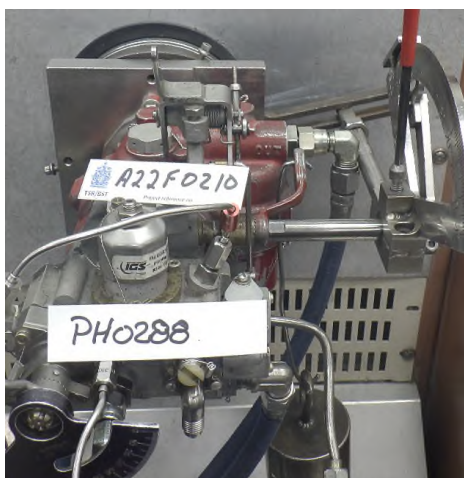
Figure 4

Prior testing the unit, once installed on the test bench (Figure 4), the air leak check, using the Leak-Tech fluid, identified light bubbling coming from the torsion shaft adjustment screw on the bellows side (Figure 5). The FCU setting were adjusted to a high-power condition. The fuel flow was monitored for 5 minutes and no fluctuation nor increase or decrease was noted, indicating that the bellows are not leaking. The FCU was tested per the [REDACTED] CMM 73-20-64 Rev.02 and the following observation were noted.

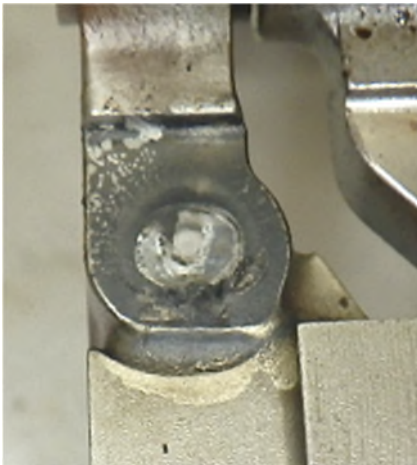
Figure 6

The FCU was split at the drive / flow body flange to inspect the governing system components and the FCU air system cleanliness. The governor system components were in good conditions. The governor lever Py pad showed some black deposit (Figure 6). The bleeds and orifices were not obstructed (Figure 7). The governor lever Py pad along with the bleeds and orifices were cleaned. The unit was re-assembled, and the governing drop was checked without change. A Py orifice class change would be required to calibrate the FCU within the CMM requirement. Finally, the bellows S/N: C19452 manufactured in 2016 was removed (figure 8). The dimension “A”, evacuated bellows length, stamped on the governor bellows end plate was 1.0166”, the measured dimension “A” was 1.0222”, meeting the CMM limits. The governor bellows leak check was satisfactory (Figure 9).

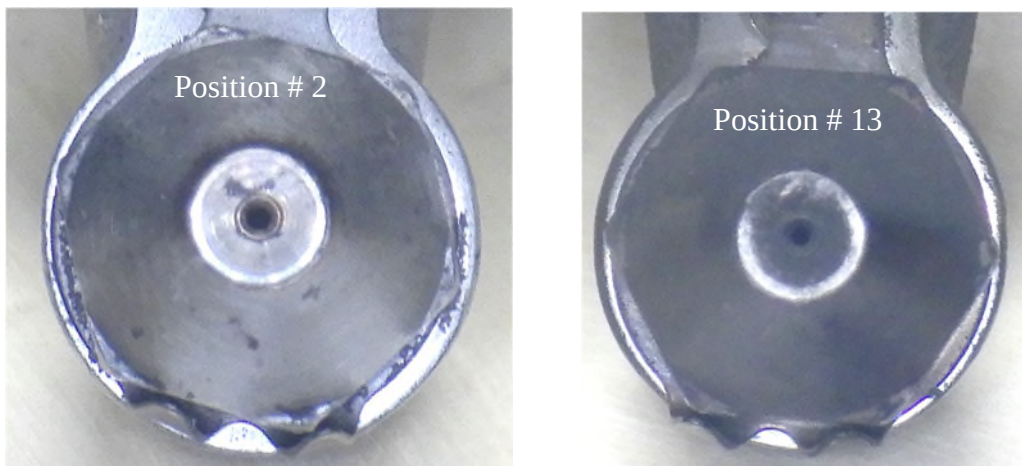
Figure 10

The as received visual inspection showed that the fuel nozzles installed from position 10 to 14, pilot view clockwise, had a light film of black deposit on the nozzle tips (Figure 10). The fuel nozzles position # 3, # 8, and # 13 locking tab washers were not installed as per the CMM requirements. The locating pin on the adaptor position # 11 was slightly shorter compared to the other ones.

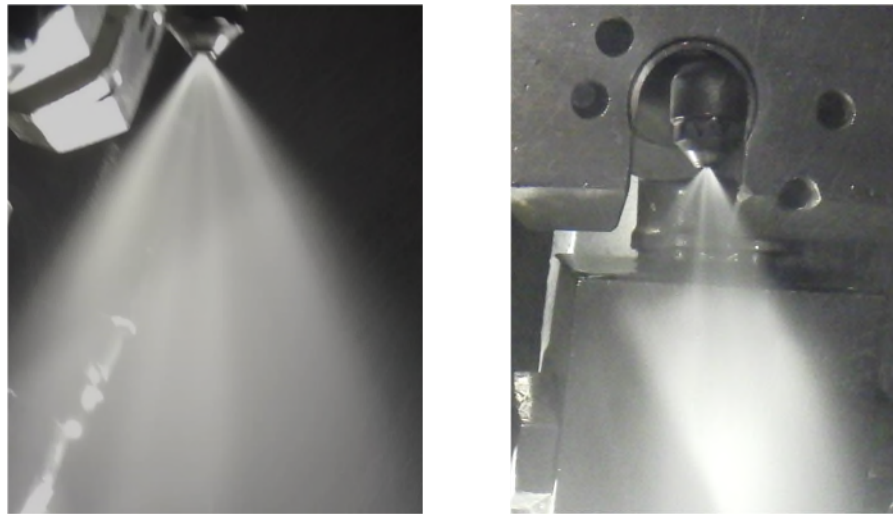
Figure 11

Testing demonstrated that the fuel nozzle installed at the position # 6 was 0.2 PPH below the minimum limit. The fuel nozzle installed at the position # 4 showed a spray angle of two degrees below the minimum limit. The spray quality of each nozzle's tips showed streaks and voids to different degrees typical of nozzles that had accumulated running time (Figure 11). There was no spitting nor drooling detected and the pressure test was satisfactory for each of them.
