CEN22LA312

Group Chair's Factual Report - Attachment # 2

PWC Service Investigation Accident/Incident Report No.: 22-118, Materials  
Laboratory Analysis

October 24, 2023

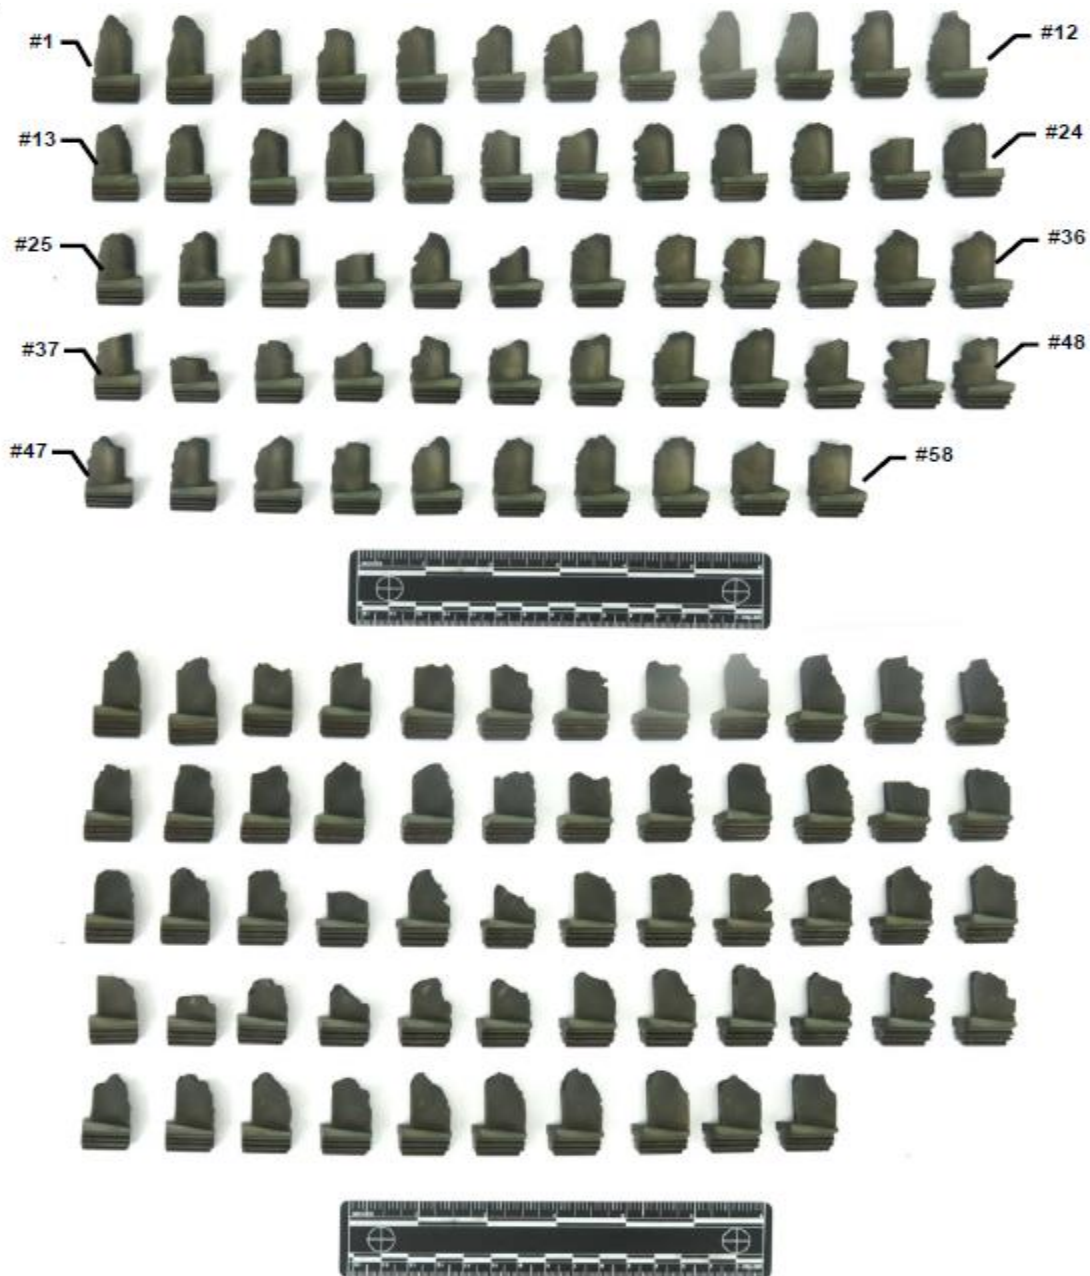
Photo No. 31

General suction side (top image) and pressure side (bottom image) views of the submitted CT blades. The blades were numbered from #1 to #58 (Ref. Photo No. 31).

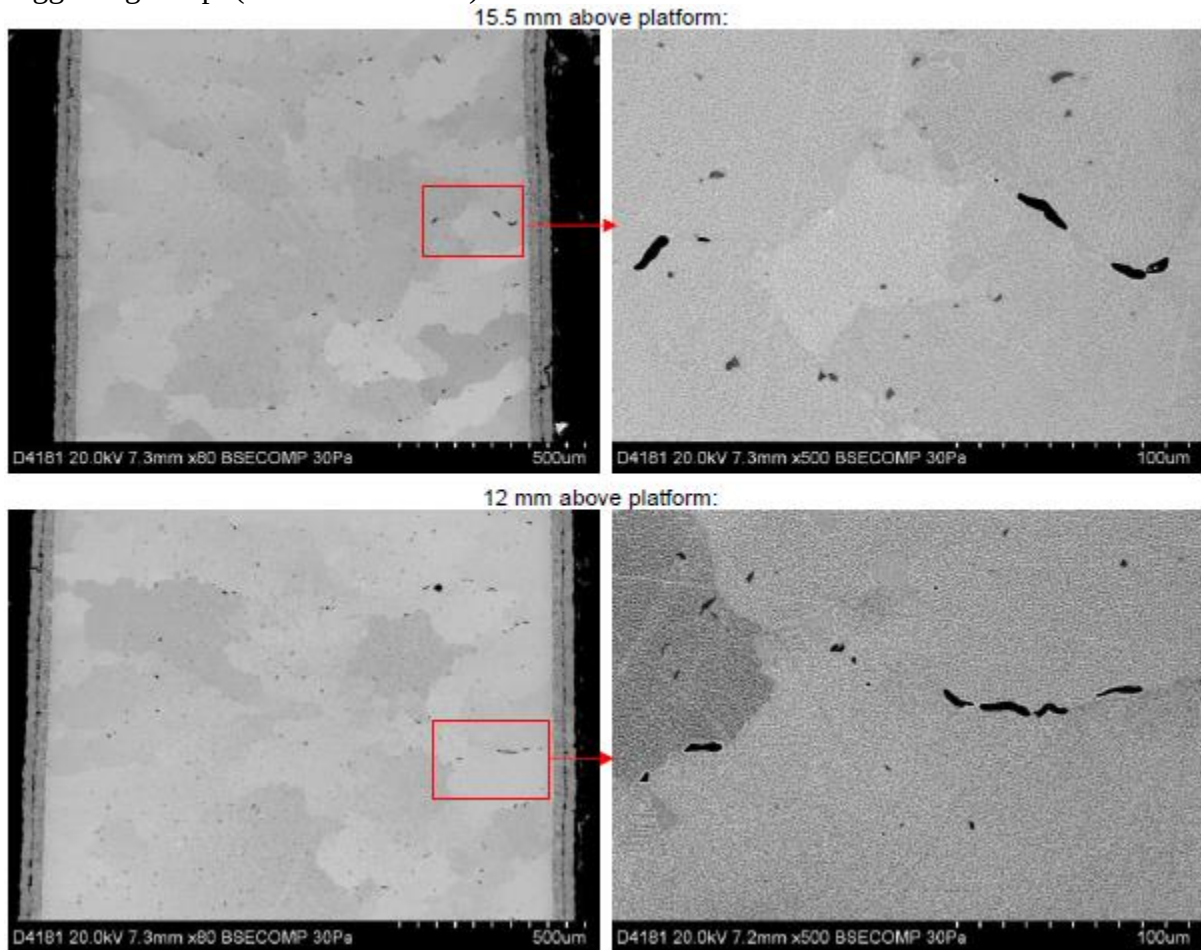
Blade No. 20 was submitted for metallographic cross section examination at 0.25 inches from the trailing utilizing a scanning electron microscope (SEM). Micro voids perpendicular to the airfoil axis and located at grain boundaries are observed at various heights with respect to the platform suggesting creep. (Ref. Photo No 34).

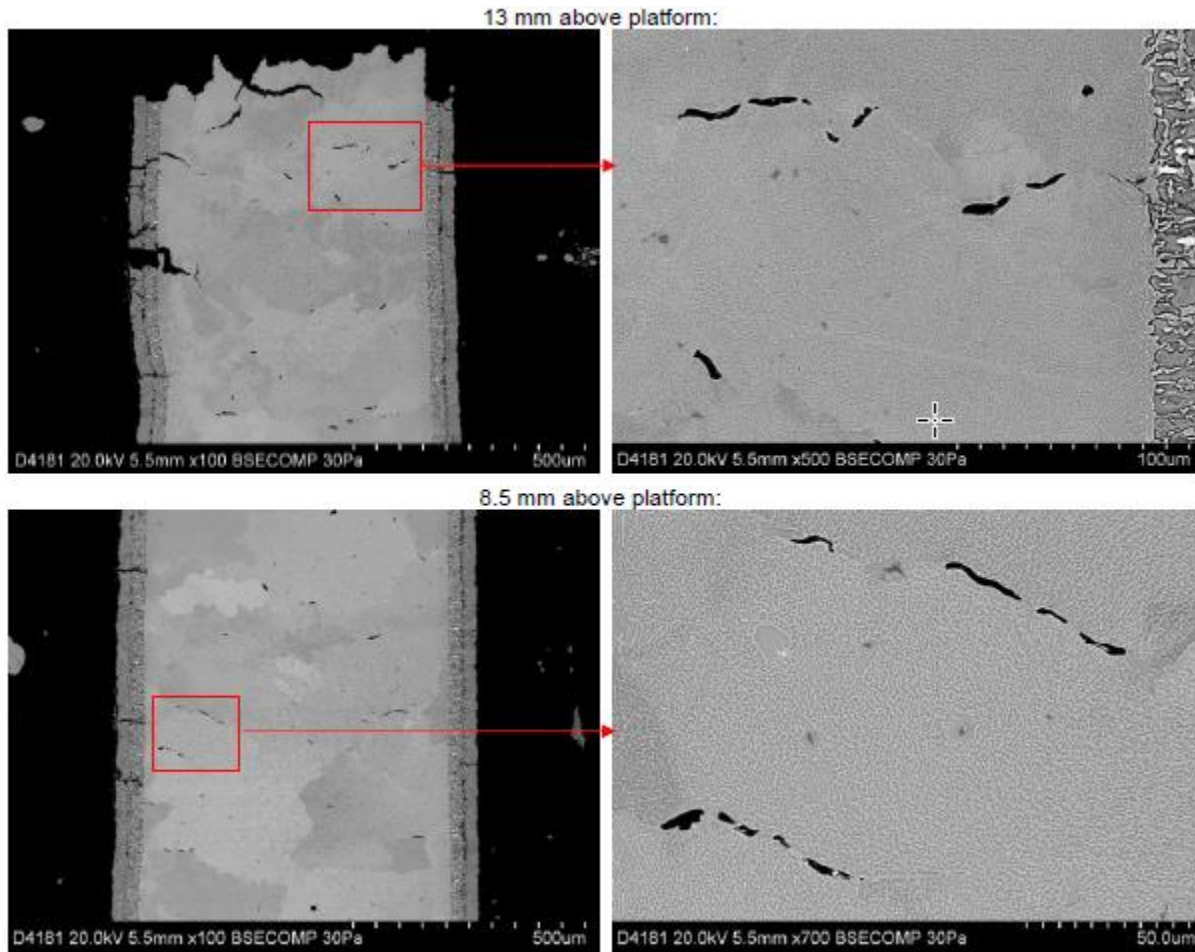
Photo No. 35

Blade No. 39 was submitted for metallographic cross section examination at 0.125 inches from the trailing utilizing SEM. Micro voids perpendicular to the airfoil axis and located at grain boundaries are observed at various heights with respect to the platform suggesting creep. (Ref. Photo No 35).

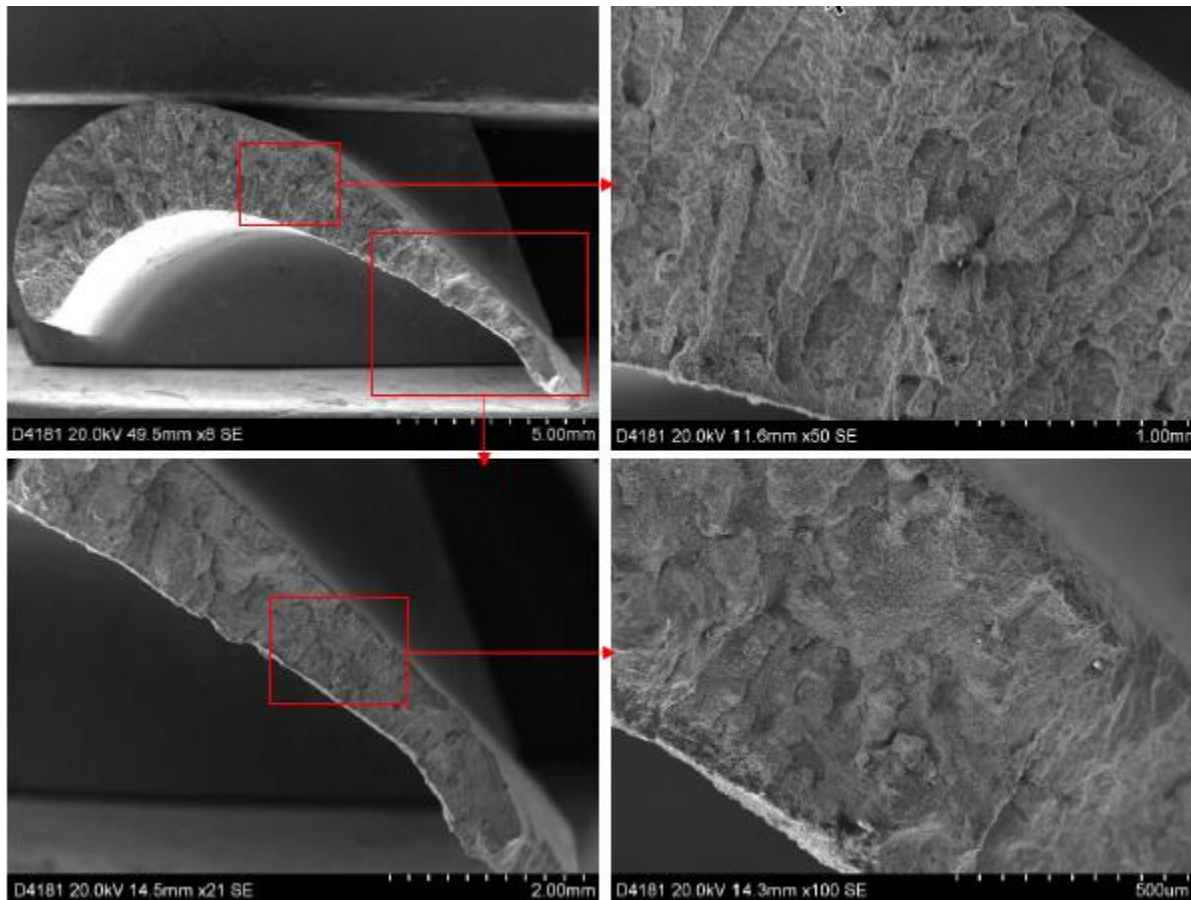
Photo No. 36

The fracture surface of blade No. 23 was examined under an SEM. The top right image (Ref. Photo No. 36) shows the typical overload fracture features. The trailing edge region which showed a different fractographic aspect, is heavily oxidized which inhibited the observation of fractographic features, still, the roughness of the fracture surface and absence of progression marks suggest that this fracture is most likely not a result of fatigue.
