**From:** Howell, William J (FAA) <[REDACTED]>  
**Sent:** Thursday, July 14, 2022 2:35 PM  
**To:** Williams Shaun  
**Subject:** Fuel Sump results- N478WT accident aircraft Rapid City, SD PA24-260.  
**Attachments:** 20220714\_075407.jpg; 20220714\_075355.jpg; IMG\_2132.JPG

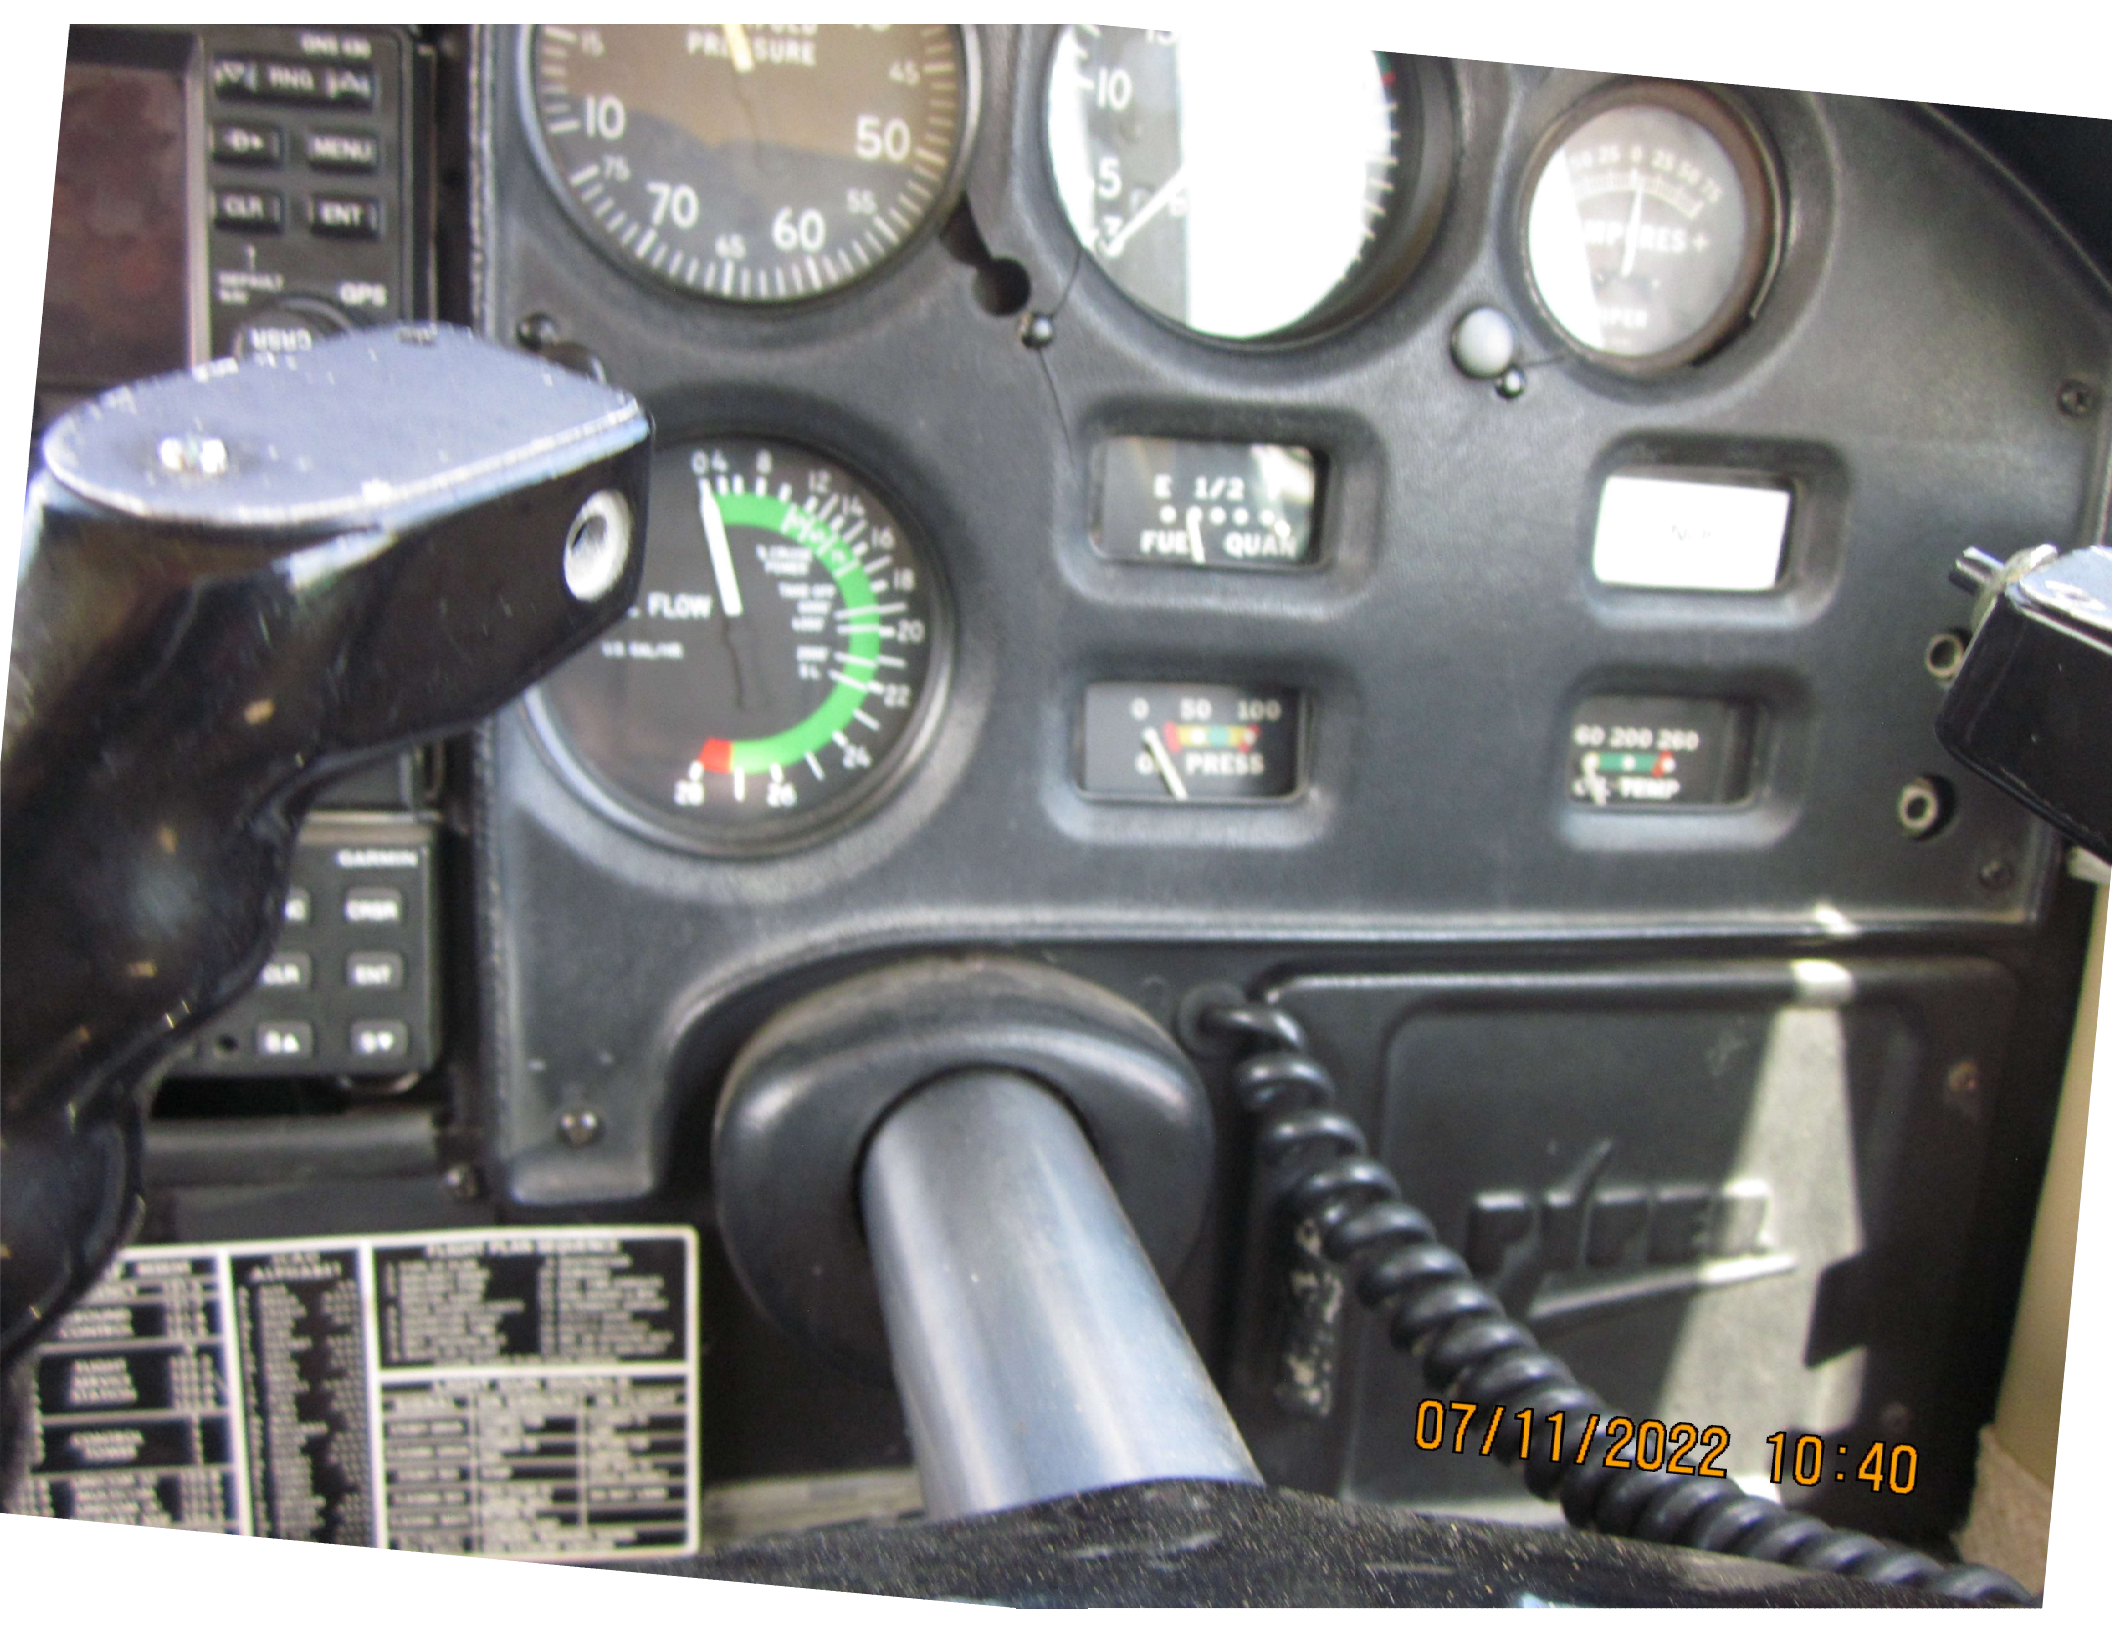
Fortunately we were lucky enough to start with the dry LH AUX and proved there was not one drip of fuel in the LH aux tank and associated tubing. I took a bar and placed it in the LH tank as deep as I could reach and found no traces of fuel. The 3<sup>rd</sup> attachment to this email is the fuel quantity indication when selecting LH AUX.
