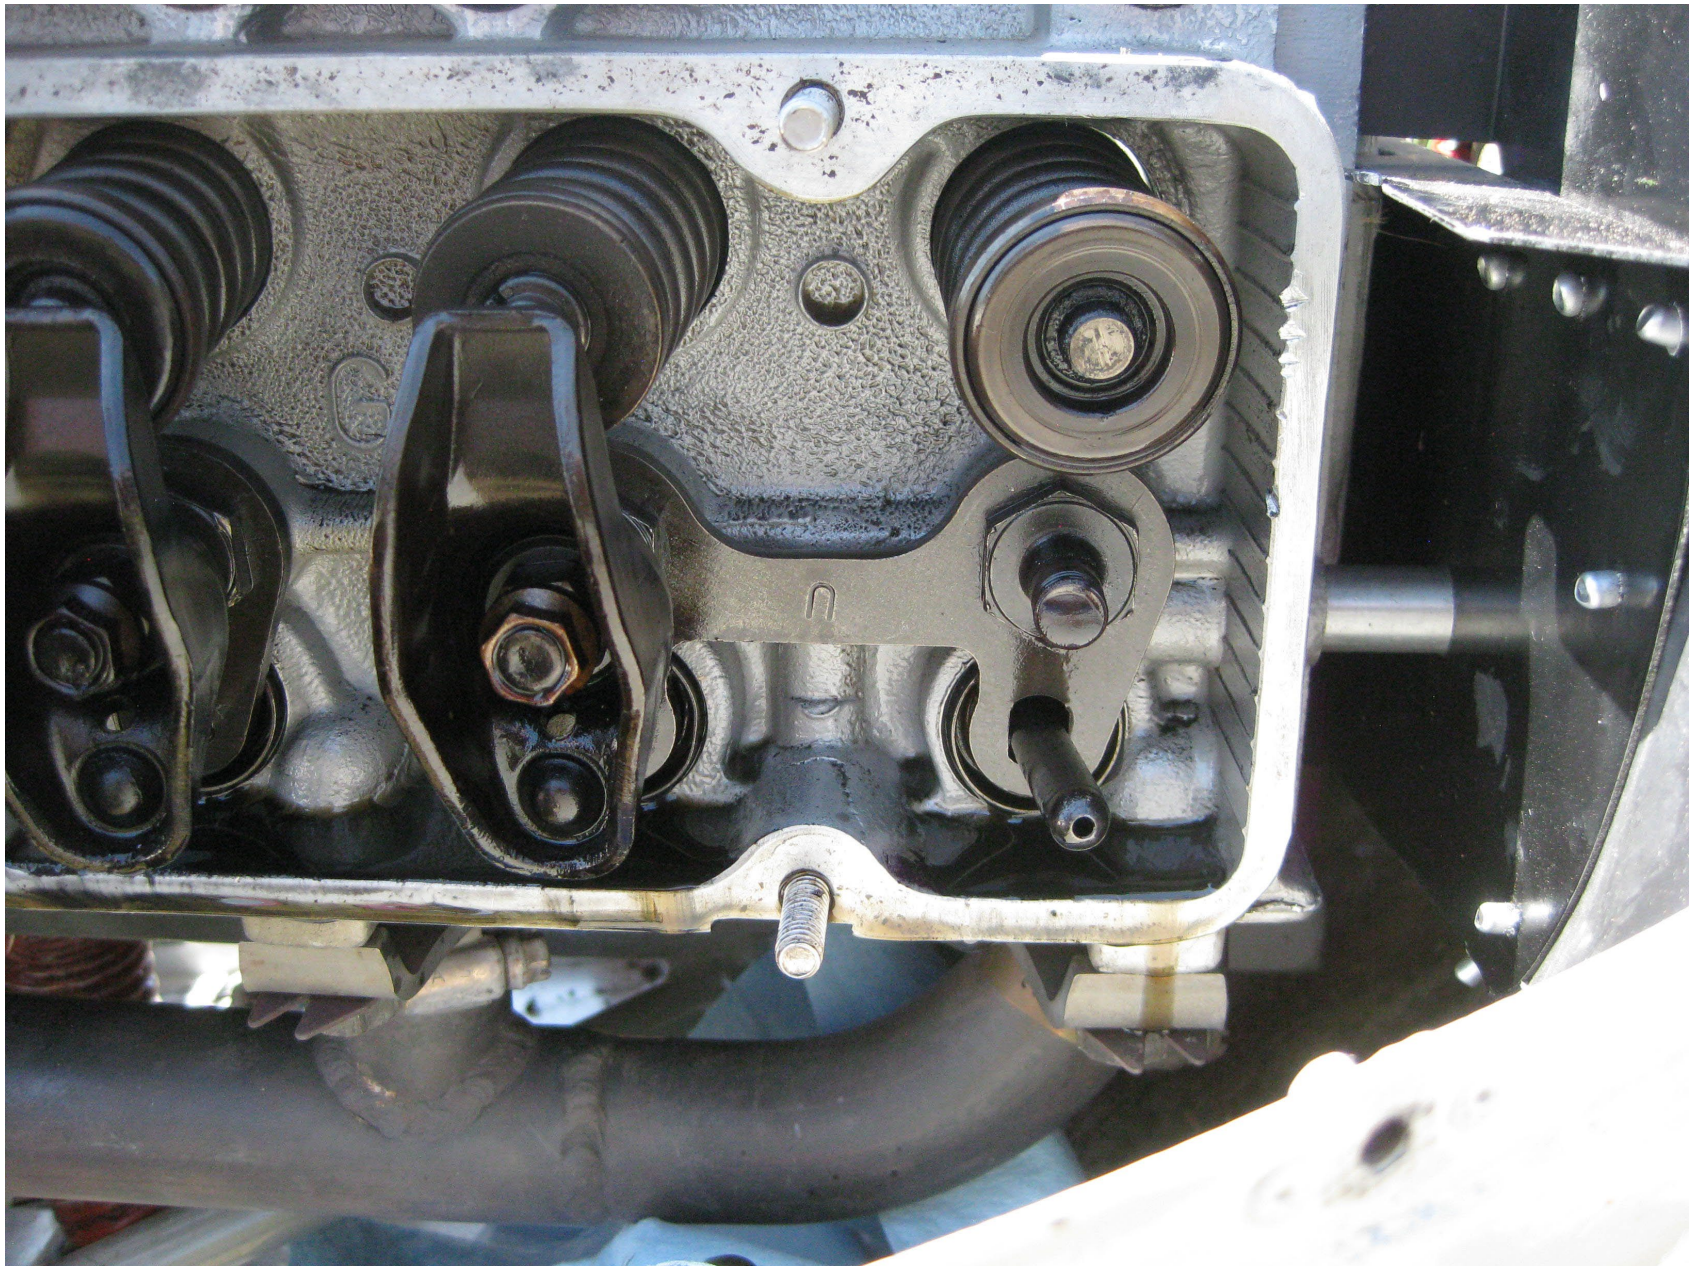
**Photo 1 – No. 5 Cylinder and Rocker Arm (photograph provided by airplane owner)**

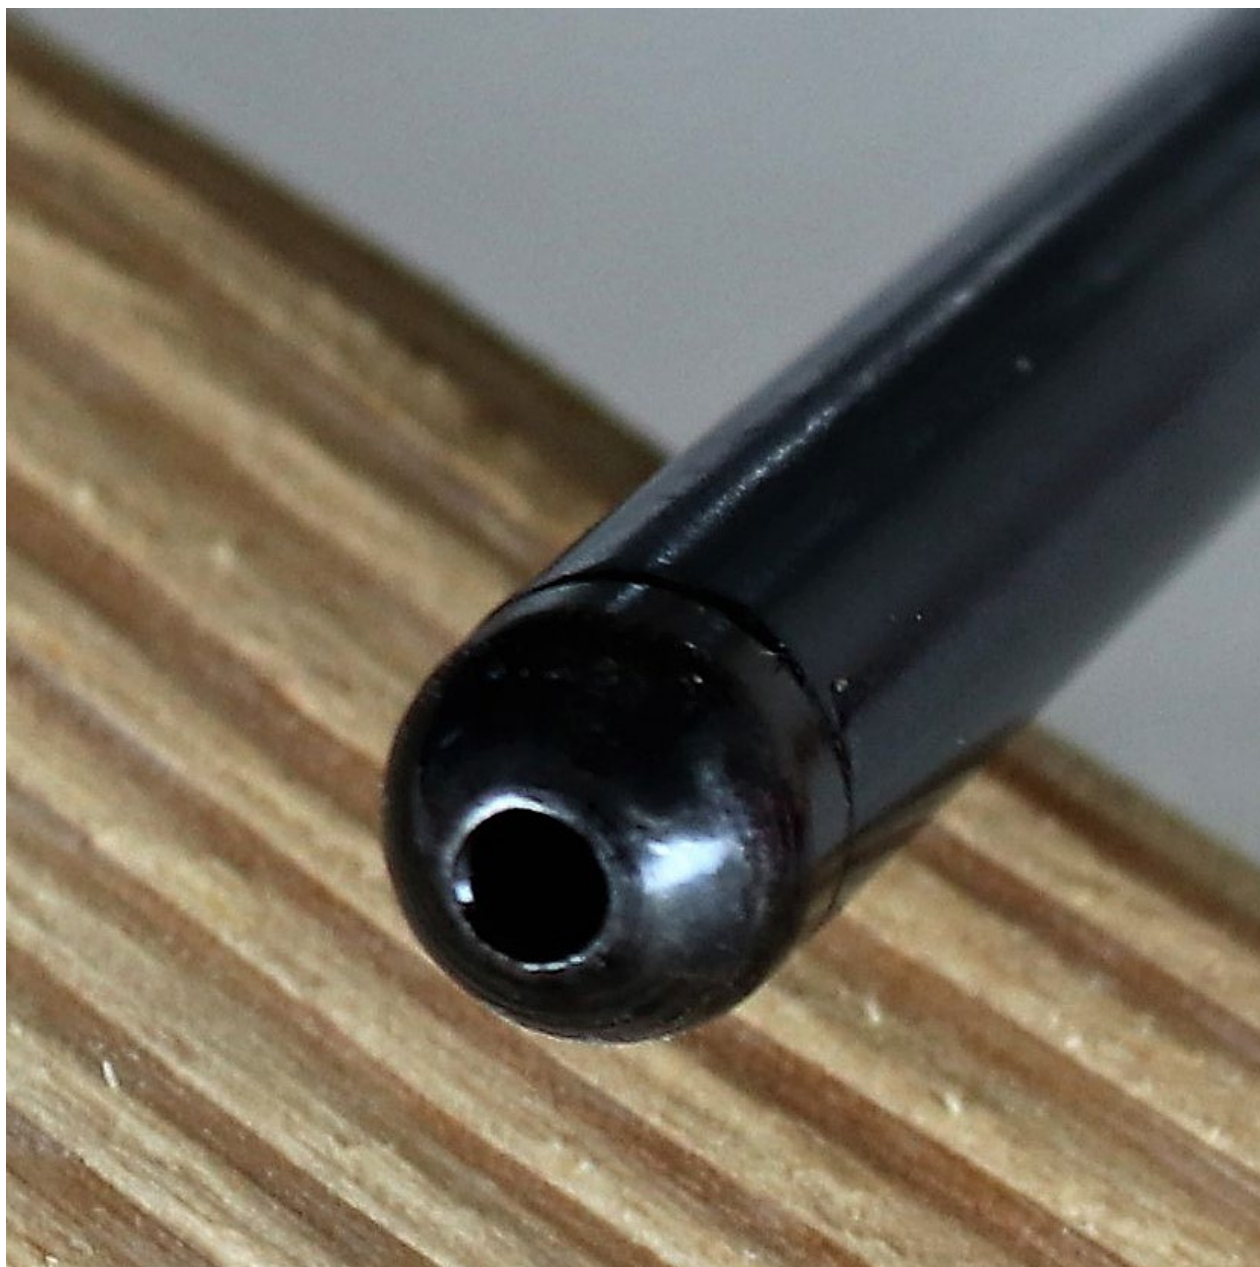
**Photo 2 – End of Push Rod (photograph provided by airplane owner)**

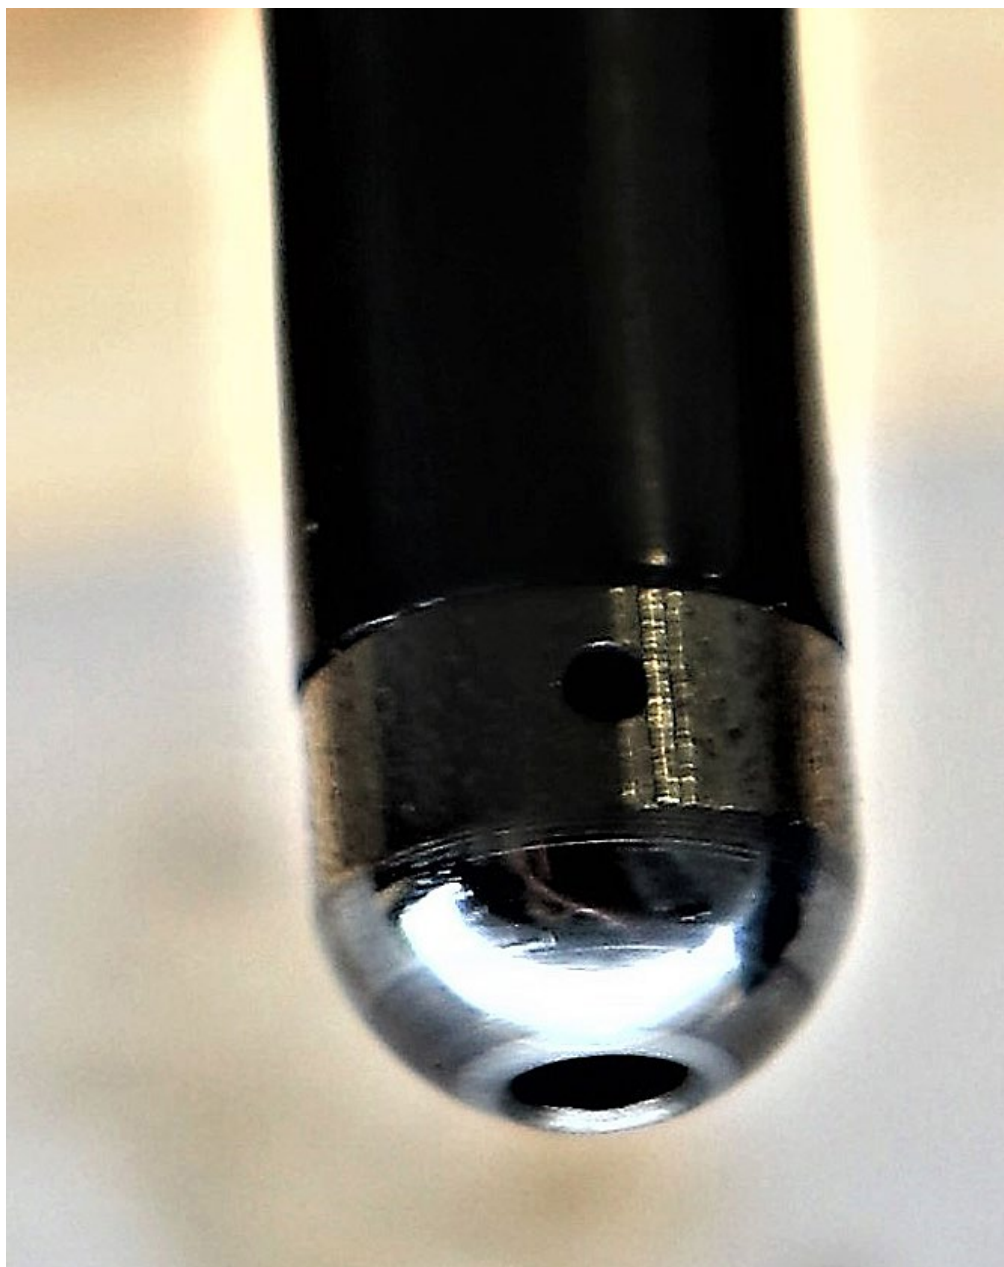
**Photo 3 - End of Push Rod (photograph provided by airplane owner)**

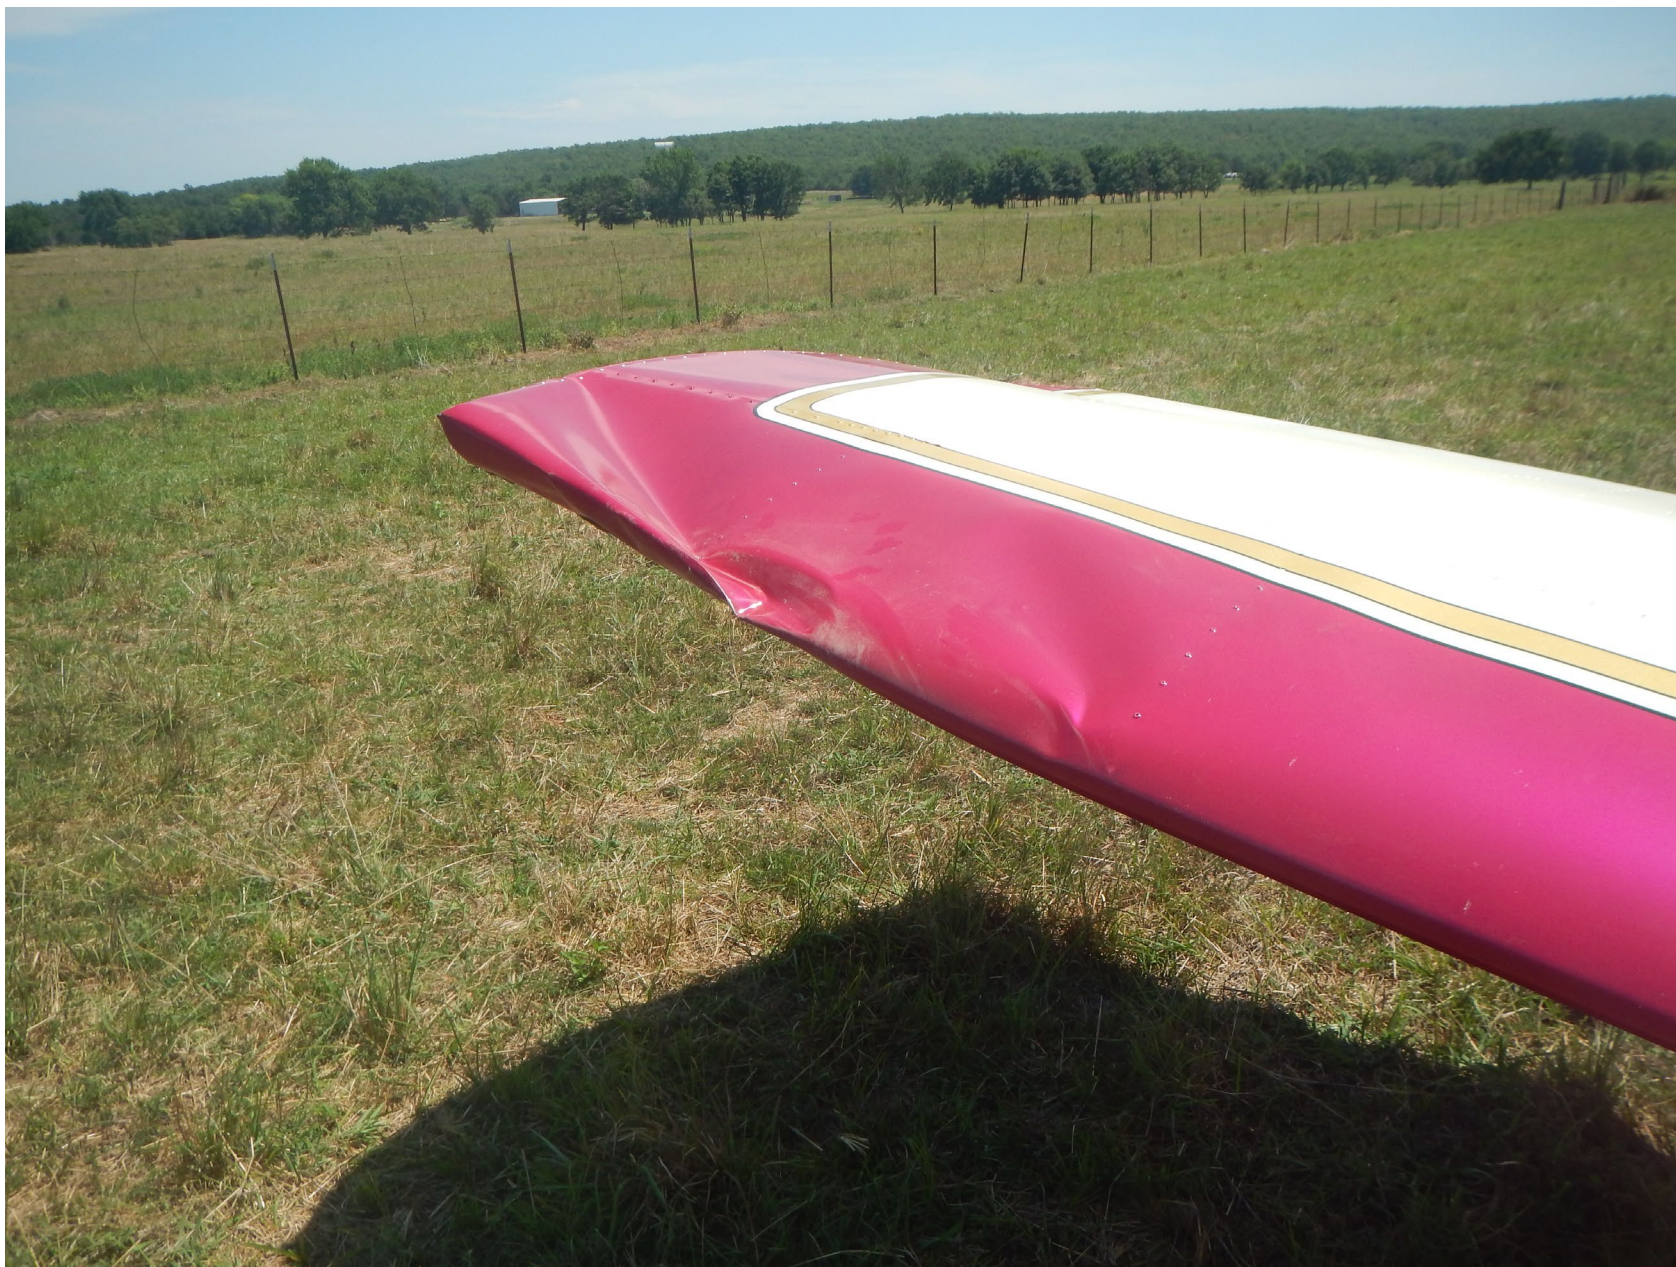
**Photo 4 – Right Wing Damage (photograph provided by airplane owner)**
