CEN22LA318

## INVESTIGATION PHOTOGRAPHS

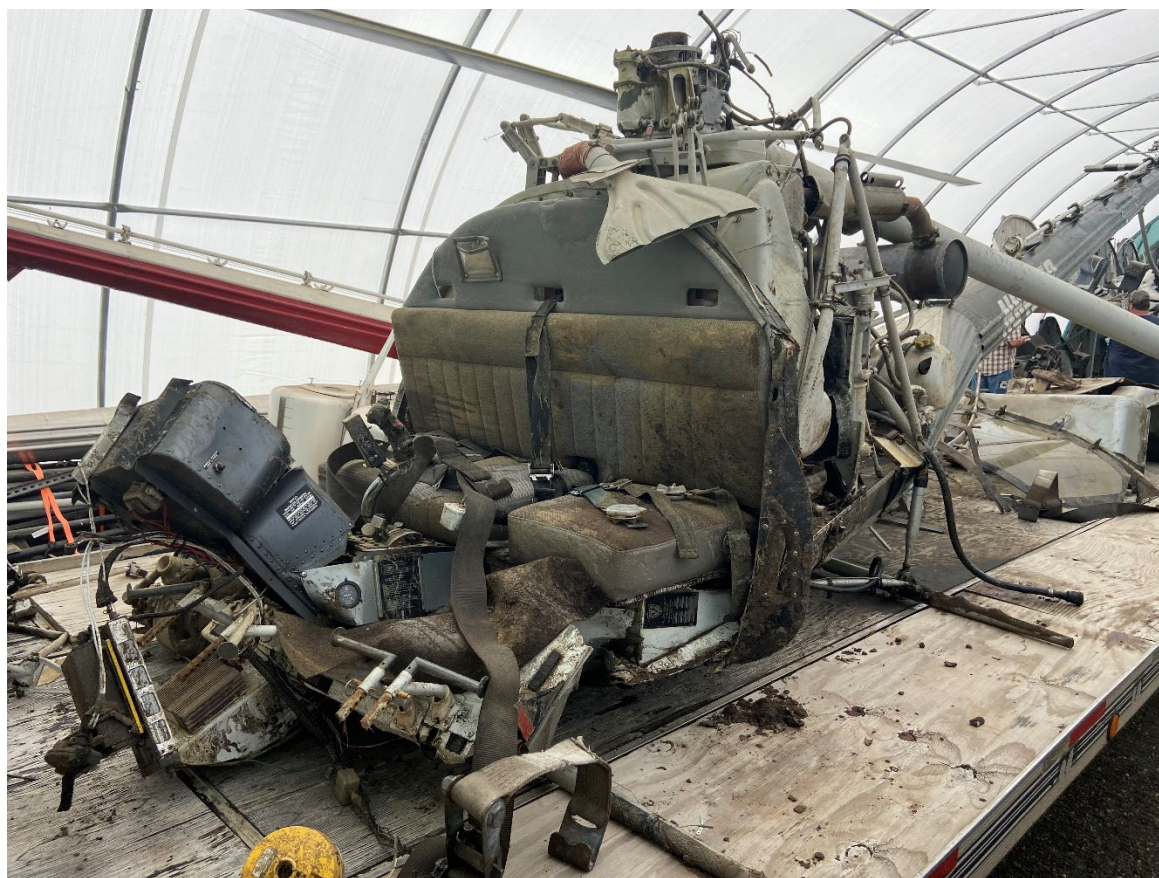
**Photograph 1 - Wreckage Overview (Courtesy of FAA)**

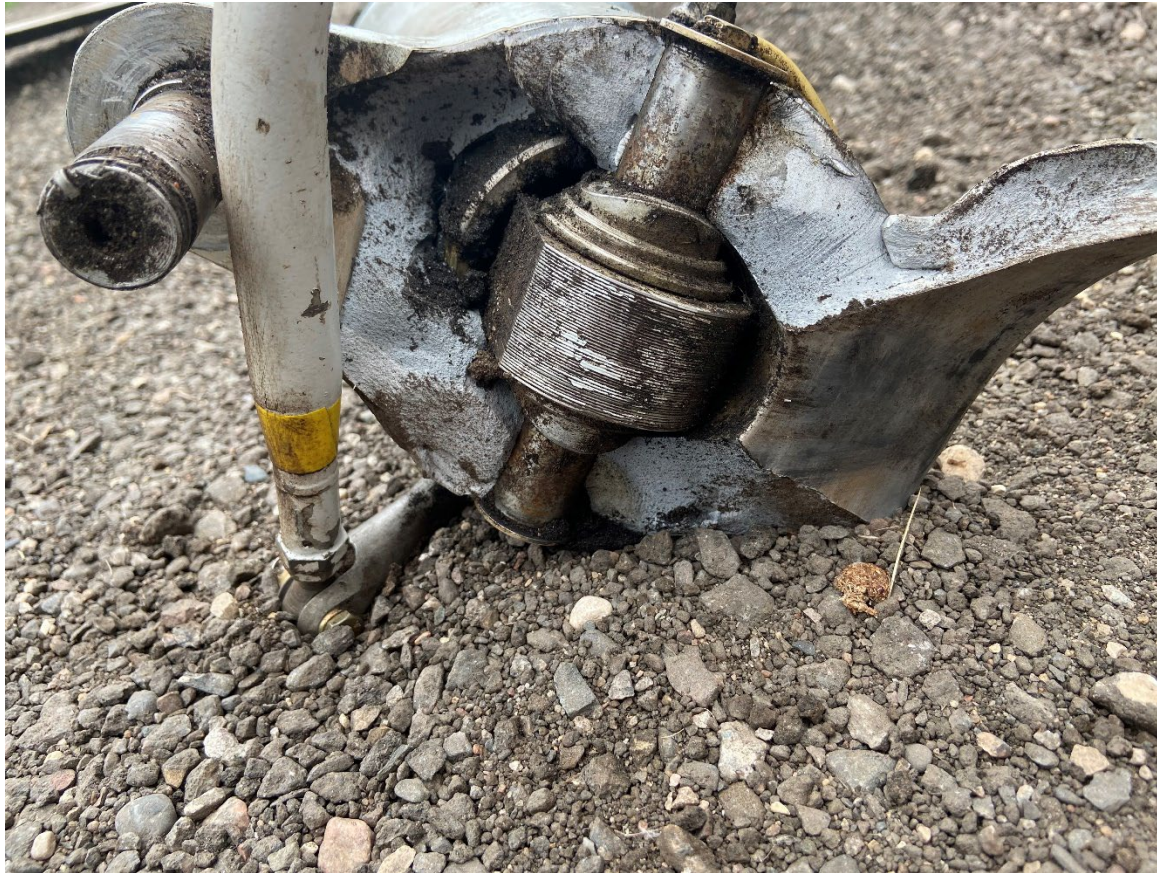
**Photograph 2 - Main Rotor Mast Hub (Courtesy of FAA)**

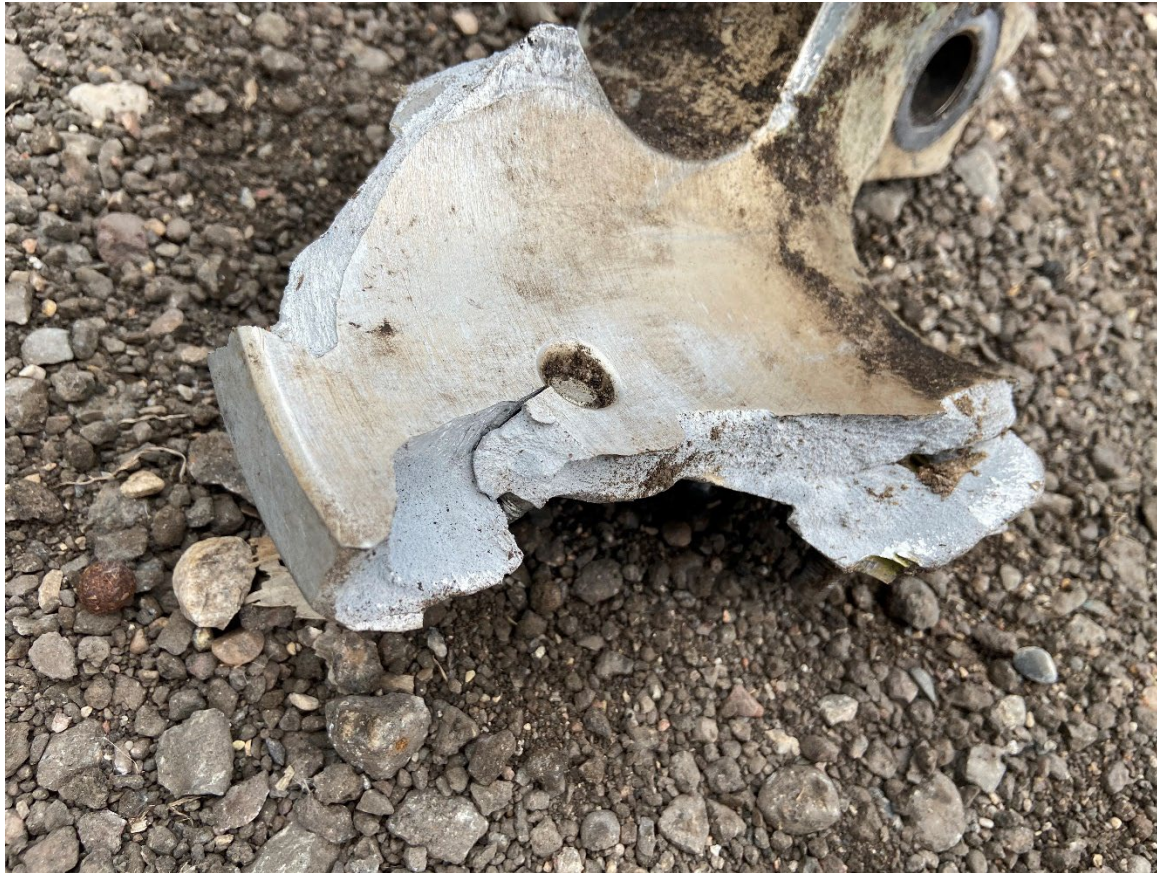
**Photograph 3 - Fractured Rotor Hub (Courtesy of FAA)**

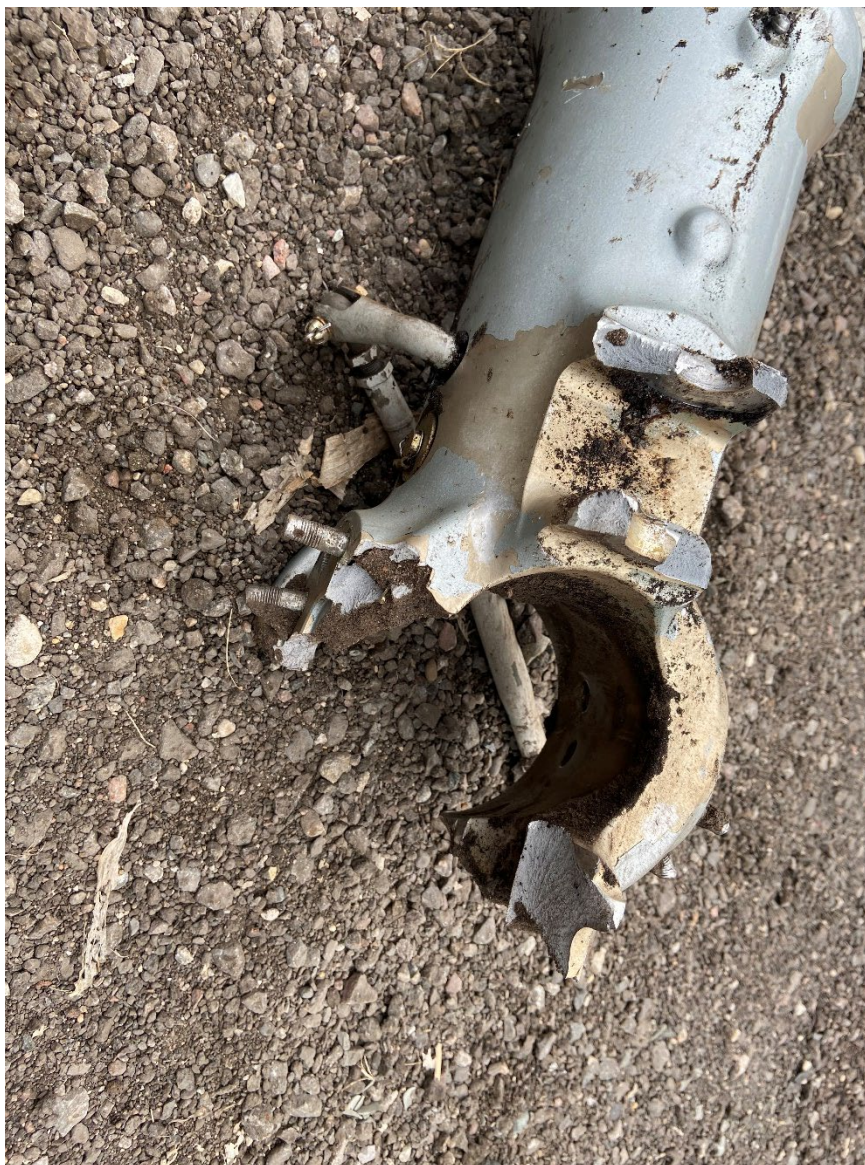
**Photograph 4 - Main Rotor Mast Hub (Courtesy of FAA)**
