Jason Aguilera  
Senior Air Safety Investigator  
Aviation Safety - Central Region

**Subject:** CEN22LA318

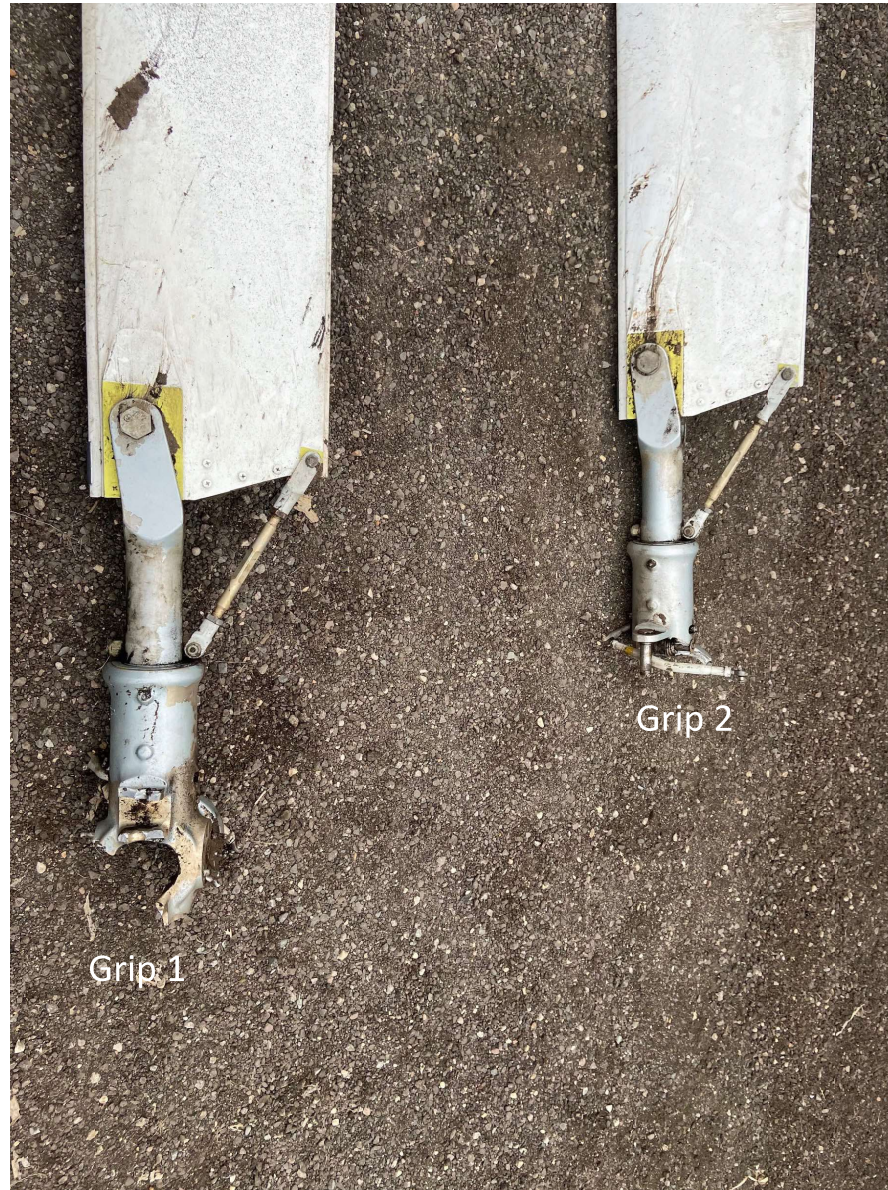
Grip 1

"Based on the submitted photographic evidence, pieces from both main rotor blade grips exhibit features on the fracture faces consistent with progressive crack growth (fatigue crack growth) as documented in the attached file (CEN22LA318--Grip fractures)."
