**From:** [REDACTED]  
**To:** [REDACTED]; [REDACTED]  
**Cc:** [REDACTED]  
**Subject:** RE: EXT: CEN22LA328 (N228MT) - Additional Questions  
**Date:** Friday, July 22, 2022 12:50:02 PM

I have been assigned the recent accident with N228MT. The NTSB case number is CEN22LA328.

## **Helicopter Landing Sites: Free from Debris**

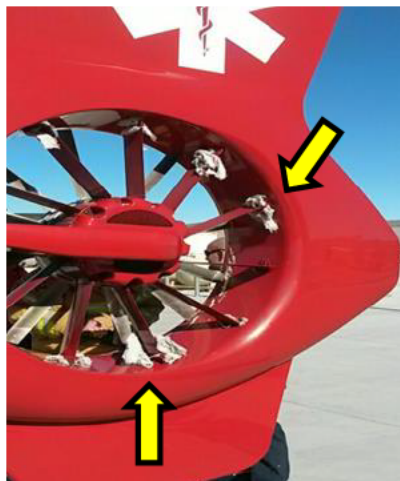
- The pilot of an Airbus (formerly Eurocopter) EC135 P2+ helicopter reported that, while landing at a public safety training center, he felt the helicopter shudder unexpectedly. The pilot immediately landed the helicopter without further incident. A postflight examination revealed that a towel had been ingested into the fenestron (see figures 1 and 2). The towel ingestion resulted in separation of the fenestron hub cover, which was subsequently ingested, substantially damaging the helicopter. The pilot reported that the towel came from an unsecured storage container near the landing site. ([GAA16LA056](#))

**Figure 1.** Fenestron with towel pieces.

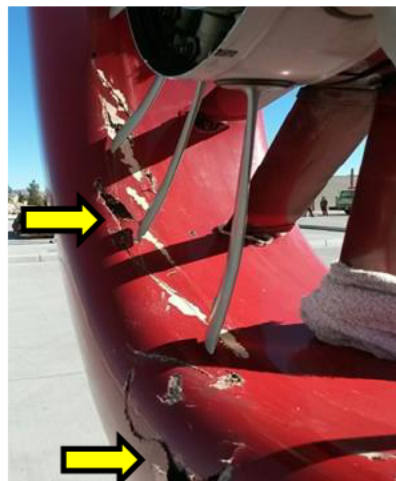
**Figure 2.** Lower fenestron housing.

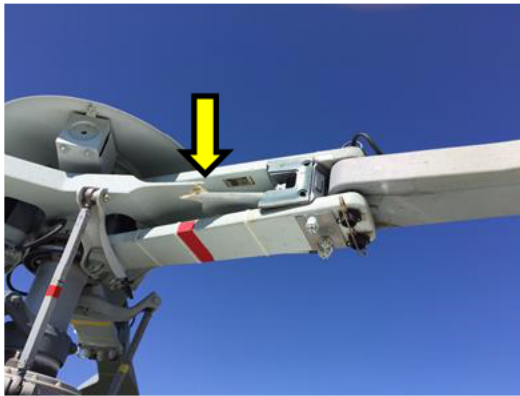
- The pilot of an Airbus (formerly Eurocopter) AS350 B3 helicopter was conducting a remote, high-altitude landing on a mountain during a rescue mission when the main rotor system was fouled by a rope that was not properly secured by ground personnel during the loading process. The helicopter abruptly rotated to the left, began to shake violently, and impacted terrain before the pilot regained control of it and made an emergency landing. A postflight examination revealed substantial damage to the main rotor system, tail boom, and empennage (see figures 3 and 4). ([GAA15CA258](#))

**Figure 3.** Main rotor system (Starflex assembly).

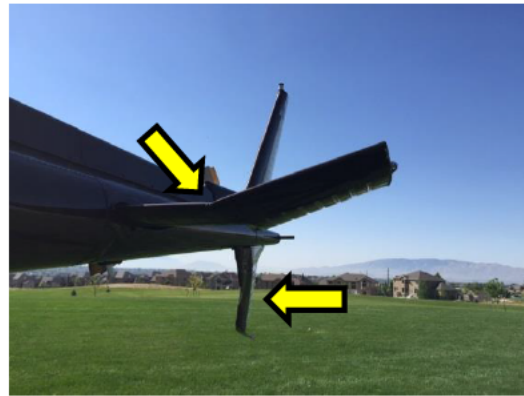
**Figure 4.** Empennage (horizontal stabilizer and vertical fin).
