## Service Investigation

## FACTUAL NOTES, ENGINE TEARDOWN INVESTIGATION IN SUPPORT OF ACCIDENT INVESTIGATION OF SCHWEIZER GRUMMAN AG-CAT MODEL 164B N629EH PERFORMED FOR THE NTSB.

**Application:** Schweizer Grumman AG-CAT model 164B - N629EH

**Engine Model:** PT6A-34

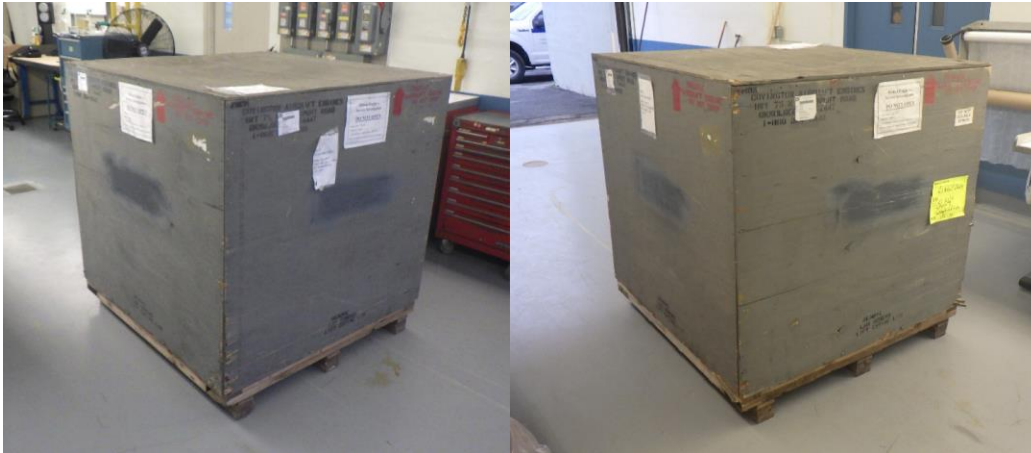
Photo No. 1

The engine was received in a wooden box. The engine externals were dirty, and evidence of impact damage was observed (Photo No. 1 & Photo No. 2) The compressor rotated freely through the started pad gearshaft splines. It was not possible to rotate the propeller shaft. The engine data plate confirmed the Serial No. 56841 (Photo No. 3).

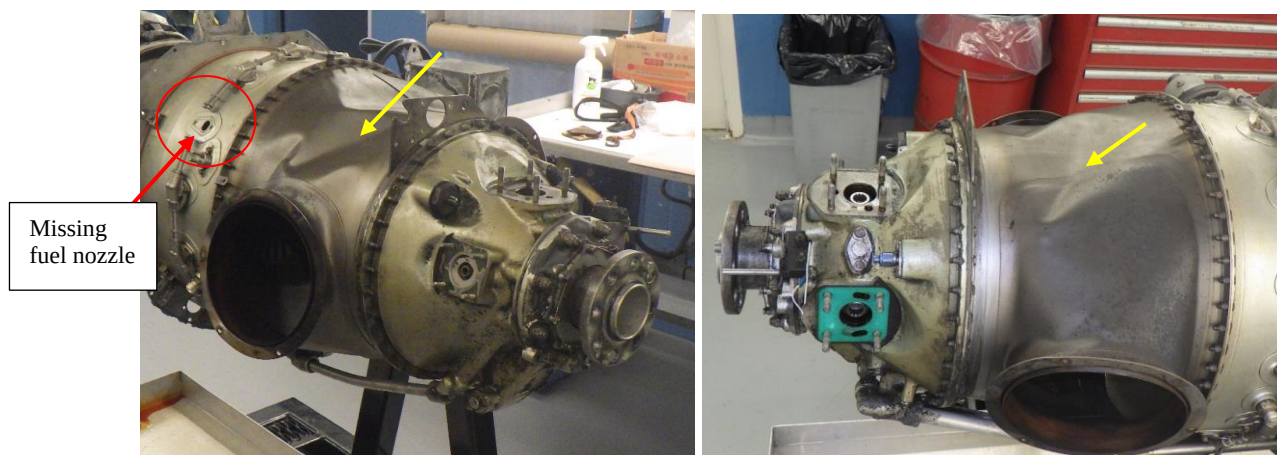
**Reduction Gearbox (RGB):** The RGB was dirty, and it was not possible to rotate the propeller shaft (Photo No. 4).

**Exhaust Duct:** The exhaust duct was buckled at the top and bottom (yellow arrows, Photo No. 4 & Photo No. 5). The PT blades trailing edge side viewed through the exhaust case did not exhibit any visual damage.

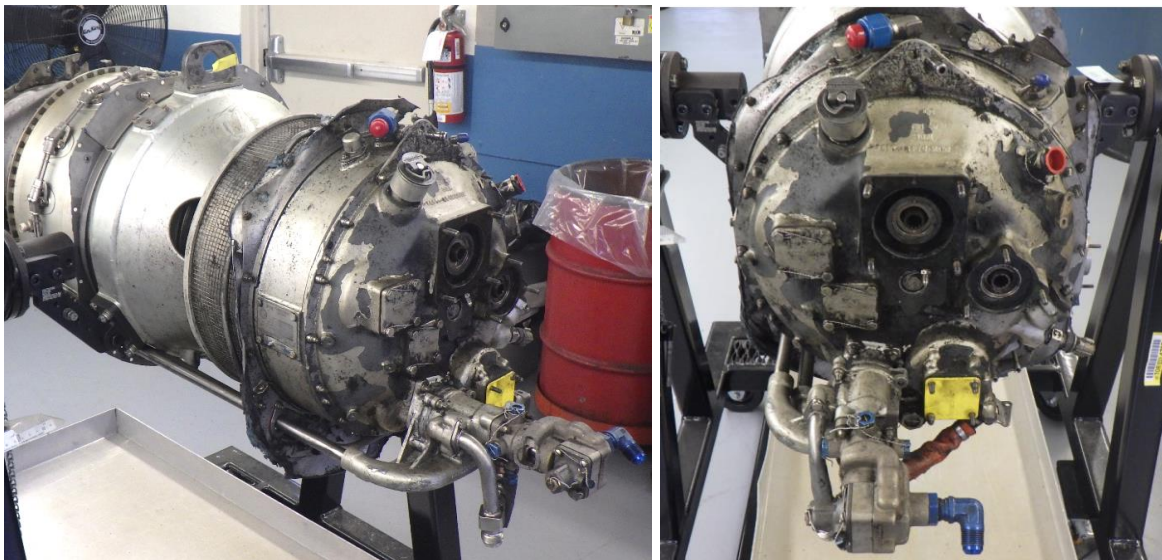
Photo No. 6

**Accessory Gearbox (AGB) and Inlet Case:** The AGB was dirty and exhibited coating loss (Photo No. 6). The AGB was rotated through the Starter pad gearshaft splines. The airframe low pressure fuel pump was received with the engine. A view of the inlet case with the inlet screen removed is shown in Photo No. 7. Environmental debris was observed in the inlet.

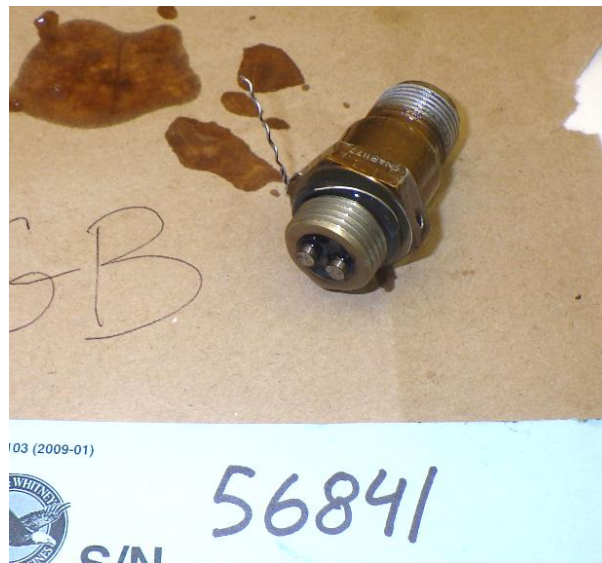
Photo No. 8

**Chip Detector:** The RGB chip detector was clean (Photo No. 8).

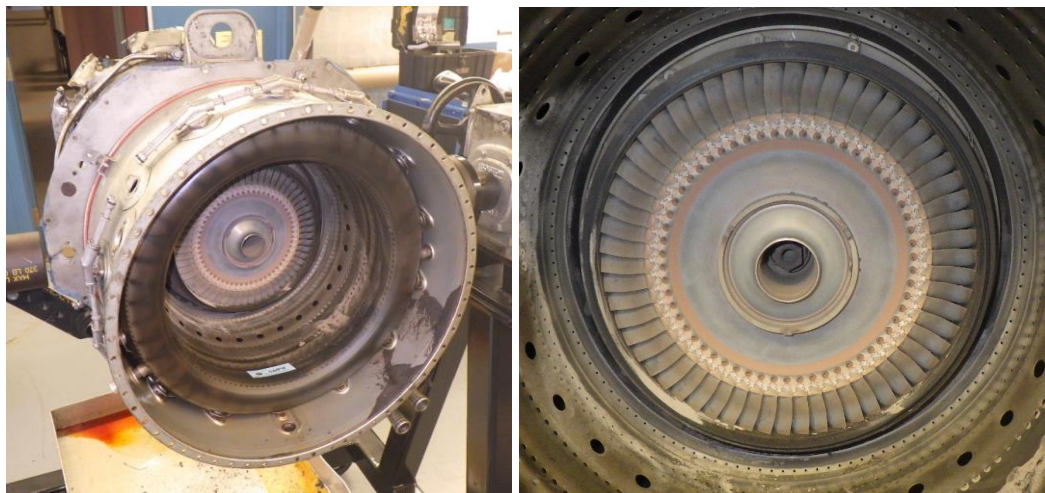
Photo No. 9

The CT disc did not show any primary distress (Photo No. 9). The CT blades did not show any signs of primary distress (Photo No. 10). The CT shroud segment showed localised rubbing (Photo No. 11). The CT vane ring showed a normal engine running condition.

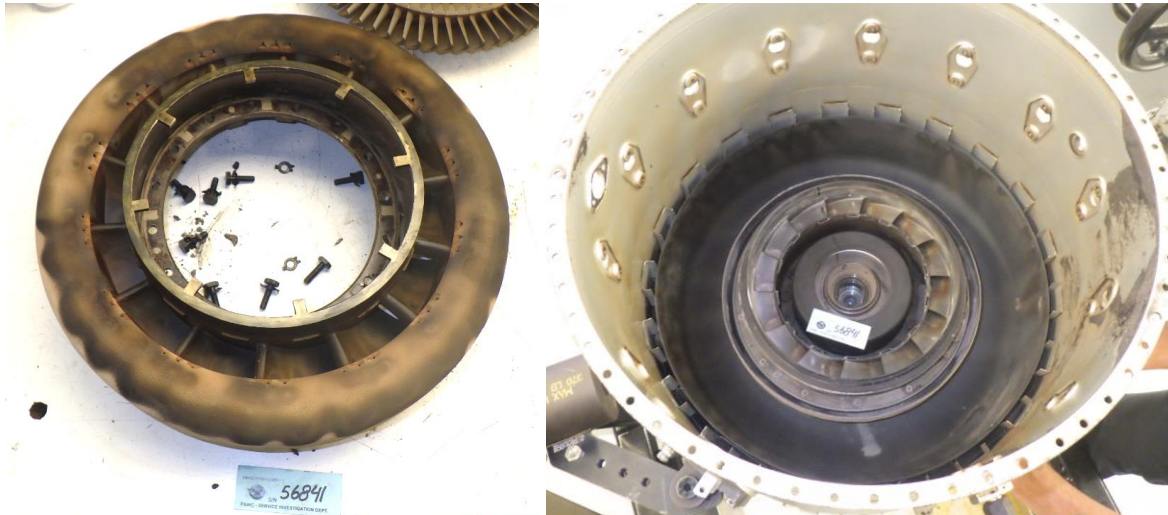
Photo No. 12

The small exit duct, large exit duct and combustor liner showed a normal in-service condition (Photo No. 12 & Photo No. 13).

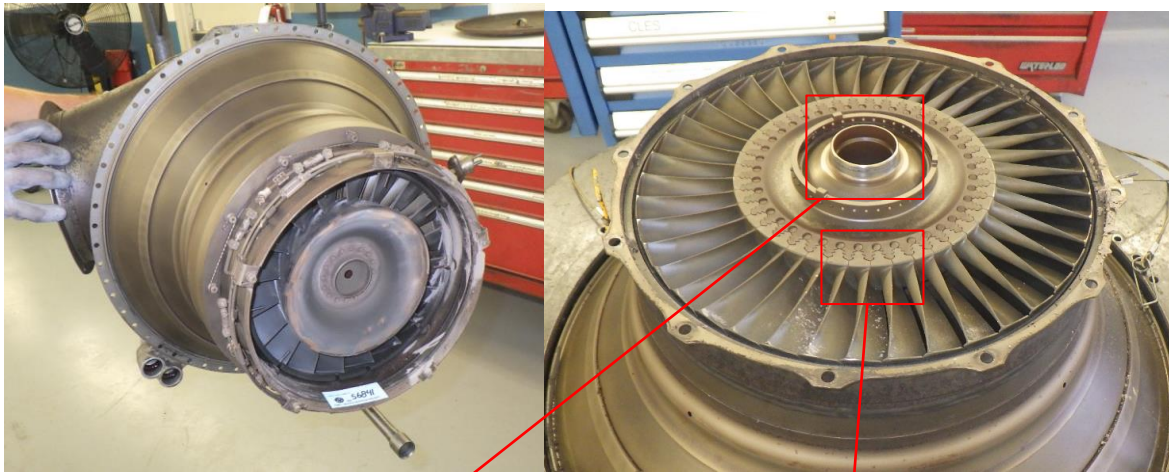
Photo No. 14

The inter turbine temperature (ITT) probes did not show any visual damage. The PT vane airfoils were covered with whitish deposits and debris. The power turbine disc and PT blade platform are exhibited circumferential rubbing wear from contact with the PT baffle. (Photo No. 14 to Photo No. 16). The PT blade tip and PT shroud exhibited rubbing wear.

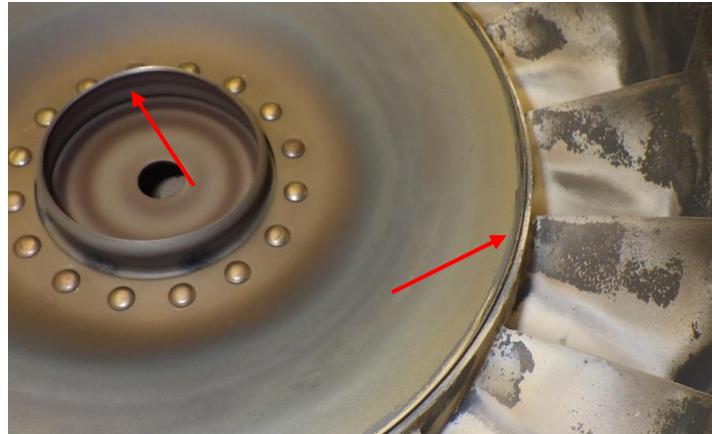
**Photo No. 16**

**Rubbing wear on PT baffle from contact with PT disc and blades**

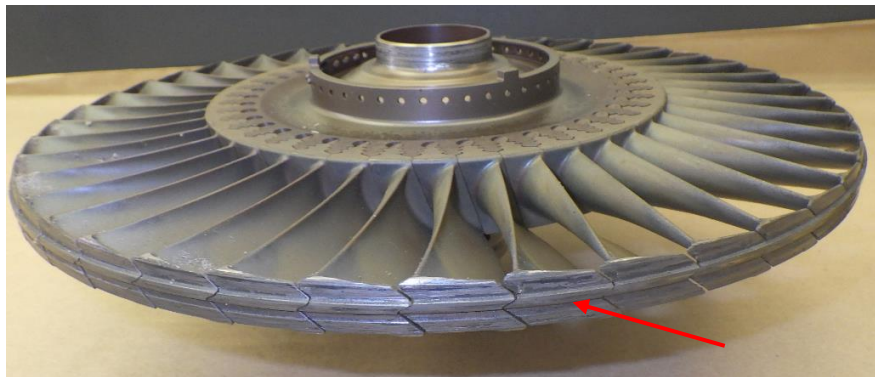
**Photo No. 17**

**PT blade shrouded tip rubbing wear**

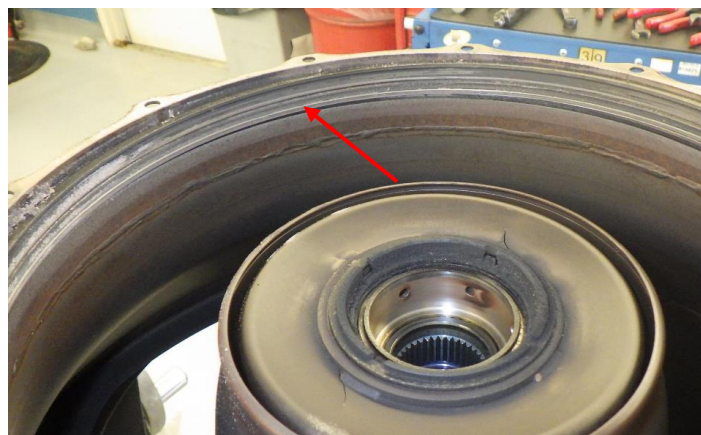
**Photo No. 18**

**PT shroud rubbing wear**

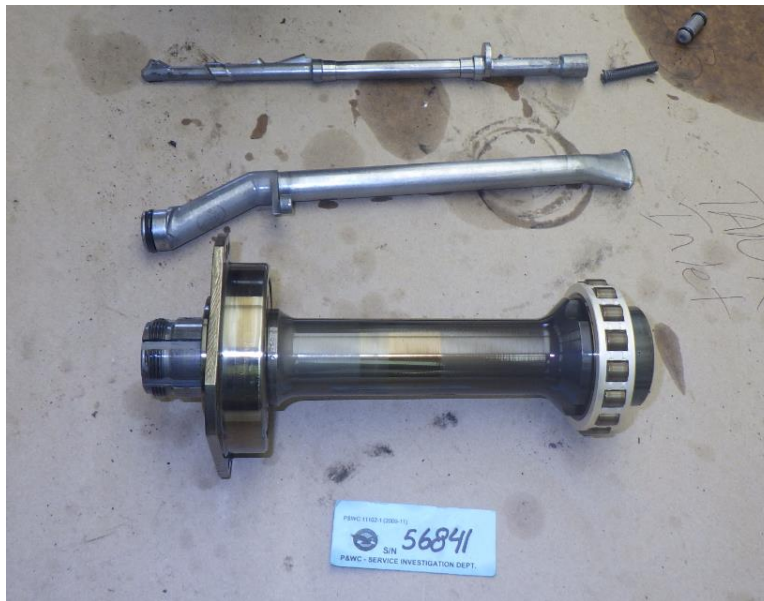
Photo No. 19

The No. 3 bearing knife edge seal was seized into the PT shaft housing and once removed allowed free rotation of the PT shaft. The No. 3 and 4 bearings rotated freely and did not show any signs of primary distress. (Photo No. 19).

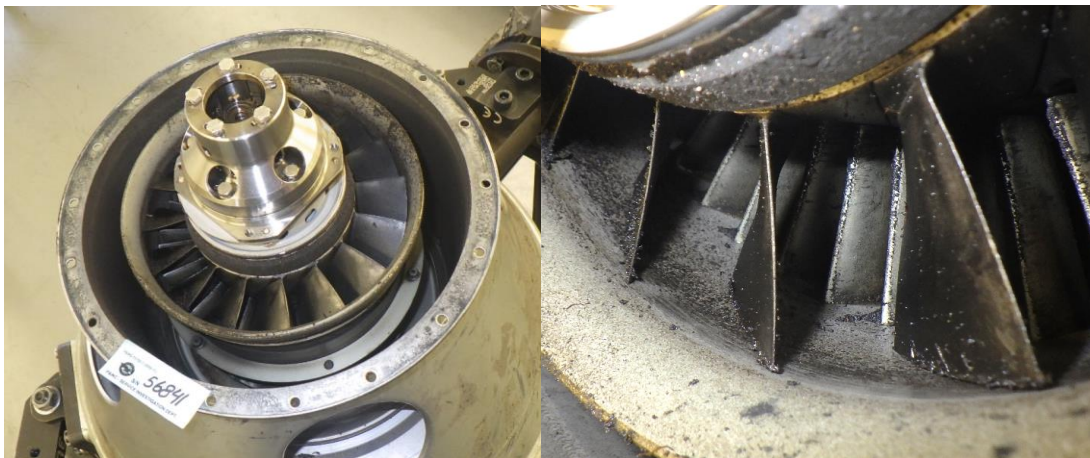
Photo No. 20

The 1<sup>st</sup> stage compressor rotor airfoils were dirty as shown in Photo No. 20.. The compressor was disassembled and there was no primary distress in any of the compressor stages (Photo No. 21 & Photo No. 22). The No.1 bearing and No.2 bearing rotated freely with no sign of primary distress (Photo No. 23).

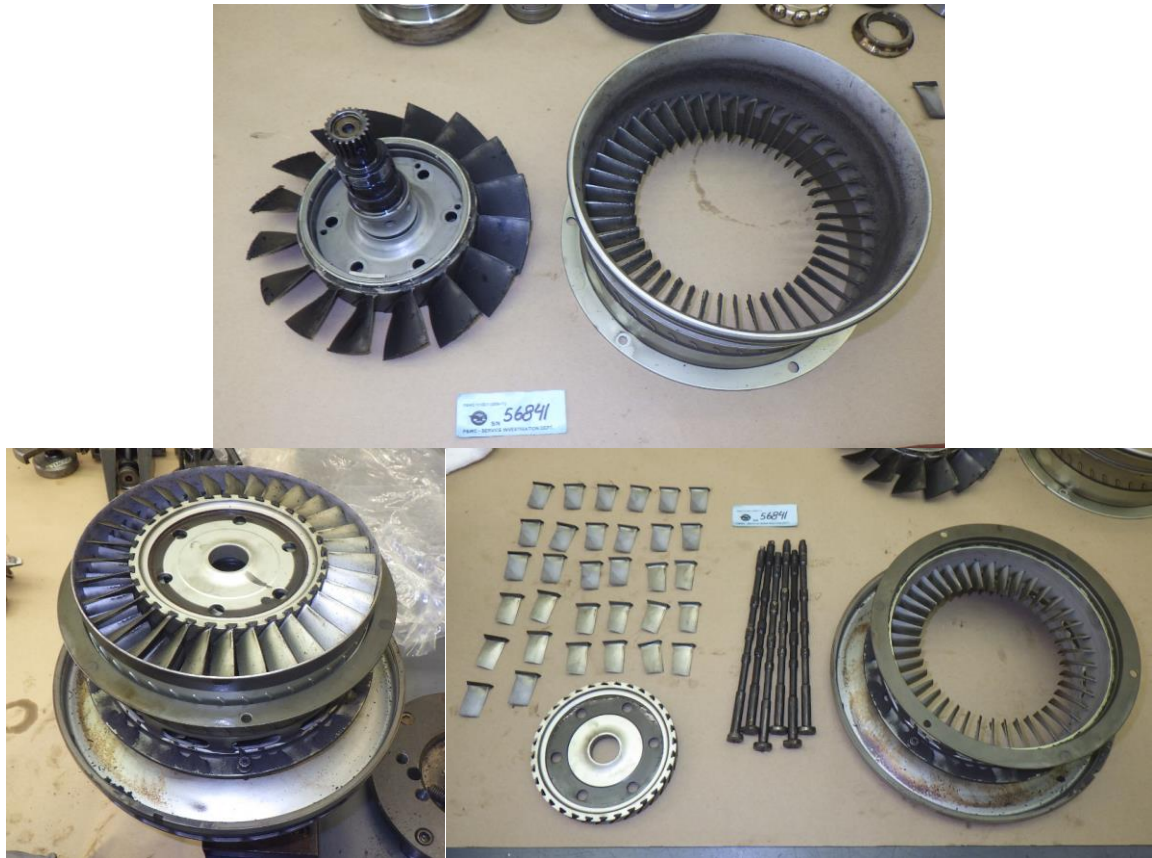
**Photo No. 21**  
**1<sup>st</sup>, 2<sup>nd</sup> & 3<sup>rd</sup> stage compressor rotors**

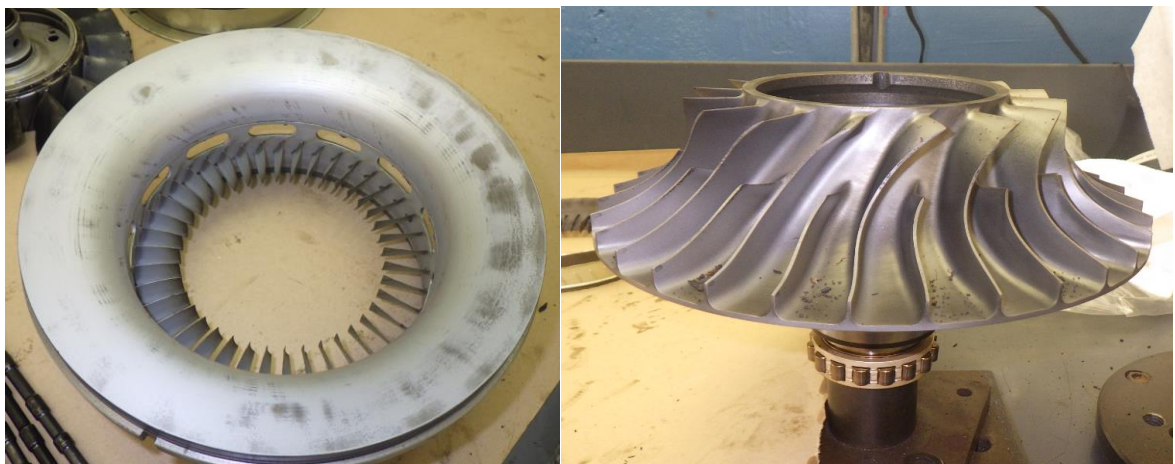
**Photo No. 22**  
**Centrifugal impeller**

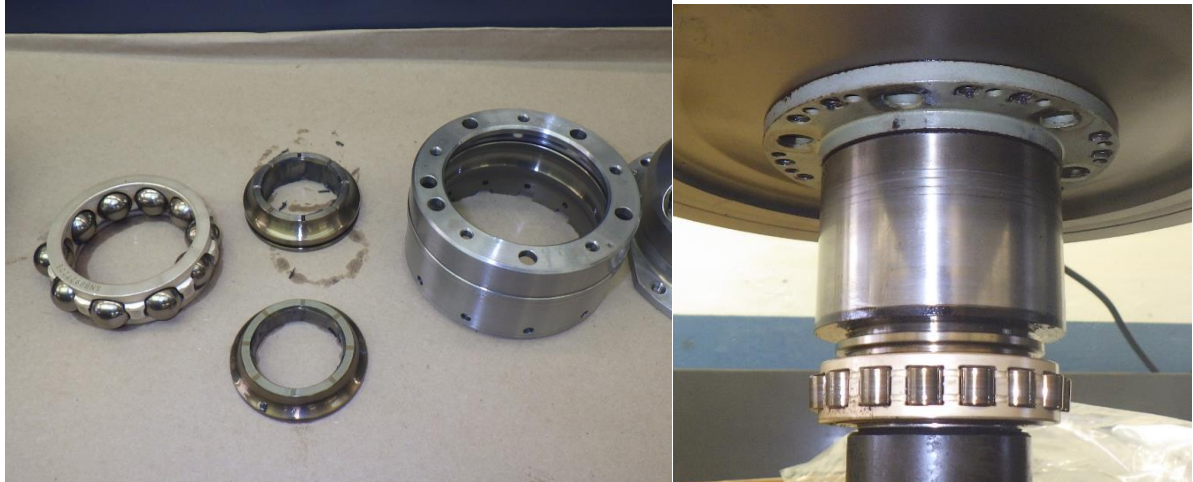
**Photo No. 23**  
**No.1 bearing and No. 2 bearings**

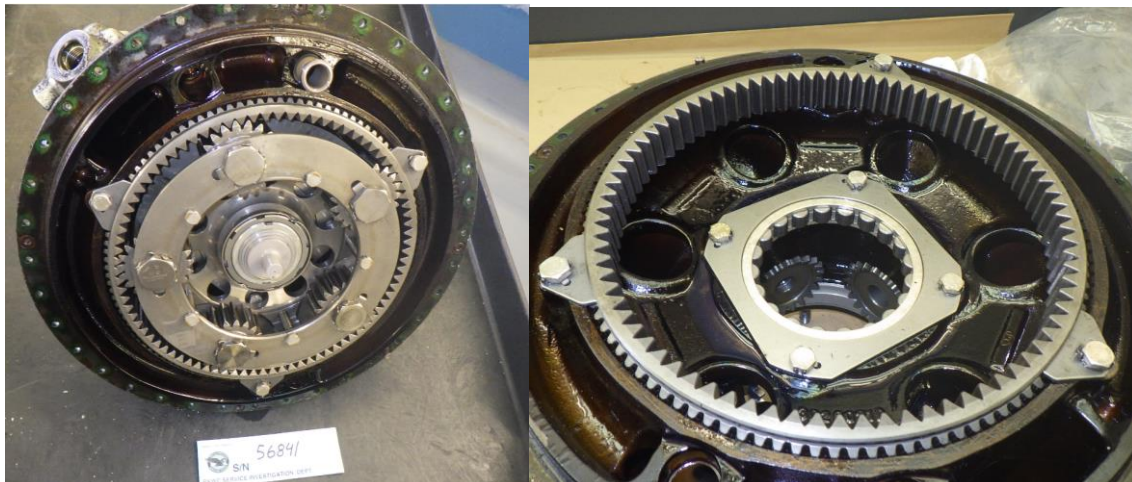
**Photo No. 24**

The RGB was partially disassembled to access the 1<sup>st</sup> and 2<sup>nd</sup> stage reduction gearsets. Both the 1<sup>st</sup> stage and 2<sup>nd</sup> stage planetary gearsets rotated freely without any signs of distress (Photo No. 24 & Photo No. 25).

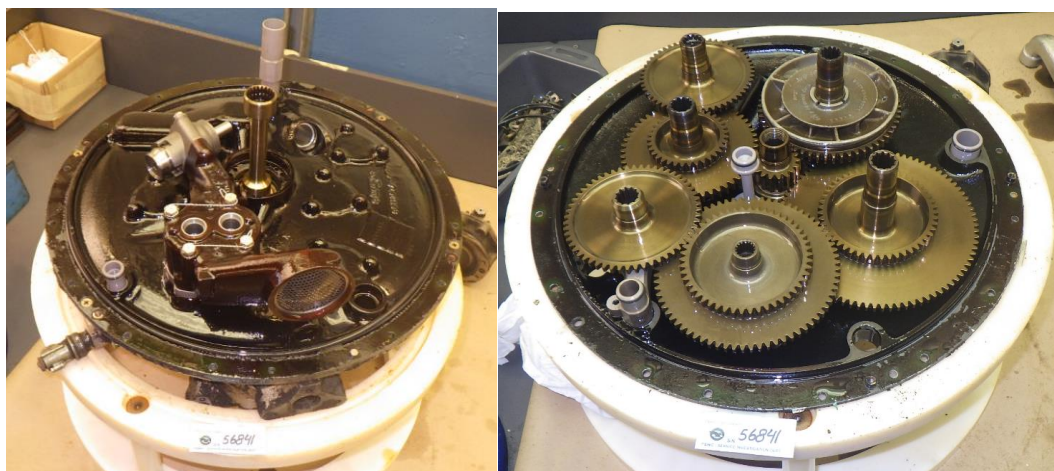
Photo No. 26

The AGB internal gears did not show any primary distress (Photo No. 26). The internal surface of the AGB showed coating peeling (Photo No. 27). The oil pressure pump, the external oil scavenge pump (RBG, 3 & 4 bearing), the No. 2 bearing oil scavenge pump and the AGB scavenge pump all rotated freely and disassembly did not reveal any sing of primary distress (Photo No. 28 to Photo No. 31).

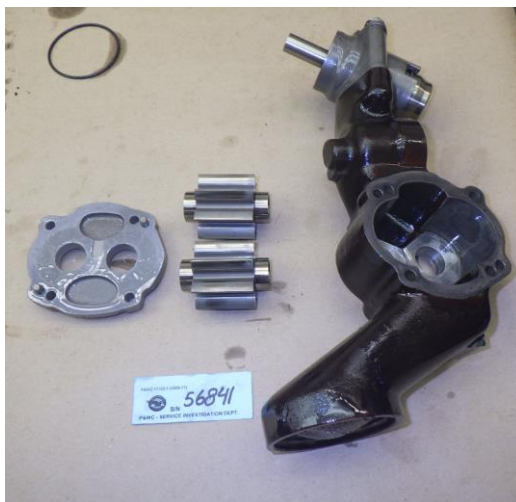
Photo No. 28  
Oil Pressure Pump

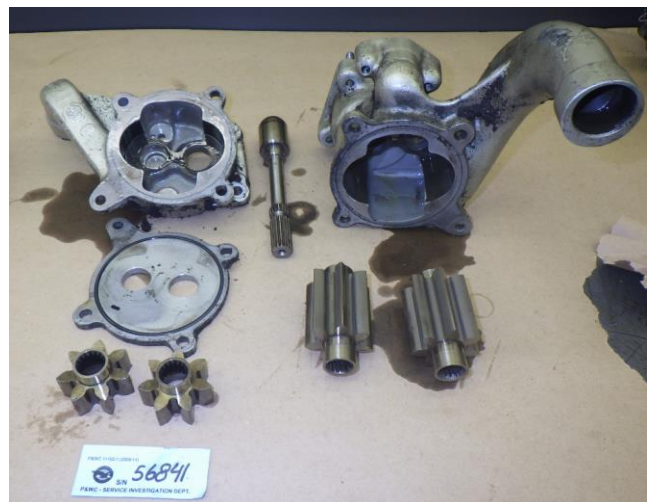
Photo No. 29  
External oil scavenge pump

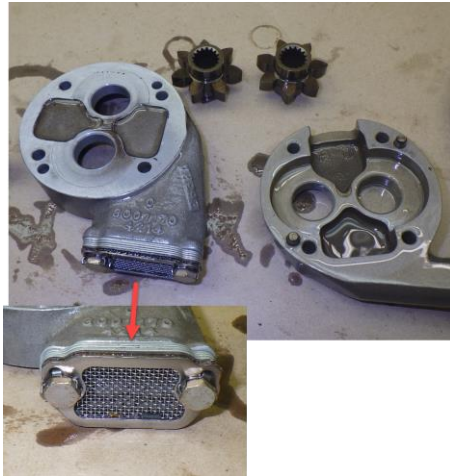
**Photo No. 30**  
**No. 2 bearing oil scavenge pump**

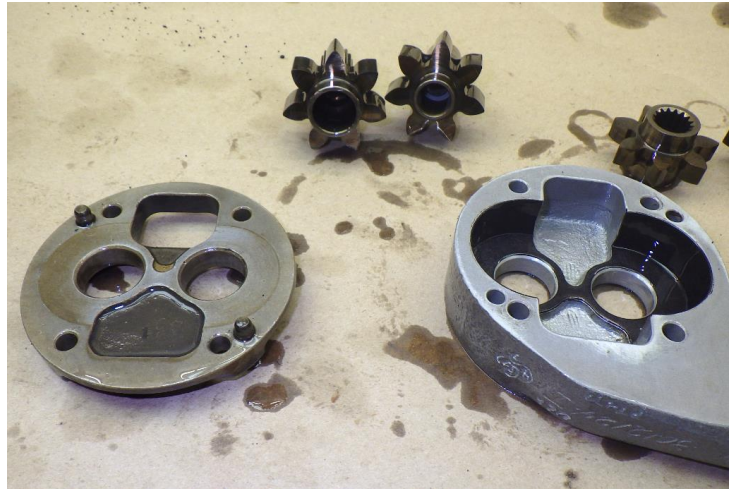
**Photo No. 31**  
**AGB oil scavenge pump**

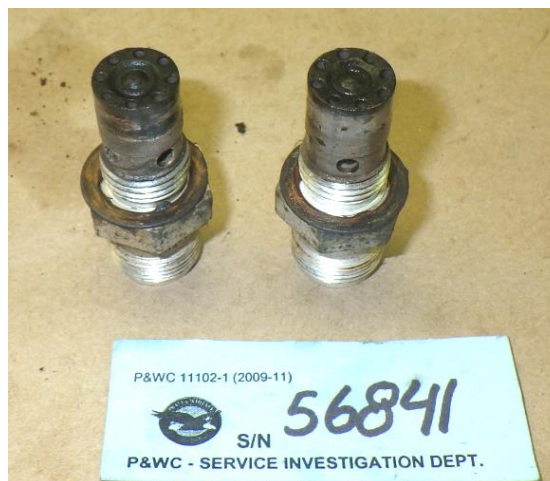
**Photo No. 32**

**Ignition Plugs:** The ignitor plugs exhibited a normal engine condition (Photo No. 32).

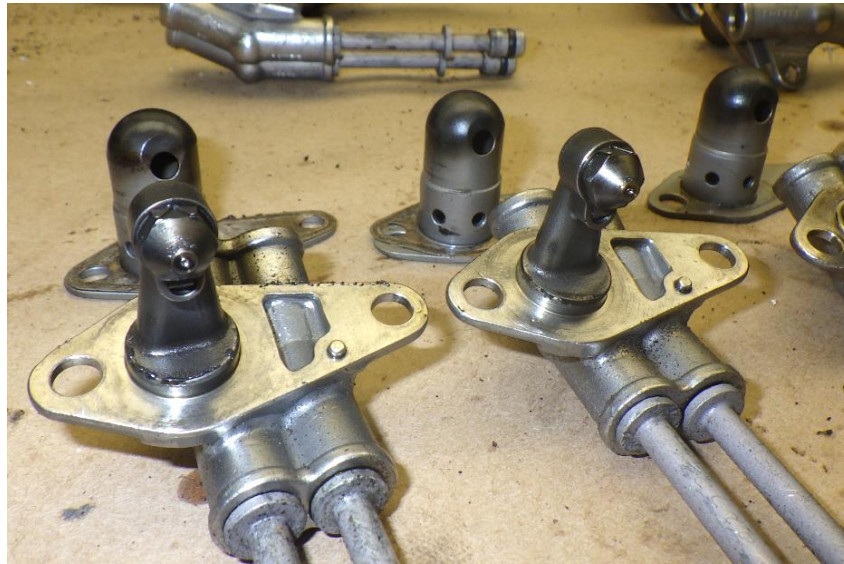
**Photo No. 33**

**Fuel Nozzles:** The fuel nozzles did not show any sings of primary distress (Photo No. 33).

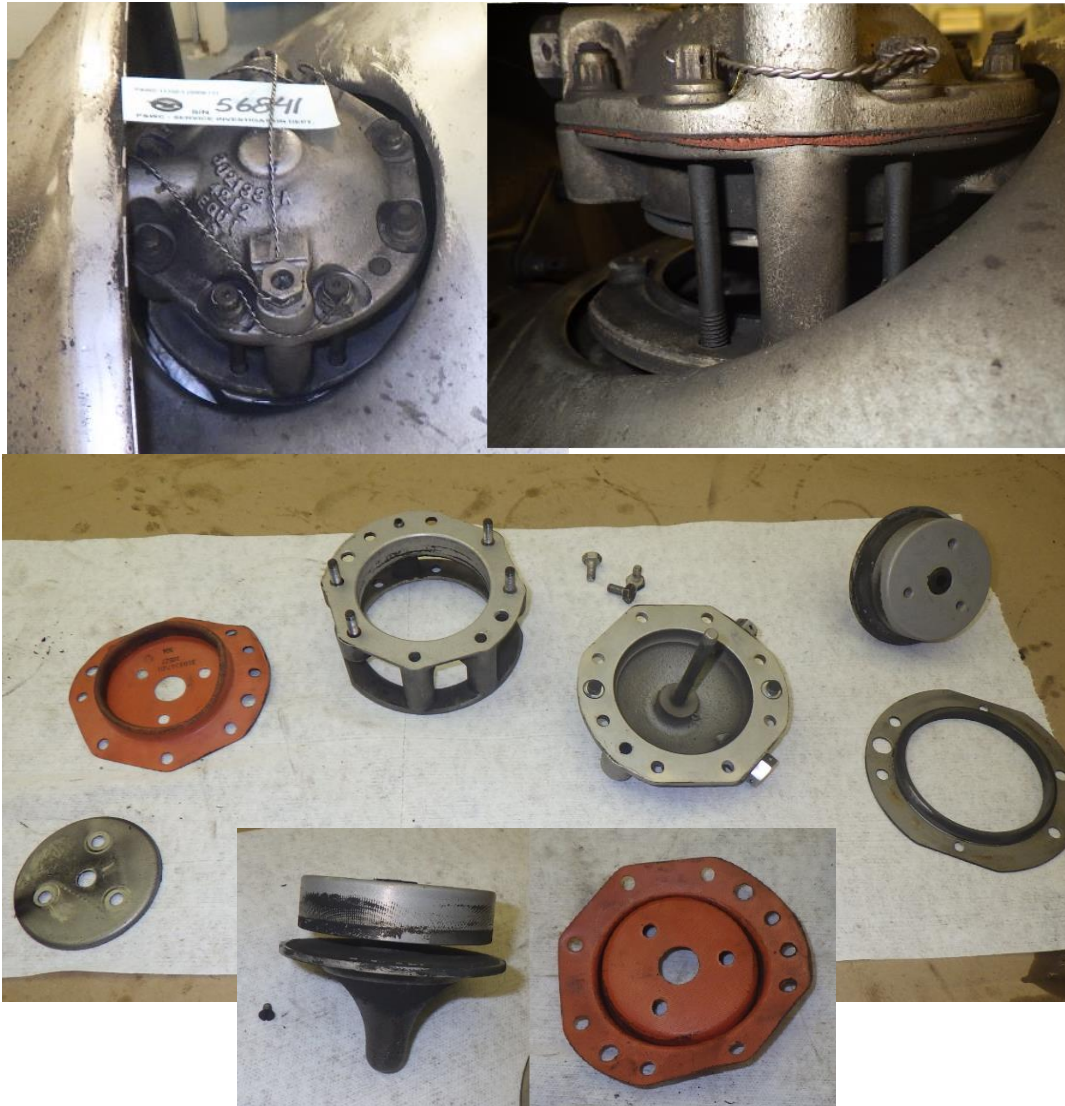
Photo No. 34

**Compressor Bleed Valve (BOV):** The BOV was observed to be in the fully opened position. The BOV was removed, and the piston was free to move through its entire range. The BOV was leak tested and disassembled and there were no indications of malfunction (Photo No. 34).
