# Rolls-Royce Engine Investigation Report

Accident Date: 1 August 2022  
Accident Location: Arcadia, IA  
Aircraft Type: Bell 206B  
Aircraft Reg: N169AA  
Engine Model: M250-C20B  
Engine S/N: 831700  
Engine Rating: 420 shp (takeoff)

Wreckage Exam Date: 7 October 2022  
Wreckage Exam Location: Wentworth Aviation - Lakeville, MN

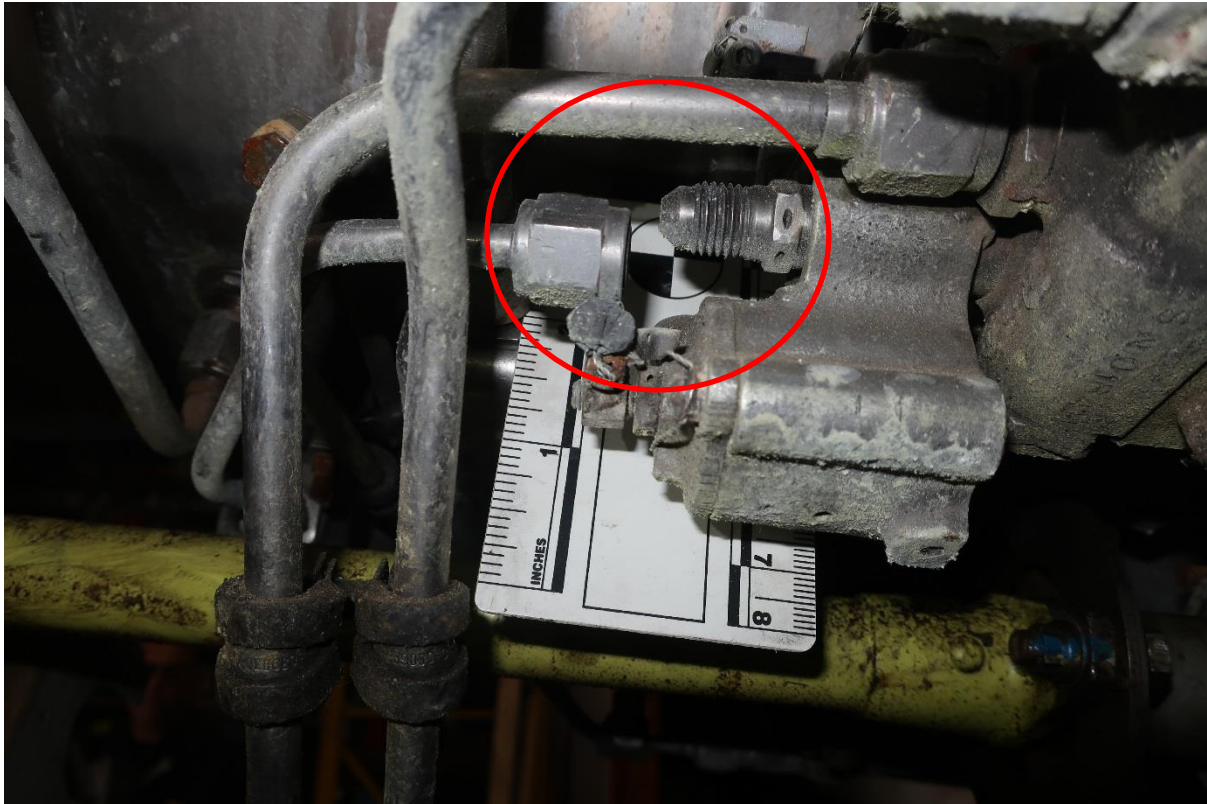
All external air, fuel, and oil line connections were at least finger tight except for the pneumatic air line connecting the PTG to the FCU. The air line was not connected to the FCU and an observed gap was noted between the line and FCU union. This pneumatic line is one of several that use air pressure to communicate fuel scheduling demands between the PTG and FCU. The security of this line is necessary for proper engine operation and the result of the observed disconnection would be a reduction in fuel supplied to the engine.

Figure 1. Loose pneumatic line connection at the FCU

Summary: The only anomaly observed which would preclude normal engine operation was the disconnected pneumatic air line from the PTG to the FCU. This condition would result in the FCU reducing fuel to a sub-idle condition and the engine would not be capable of producing power for continued flight.
