# National Transportation Safety Board

CEN22LA351

## **INVESTIGATION SUMMARY**

Location: Arcadia, Iowa  
Date: August 1, 2022  
Time: 0915 central daylight time  
Helicopter: Bell 206B, N169AA

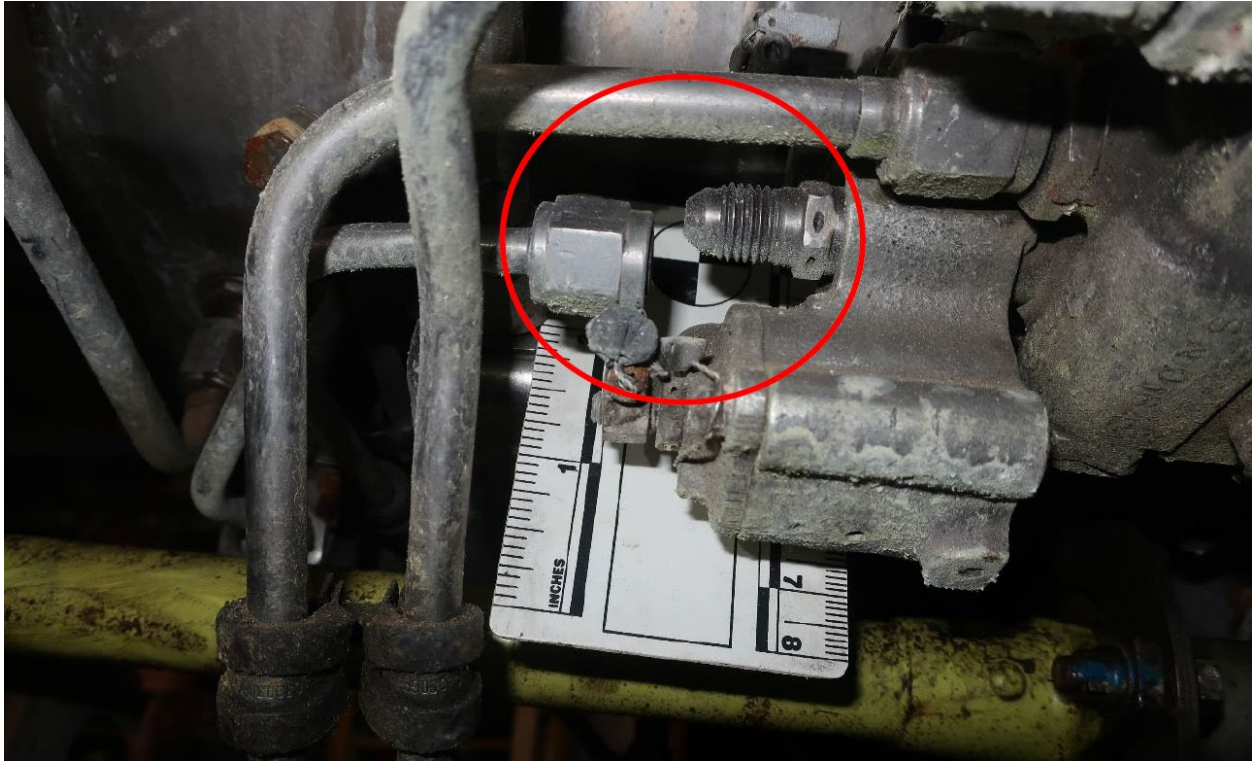
All external air, fuel, and oil line connections were at least finger tight except for the pneumatic air line connecting the PTG to the FCU. The air line was not connected to the FCU and an observed gap was noted between the line and FCU union. This pneumatic line is one of several that use air pressure to communicate fuel scheduling demands between the PTG and FCU. The security of this line is necessary for proper engine operation and the result of the observed disconnection would be a reduction in fuel supplied to the engine.

Figure 1. Loose pneumatic line connection at the FCU

The only anomaly observed which would preclude normal engine operation was the disconnected pneumatic air line from the PTG to the FCU. This condition would result in the FCU reducing fuel to a sub-idle condition and the engine would not be capable of producing power for continued flight.

During the engine examination a B-Nut on the tube p/n 6870035 was found with no thread engagement at the fuel control end. Residual torque paint was identified, however, there was no new-effective torque paint identified on any B-Nut.

The B-Nut that was found loose is difficult to access when other tubes are installed. Rolls-Royce designed, developed, and released a special tool, p/n 23083893, to access this B-Nut. On October 24, 2016, it was released to the field via Commercial Service Letter (CSL) 1273. The CSL provides details on how to manufacture the tool locally. The tool is also available for purchase on the Boeing web site. Operators are advised that torque paint / slippage indication is to be applied to all B-Nuts per the Operation and Maintenance Manual (OMM). Strict adherence to Rolls-Royce specified manuals is essential to the safe and reliable operation of the M250-C20 Series engine. Failure to maintain the M250-C20 Series engine in accordance with the OMM and supporting customer publications can result in a decrease in airworthiness of the engine.
