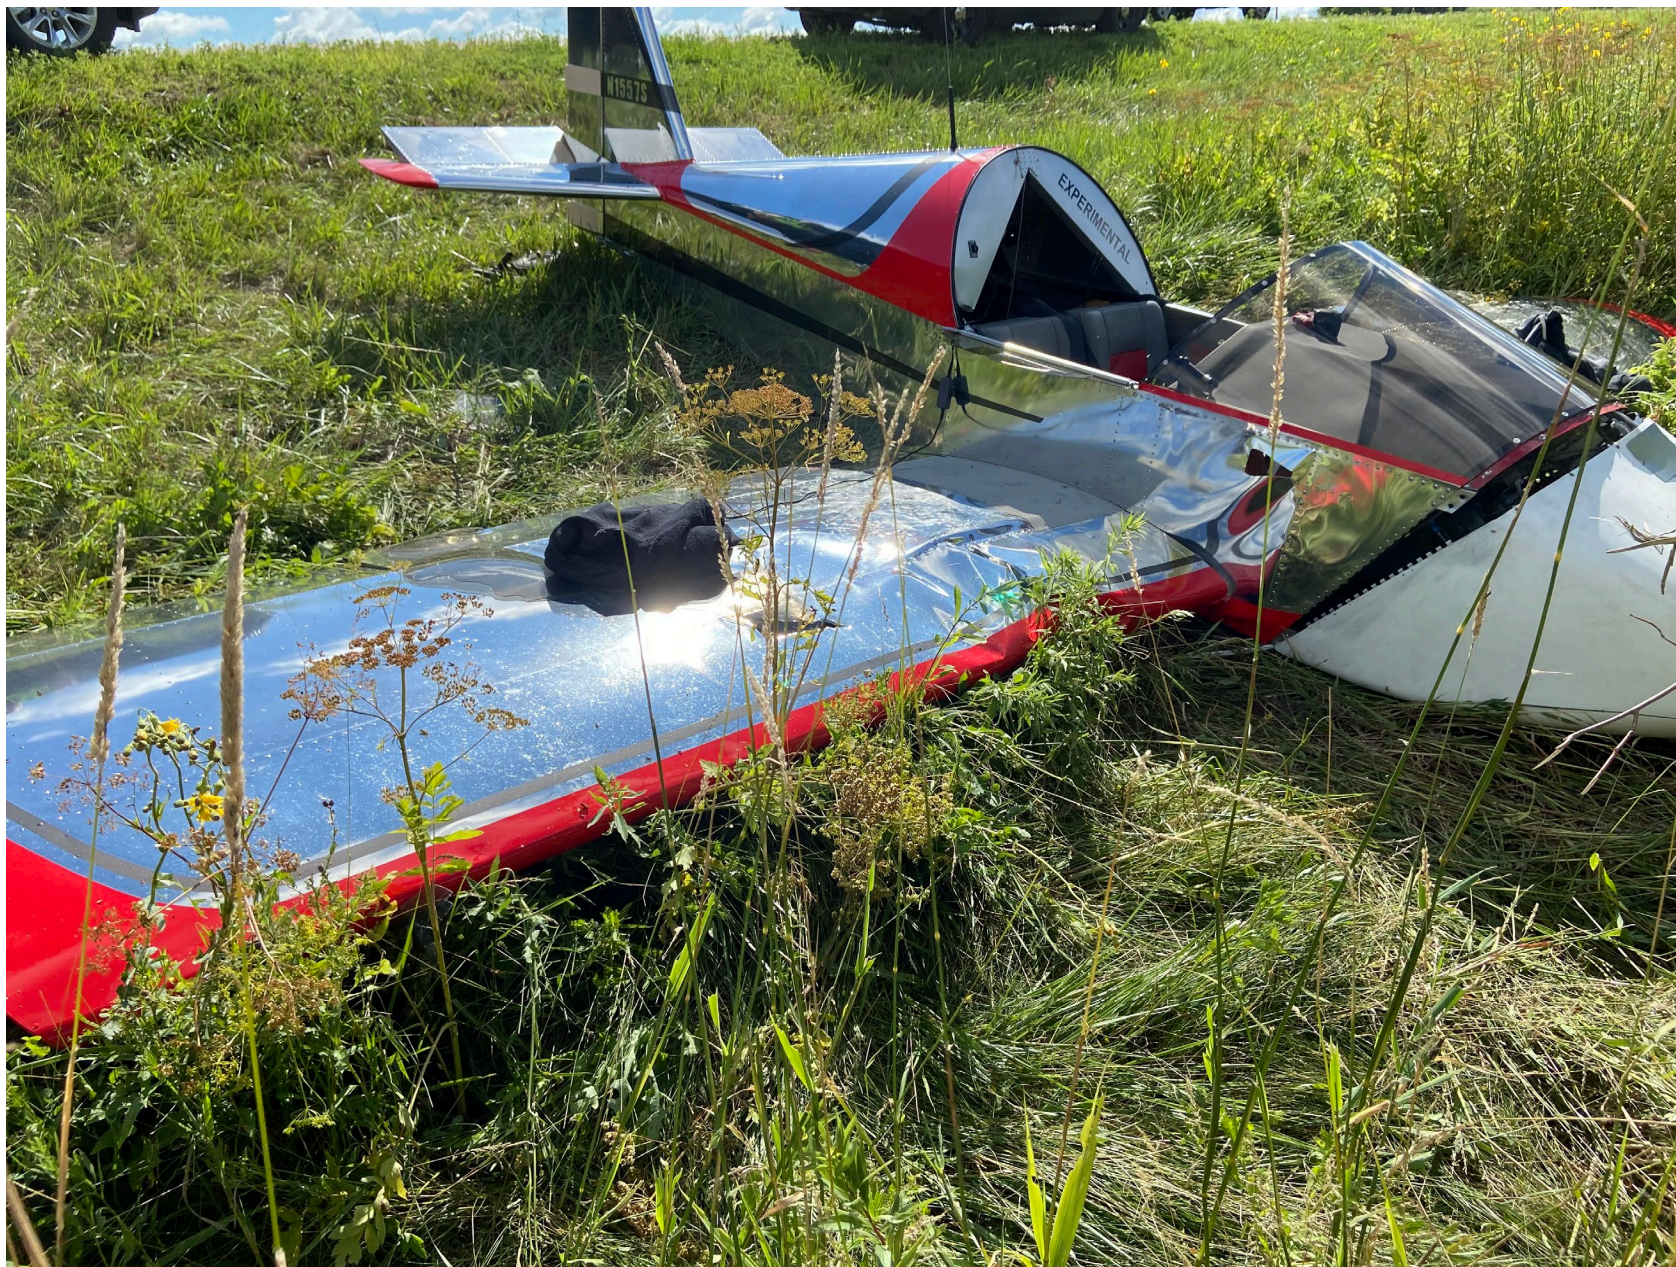
**Photo 1 – View of the substantial damage sustained to the right wing at the accident site (courtesy of the Federal Aviation Administration).**

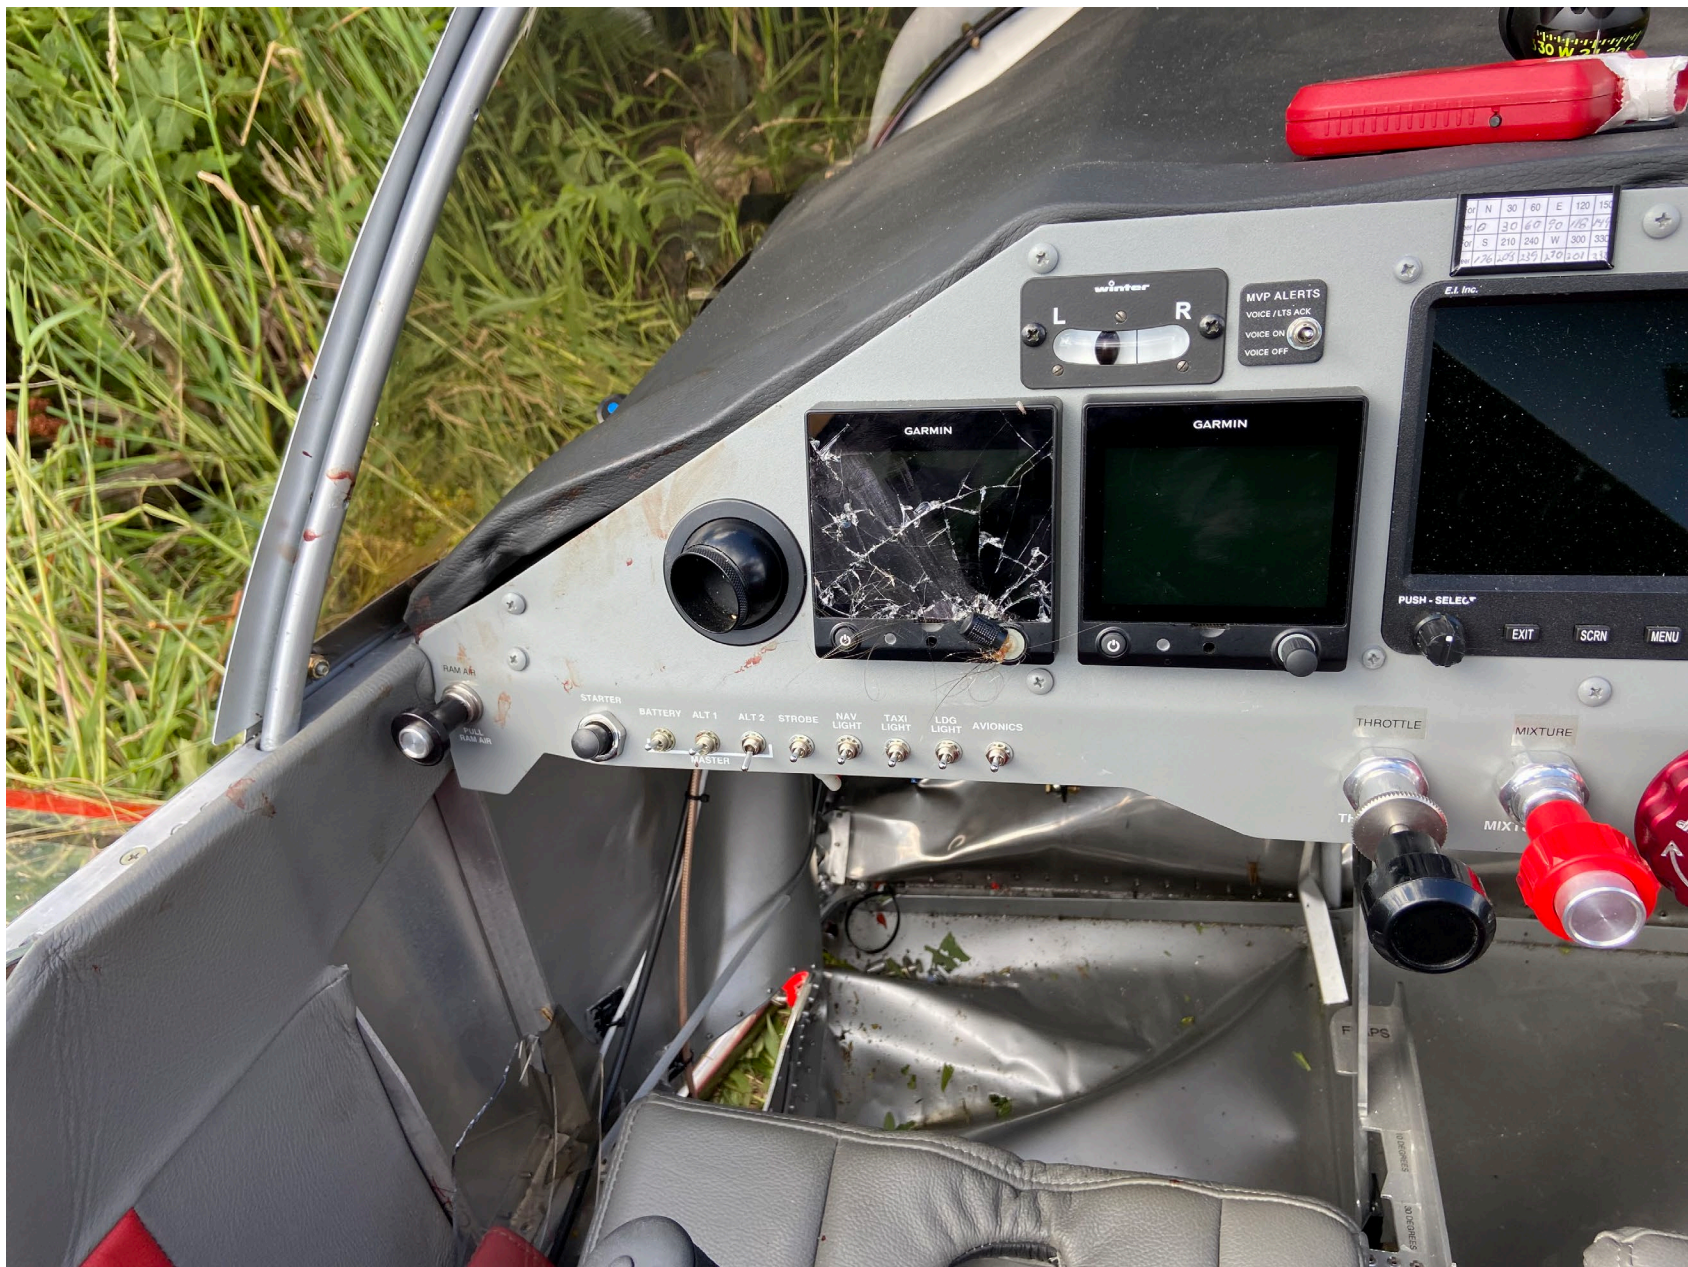
**Photo 2 – View of the substantial damage sustained to the fuselage at the accident site (courtesy of the Federal Aviation Administration).**

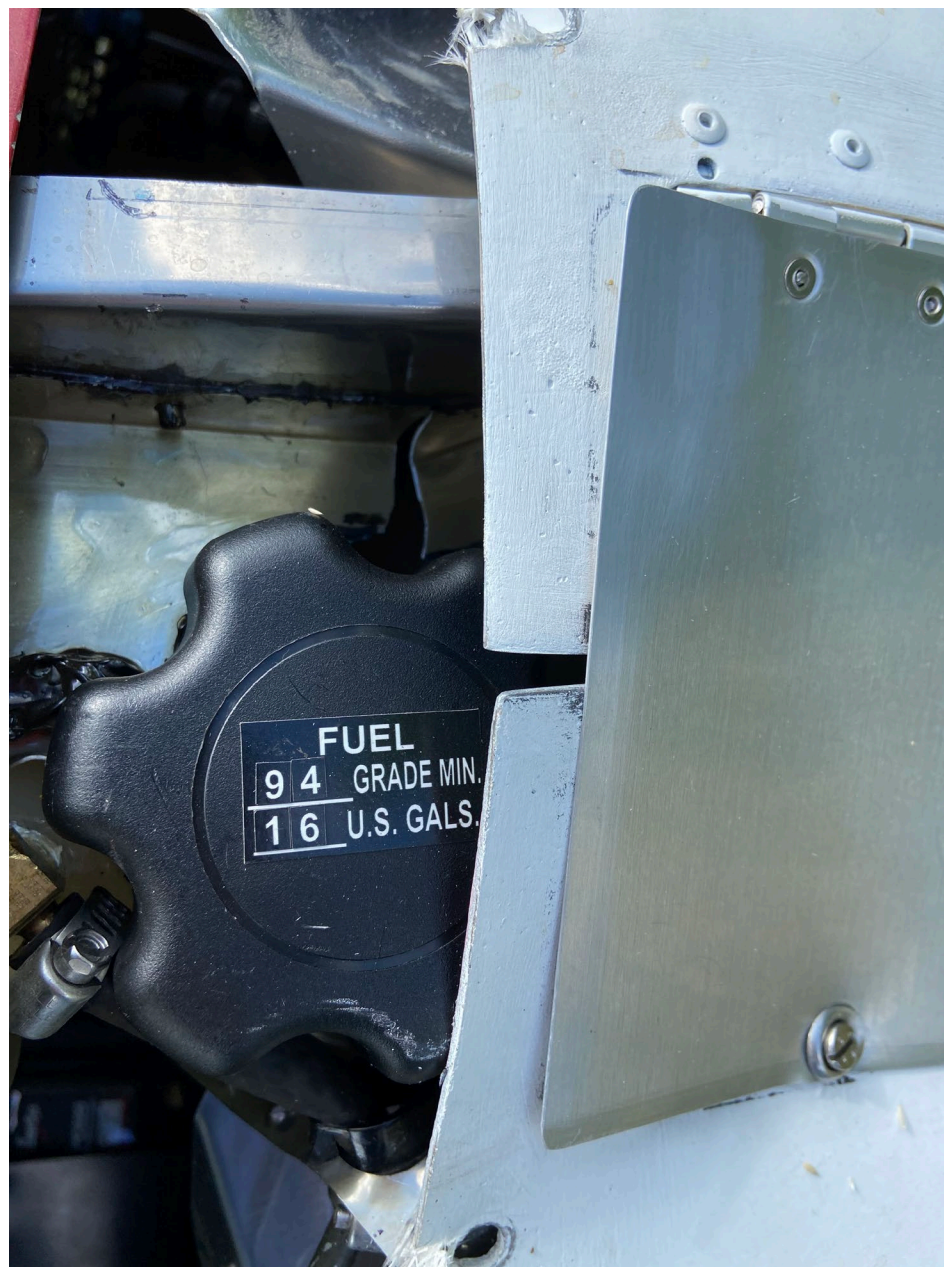
**Photo 3 – View of the fuel tank cap at the accident site (courtesy of the Federal Aviation Administration).**

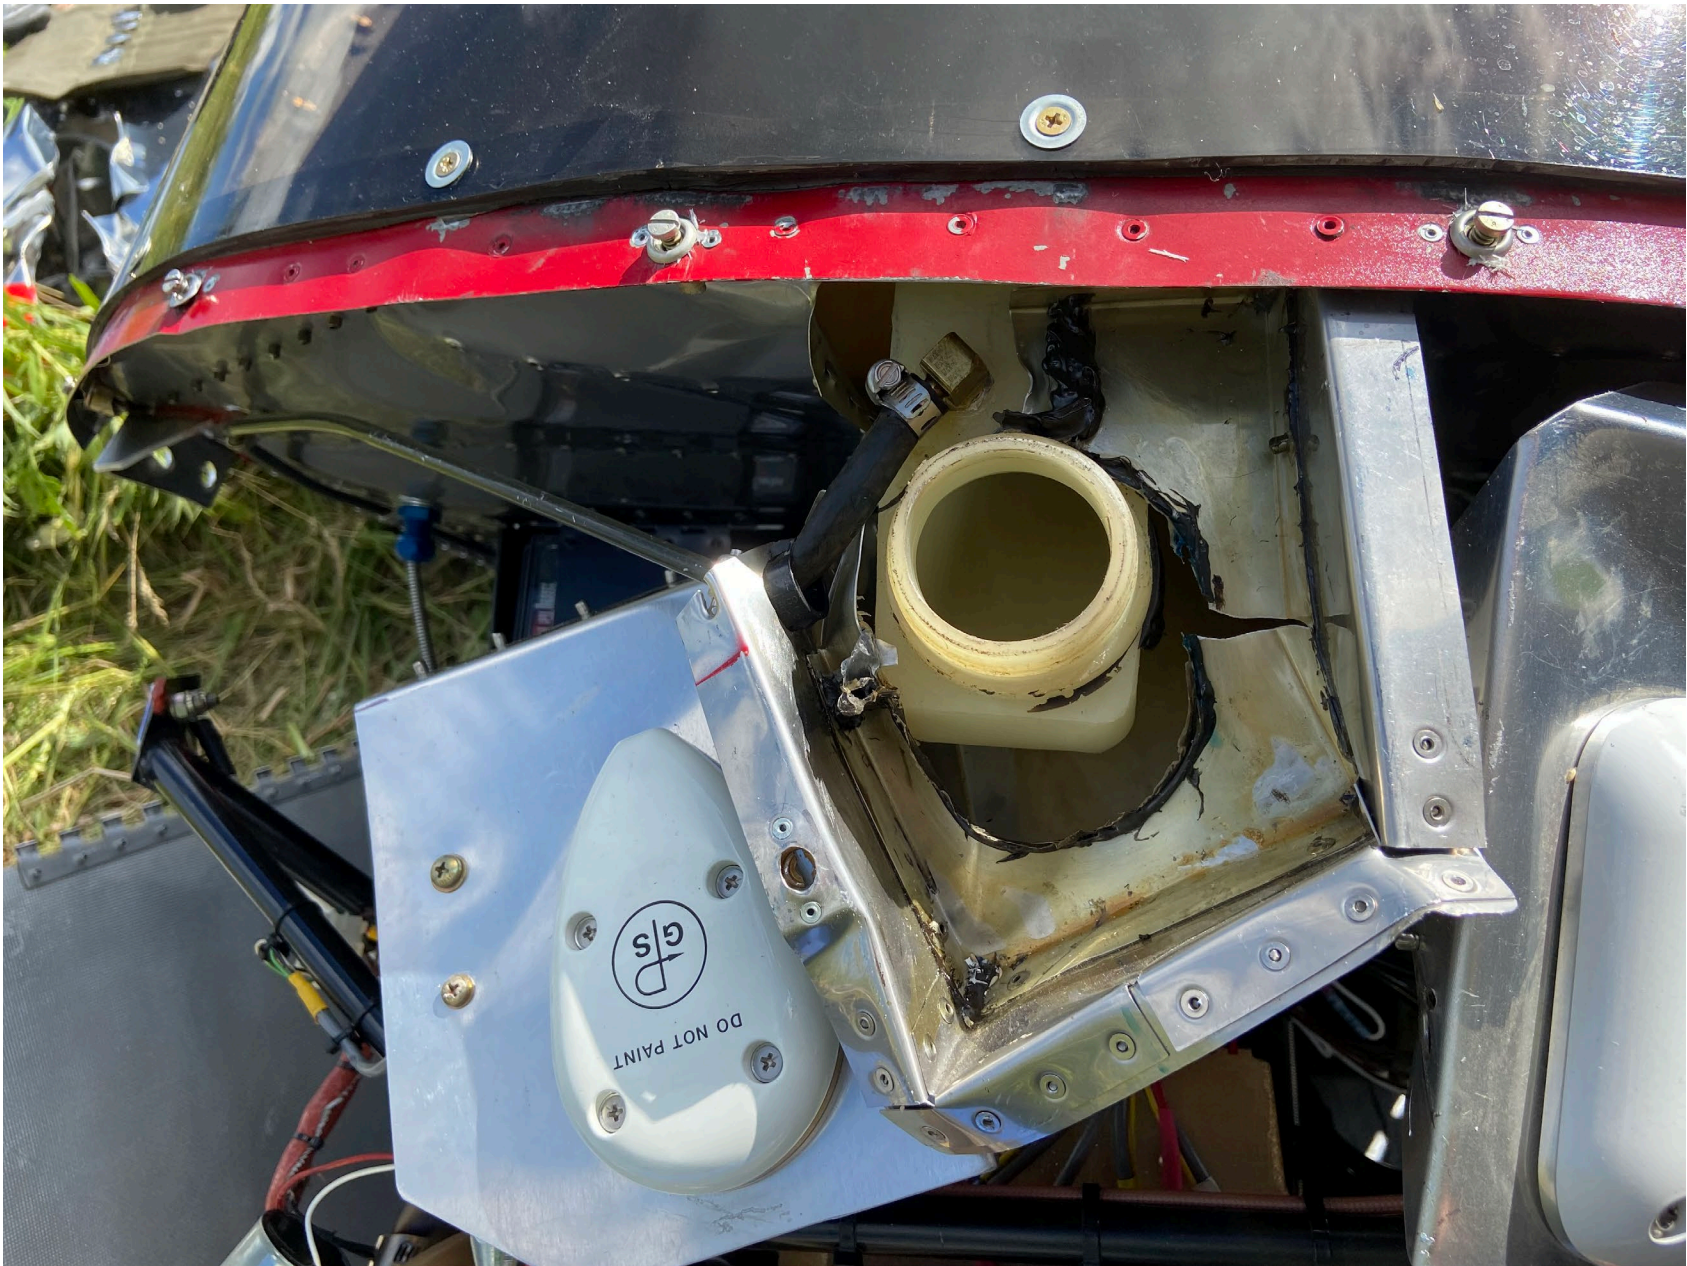
**Photo 4 – View of the fuel tank at the accident site, with the fuel tank cap removed (courtesy of the Federal Aviation Administration).**

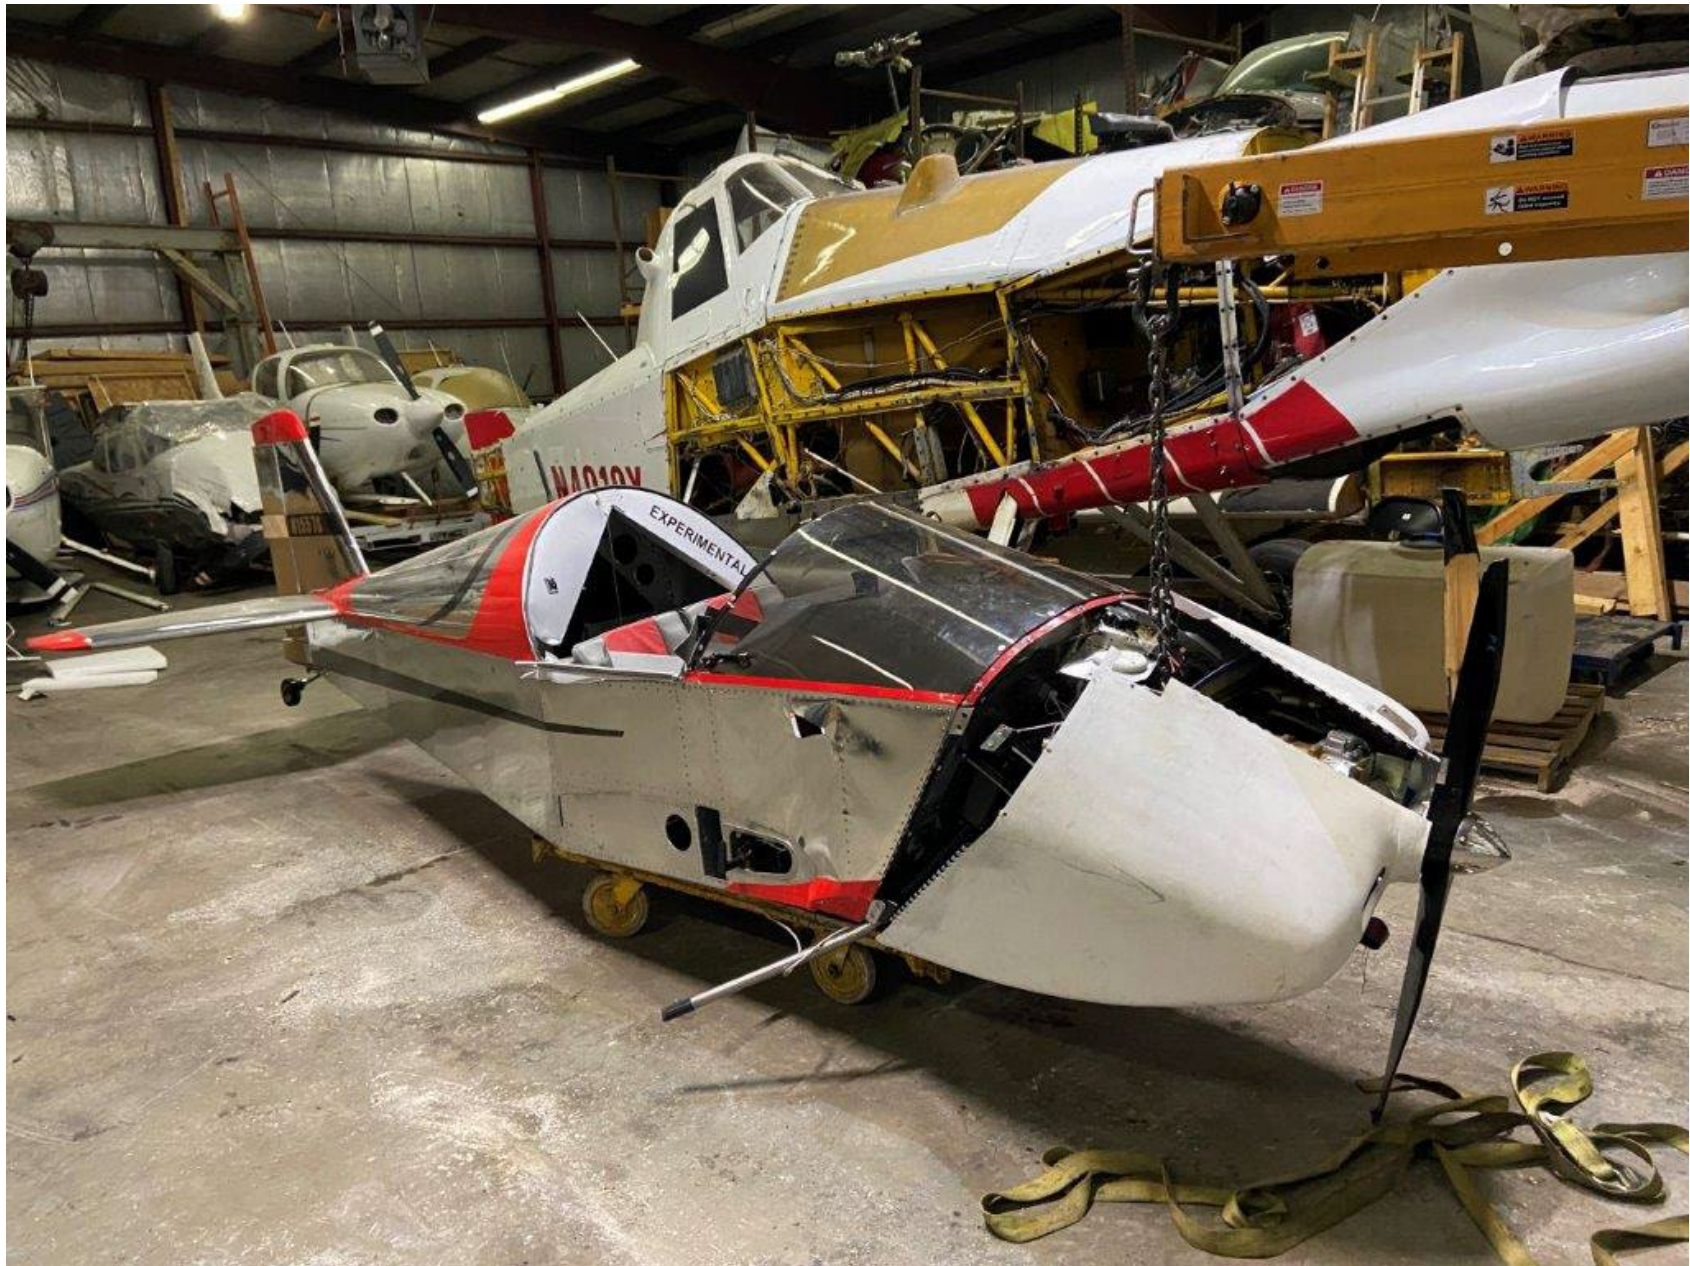
**Photo 5 – View of the right side of the airplane at the salvage facility (courtesy of the Federal Aviation Administration).**

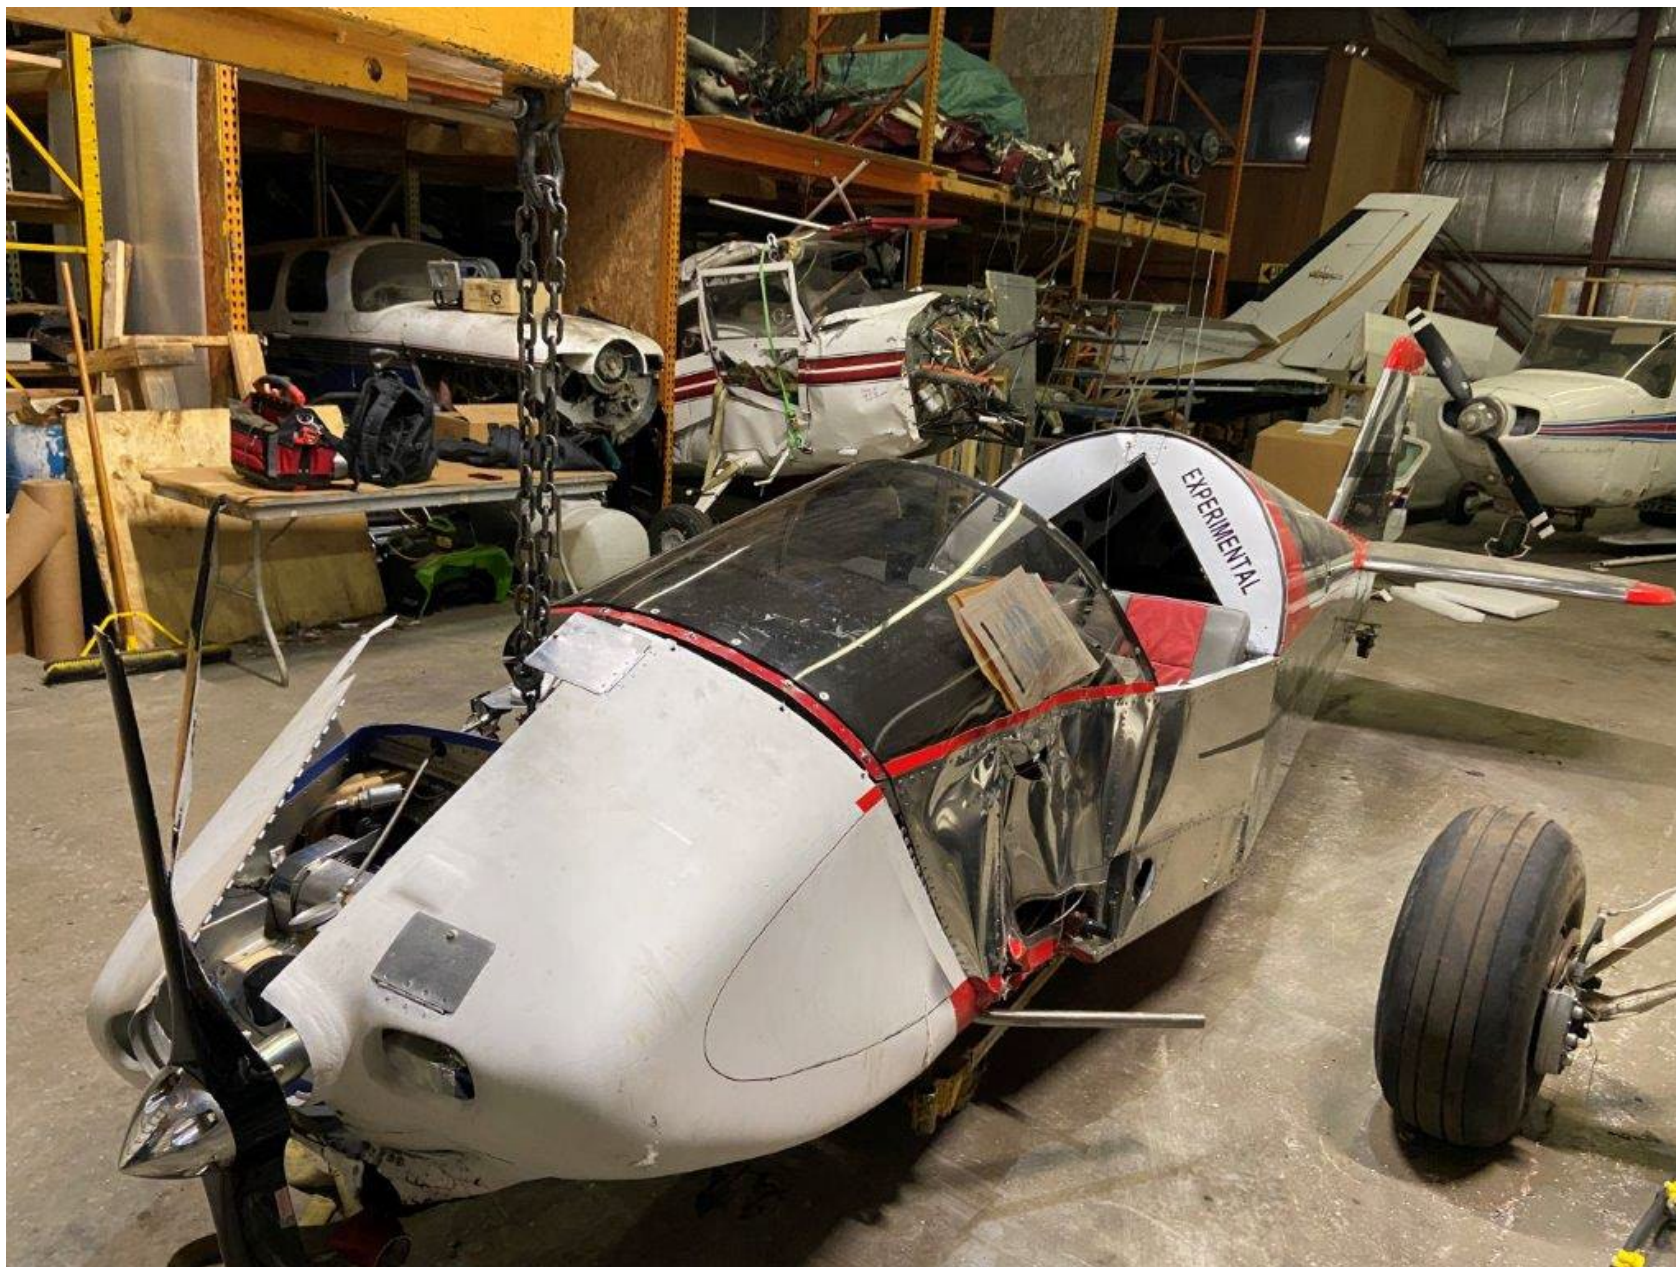
**Photo 6 – View of the left side of the airplane at the salvage facility (courtesy of the Federal Aviation Administration).**

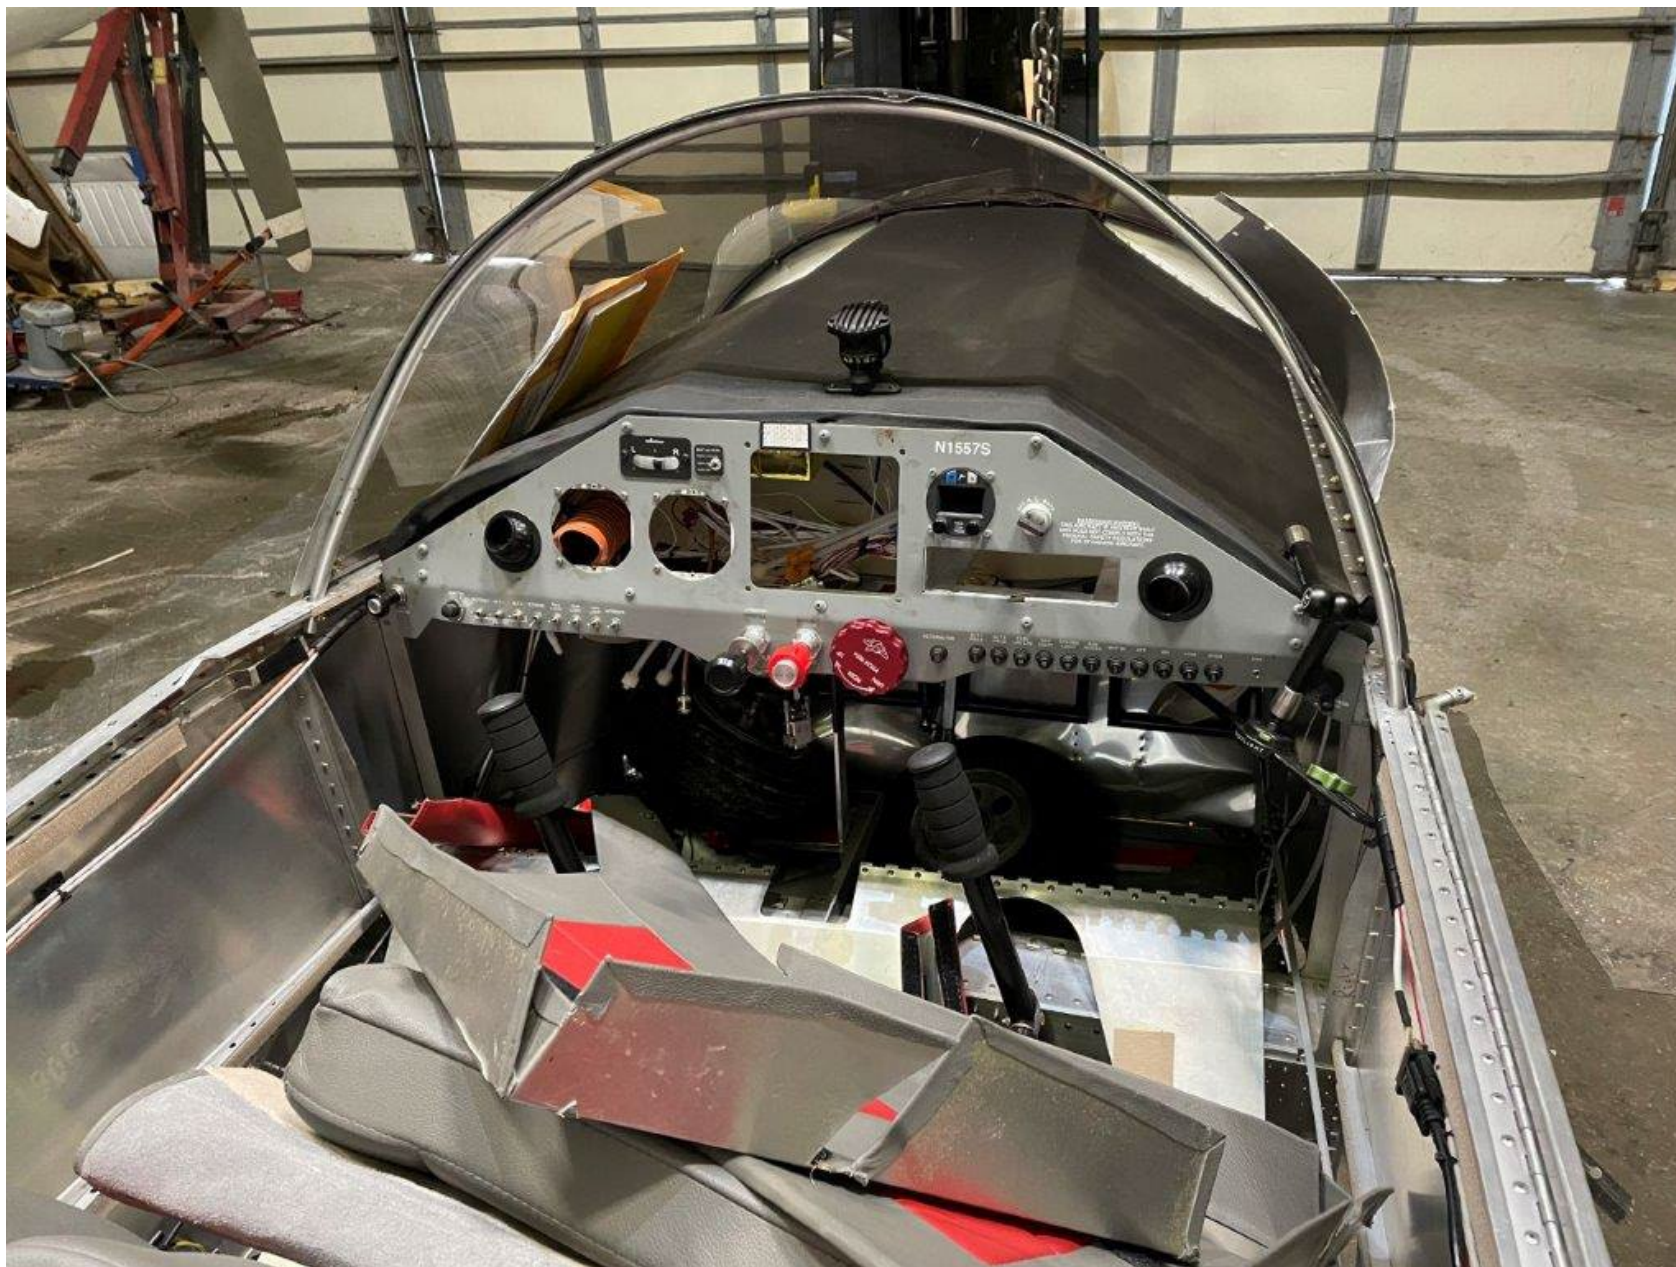
**Photo 7 – View of the cockpit at the salvage facility (courtesy of the Federal Aviation Administration).**

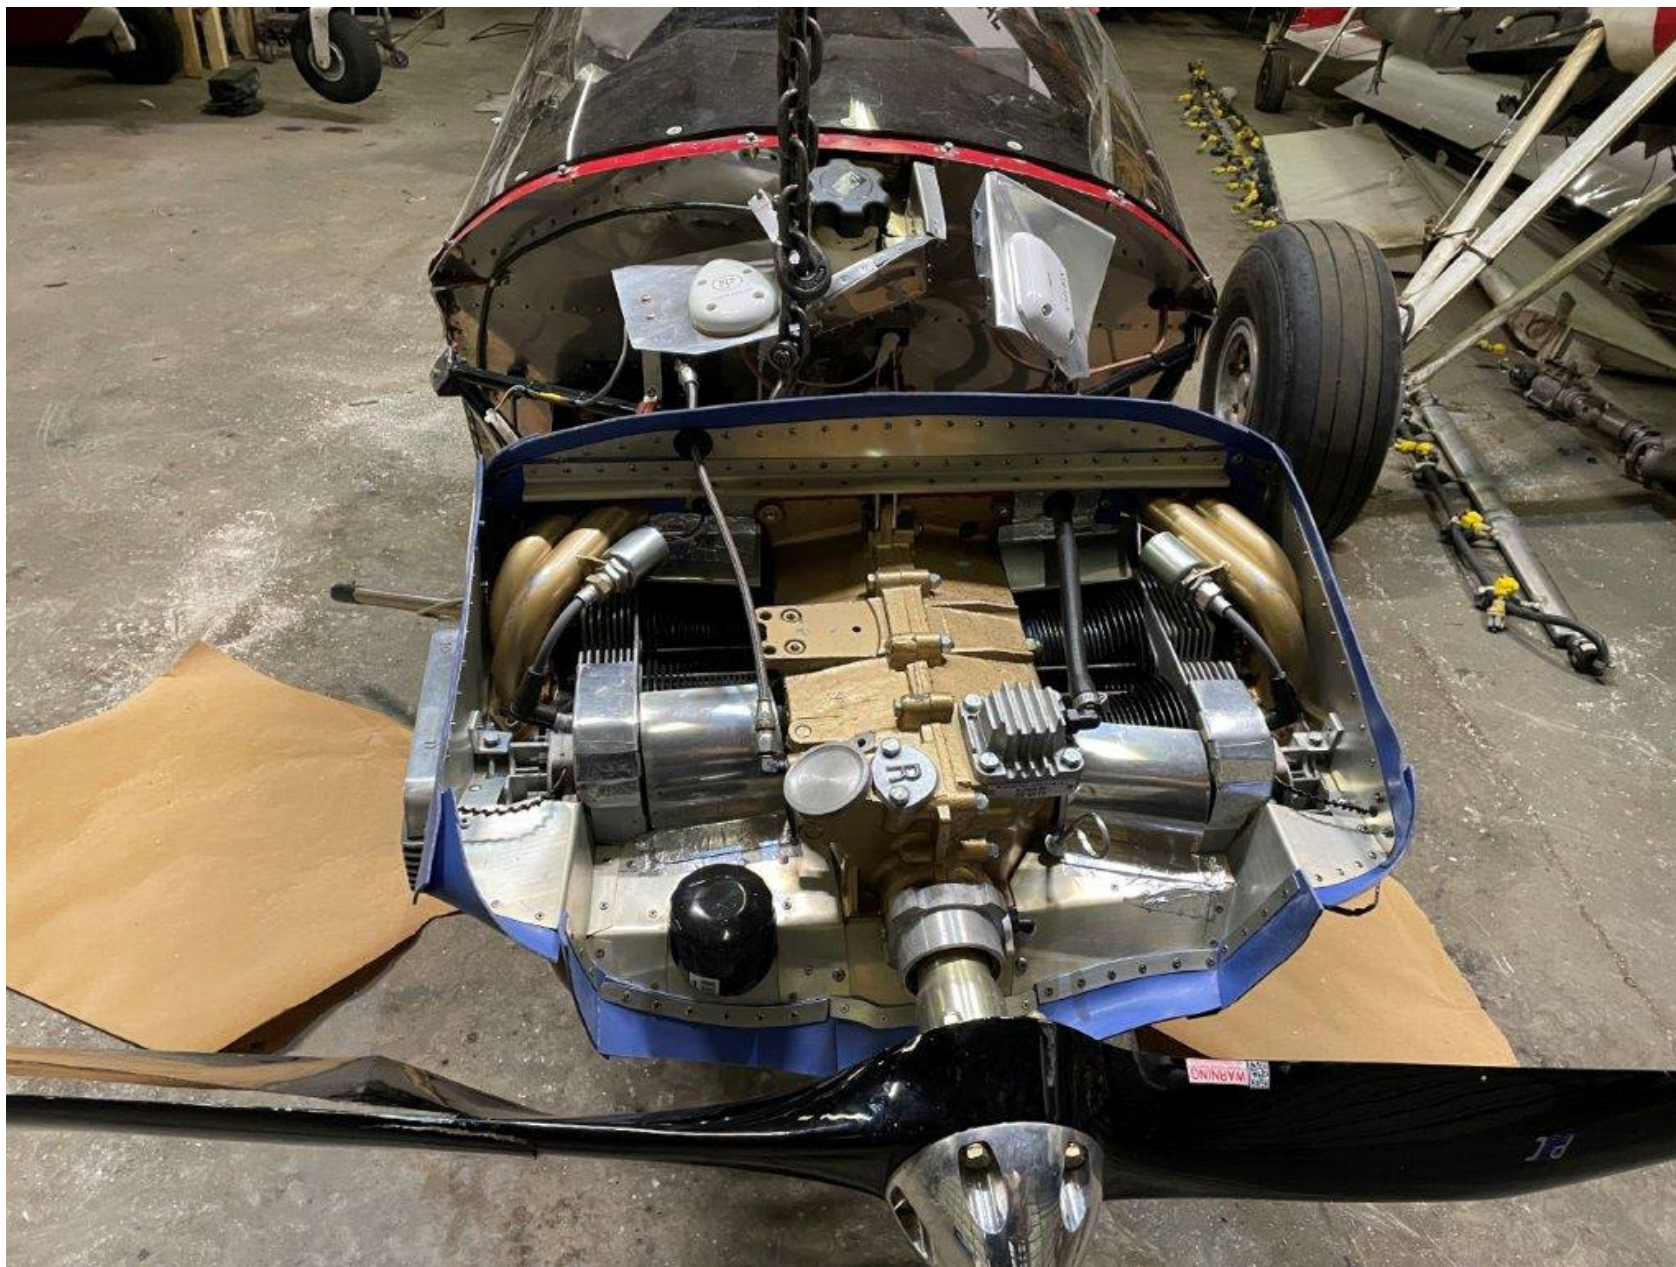
**Photo 8 – View of the propeller and the front of the engine at the salvage facility (courtesy of the Federal Aviation Administration).**

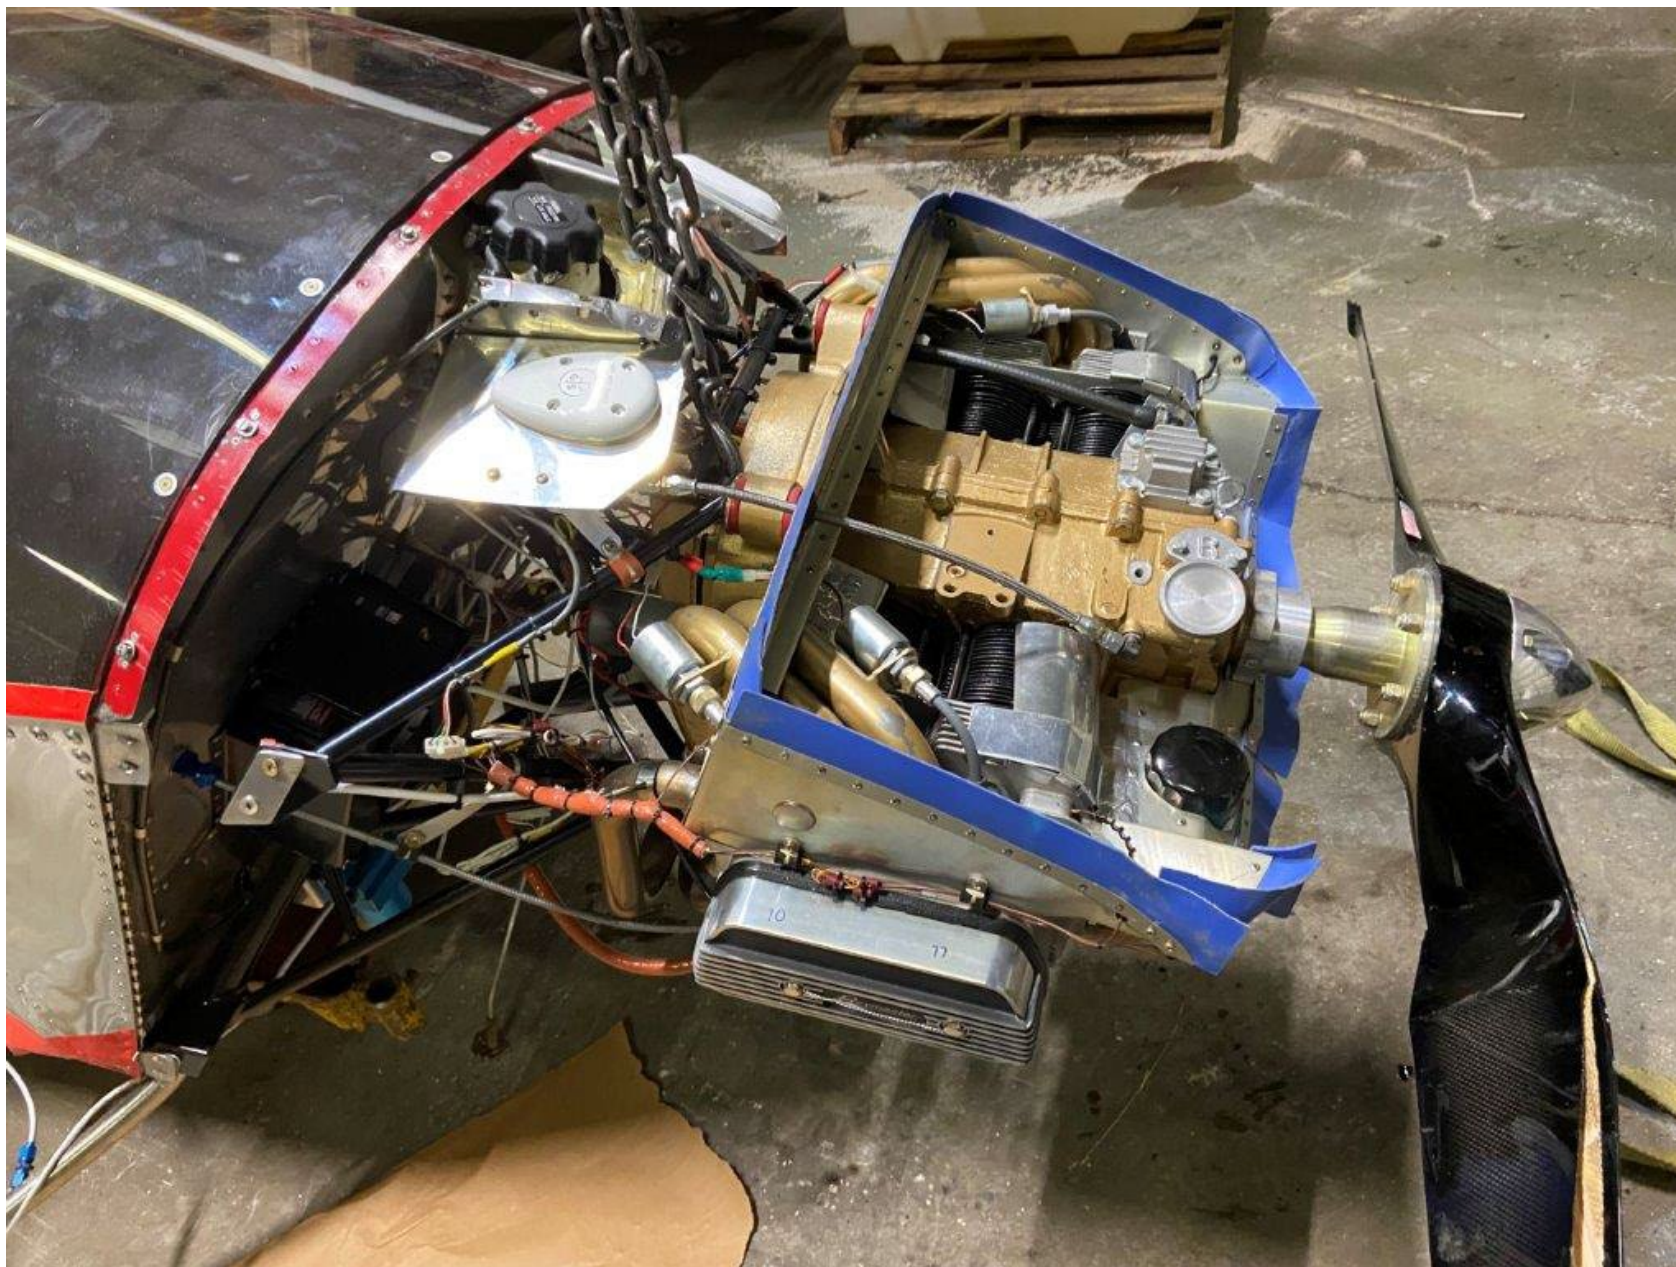
**Photo 9 – View of the right side of the engine at the salvage facility (courtesy of the Federal Aviation Administration).**

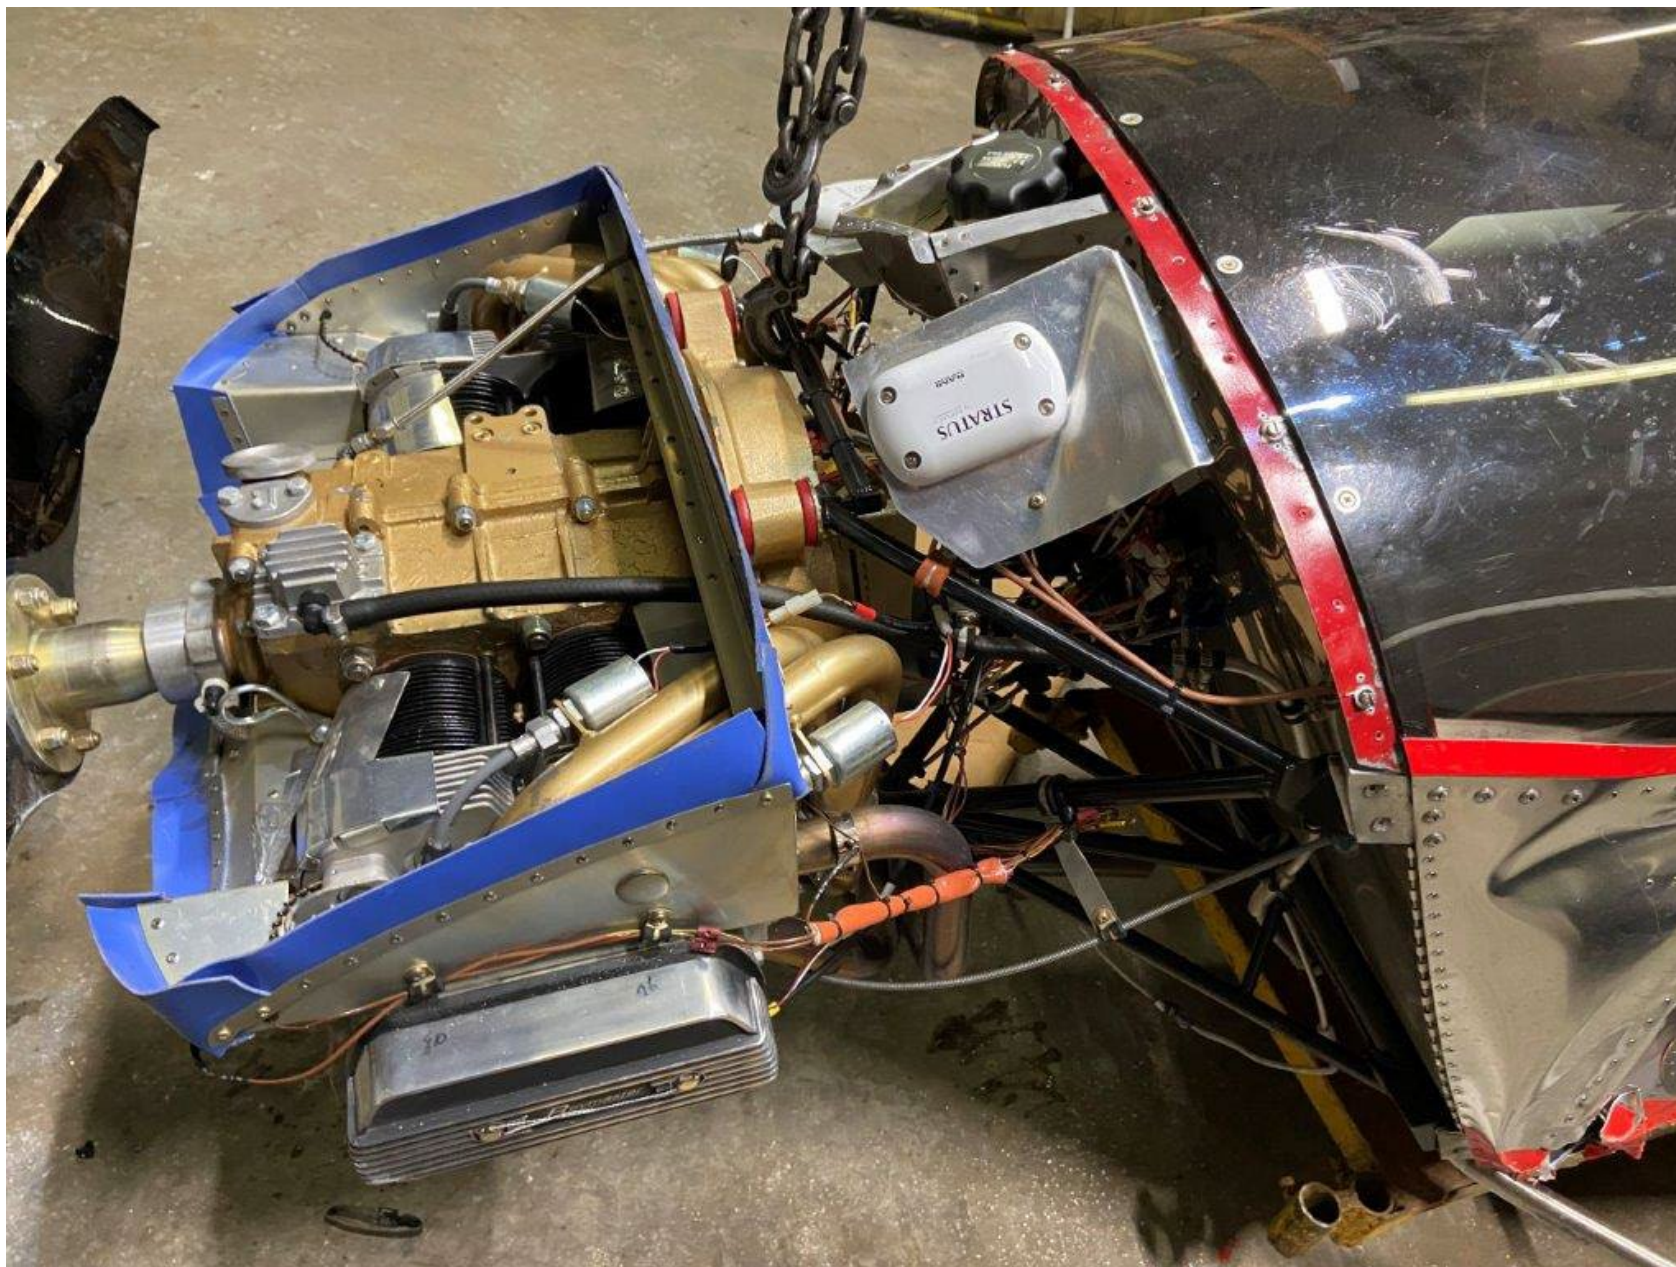
**Photo 10 – View of the left side of the engine at the salvage facility (courtesy of the Federal Aviation Administration).**
